Air Transportation Safety Investigation Report A18A0018

IN-FLIGHT ELECTRICAL ARCING

Porter Airlines Inc.
Bombardier DHC-8-402, C-GLQG
Fredericton, New Brunswick, 45 nm SW
10 March 2018

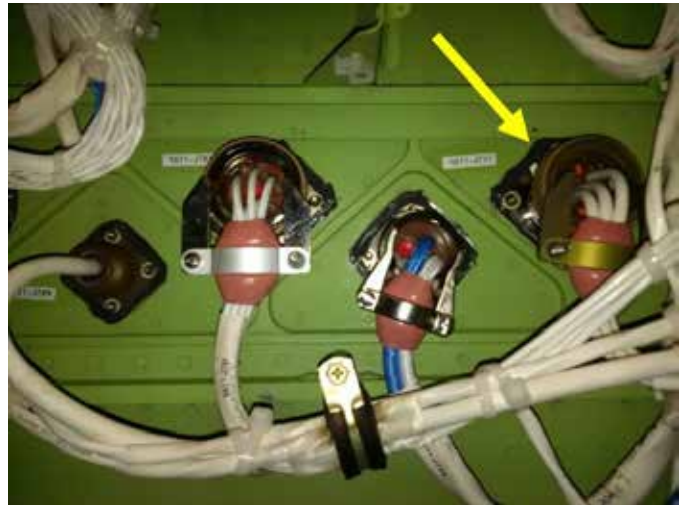
The 9811-J711 connector (part number MS3450L24-11S) is a bulkhead-mount-type electrical connector with a threaded coupling nut. The wires of the 9811-J711 connector are crimped into connector pins that are retained in the connector insulation insert using pin-locking mechanisms, and are secured in position by a strain relief clamp on its 90° backshell (Figure 1). The current carrying capacity of each of the 8-gauge sockets in connector 9811-J711 is rated at 46 A.

Figure 1. The 9811-J711 electrical connector, indicated by the arrow (Source: Bombardier Aerospace, with TSB annotations)

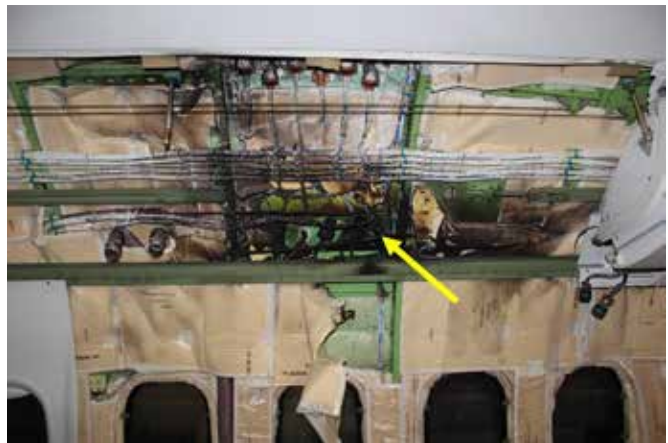
The electrical arcing that occurred before the 50 A thermal-type circuit breaker tripped caused minor pitting damage to adjacent wiring bundles, and heat damage and sooting to the insulation blankets and the structure of the outer panel of the overhead baggage compartment (Figure 2 and Figure 3).

Figure 2. Area of heat damage at row 14 of the occurrence aircraft, shown with left cabin wall upholstery removed (arrow indicates electrical connector 9811-J711)

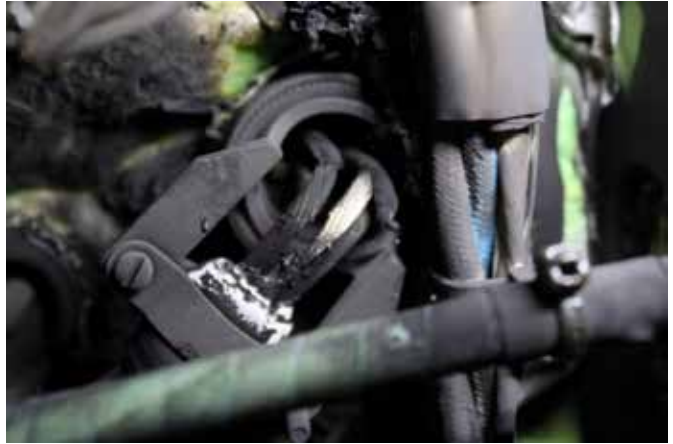
The 50 A thermal-type circuit breaker in the left engine nacelle AC control box was found to have tripped. The source of the smoke and heat damage was determined to be arcing from the 9811-J711 electrical connector plug assembly in the fuselage at the left-wing-root area. The arcing damage of the electrical connector is consistent with an electrical short circuit within the connector. Because of the destructive nature of this arcing, the connector pin-locking mechanisms and insulation insert material were obliterated, and the source of the electrical short could not be identified.

The TSB Engineering Laboratory performed a computerized tomography (CT) scan of the occurrence electrical connector, then generated 3-dimensional models of the connector superimposed on wiring to represent the manufacturer-specified minimum and the maximum wiring bend radius between the pin-locking mechanisms and the strain relief clamp. The 3-dimensional models were compared to occurrence images, and it was determined that the wiring alignment was correct and that the actual bend radius of the wiring was within manufacturer specifications.

Figure 3. Electrical connector 9811-J711 on the occurrence aircraft
