Railway Transportation Safety Investigation Report R17Q0088

CROSSING COLLISION

Mile 77.2, Canadian National Railway Company La Tuque Subdivision

25 October 2017

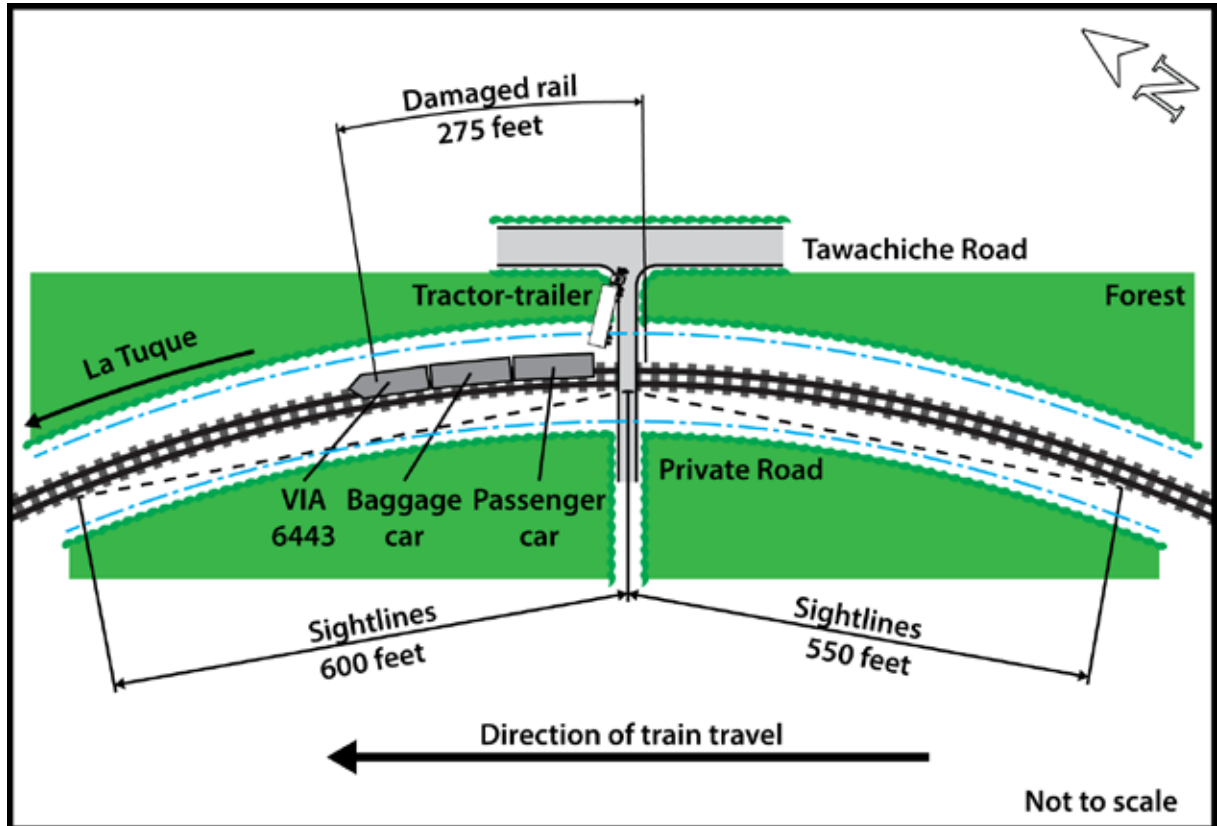
Figure 2. Derailment site at Mile 77.2 of the La Tuque Subdivision

The truck had been pushed in the ditch and was on its left side, perpendicular to the track, in the northwest quadrant of the crossing (Figure 2).

The load of logs rolled over and the trailer was twisted. Approximately 200 litres of diesel spilled from the truck's fuel tank.²

Grooves were visible on the ties starting about 20 feet east of the crossing and extending to the west along the track up to the front wheels of the locomotive. The ties were grooved and some of them were destroyed. The derailed wheels travelled over the tie plates and anchors at the gauge side of the south rail for a distance of about 275 feet. The north rail was rolled out and wheel marks were observed along the web extending west up to the front of the locomotive. Approximately 250 feet of rail had to be replaced.
