Rail Transportation Safety Investigation Report R17T0170

EMPLOYEE INJURY

Canadian Pacific Railway
Freight train 141-30
Mile 113.0, Galt Subdivision
London, Ontario
31 July 2017

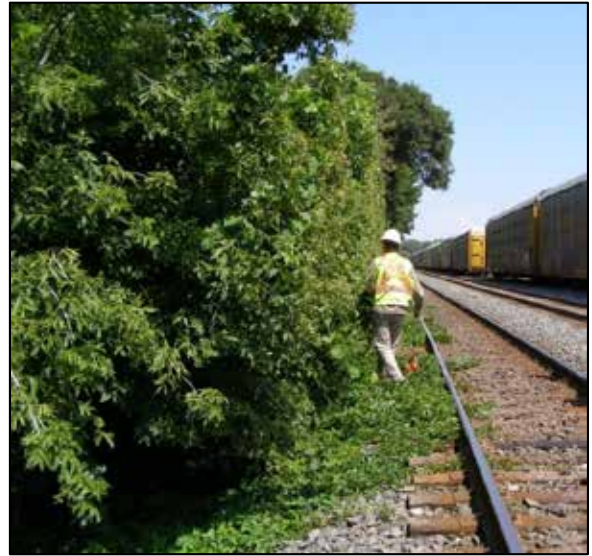
Over the next 5 minutes, the conductor followed normal protocol for calling distance to couple. About 25 seconds after the conductor radioed "30 cars," the LE advised the conductor that the distance counter was indicating 1000 feet to go. Almost immediately, the conductor told the LE to stop the movement. Unknown to the LE, the head end of the movement had encountered thick brush along the railway right-of-way (Figure 3). The thick brush rubbed against the side of the car, making it difficult for the conductor to hold on to the car.

Figure 3. View of brush encountered by the conductor

During post-occurrence examination of the site, more than 370 feet of continuous dense brush was present along the north side of the railway right-of-way, encroaching to within about 2 feet of the north rail. When riding the side of a typical rail car, a crew member would be positioned several feet beyond the field side of the rail.

Following this occurrence in London, CP immediately sent out a system bulletin to warn operating crews of the vegetation obstruction. Brush was then cleared in the area of the accident.
