# Marine Transportation Safety Investigation Report M17C0108

## GROUNDING

Tanker *Damia Desgagnés*  
St. Lawrence Seaway, near Morrisburg, Ontario  
15 June 2017

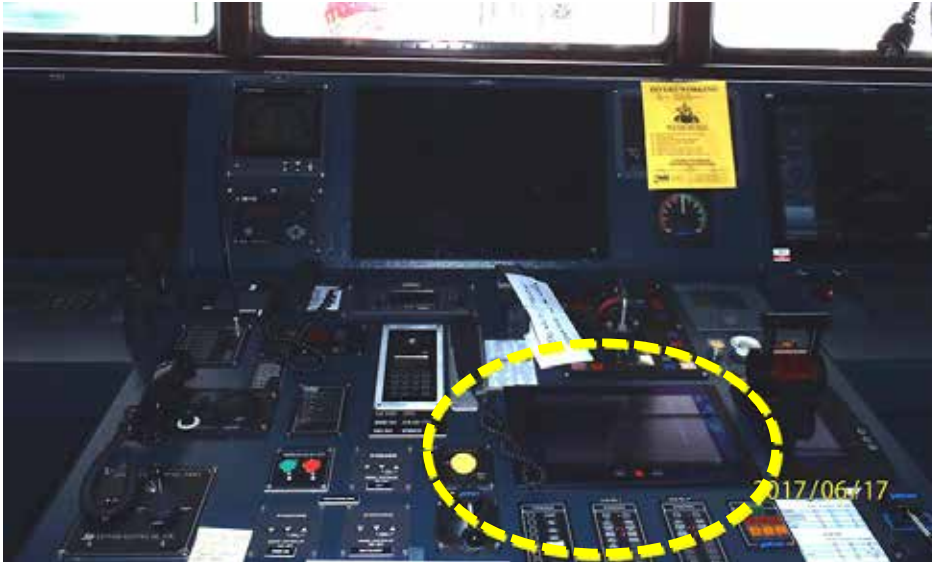
The investigation found that the main engine had been inadvertently shut down by the accidental activation of the main engine shutdown button on the integrated alarm monitoring and control system touch screen on the bridge. The touch screen was mounted horizontally in the centre bridge console near the steering and propulsion controls (Figure 2). At the time of the loss of propulsion, 4 crew members were within 2 m of the screen. Post-occurrence testing showed that the touch screen was reactive to a variety of mediums including the telephone cord situated next to it. In Figure 2, the telephone cord is visible near the face of the screen.

Figure 2. Centre bridge console on the *Damia Desgagnés*, showing the horizontal mounting location of the integrated touch screen that was activated and caused the accidental main engine shutdown

On 17 June, the managing company installed a plastic cover over the vessel’s touch screen to prevent the recurrence of an inadvertent shutdown. On 21 December, after a thorough review, the equipment manufacturer disabled the main engine shutdown function of the touch screen and the plastic cover

was removed under the supervision of the managing company. Because the touch screen was highly sensitive, certain functions were removed from the wheelhouse without reducing the ability to properly control the ship. As of February 2018, these adjustments have been made to both company ships that are similarly equipped. In case of an emergency, the main engine can still be shut down from the bridge via the traditional shutdown button.

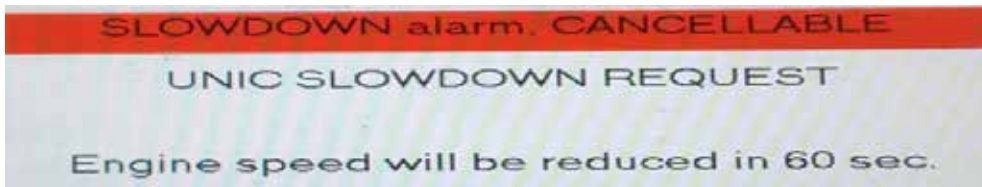
When the main engine shutdown button was activated on the touch screen, a generic system status message appeared on the touch screen, stating “SLOWDOWN alarm. CANCELLABLE UNIC<sup>2</sup> SLOWDOWN REQUEST[,] Engine speed will be reduced in 60 sec” (Figure 3). The message did not specify that the engine was about to shut down, nor did it indicate how the shutdown was activated or from where (bridge, engine room, emergency stop, etc.).<sup>3</sup>

Figure 3. Message following main engine shutdown on touch screen on bridge

Although the bridge team noticed this message, none of the bridge team crew members were aware of its meaning or that propulsion could be shut down in this manner.

Post-occurrence testing of the system determined that the slowdown alarm could not be cancelled, as seemed to be indicated in the on-screen message.

Since the message displayed on the touchscreen was ambiguous and did not clearly identify the abnormal situation or the source of the alarm, it caused distraction.

The message on the touch screen was unclear to the operator and did not correspond to the direction of action of the controlled equipment or provide a positive confirmation of the action. As well, the shutdown was able to be activated by a single push of a button.
