# Marine Transportation Safety Investigation Report M17C0205

## LOSS OF POWER AND SUBSEQUENT GROUNDING

Chemical product carrier *Bro Anna*  
Beauharnois, Quebec  
29 August 2017

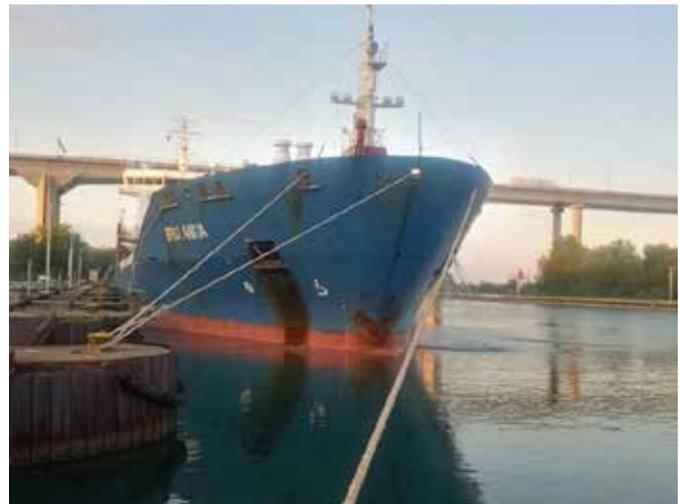
Figure 1. The *Bro Anna*

The *Bro Anna* (Figure 1) is a double-hulled chemical product carrier registered in the Marshall Islands (International Maritime Organization number 9344435). The superstructure and machinery space are located aft and the vessel's propulsion system consists of a main engine that drives a controllable pitch propeller. The vessel is fitted with 3 auxiliary generators, a bow thruster, a shaft generator, and an emergency generator.

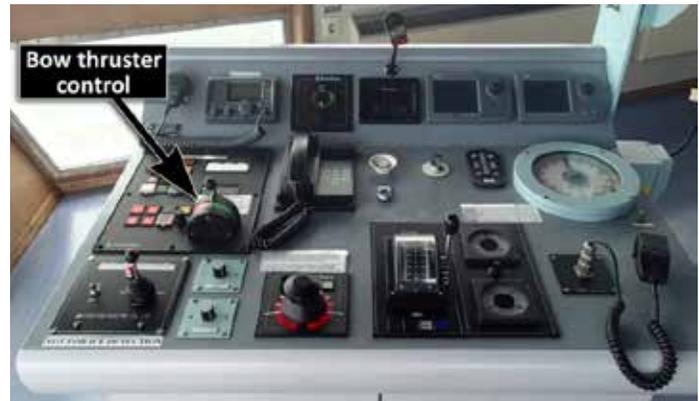
The bridge is equipped with 2 very high frequency (VHF) radiotelephones, an electronic chart display and information system (ECDIS), 2 radars, and 3 conning stations: 1 amidships, 1 port, and 1 starboard. The conning stations are fitted with controls for the main engine, the controllable pitch propeller, the bow thruster, and the steering gear (Figure 2).

Figure 2. Port conning station showing location of bow thruster control

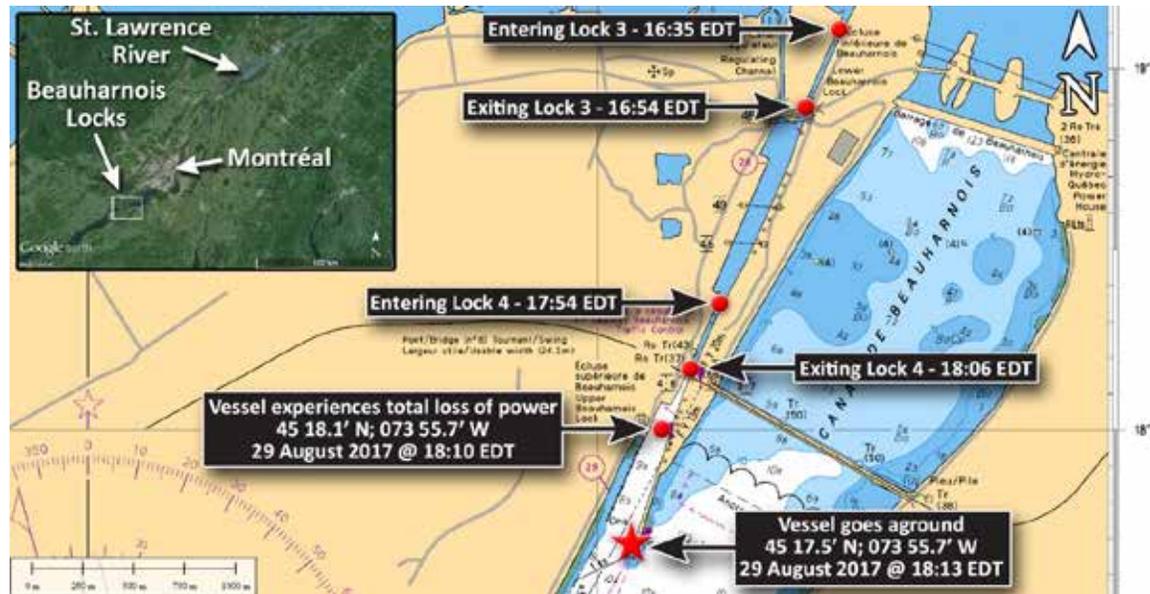
At 1813, the vessel made contact with the breakwater on the south side of the Beauharnois Canal and subsequently ran aground (Figure 3). The vessel's speed at the time of the grounding was estimated at 4.7 knots.

Figure 3. Vessel's progress through the locks until the time of the grounding (Source: Canadian Hydrographic Service and Google Earth, with TSB annotations)
