AVIATION INVESTIGATION REPORT

A15C0163

Icing encounter, loss of control, and collision with terrain

Wasaya Airways Limited Partnership
Cessna 208B, C-FKDL
Pickle Lake, Ontario, 10 nm N
11 December 2015

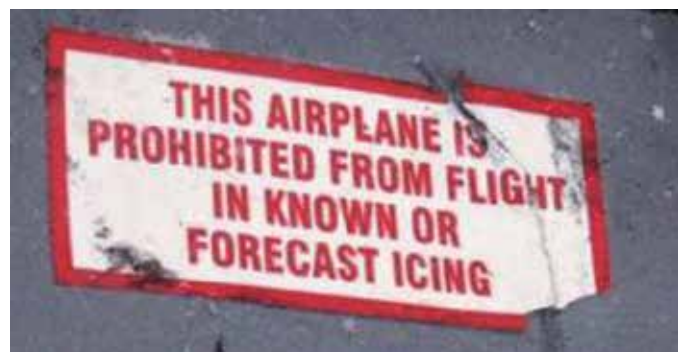
Figure 1. C-FKDL cockpit placard

C-FKDL was fitted with a McCauley aluminum 3-bladed, constant-speed, full-feathering, and reversible propeller. The aircraft was certified for day and night VFR as well as instrument flight rules (IFR) flight, and it was prohibited from flight in known or forecast icing conditions. The prohibition was prominently placarded in the cockpit in view of the pilot (Figure 1).

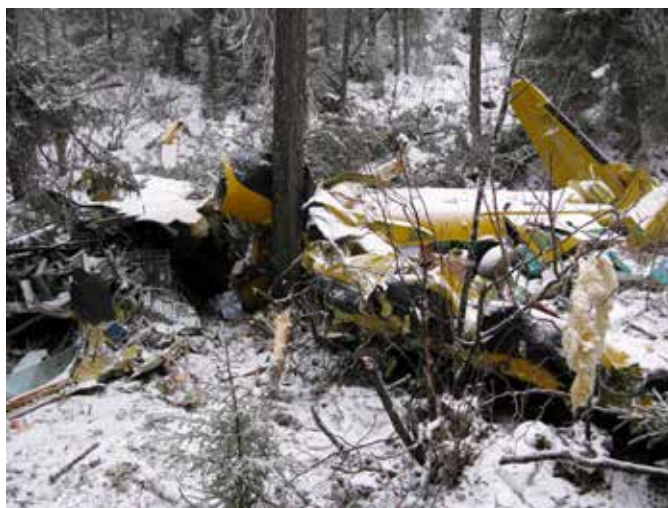
Figure 3. Left front view of wreckage

All of the damage to the aircraft was attributable to impact forces. All of the flight control surfaces and major structural components were found with the wreckage.

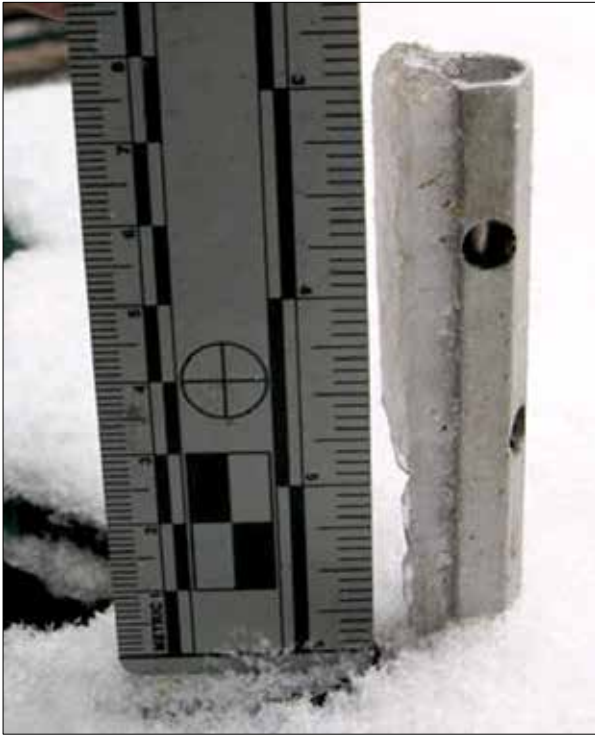
Examination of the airframe wreckage at the crash site revealed accretion of ice about five sixteenths of an inch thick on the outside air temperature probe (Figure 4), antennas (Figure 5), and other protruding components. There was residual ice on the de-icing boots on the vertical stabilizer (Figure 6), horizontal stabilizer (Figure 7), and right wing (Figure 8), indicating that the boots had been operated after in-flight accretion of ice.

Figure 4. Ice on the outside air temperature probe

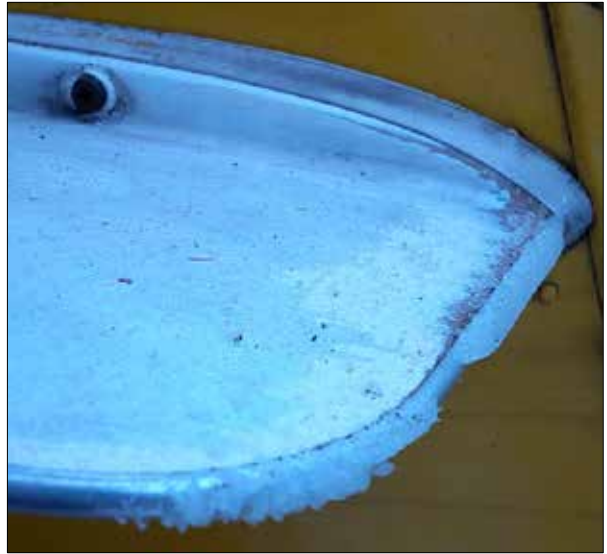
Figure 5. Ice on an antenna on the right side of the vertical stabilizer

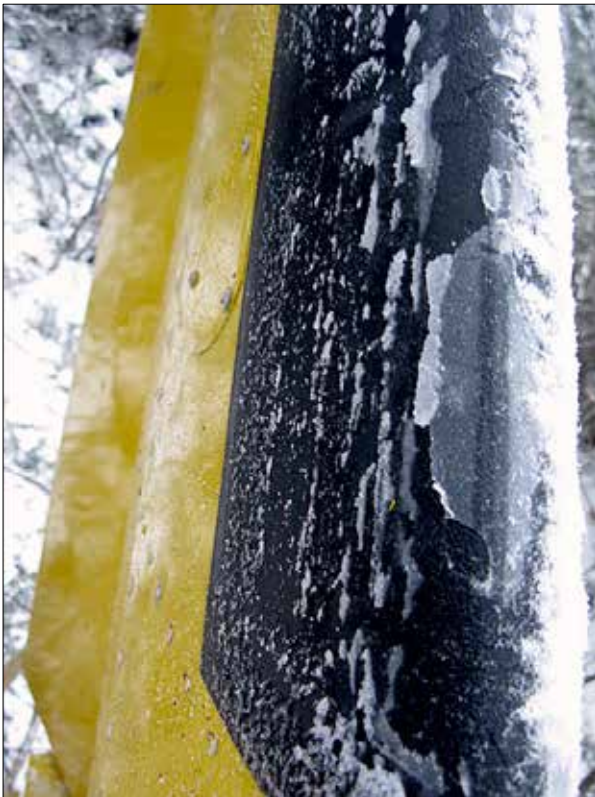
Figure 6. Ice on the right side of the vertical stabilizer

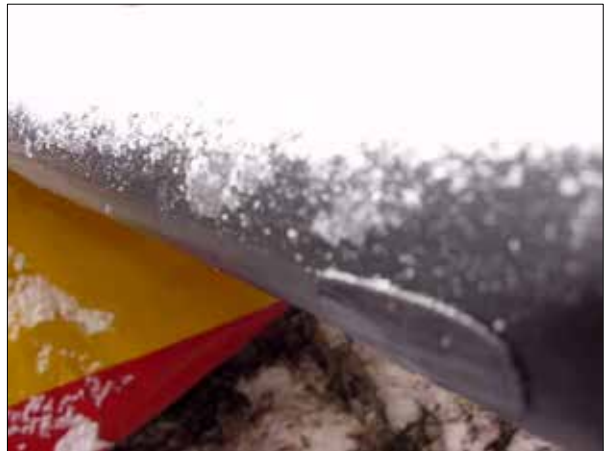
Figure 7. Ice on the leading edge of the left horizontal stabilizer

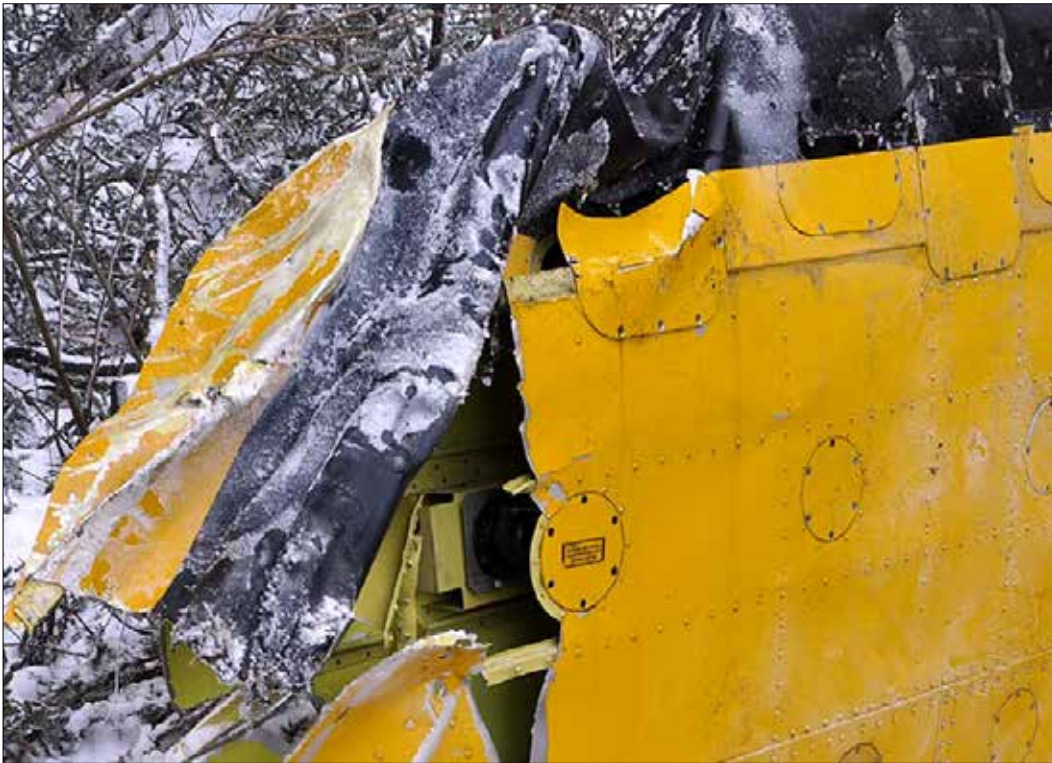
Figure 8. Ice on the leading edge of the right wing outboard section

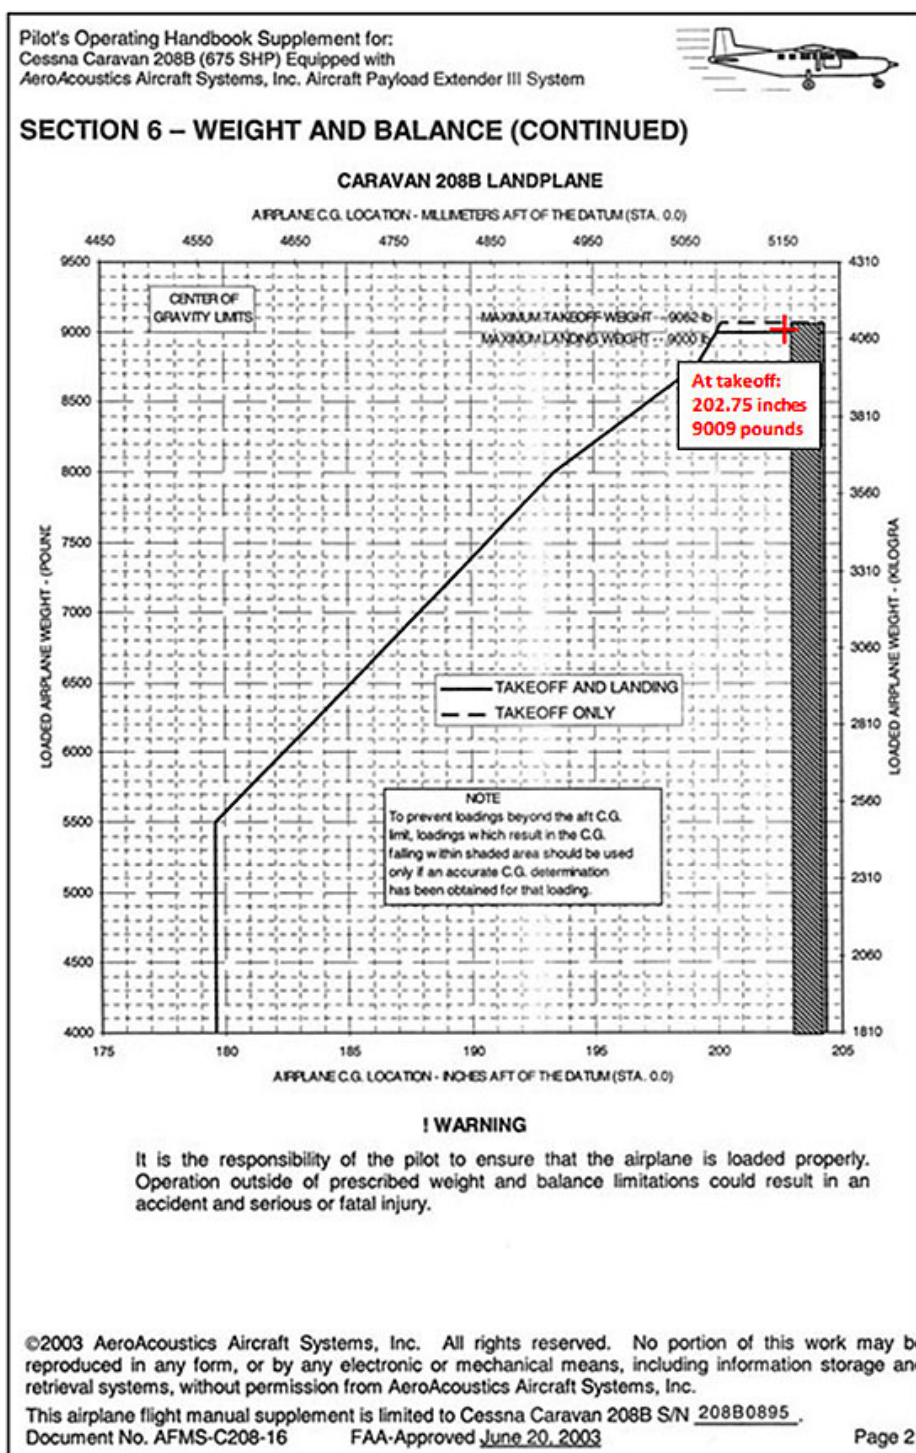
Appendix A – Weight and balance for flight WSG127

Investigators calculated the take-off weight for WSG127 at 9009 pounds, with a centre of gravity 202.75 inches aft of datum (Appendix A). The weight and centre of gravity were within the prescribed limits for an aircraft prohibited from operating in icing conditions.

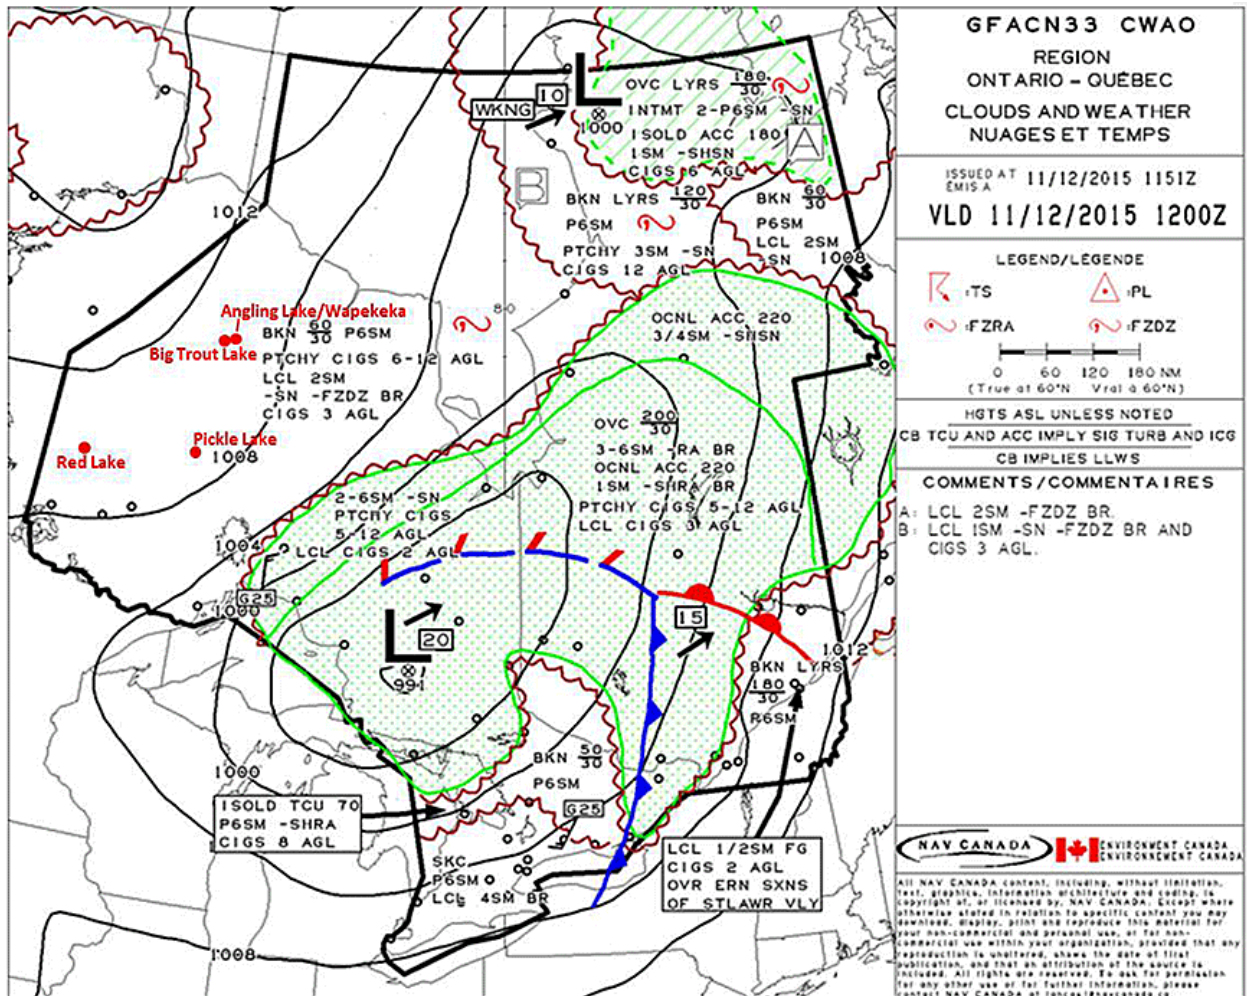
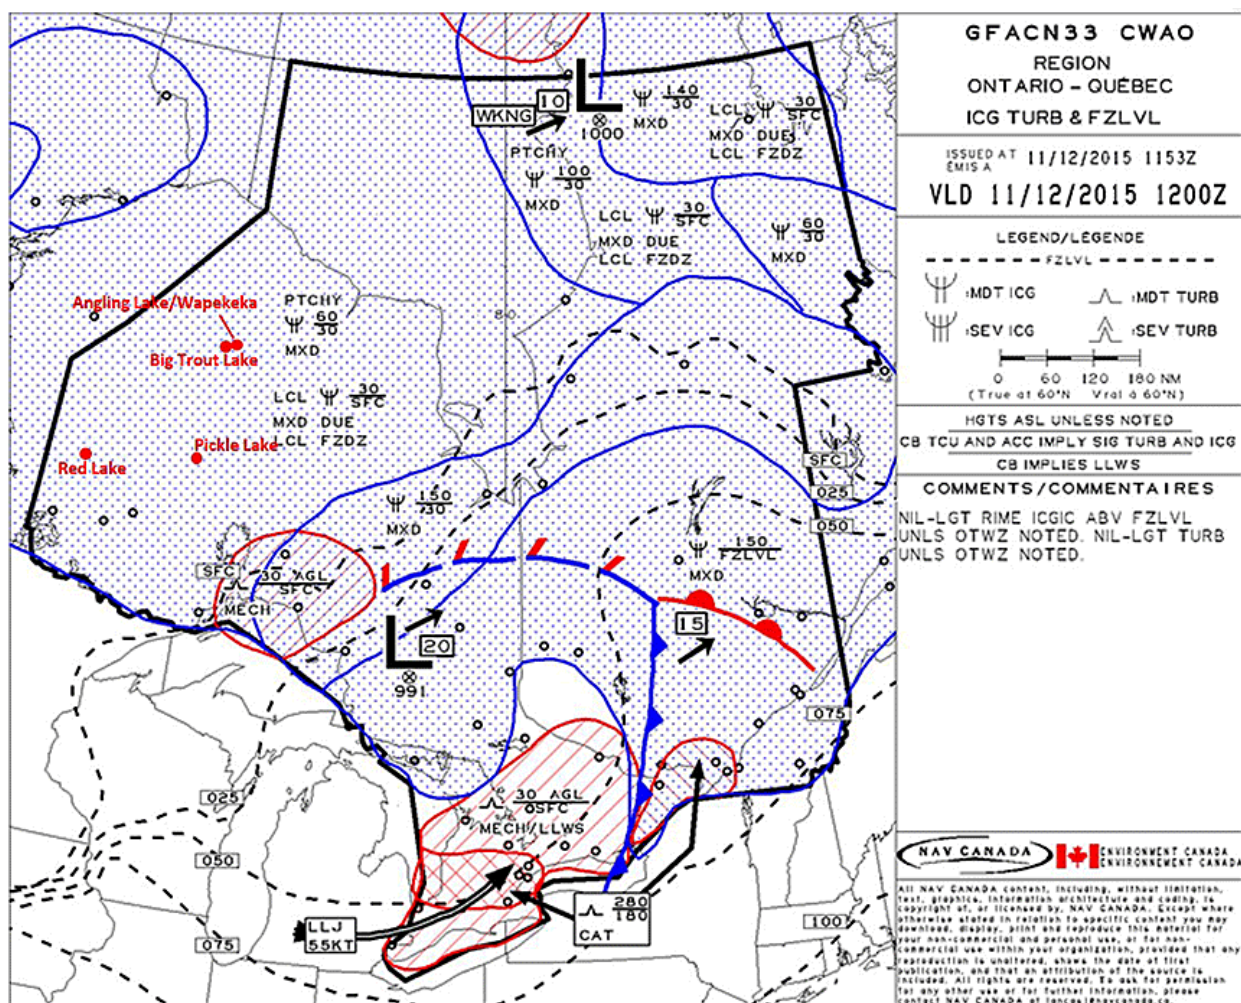
Appendix B – Graphical area forecast CN33 valid at 0700 EST (1200 UTC) 11 December 2015

Appendix B shows the 2 graphics of the Ontario–Quebec GFA valid at 0700, depicting the following conditions that were forecast over the northwestern Ontario region:

- Clouds and weather (issued at 0651): broken clouds based at 3000 feet ASL topped at 6000 feet ASL; patchy ceilings based at 600 to 1200 feet AGL; and local visibility 2 sm with light snow, light freezing drizzle, mist, and ceilings at 300 feet AGL.
- Icing, turbulence, and freezing level (issued at 0653): Freezing level at the surface; no moderate or severe turbulence; patchy moderate mixed icing between 3000 and 6000 feet ASL; and local moderate mixed icing from the surface to 3000 feet ASL due to freezing drizzle.
- No SIGMET or AIRMET was issued following the GFA.

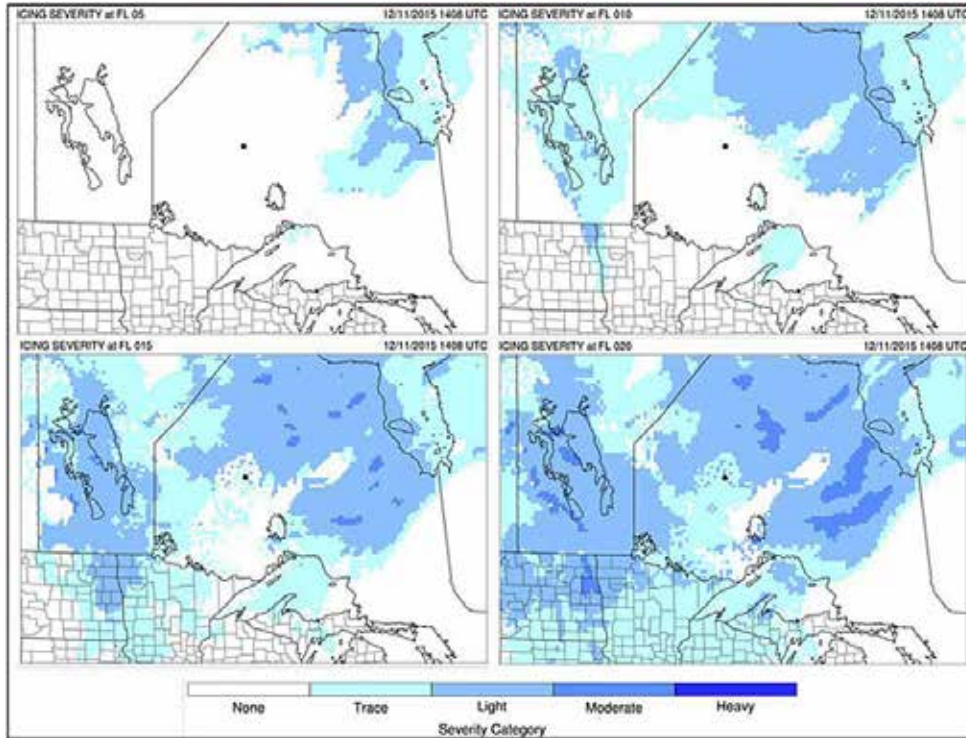
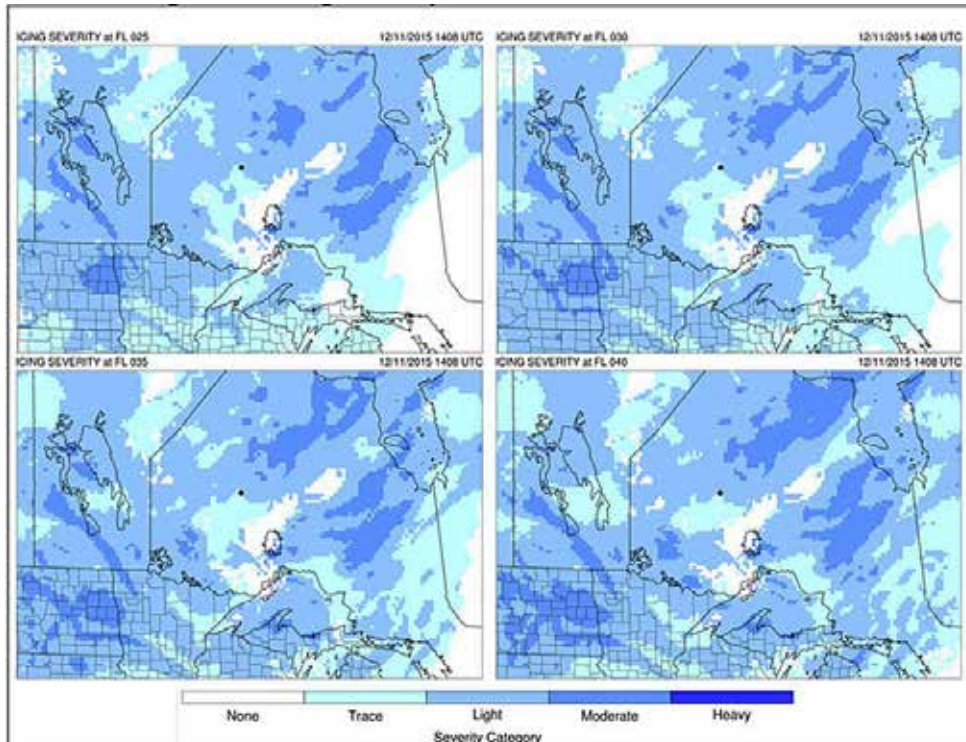
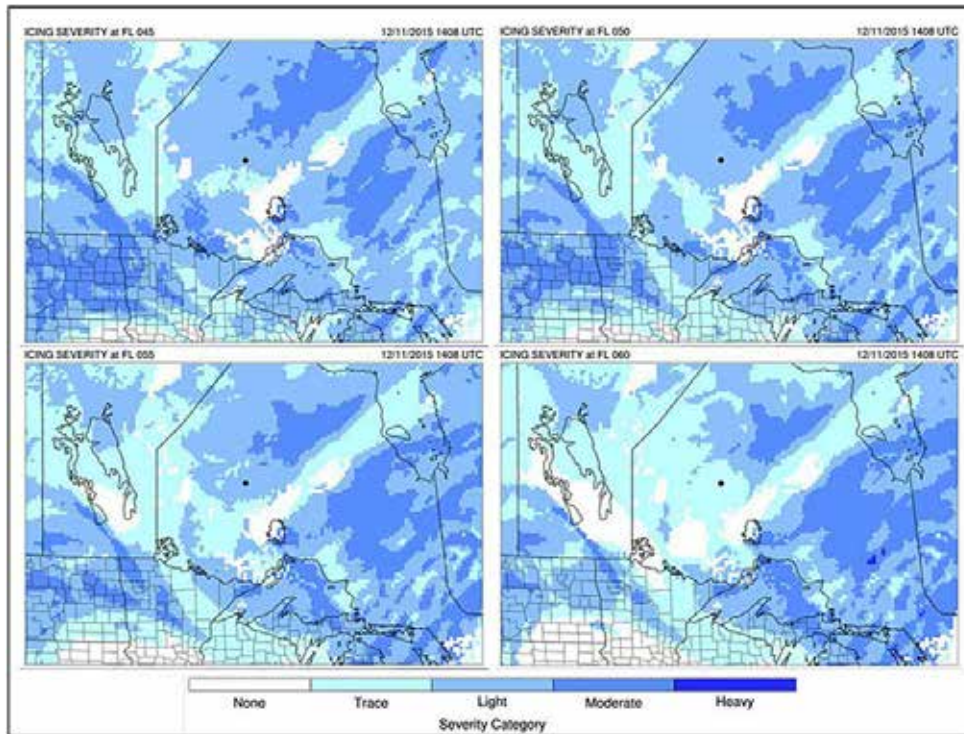
Appendix D – Current Icing Product showing severity of icing: 11 December 2015 at 0908 (1408 UTC)

The CIP icing severity graphics (Appendix D) depict the icing severity potential in the CYPL area as trace to light icing conditions from 1500 to 2500 feet ASL and as light icing conditions from 2500 to 5000 feet ASL.

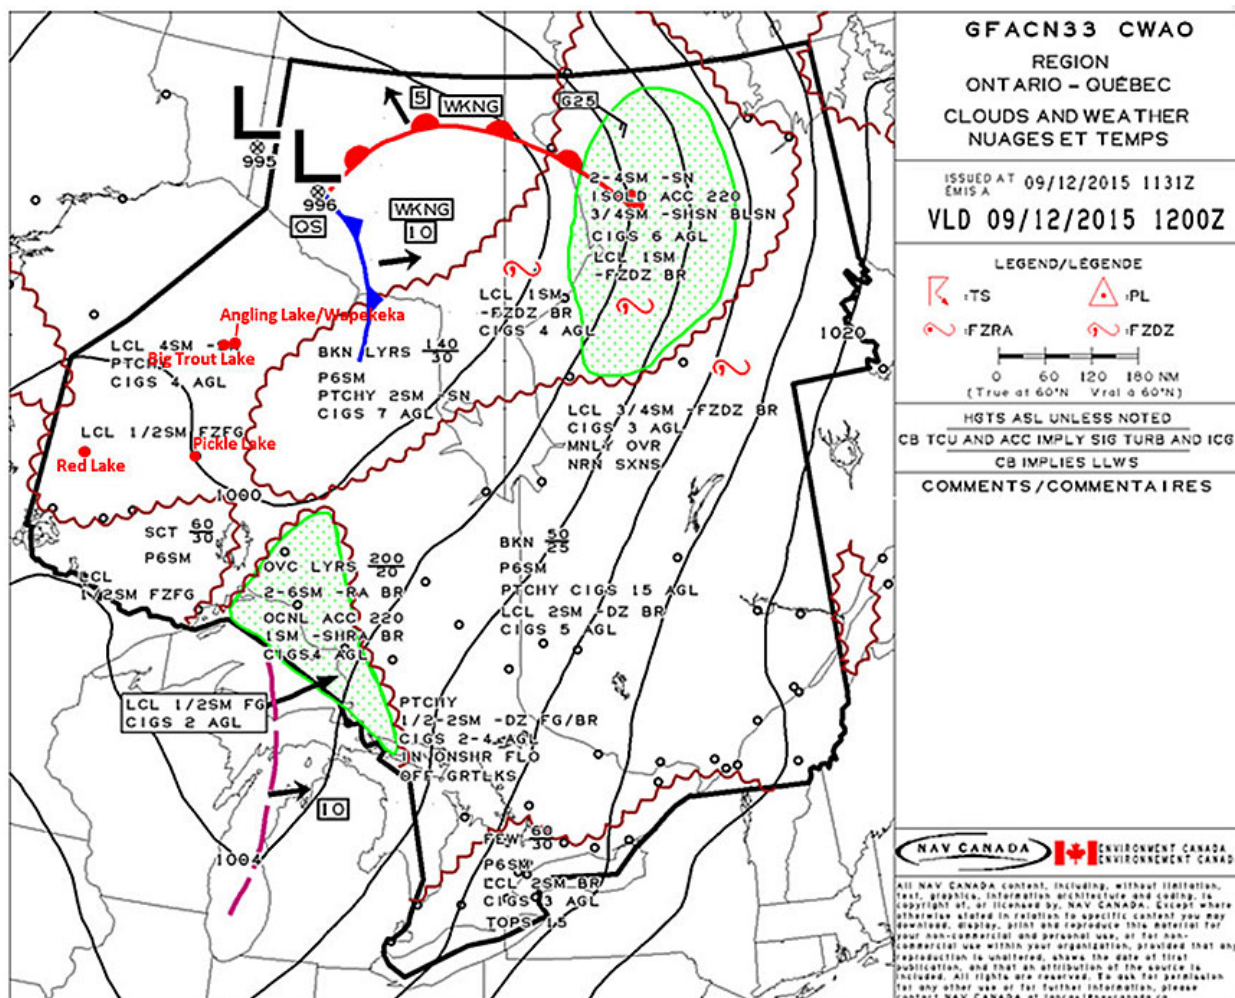
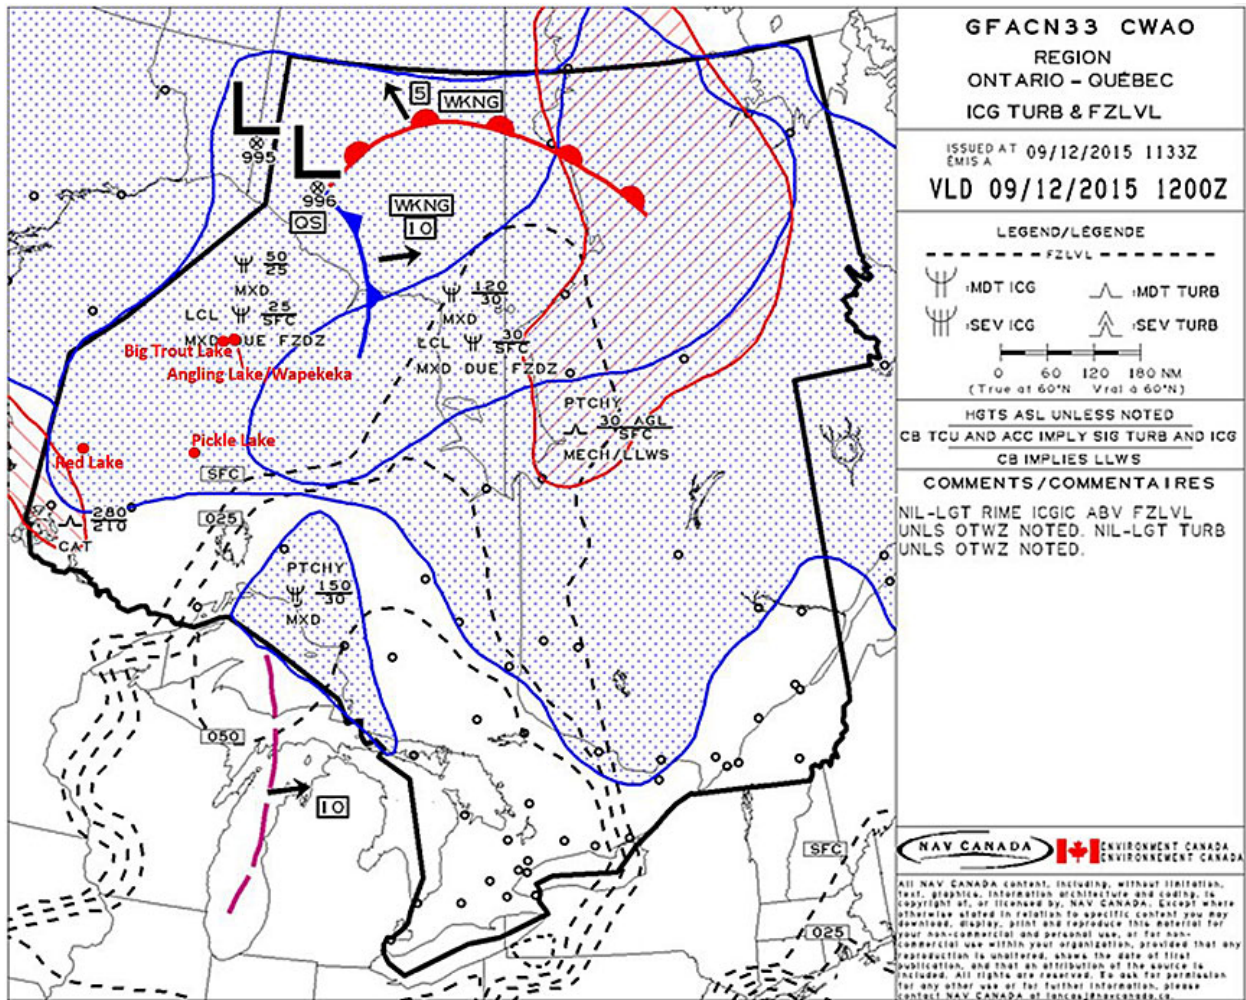
*Appendix F – Graphical area forecast CN33 valid at 0700 EST
(1200 UTC) 09 December 2015*

Appendix F shows 2 graphics from the Ontario–Quebec GFA valid at 0700 on 09 December 2015, depicting the following conditions, which were forecasted over the northwestern Ontario region:

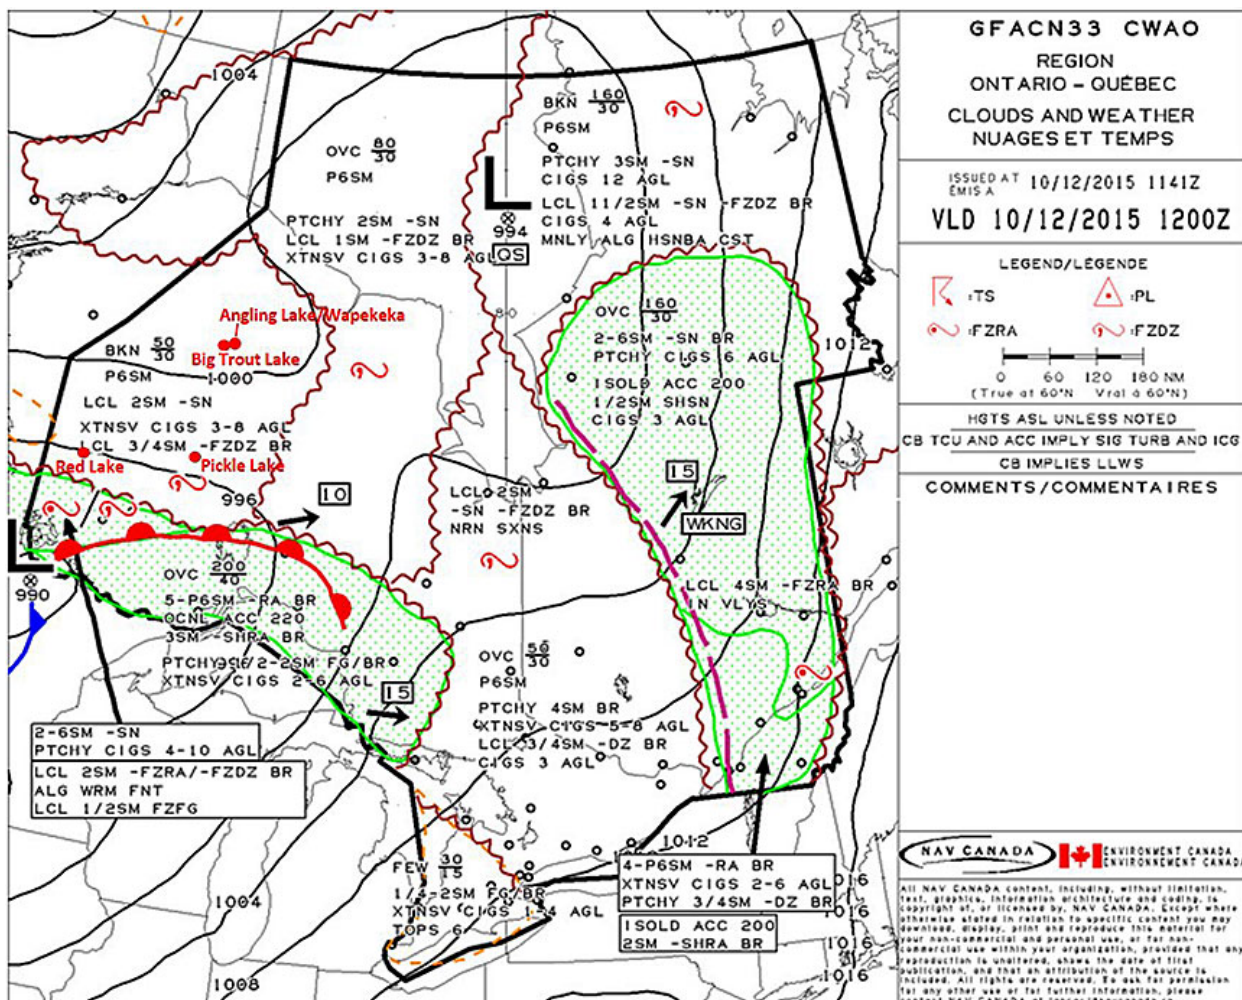
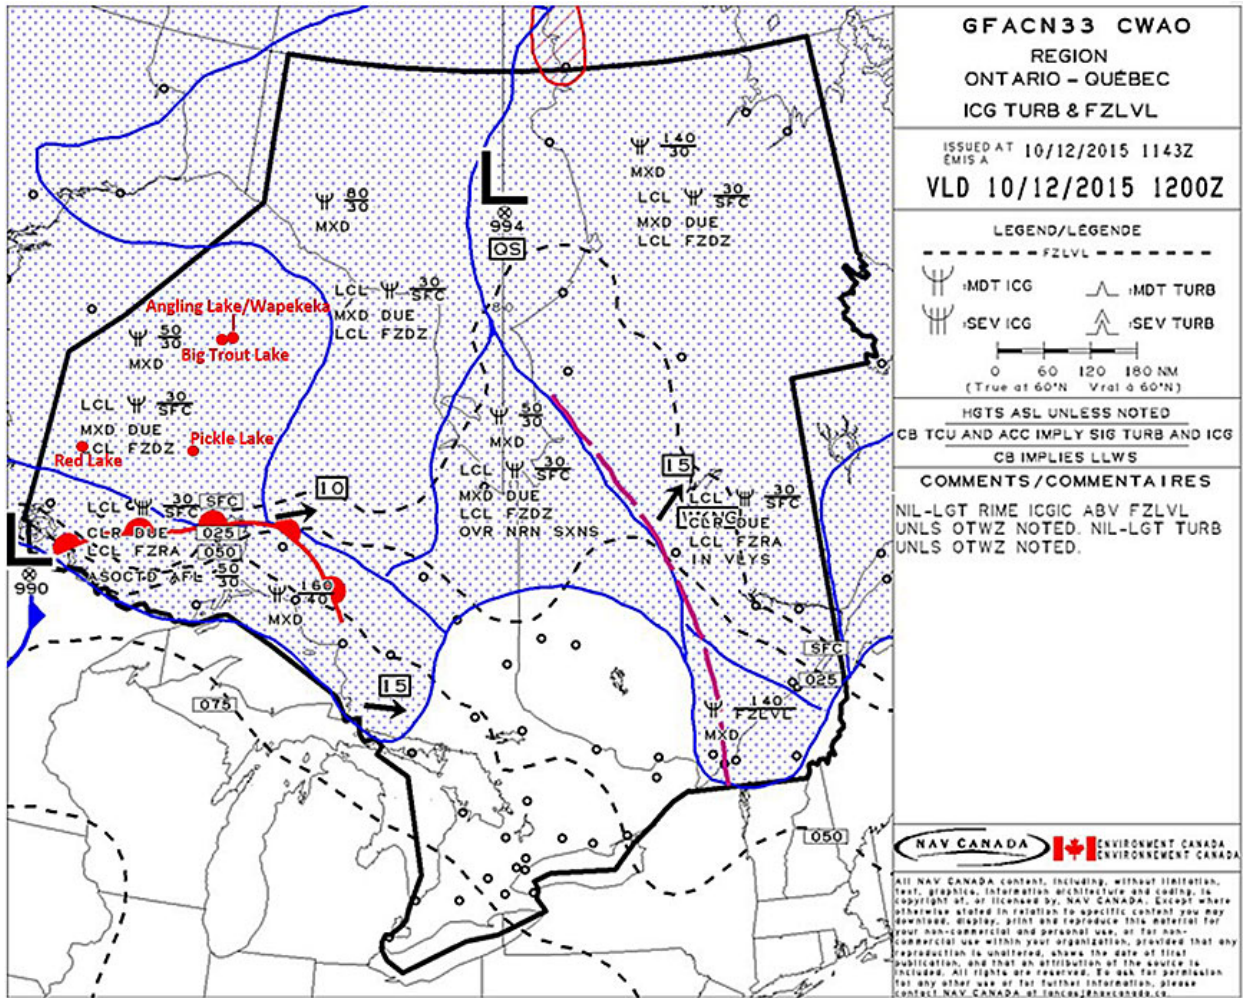
Appendix G – Graphical area forecast CN33 valid at 0700 EST (1200 UTC) 10 December 2015

Appendix G shows 2 graphics from the Ontario–Quebec GFA valid at 0700 on 10 December 2015, depicting the following conditions that were forecasted over the northwestern Ontario region:

- Clouds and weather (issued at 0641): broken clouds based at 3000 feet ASL and topped at 5000 feet ASL with visibility greater than 6 sm; local visibility 2 sm with light snow; extensive ceilings at 300 to 800 feet AGL with local visibility $\frac{3}{4}$ sm in mist and light freezing drizzle.
- Icing, turbulence, and freezing level (issued at 0643): freezing level at the surface; no moderate or severe turbulence; moderate mixed icing from 3000 to 5000 feet ASL, with local moderate mixed icing from the surface to 3000 feet ASL due to freezing drizzle.
