AVIATION INVESTIGATION REPORT

A16A0032

Collision with terrain

Mitsubishi MU-2B-60, N246W

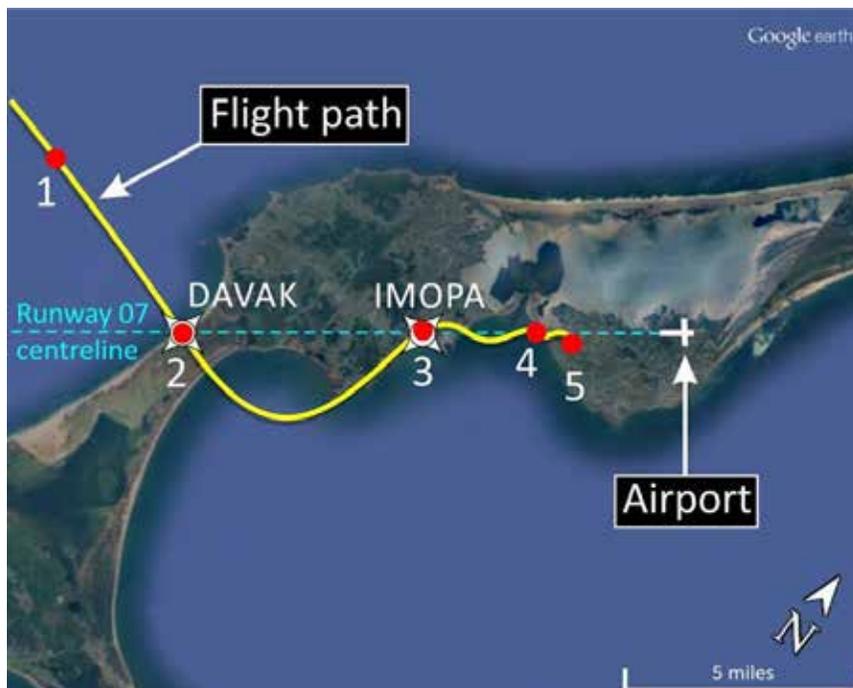
Figure 1. Flight path (Source: Google Earth, with TSB annotations)

At 1227:14, the aircraft crossed DAVAK on a heading of 114°M at 4500 feet ASL—1500 feet higher than the published procedure crossing altitude. The aircraft was descending at 1600 fpm and at an airspeed of 238 knots—about 100 knots above the recommended approach speed of 140 KIAS.¹² This resulted in the aircraft deviating significantly from the inbound course of 072° and subsequently proceeding on a meandering flight path.

Almost immediately afterwards, the aircraft crossed IMOPA—the final approach waypoint, 4.2 nm from the runway—at 2200 feet ASL, which is 790 feet above the published crossing altitude of 1410 feet ASL. The aircraft was descending at 1900 fpm, the speed was 188 knots—about 50 knots above the recommended approach speed of 140 KIAS—and the power levers remained at idle.

Immediately following the power application, the aircraft experienced an upset, yawed, and quickly rolled to the right, exceeding a 70° angle of bank, and then rapidly descended. The pilot was caught by surprise and reacted by trying to counteract these conditions. At approximately 150 feet AGL, the aircraft regained a wings-level attitude. However, the aircraft was still descending at a high rate and had not regained the loss of altitude resulting from the upset. During this time, the aircraft’s rate of descent increased from 1350 fpm, reaching a maximum of 4600 fpm. There was insufficient altitude to recover the aircraft.

1. 4.7 nm from DAVAK, 6800 feet ASL, 240 knots, 2500 fpm descent
2. At DAVAK, 4500 feet ASL, 238 knots, 1600 fpm descent (1500 feet above the published crossing altitude, about 100 knots above the recommended approach speed)
3. At IMOPA, 2200 feet ASL, 188 knots, 1900 fpm descent (790 feet above the published crossing altitude, about 50 knots above the recommended approach speed; gear and flaps should be set)
4. 2.7 nm from the runway, 1440 feet ASL, 1200 fpm descent, 175 knots, gear and flaps selected (the aircraft should be levelling at 620 feet ASL and slowing to 125 KIAS)
5. Impact: 1.4 nm from the runway and about 1000 feet south of the centreline
