AVIATION INVESTIGATION REPORT

A16P0078

Hard landing on water

Inland Air Charters Ltd.
de Havilland DHC-2 Mk. I (Beaver), C-FJOM
Kitkatla, British Columbia
24 May 2016

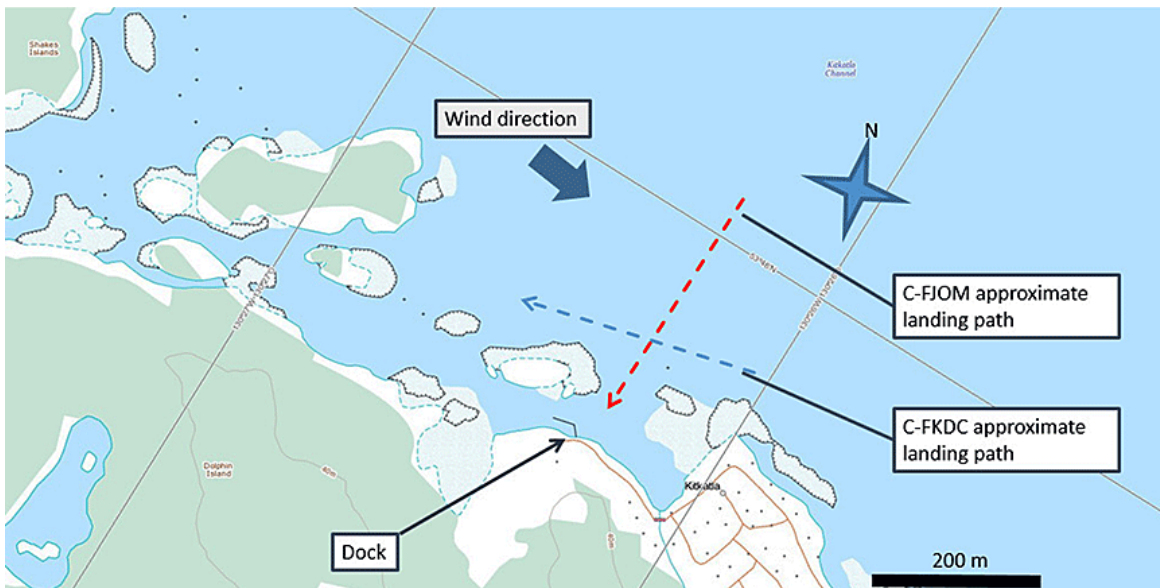
The pilot of C-FJOM determined that the wind and water-surface conditions at Kitkatla were suitable for a crosswind landing, and carried out an approach directly toward the shoreline and dock (Figure 1). The aircraft touched down approximately 200 m from shore.

Figure 1. Landing paths of the 2 Inland Air Charters Ltd. aircraft (Source: Natural Resources Canada, with TSB annotations)

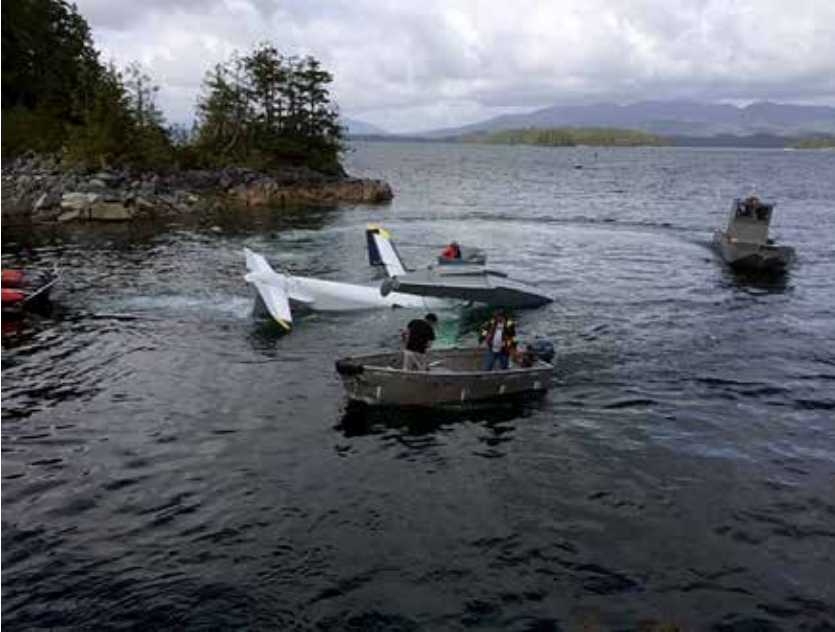
When the aircraft subsequently touched down on the right-hand float, the float support structure collapsed. C-FJOM entered the water in a steep nose-down attitude before coming to rest inverted and partially submerged. The aircraft rapidly filled with water. The occupants, who were submerged in cold water and partially upside down, were able to escape the submerged cabin with varying degrees of difficulty. Boaters arrived on scene immediately and assisted with the egress of the aircraft occupants (Figure 2).

Figure 2. The partially submerged occurrence aircraft (Source: Royal Canadian Mounted Police)

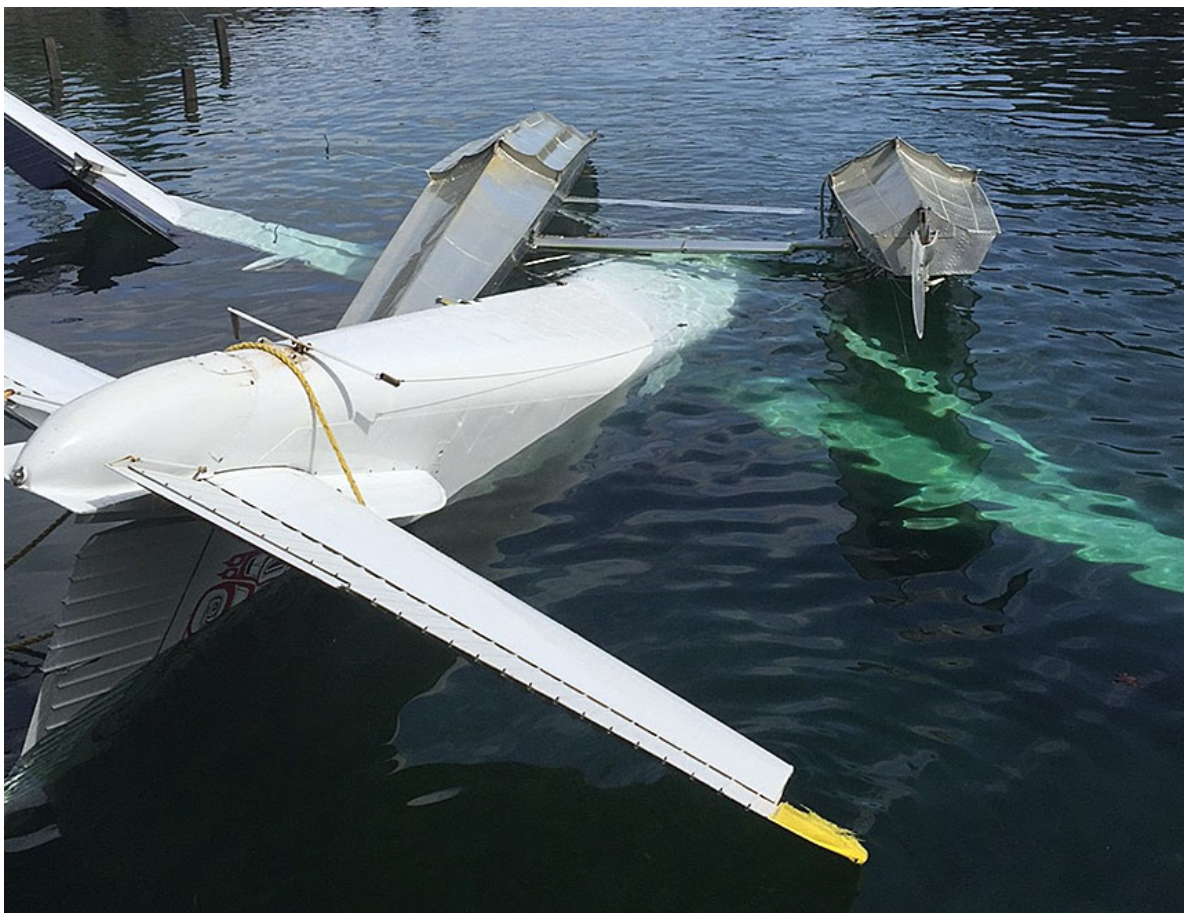
The initial impact of the aircraft on the water produced a side load from the left, which in turn applied a counter-clockwise roll moment (viewed from behind) to the left-hand float. This event fractured the left-hand support struts at the bottom-end attachments. The side load was transmitted through the spreader bars to the right-hand float. Strut geometry forced the right-hand float out and upward. The right-hand float strut fractures exhibited a clockwise rotation (opposite to the left-hand float), indicating that a second impact had occurred on the right side, which pushed the right-hand float further upward. The right-hand float contacted and bent the right-hand wing strut, and the float transom gouged a hole in the aft fuselage. At some point in the sequence, the front left spreader bar attachment fractured and the left-hand wingtip struck the water (Figure 3).

Visual examination of the fracture surfaces on the ends of the float struts and attachments revealed overload fractures in all cases, with no evidence of pre-existing progressive failure modes. The front left spreader bar attachment was examined in greater detail and also revealed an overload fracture. Its material composition, electrical conductivity, and hardness were assessed and found to be within the specifications for the material. The float attachment fittings were appropriate for the modifications to the aircraft.

Figure 3. The partially submerged occurrence aircraft showing damage to the float structure (Source: Royal Canadian Mounted Police)

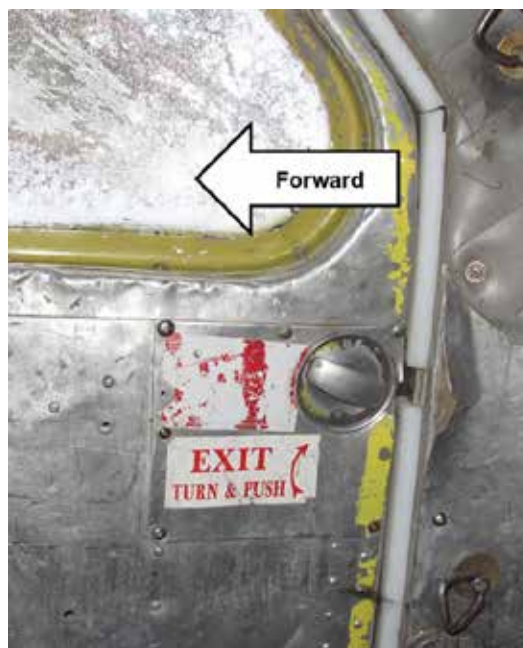
Figure 4. Interior right-hand door handle

The interior handle on the main cabin doors is located near the aft edge of the door, immediately below the window. The handles are most easily accessed by passengers sitting in the rear sling seat. All of the aircraft's interior door handles (Figure 4) consist of a short metal bar mounted in a shallow circular recess. Occupants open the cabin doors by rotating the bar with their thumb and fingertips. Because the aircraft is usually positioned such that the dock is to its left side, the doors on the right are rarely used. Inland Air did not require that passengers physically open and close the doors as part of the safety briefing, and the passengers on the occurrence flight did not do so.
