AVIATION INVESTIGATION REPORT

A16W0092

Nose landing gear failure to extend

Beechcraft 1900D, C-GORF

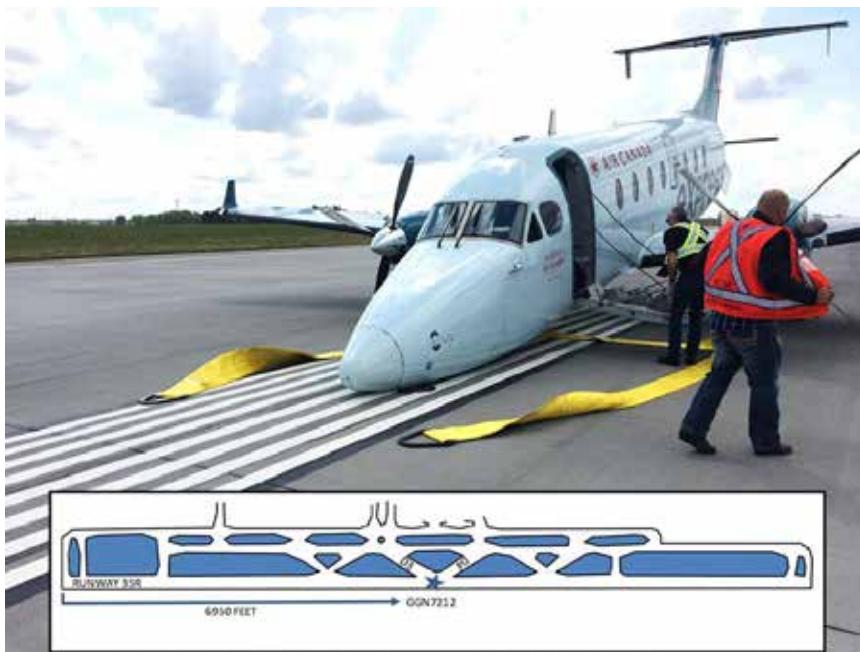
Figure 2. Resting position of C-GORF on Runway 35R (Source: Calgary Airport Authority)

Some smoke and fumes were present in the cabin due to the nose scraping along the runway, but there was no fire. The actions of the flight crew resulted in minimal damage to the aircraft and no injuries to the passengers.

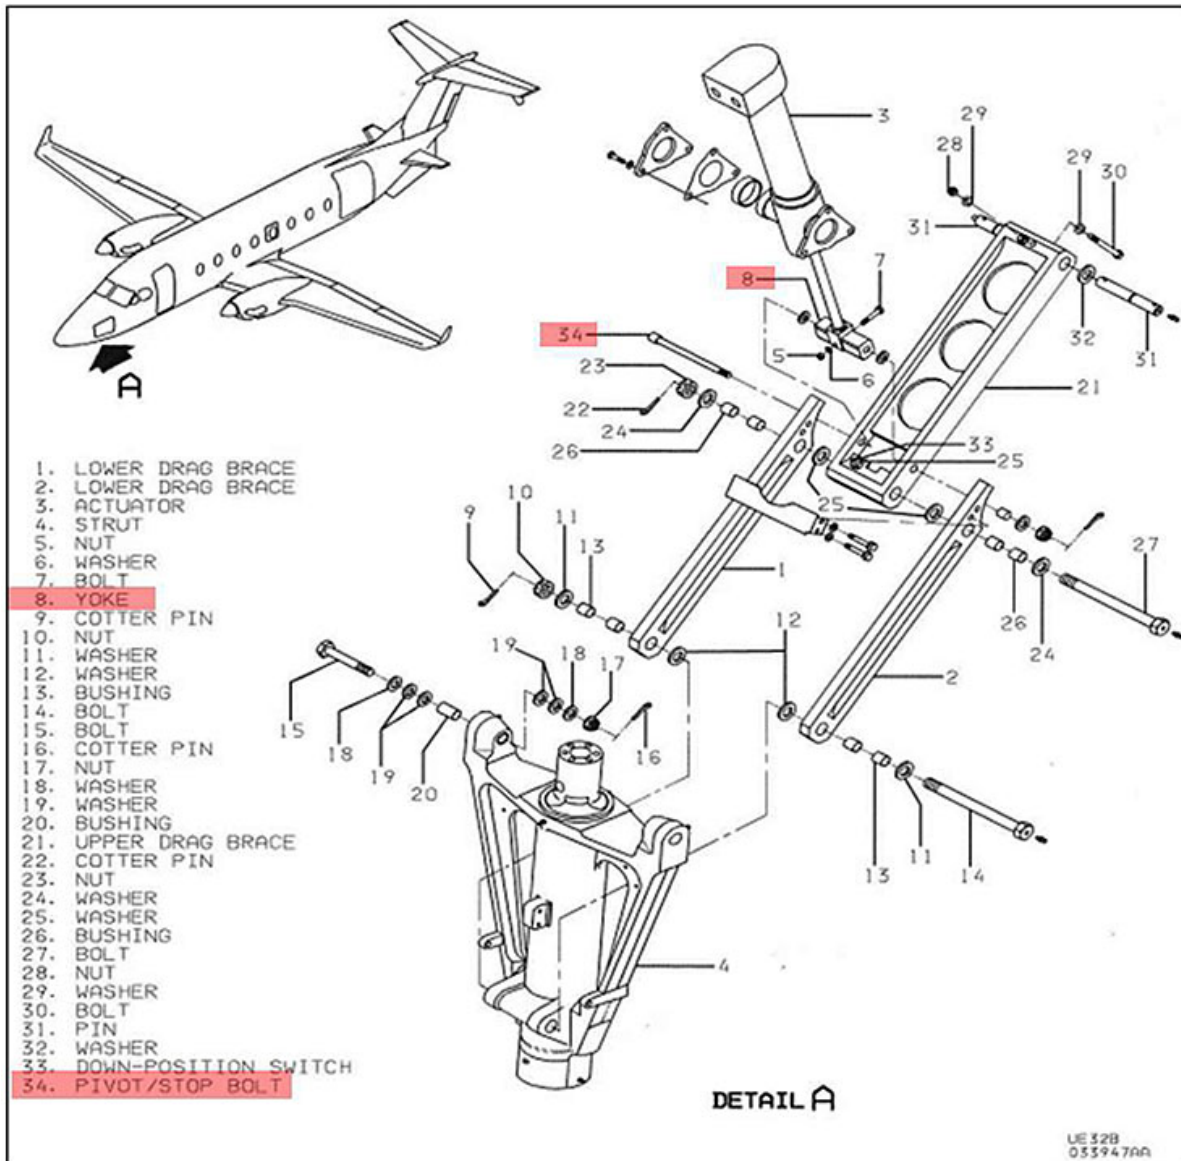
Figure 3. Beechcraft 1900D nose landing gear parts diagram (Source: Beechcraft Corporation, *Model 1900D Airliner Maintenance Manual*, 32-20-01, Figure 201 (sheet 1 of 2), p. 206 (01 November 2013))

The failure of the retract-and-extend mechanism of the nose landing gear was initiated by a yoke lubrication problem. The bolt with part number 114-820107-1 on the occurrence aircraft was not lubricated as required. The yoke should turn freely around the yoke's pivot/stop bolt; however, the occurrence yoke's pivot/stop bolt was seized in the yoke due to deteriorated grease and corrosion for 2 reasons: First, the deteriorated grease did not provide lubrication. Second, insufficient lubrication allowed the penetration of moisture between the bolt and the bore surface, causing corrosion on both surfaces. The bolt seizure resulted in abnormal loading on the yoke's pivot/stop bolt and the actuator clevis during retraction and extension of the nose landing gear. This led to fatigue cracking and failure of the yoke's pivot/stop bolt ends.

The failure of the retract-and-extend mechanism of the nose landing gear was initiated by a yoke lubrication problem. The lack of lubrication caused the pivot/stop bolt in the nose landing gear yoke to seize and break, which eventually prevented the nose landing gear from fully extending.
