AVIATION INVESTIGATION REPORT A16W0126

Loss of power and collision with trees

Bell 206B (Helicopter), C-GHHU

05 September 2016

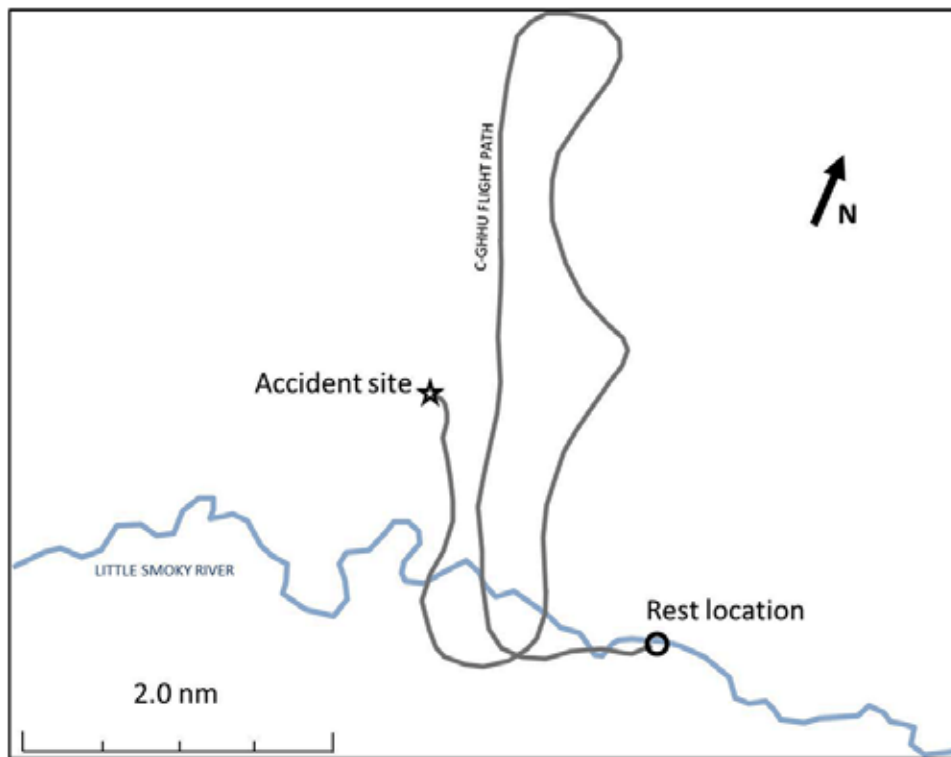
As the helicopter proceeded northbound, 1 of the surveyors identified the line as incorrect and indicated the need to reposition 1 line to the west. The pilot carried out a right turn and flew the helicopter approximately 4 nm south. The pilot then completed another right turn to roll out on the correct survey line (Figure 2). Moments later, at 1520, while flying at 58 mph in a descending left turn, approximately 160 feet above ground level (AGL), C-GHHU lost all engine power. This was immediately followed by a decay in N_R and a descent. The engine-out and rotor-low-rpm warning horns did not activate, and no warning lights illuminated on the annunciator panel.⁶ Within 2 to 3 seconds, the aircraft descended and struck the trees. The heading at the time of impact was 246° magnetic. The helicopter came to rest suspended by the trees that it collided with, in a nose-high position, listing approximately 60° to the left and with its forward section approximately 7 feet above the ground; it did not strike the ground, but the aft portion settled to the ground.

Figure 2. Flight path of C-GHHU from the rest area on Little Smoky River to the accident site

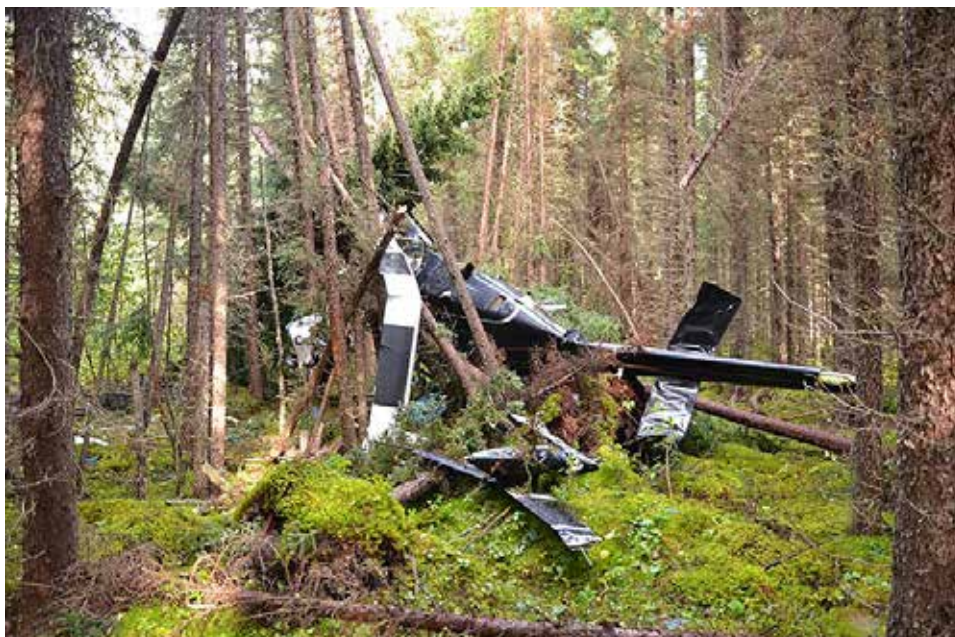
All of the helicopter's components were located and identified within a 50-foot radius of the aircraft (Figures 3 and 4). The helicopter's forward section and cockpit were destroyed. The cabin sustained substantial impact damage, particularly on the left side of the fuselage. The fuel cell was punctured during the impact sequence and was leaking. The main-rotor head was intact, with its 2 rotor blades still attached. Both main-rotor blades sustained minor damage consistent with low N_R , indicating that no power was being produced at the time of impact.

The tail-rotor was intact. One blade was straight with no damage to its skin. The other blade had sustained impact damage and was bent in 2 locations. The damage observed on both tail-rotor blades was consistent with low tail-rotor rpm, indicating that no power was being produced at the time of impact.

Figure 3. View of C-GHHU from aft left (severed vertical fin visible to the left of tail boom)

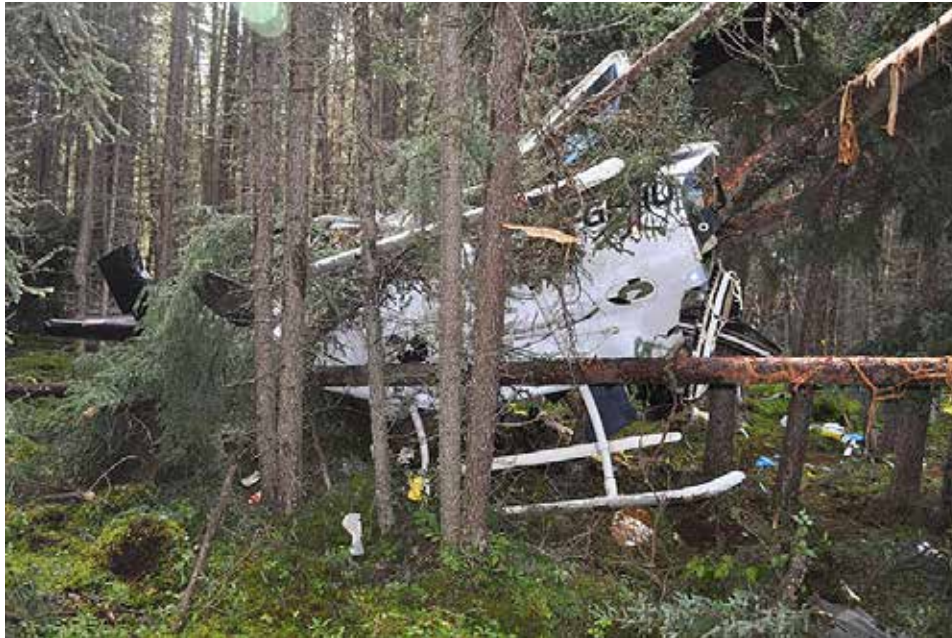
Figure 4. View of C-GHHU from front right (underside of helicopter visible)

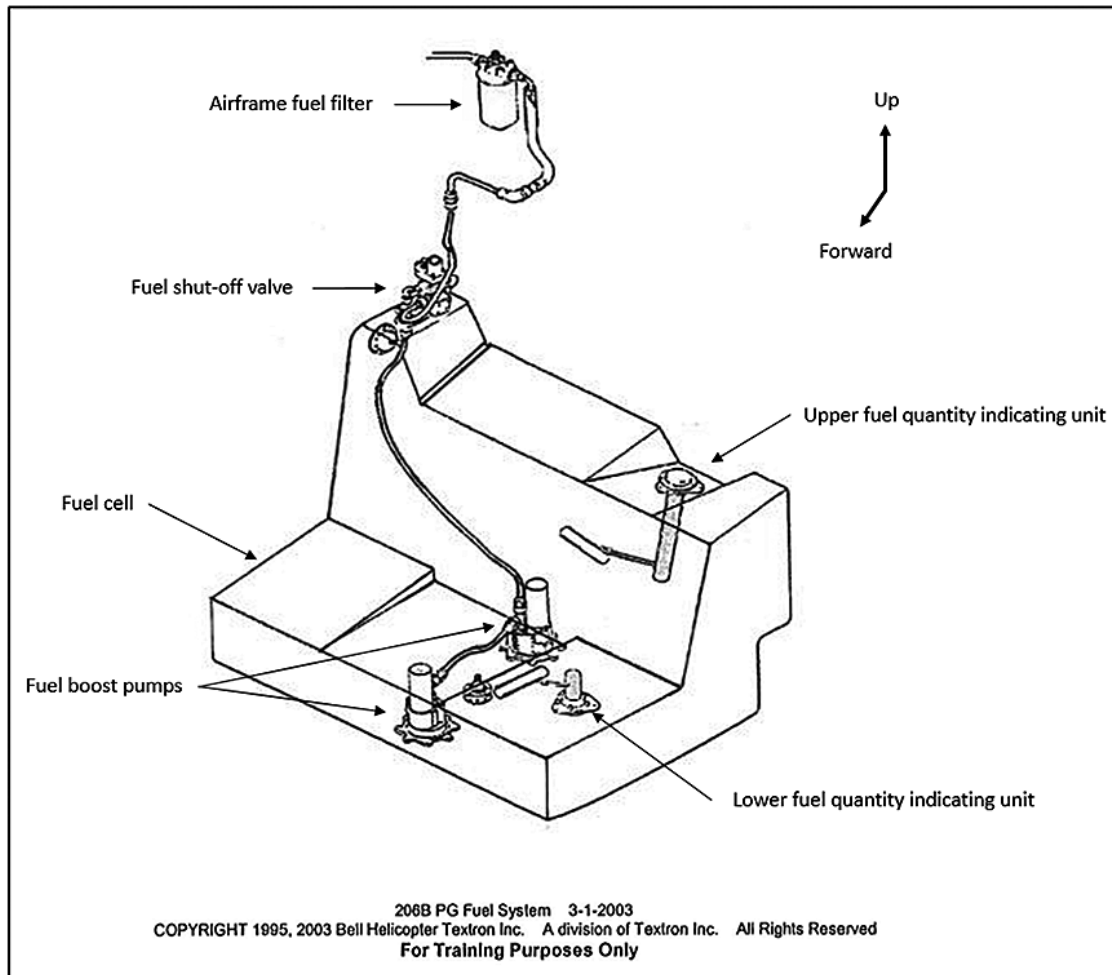
Appendix A – Bell 206B helicopter fuel system

The Bell 206B helicopter's fuel system can be susceptible to unporting when operating with less than 20 USG and acceleration forces are present. The TSB laboratory conducted further analysis of potential unporting at various fuel levels. With 10, 15, and 20 USG of fuel in the tank, the minimum lateral acceleration required for the fuel displacement to cause fuel unporting would be 0.12g, 0.21g, and 0.32g, respectively. These forces can be due to turbulence or pilot flight control inputs. The greatest susceptibility occurs when 1 or both of the boost pumps are inoperative. The manufacturer states that, in these circumstances, 10 USG are unusable.

While the helicopter was making a left turn, it is likely that acceleration forces caused 1 or both of the boost pumps to unport. The introduction of air into the combustion chamber interrupted fuel flow, resulting in an engine flame-out.

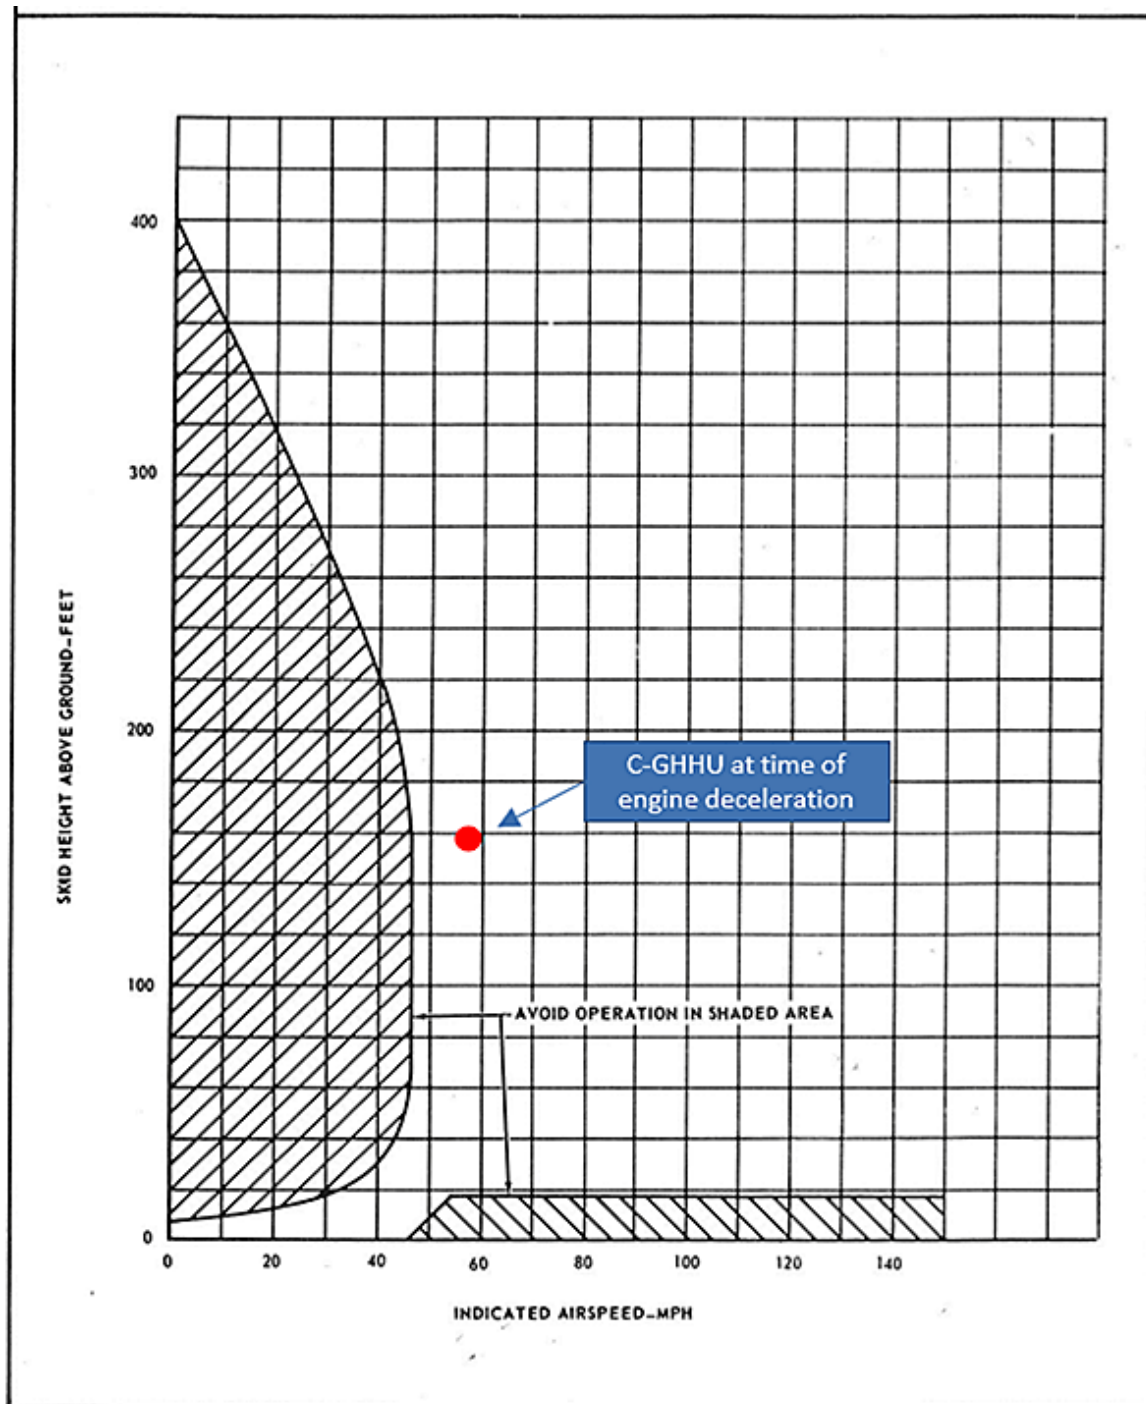
Appendix B – Height/velocity diagram

The height/velocity diagram (Appendix B) is a graph of safe and unsafe helicopter flight profiles; it shows the combinations of altitude and airspeed that may not allow sufficient time or altitude to enter a stabilized autorotative descent.²⁴ The diagram identifies altitude and airspeed combinations where operation should be avoided due to the low likelihood of being able to carry out a successful autorotative descent and landing.
