# AVIATION INVESTIGATION REPORT

## A16O0149

### **Risk of collision**

Porter Airlines Inc., DHC-8-402, C-GKQA  
and

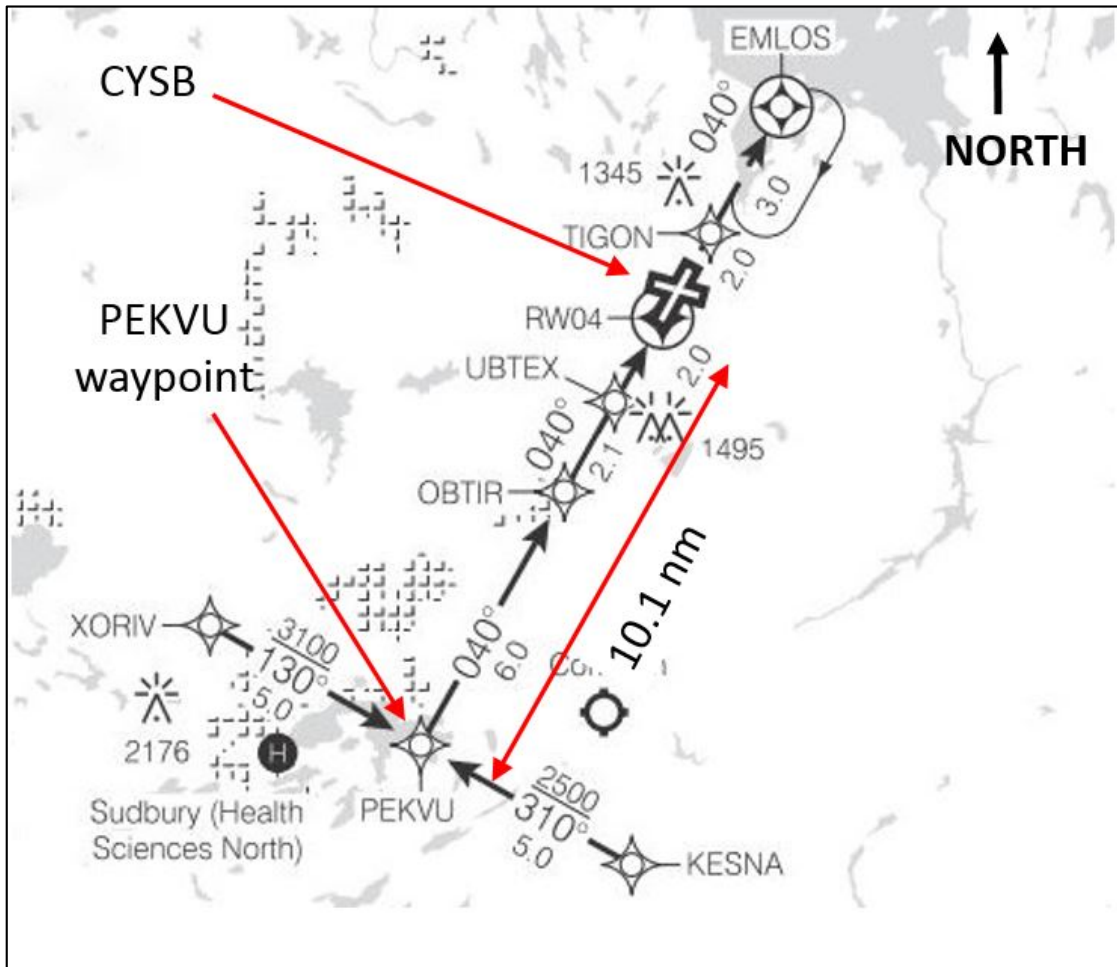
At CYSB, the same runway surface serves as both Runway 04 and Runway 22; its designated number is determined by the direction of takeoff or landing (Appendix A). Runway 22 was the active runway<sup>3</sup> when POE533 was approaching CYSB from the south. However, the North Bay controller,<sup>4</sup> who was located at the Toronto Area Control Centre (ACC), authorized POE533 to fly direct via the PEKVU initial approach waypoint. PEKVU is located at 10.1 nautical miles (nm) final on the area navigation (RNAV) approach<sup>5</sup> to Runway 04, and is situated on the extended runway centreline for departures from Runway 22 (Figure 1 and Appendix B).

Figure 1. Plan view of the RNAV Runway 04 approach chart, showing PEKVU initial approach waypoint (Source: NAV CANADA, *Canada Air Pilot*, Instrument Procedures, Ontario CYSB RNAV [GNSS] RWY 04, with TSB annotations)

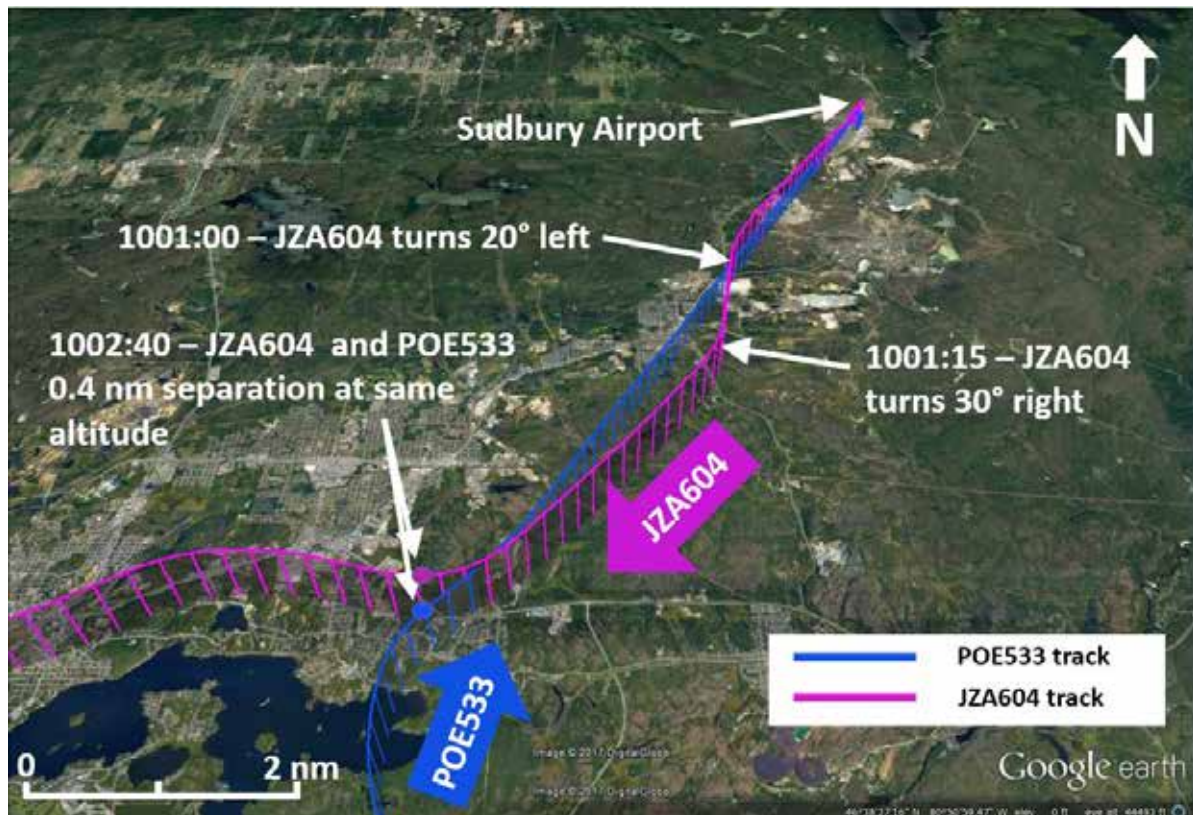
At 1001, JZA604 turned left (east), 20° from the runway extended centreline, which was also the approach path for Runway 04 (Figure 2). The North Bay controller had not been informed of this turn or noticed it on the radar, and subsequently suggested<sup>12</sup> that JZA604 turn 30° to the right (west). The controller then informed JZA604 of POE533's position.

Figure 2. Flight tracks of JZA604 and POE533 (Source: Google Earth, with TSB annotations)

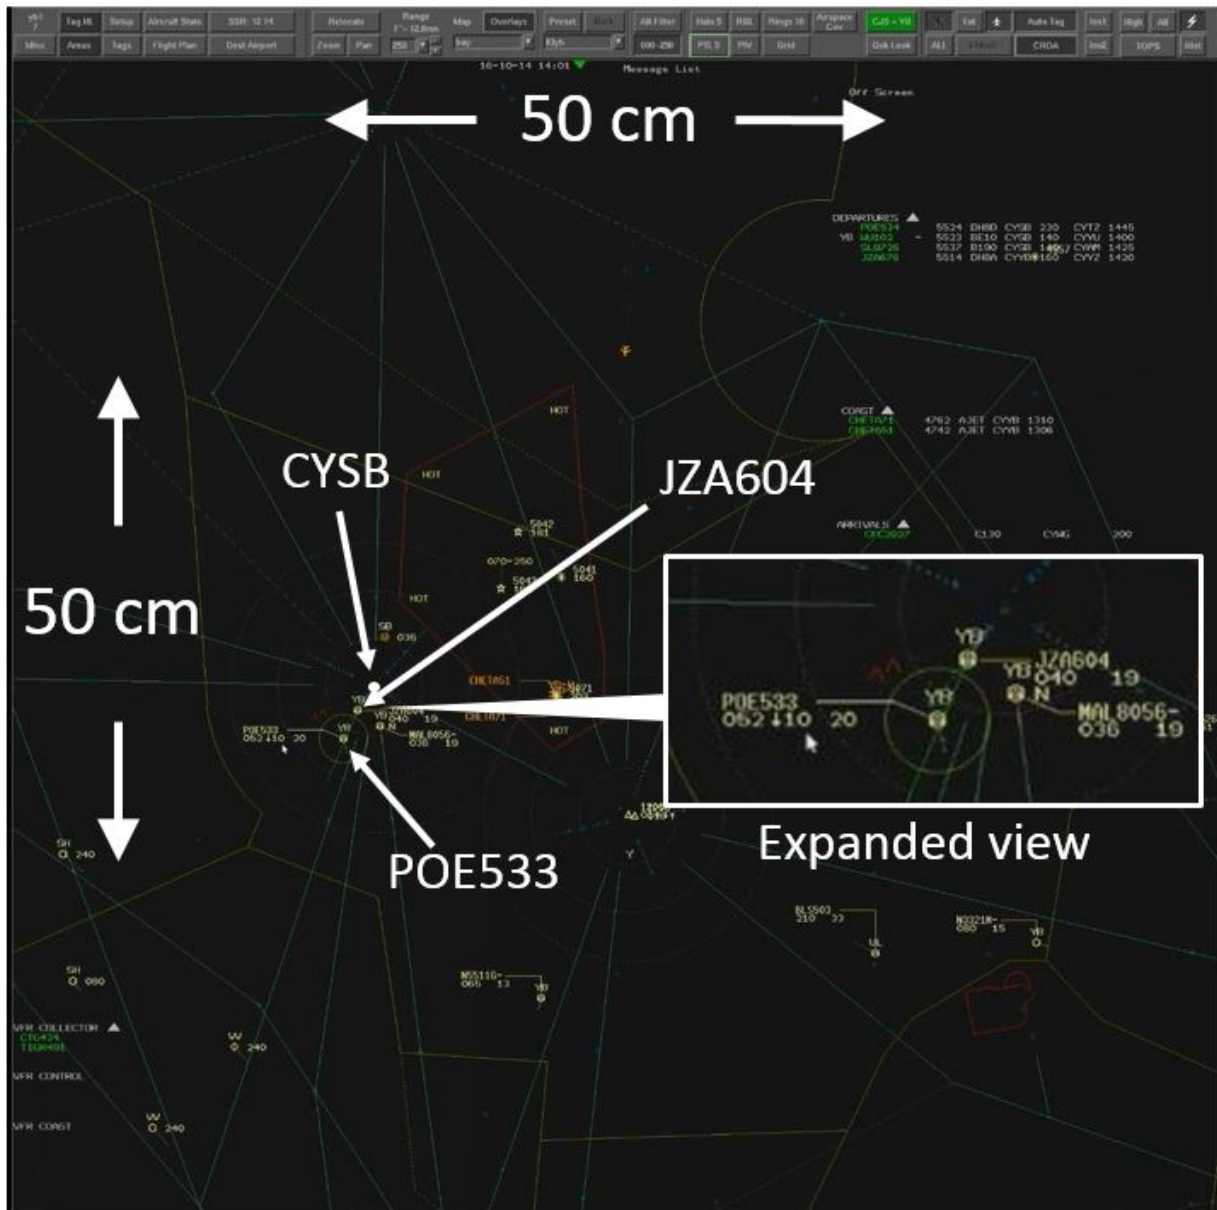
At the time of the occurrence, the CSiT used by the North Bay controller displayed altitude information for both POE533 and JZA604, along with their present-position symbols. Given the large area of the North Bay Sector, the CSiT range was set to 250 nm, whereby 1 cm of screen resolution was equal to approximately 5 nm. This setting enabled the controller to see the entire sector (Figure 3). However, if a target makes a small heading change while the range is set to this scale, it will not be immediately apparent on the screen.

Figure 3. Screenshot of the North Bay controller’s Canadian Automated Air Traffic System situational display at 1001:30 (Source: NAV CANADA, with TSB annotations)
