AVIATION INVESTIGATION REPORT

A16W0170

Runway incursion

Calgary Control Tower

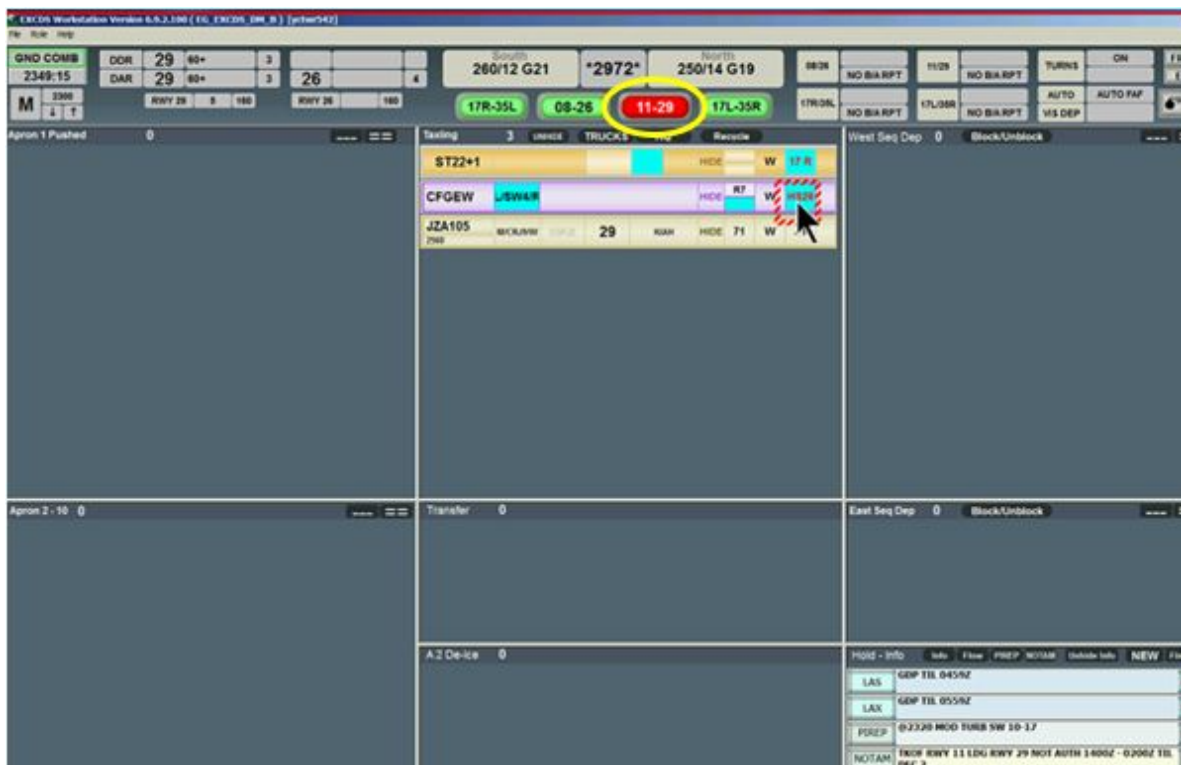
Calgary Control Tower EXCDS includes a runway jurisdiction system (RJS) that serves as a memory aid indicating when a runway is controlled by the ground or tower position. The RJS is located at the top of the EXCDS display, below the wind and altimeter information (Figure 2). Each of the airport’s 4 runways is represented by a button, the colour of which indicates who has jurisdiction of that runway. If the button is green on a controller’s display, that controller’s position has jurisdiction of the runway; if it is red, the runway is owned by (i.e., under the control of) another controller.

Figure 2. Image of the combined ground controller’s EXCDS display when C-FGEW was cleared to cross Runway 29. The runway jurisdiction system shows Runway 11/29 in red, indicating that it is under the jurisdiction of another controller (Source: NAV CANADA, with TSB annotations).

A memory aid was provided to allow controllers to verify runway ownership prior to clearance of aircraft onto a runway. The runway jurisdiction system (RJS) consisted of 4 indicators (one for each runway) that were located at the top of the extended computer display system (EXCDS) display. The indicators were green if a controller owned the runway and red if another controller owned the runway. Investigations into previous, similar runway incursions had found that the RJS did not provide an effective reminder of the need to carry out coordination, as it was always present and did not attract sufficient attention at the appropriate time. Similarly in this occurrence, the RJS did not provide a sufficiently compelling cue to ensure that the combined ground controller did not revert to the well-practised routine of clearing aircraft across Runway 29 without coordination.

- **EXCDS was modified** to ensure that the RJS memory aid would not be blocked on the display by dialog boxes used by the controller to enter information.
- As of November 2016, **all action plans resulting from safety investigations are required to have an implementation date**, and any changes made to a plan or its dates are tracked by the Safety and Quality group.
