AVIATION INVESTIGATION REPORT

A17W0024

Loss of control and collision with terrain

Tecnam P2006T, C-GRDV

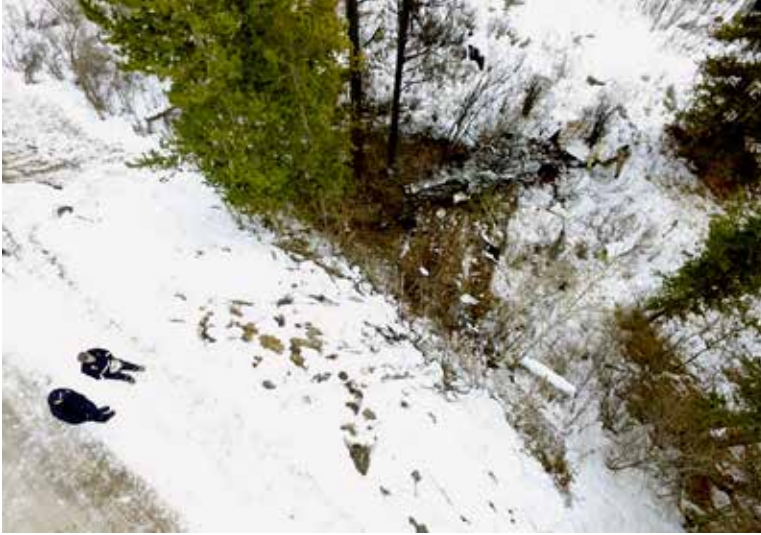
The wreckage was situated near a road, at the foot of an embankment, at an elevation of 4850 feet ASL. The aircraft had been almost entirely consumed by fire. Ground scars and damage to the aircraft were consistent with a high-speed collision with the slope while the aircraft was in a near-vertical attitude. The top of the aircraft had struck the embankment first, and the aircraft had continued down the slope for 50 feet before coming to rest at the foot of the escarpment, where a post-impact fire ignited (Figure 1).

Figure 1. Accident site as viewed from the embankment above, showing the left side of the aircraft and looking south (Source: Alberta Occupational Health and Safety)

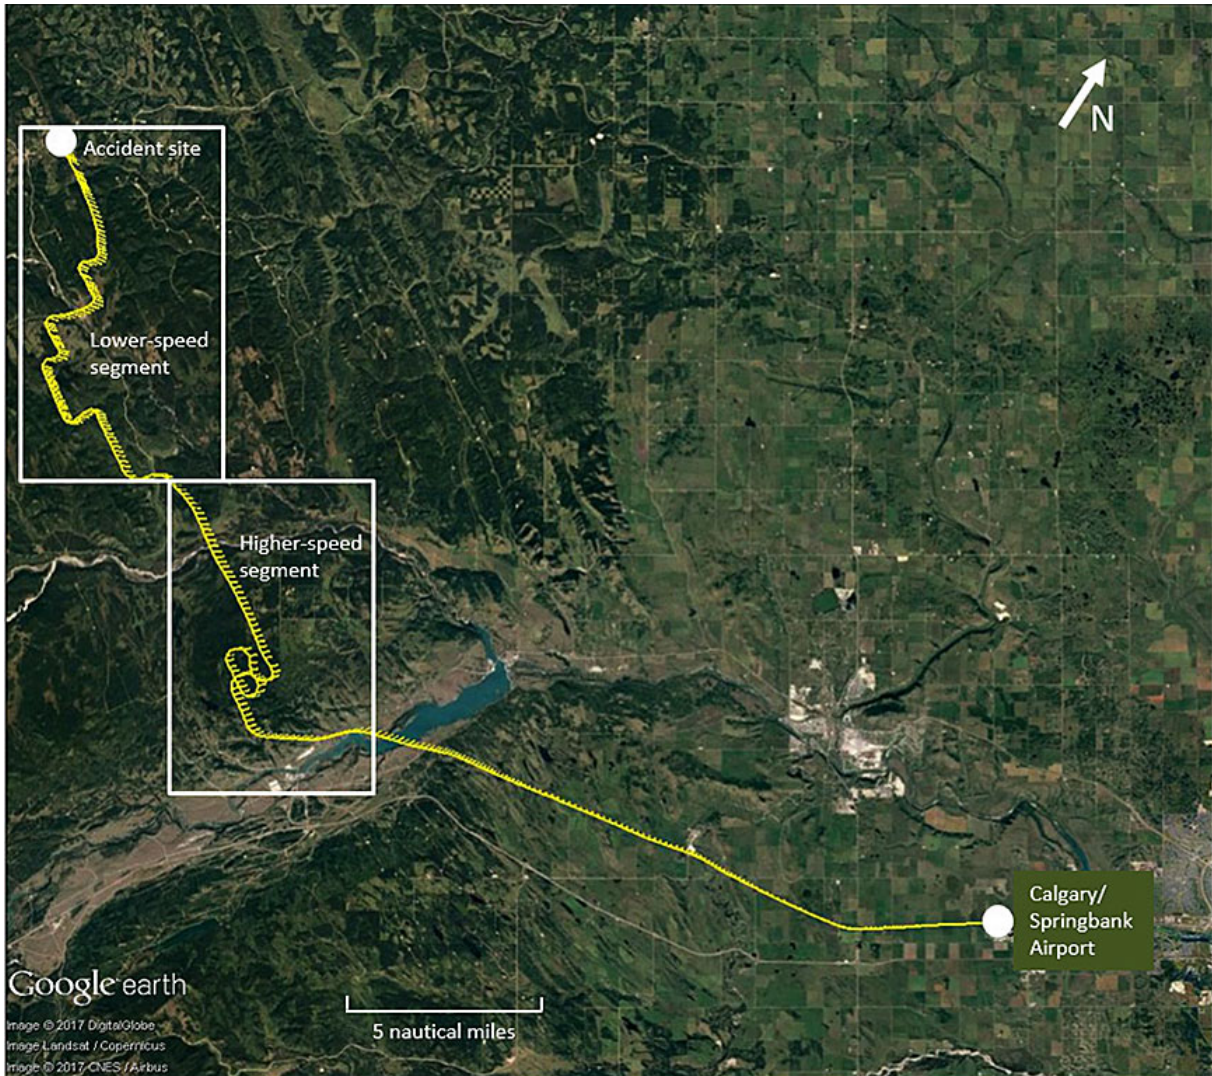
Appendix A – Occurrence flight path

The training flight was to consist of 2 segments: the first was to be conducted at higher speeds, and the second at lower speeds (Appendix A). Once the desired altitude had been reached, the first flight segment was conducted over a period of 9 minutes, at airspeeds ranging from 100 to 120 knots calibrated airspeed (KCAS).² It included a sequence of turns, which were carried out from 1648 to 1650, and consisted of a 360° right turn, a 180° right turn, and a 180° left turn. The turns were flown at approximately 95 to 115 KCAS, with an angle of bank of approximately 45° and vertical acceleration of up to 1.3g.³ The higher-speed segment of the flight concluded at 1653 with a 90° left-to-right turn sequence with bank angles of about 30°.

The aircraft then slowed. The remainder of the segment was conducted at lower airspeeds and included a series of alternating 90° turns at bank angles of 20° to 30° and speeds ranging from 65 to 80 KCAS. Both segments of the flight were conducted at 8000 feet ASL, with very little variation in altitude.

At 1701, the aircraft accelerated to about 100 KCAS. At 1702, its airspeed decreased to 65 KCAS before increasing again to 80 KCAS, and its altitude decreased by about 300 feet, constituting the largest reduction in altitude at that point in the flight. The aircraft climbed back to its original altitude at 80 KCAS; then, at 1703, it slowed to 70 to 75 KCAS. This was the aircraft's last secondary-surveillance radar position, at 2800 feet AGL, directly above the accident site.

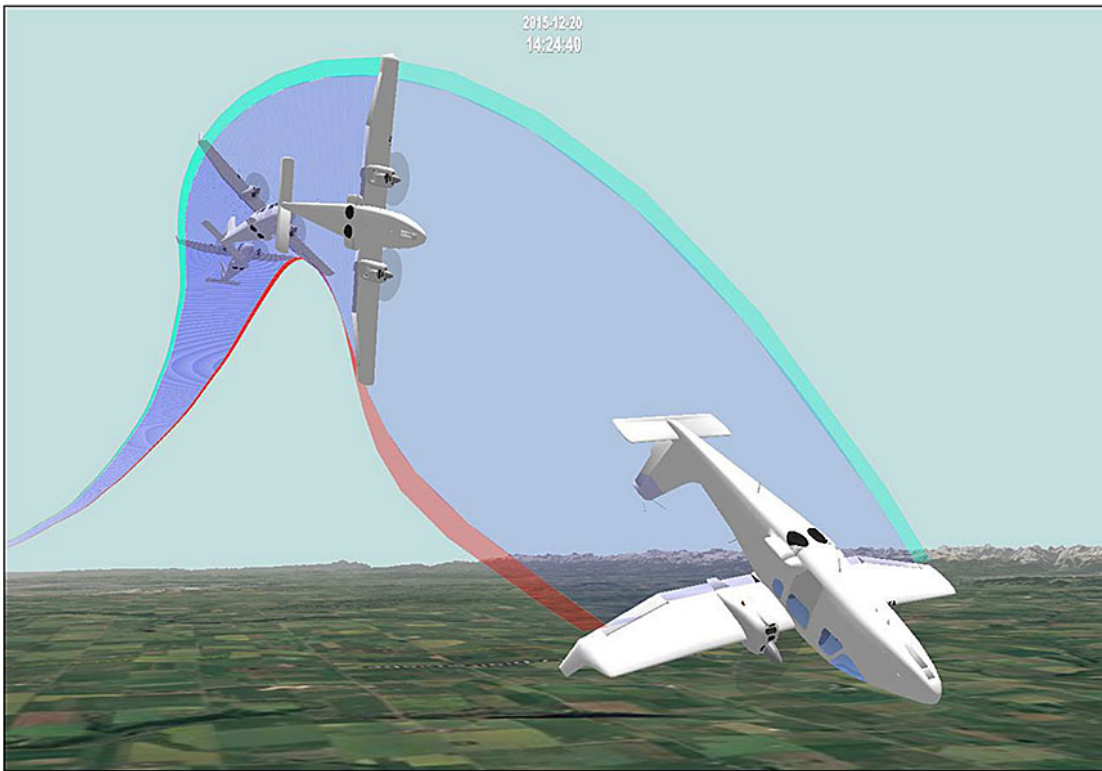
Appendix B – Flight data analysis: Spin entry sequence of previous training flights

In contrast with normal stall recoveries, these instances ranged from roll events that were recovered to wings level, to incipient spins that inverted the aircraft, to full spins¹⁴ of up to 1.5 rotations. They generally shared key characteristics (appendices B, C, and D) that had initiated the upsets:

- The aircraft involved had been flown to stall conditions in a nose-high attitude and held there upon encountering stall conditions.
- The aircraft nose had not been lowered to initiate stall recovery.
- The airspeed had continued to decline until the aircraft had eventually rolled and yawed in either direction in an aggravated stall or incipient spin.

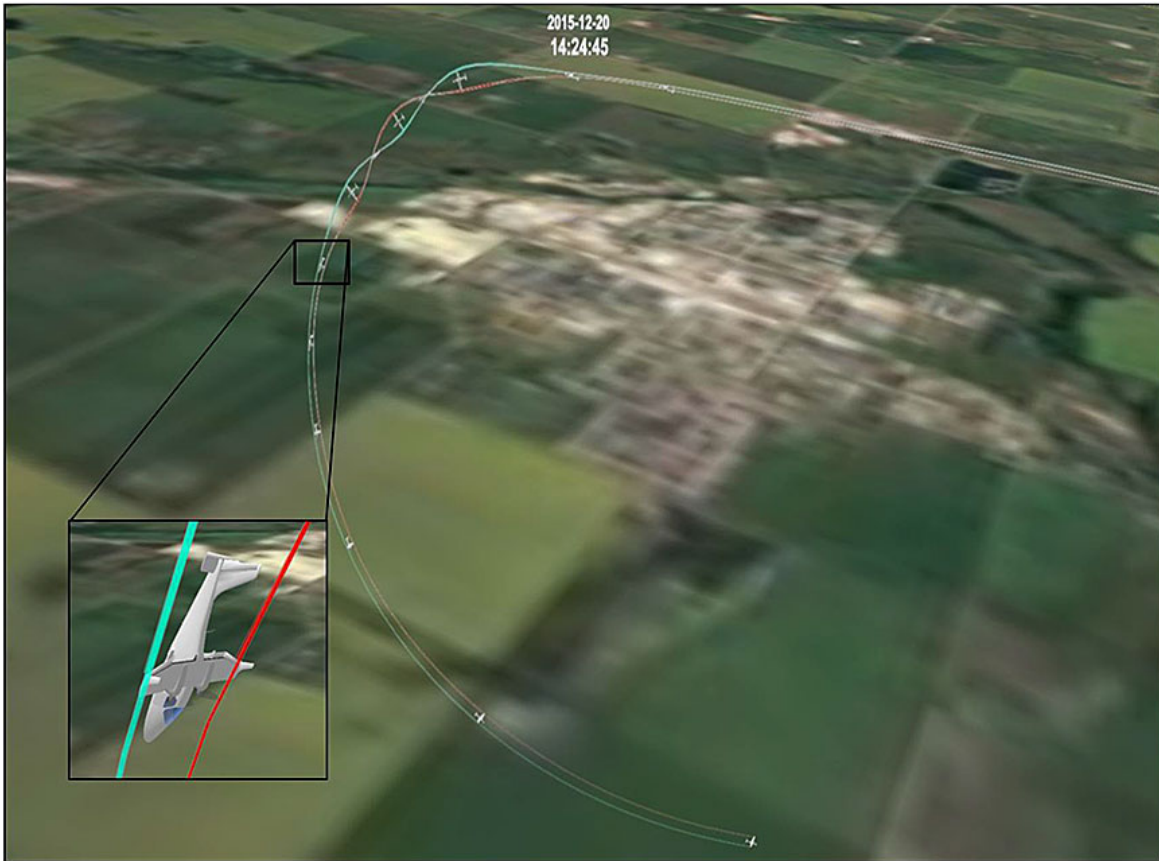
Appendix C – Flight data analysis: Spin entry and dive recovery of previous training flights

Among the recorded events was one in which an aircraft exited a spin of 1.5 rotations, became inverted, and was pulled into a steeper dive through a descending half-loop

(Appendix C). This event had the highest descent rate (12 500 feet per minute) and load factor (3.1g) of the upsets that were examined, and the second highest loss of altitude (1400 feet).

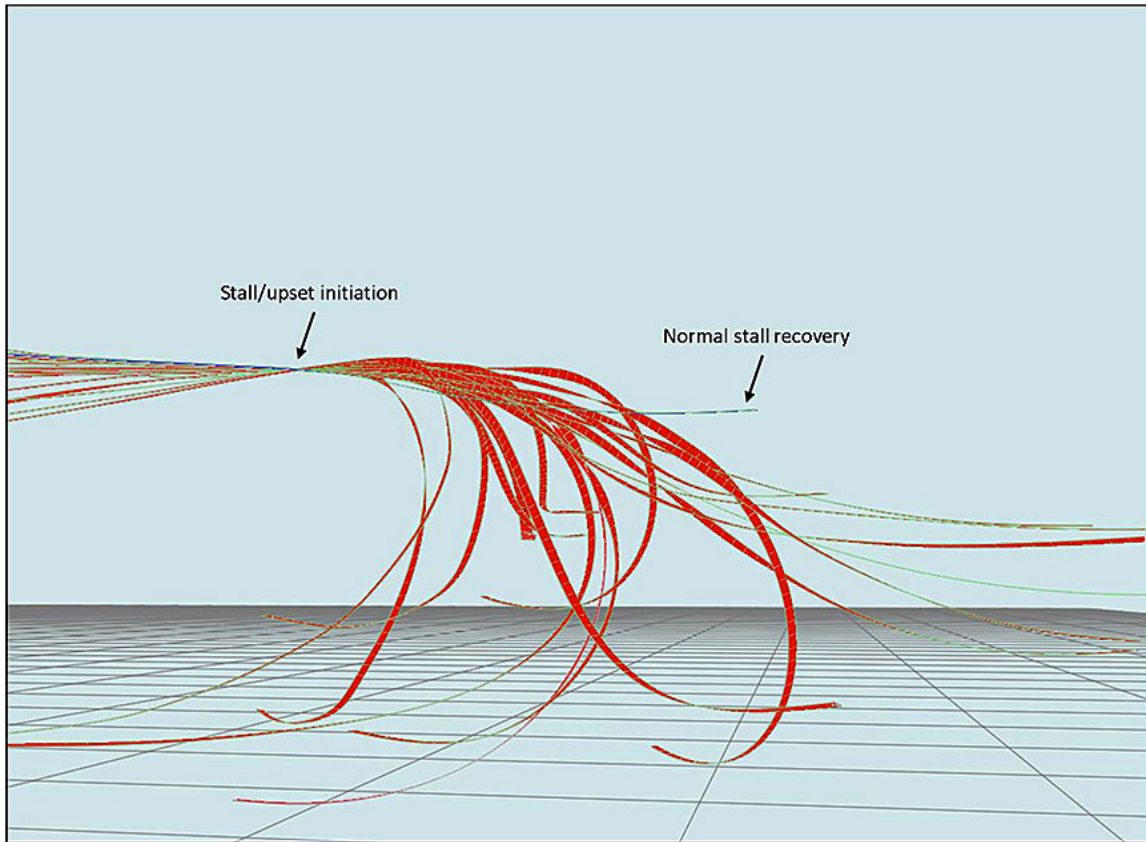
Appendix D – Flight data analysis: Comparison of flight-path shapes and altitude losses in aircraft upsets during stall-recovery training

Appendix D shows the comparative flight-path shapes and altitude losses of the aircraft involved in the upset events; a normal stall recovery is also shown. Among the events examined, the lowest recovery height above surrounding terrain was 700 feet, in an event that also involved the largest altitude loss (1500 feet).
