RAILWAY INVESTIGATION REPORT

R16E0102

Main-track derailment

Canadian National Railway Company

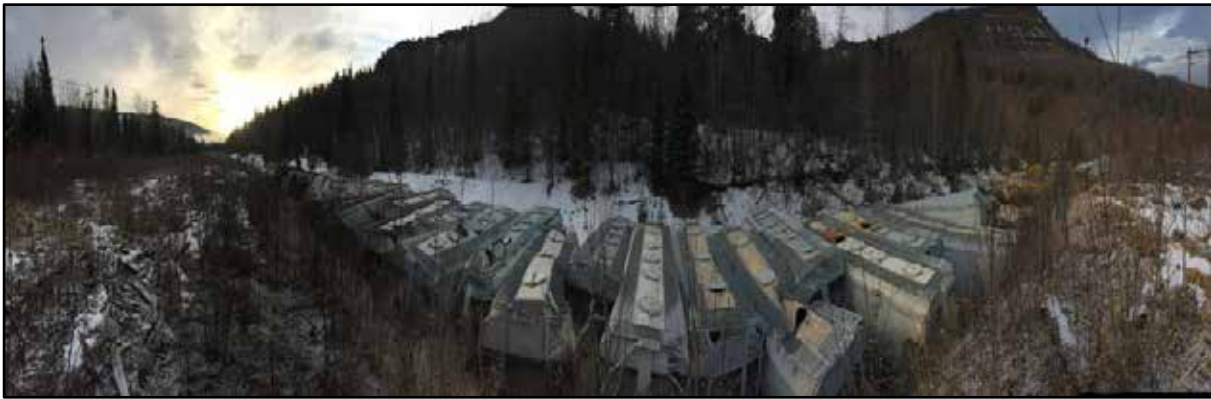
On 29 October 2016, at approximately 1953 Mountain Daylight Time, northbound Canadian National Railway Company freight train A45851-29, travelling at 27 mph, derailed 28 cars in a right-hand curve at Mile 96.38 of the Grande Cache Subdivision. The derailed cars were covered hopper cars loaded with frac sand. The derailment damaged about 1300 feet of track. There were no injuries.

Figure 2. Derailed cars

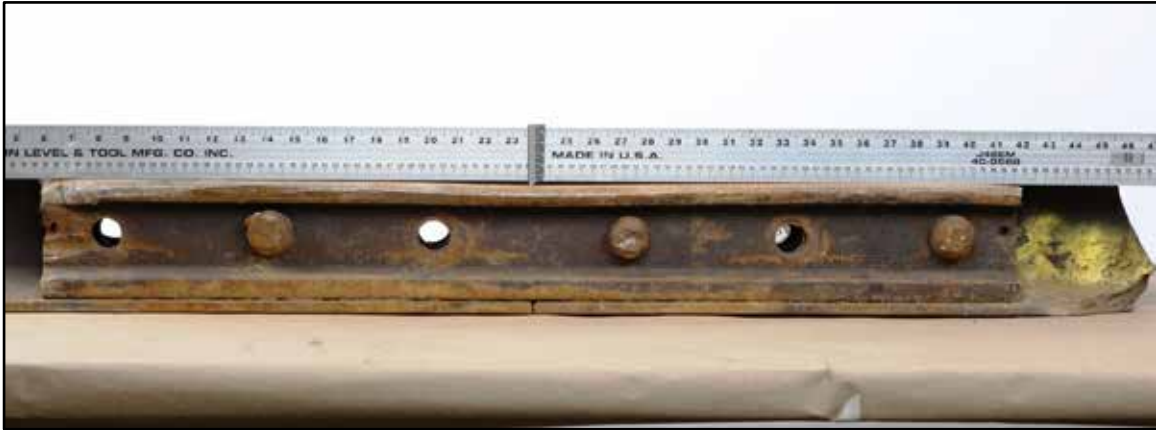
A 34-foot plug rail (1987 Sydney) had been previously installed in the high rail near Mile 96.38. Prior to the occurrence, both joints for the plug rail were reported to be fully bolted. Following the occurrence, both joints were intact, but the nuts (on the gauge side) for 3 bolts had been sheared off on each joint (Figure 6). The plug rail was also broken near the south joint.

Figure 6. Gauge joint bar with missing bolts

The gauge joint bars showed wheel flange contact. The rail head wear on the high rail was 7 mm, which was 1 mm less than the limit of 8 mm specified in the CN Engineering Track Standards (ETS) before high clearance joint bars are required.

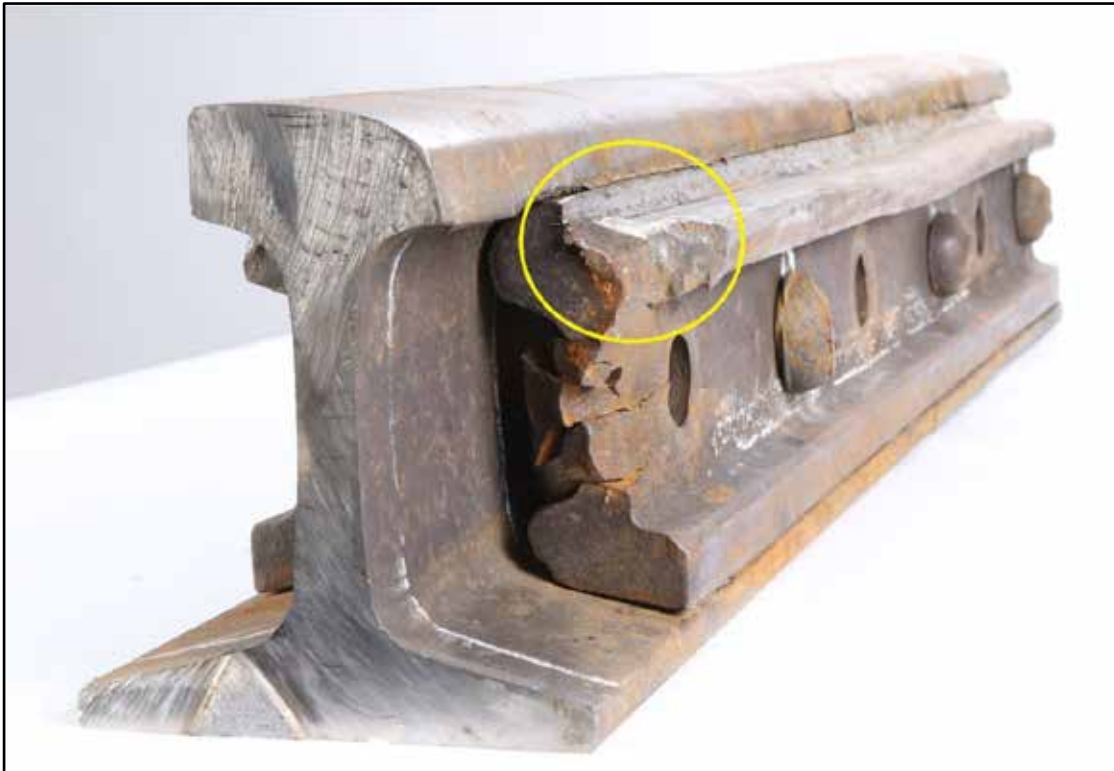
A detailed examination of the rail joint (Figure 8) made it possible to determine that the plug rail and piece of rail failed in overstress as a result of derailment forces. No pre-existing defect was observed.

The gauge-side joint bar and 3 empty bolt holes showed wheel flange impact damage. There were 3 missing joint bar bolts that were likely broken off during the derailment sequence.

Figure 8. Gauge bar and bolt hole with wheel flange impact damage on the corner of the joint bar (circled)

The joint bar was missing 3 of the 6 bolts. However, it was reported that both plug joints had been fully bolted at the time of the derailment.
