RAILWAY INVESTIGATION REPORT

R16W0242

Uncontrolled movement, collision and derailment

Canadian Pacific Railway

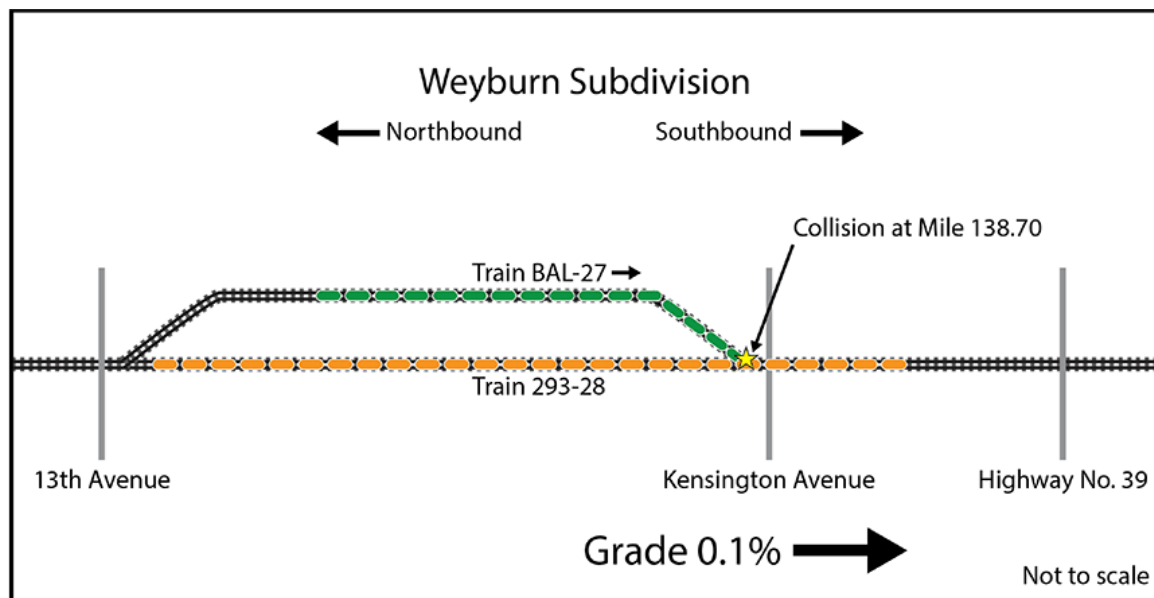
Figure 2. Site diagram with train BAL-27 in siding and northbound train 293 on the main track

At about 0440, train BAL-27 entered the Estevan siding from the north siding switch and proceeded southward through the siding. As the train approached the south end of the siding, the LE manipulated the throttle and used the automatic brakes to slow the train. As train BAL-27 was stopping, the LE also used light independent brake applications and kept the train stretched as it stopped. At about 0445, train BAL-27 was brought to a stop, just clear of the fouling point with the main track at the south end of the siding. Train BAL-27 was left parked in the siding with the independent and automatic brakes fully applied as the crew waited for the arrival of northbound train 293 (Figure 2). The crew prepared to perform a passing train inspection of train 293 in accordance with the *Canadian Rail Operating Rules* (CROR)² and with CP's *General Operating Instructions*.³

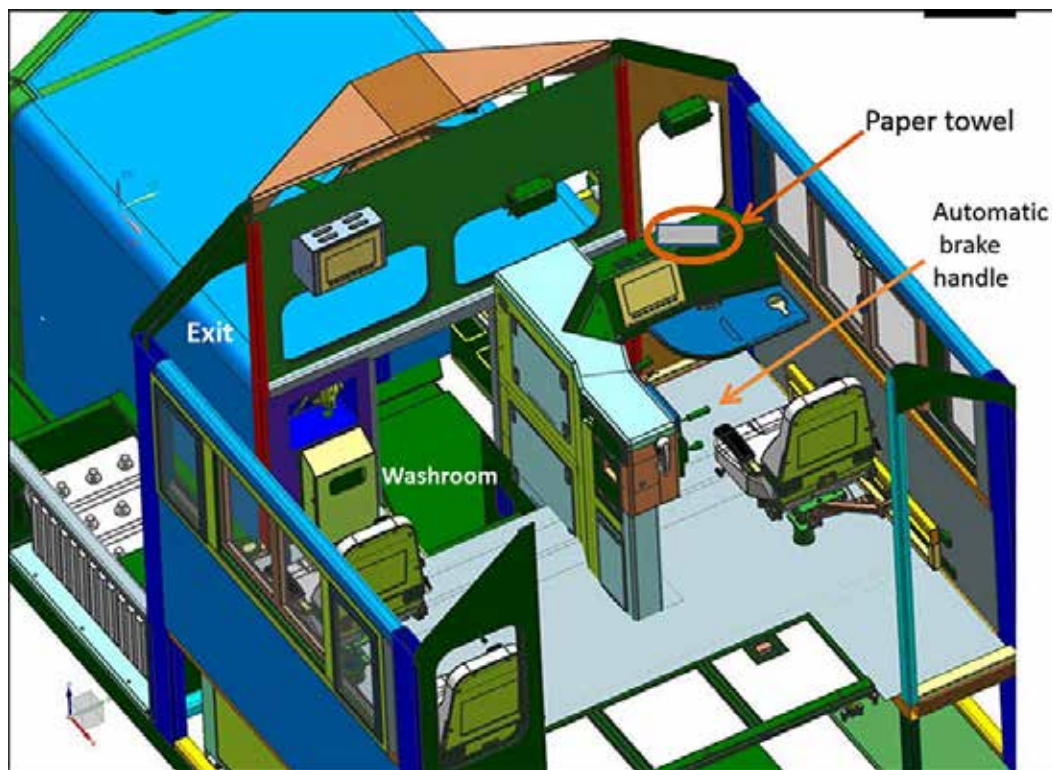
Figure 3. Locomotive cab layout

As train 293 was passing, the LE from train BAL-27 returned to the cab of locomotive CP 2275 for personal reasons. While in the locomotive cab, the LE went between the locomotive control stand and the seat to retrieve a paper towel from the locomotive console (Figure 3) and inadvertently moved the automatic brake handle to the release position. Unaware that the automatic brake handle was in the release position, the LE exited the locomotive cab and returned to the ground to complete the passing train inspection.

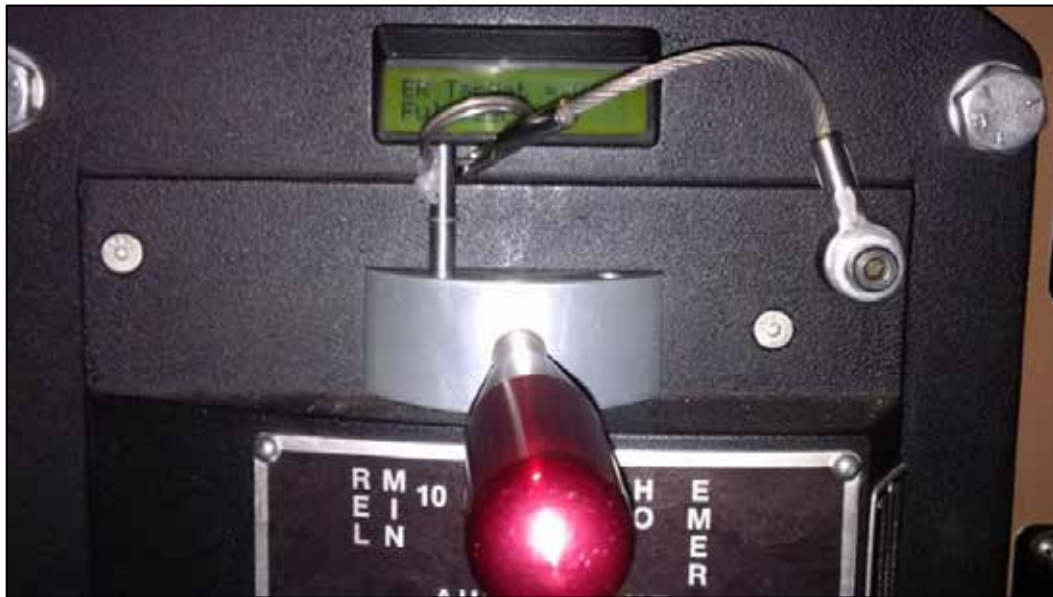
This feature is intended to be used for locomotives in a trailing position. In these situations, when the automatic brakes are cut out, the pin would be inserted to lock the automatic brake handle in the handle off position to ensure that the emergency brakes are not inadvertently applied. For the head-end locomotive, the pin is not necessarily intended to be used to prevent inadvertent movement of the automatic brake handle. However, if the pin is inserted when the automatic brake handle is in the full set position, the pin would prevent an inadvertent release of the brakes.

Figure 4. Automatic brake handle with locking pin inserted into the hole on the left side of the base of the handle, preventing the brake from being released.
