MARINE INVESTIGATION REPORT

M16C0137

Collision

Passenger vessel C03097QC

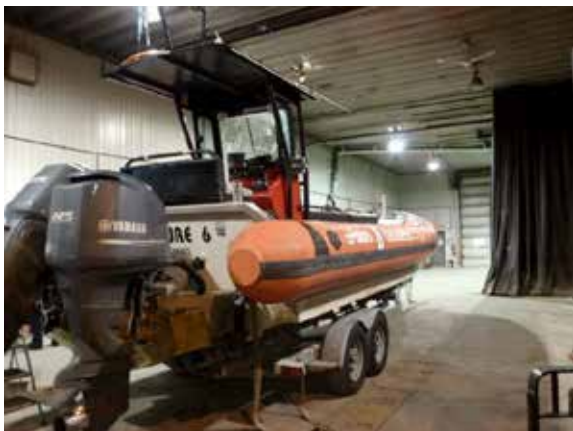
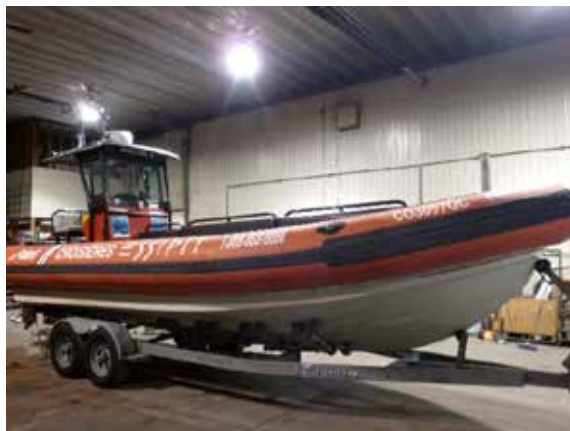
Figure 1. Stern and conning station of the *Aventure 6* Figure 2. Starboard side and bow of the *Aventure 6*

Twin outboard engines, providing a combined 450 horsepower, propel the vessel (Figures 1 and 2). Depending on its various loading conditions, the vessel has a freeboard of 67 to 78 cm in salt water.

Both outboard engines sustained minor damage as the holding-down bolts for the skegs and gearboxes were fractured. Upon impact, the on-board fire extinguisher broke free of its rack and was lost at sea.

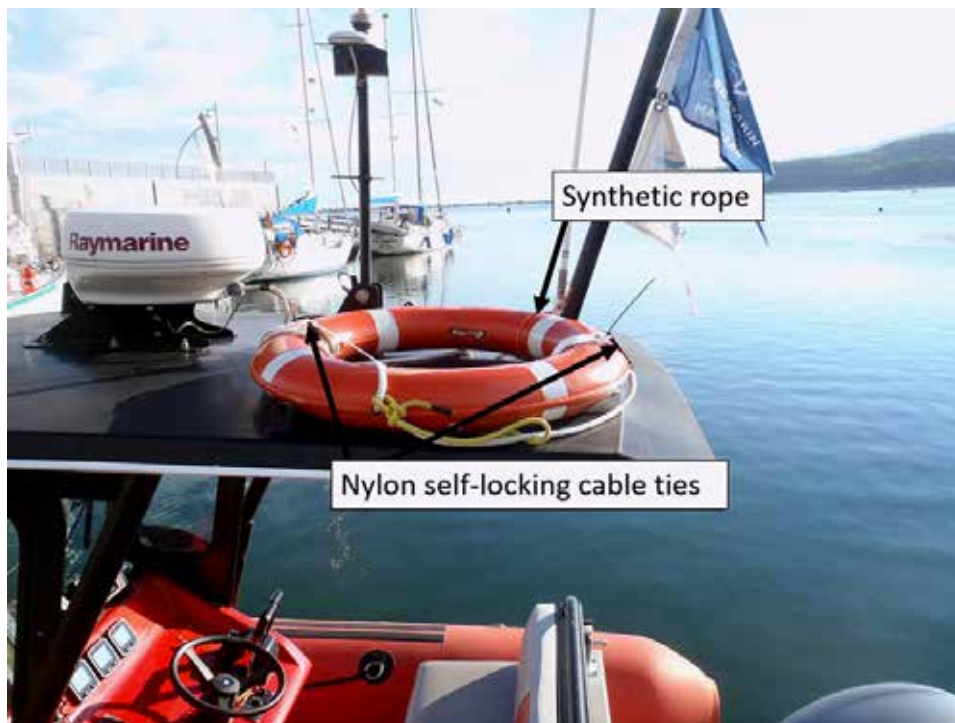
Figure 3. Lifebuoy stowage arrangement

have identified the missing re-boarding device, the improperly stowed lifebuoy, the inadequacy of a single dual-watch VHF radio to monitor 5 different frequencies, the non-configured DSC function, the incomplete passenger pre-departure briefing, and the vessel modifications done by the AR.

Specifically, the issues identified were the improper stowage of lifebuoys, the incomplete digital selective calling configuration of the very high frequency radiotelephones, the absence of a re-boarding device on board vessels that require one, the lack of use of the propulsion shutdown safety lanyard by operators, and incomplete pre-departure briefings to passengers.

After the occurrence, and after receiving Marine Safety Information Letter 01/17, Croisières Essipit modified the location and stowage of lifebuoys on its entire fleet, acquired new equipment with digital selective calling capability, equipped its fleet with a removable ladder as a re-boarding device, and updated its standard pre-departure passenger briefing to include information that had been missing.
