MARINE INVESTIGATION REPORT M17P0052

Capsizing and sinking with loss of life

Fishing vessel *Miss Cory*

06 March 2017

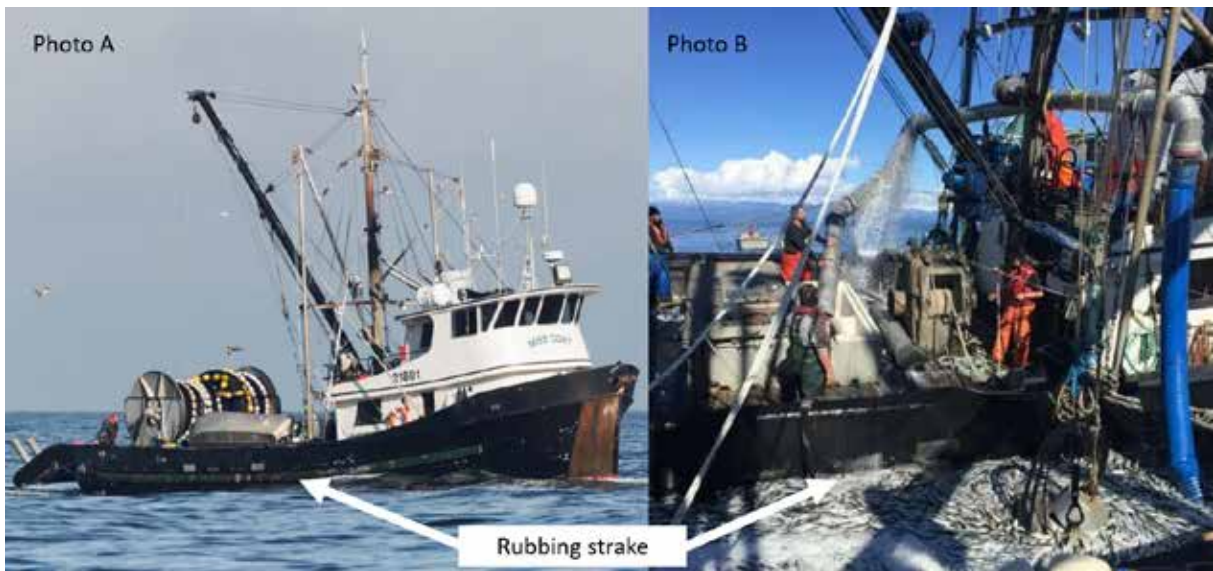
Figure 3. The rubbing strake on the *Miss Cory*, shown above the surface of the water while the vessel is voyaging (Photo A) and submerged while the vessel lists during operations (Photo B)

A delay in the availability of a packing vessel resulted in a large set of fish being tightly pursed in the seine along the *Miss Cory*'s starboard side for several hours. Unable to swim freely, many of the fish died, and as they sank and settled to the bottom of the pursed seine, their weight increased the load on the net. The load transferred to the starboard side of the *Miss Cory* and to the top of the boom, raising the vessel's centre of gravity and causing the vessel to increasingly list to starboard. This, together with a reduced freeboard caused by loading the forward holds, resulted in the vessel listing to the point where the rubbing strake was submerged in water.

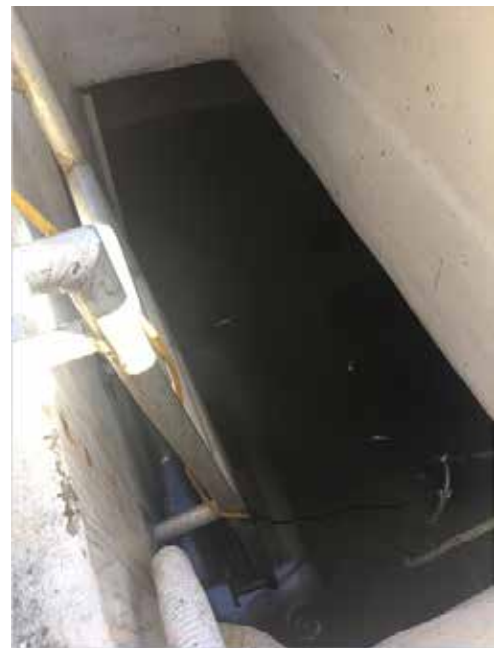
At approximately 1530, while fish were being pumped into the *Proud Venture*, the *Miss Cory* listed further to starboard. While monitoring the vessel's compartments, the crew of the *Miss Cory* detected water in the engine room and in the aft hold. The crew noted that the water level was rising rapidly and that the aft hold appeared to be approximately 50% to 75% full (Figure 4).

Figure 4. Water in *Miss Cory*'s aft hold

Because the *Miss Cory* sank, it was not possible to conduct a structural examination of the vessel; consequently, the investigation could not establish the precise condition of the hull and deck at the time of the occurrence. However, it is not unusual for a 60-year-old wooden fishing vessel to experience some leakage. Therefore, because the *Miss Cory* was caulked only up to the waterline, it likely experienced some leakage, which may have caused water to enter the vessel from behind the rubbing strake when the vessel listed and the rubbing strake was submerged. From there, the water likely made its way through the skin of the hull and into the shaft tunnel.

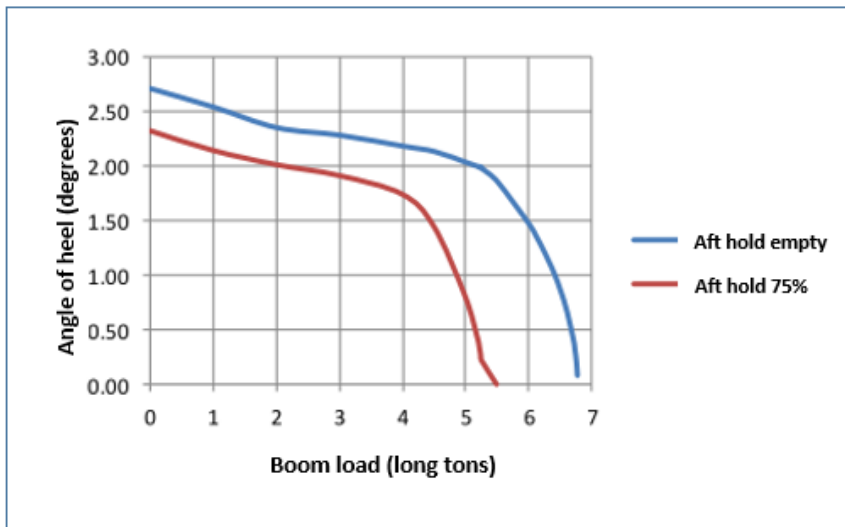
Figure 5. Limit of boom load (Image: MerLion Marine Services, with TSB annotations)

With the given parameters, it was calculated that the vessel would capsize at a boom load of 6.76 long tons with the aft hold empty, and at a boom load of 5.26 long tons with the aft hold 75% full. Figure 5 shows the angle of heel with increasing boom loads for the 2 conditions.

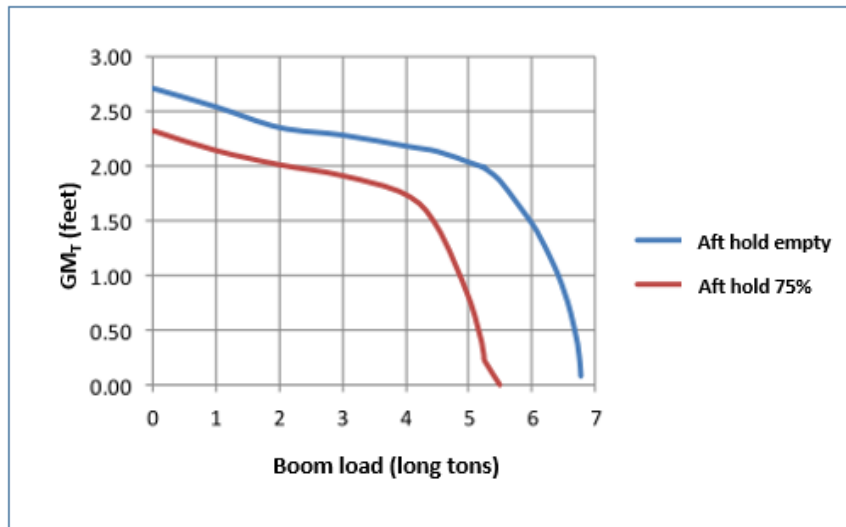
As the boom load increases, the value of the transverse metacentric height (GM_T)³⁰ decreases in a virtually linear fashion until a certain point is reached, at which point the GM_T decreases exponentially (Figure 6).

Figure 6. Transverse metacentric height (GM_T) with increasing boom load
(Image: MerLion Marine Services, with TSB annotations)

1. The angle of heel varies directly with increasing boom load up to a point, and then increases rapidly to the point of capsizing.
2. With an assumed boom load of 5 long tons, a vessel with the aft hold empty has more than twice the range of stability when compared to a vessel with an aft hold that is 75% full.
3. The value of GM_T varies directly with the boom load up to a point, and then decreases rapidly.
