## MARINE INVESTIGATION REPORT M17P0098

### **Partial sinking with loss of life**

Commercial sport fishing vessel BC1329967  
(*Catatonic*)

30 April 2017

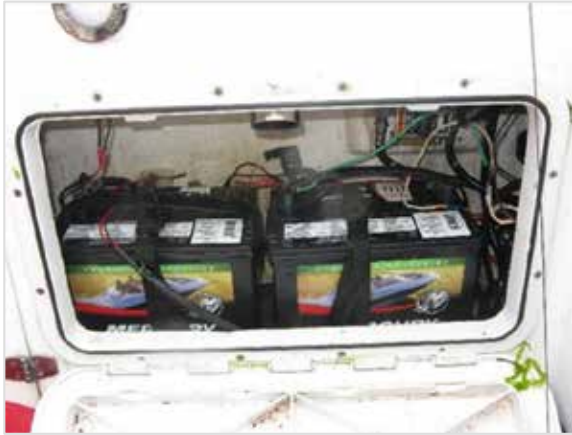
The operator purchased the vessel in January 2015. The following month, he contracted a local company to repower the *Catatonic* with 2 Mercury 225 hp outboard engines. At the same time, the contractor replaced the vessel's batteries with new ones, installed them inside the port battery compartment (Figure 3), and connected them to a single 4-way selector switch located inside the starboard battery compartment.

Figure 3. Modified, non-standard arrangement of battery banks in the port battery compartment

The 4-way selector switch could be set to 1, 2, ALL, or OFF. For convenience, the operator typically chose to keep the selector switch set to the ALL position, causing both batteries to act as a single unit. At the time of the occurrence, the selector switch was set to the ALL position.

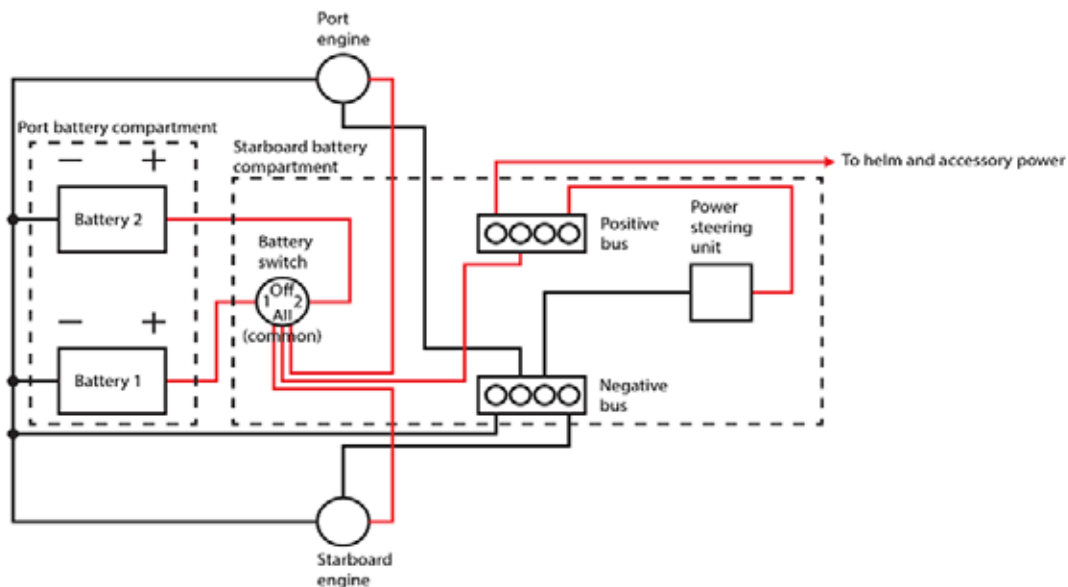
When acting as a single unit, both batteries are charged and drained simultaneously, and act as the only power source for the entire vessel (Figure 4).

Figure 4. The vessel's battery power distribution arrangement at the time of the occurrence

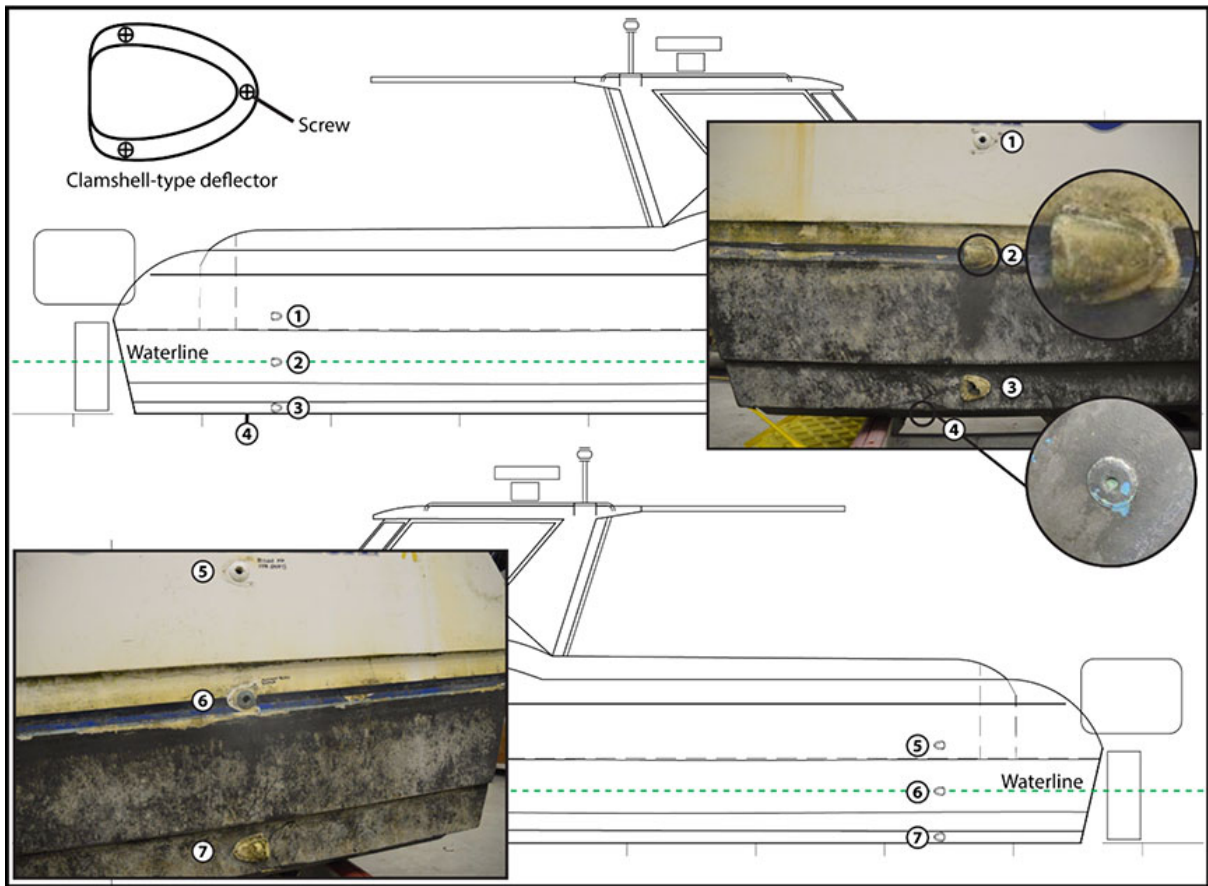
## Appendix B – Location of clamshell-type deflectors

- The clamshell-type deflector located at the stern port section of the vessel's outer hull around the waterline was missing. Three screws, about 3 mm in diameter, which originally secured the deflector, were also missing. The 3 screws had been installed 4 cm, 7 cm, and 10 cm, respectively, below the main deck level around the waterline. The waterline was observed to be about 7 cm below the deck level.<sup>34</sup>

When the 3 deflector securing screws on the port pontoon hatch cover drain went missing, the watertight integrity of the hull was compromised, and seawater was allowed to ingress into the vessel's port pontoon. The TSB determined that seawater ingressed through one of the 3 mm holes where the securing screws would normally have been installed. The ingress occurred at an approximate rate of 1 L per minute, and this rate increased as time progressed. Furthermore, the removal of the fish box drain hoses to make it easier to take out the boxes and inspect the pontoon bilges created a point of ingress for seawater that had washed on deck due to shipping seas. The water thus entered the starboard and port fish boxes through the pontoon hatch covers, eventually draining into both pontoons through the open fish box drain holes. Because the bilge pumps were run intermittently to keep the water in the bilges at a low level, the hull breach and the resulting water ingress went undetected.

At some point in time, 6 clamshell-type deflectors were fitted over 5 outlets and 1 inlet on the stern quarter of the outer hull of the vessel. Each deflector had 3 securing screws. All securing screws penetrated the hull. The deflector and securing screws for the port pontoon cover channel drain outlet were missing. Because the deflector was in line with the outriggers, it is likely that, over time, the fishing lines snagged the deflector, ripping it off.

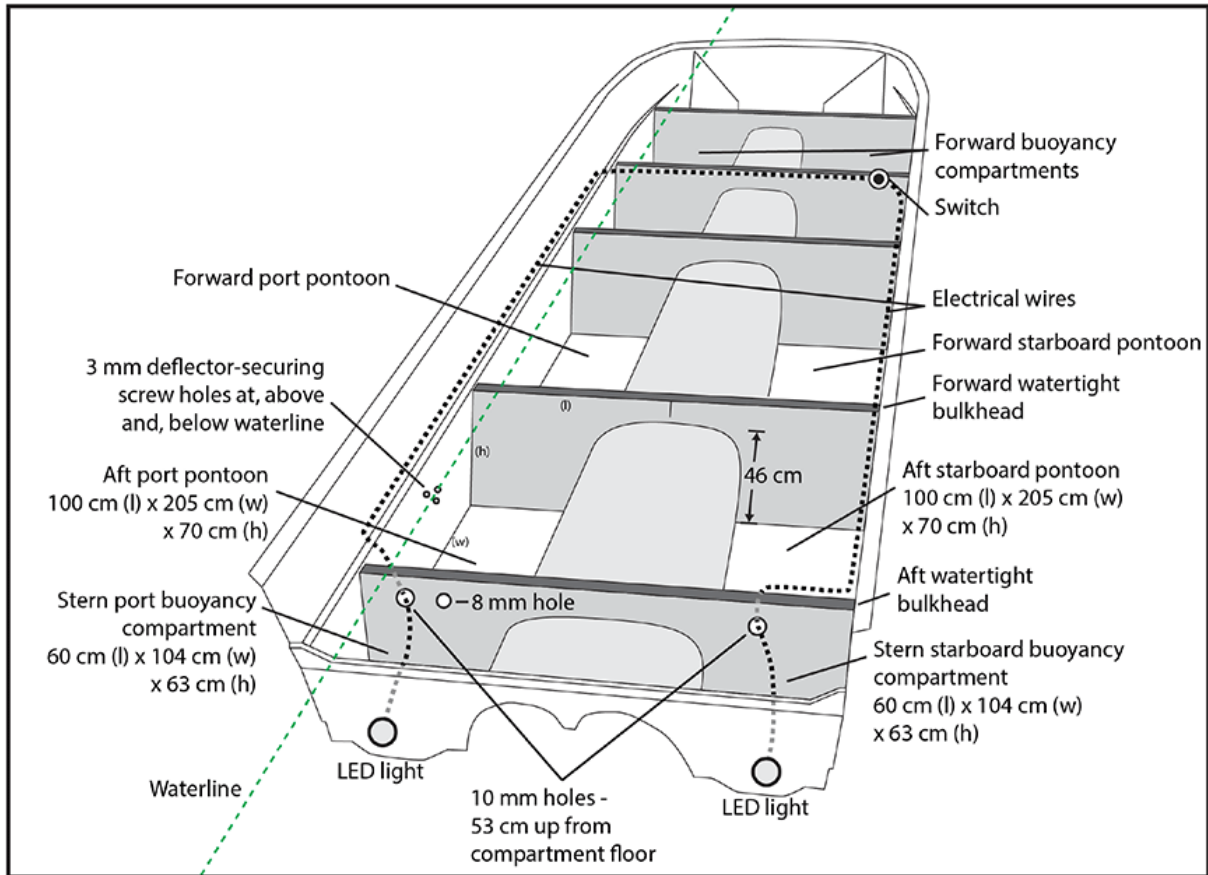
## Appendix C – Position of holes and compartments below main deck

Two electric cables run through holes in the watertight bulkhead of the stern buoyancy compartments. These cables are connected to light-emitting diode (LED) lights fitted to the stern's outer underwater hull, one on each side of the vessel (Appendix C).

- Three holes were observed on the aft watertight bulkhead separating the stern buoyancy compartment and aft pontoons: 2 holes (10 mm and 8 mm in diameter) were on the port side of the vessel, and 1 hole (10 mm in diameter) was on the starboard side. All 3 holes were located about 53 cm in height from the keel.

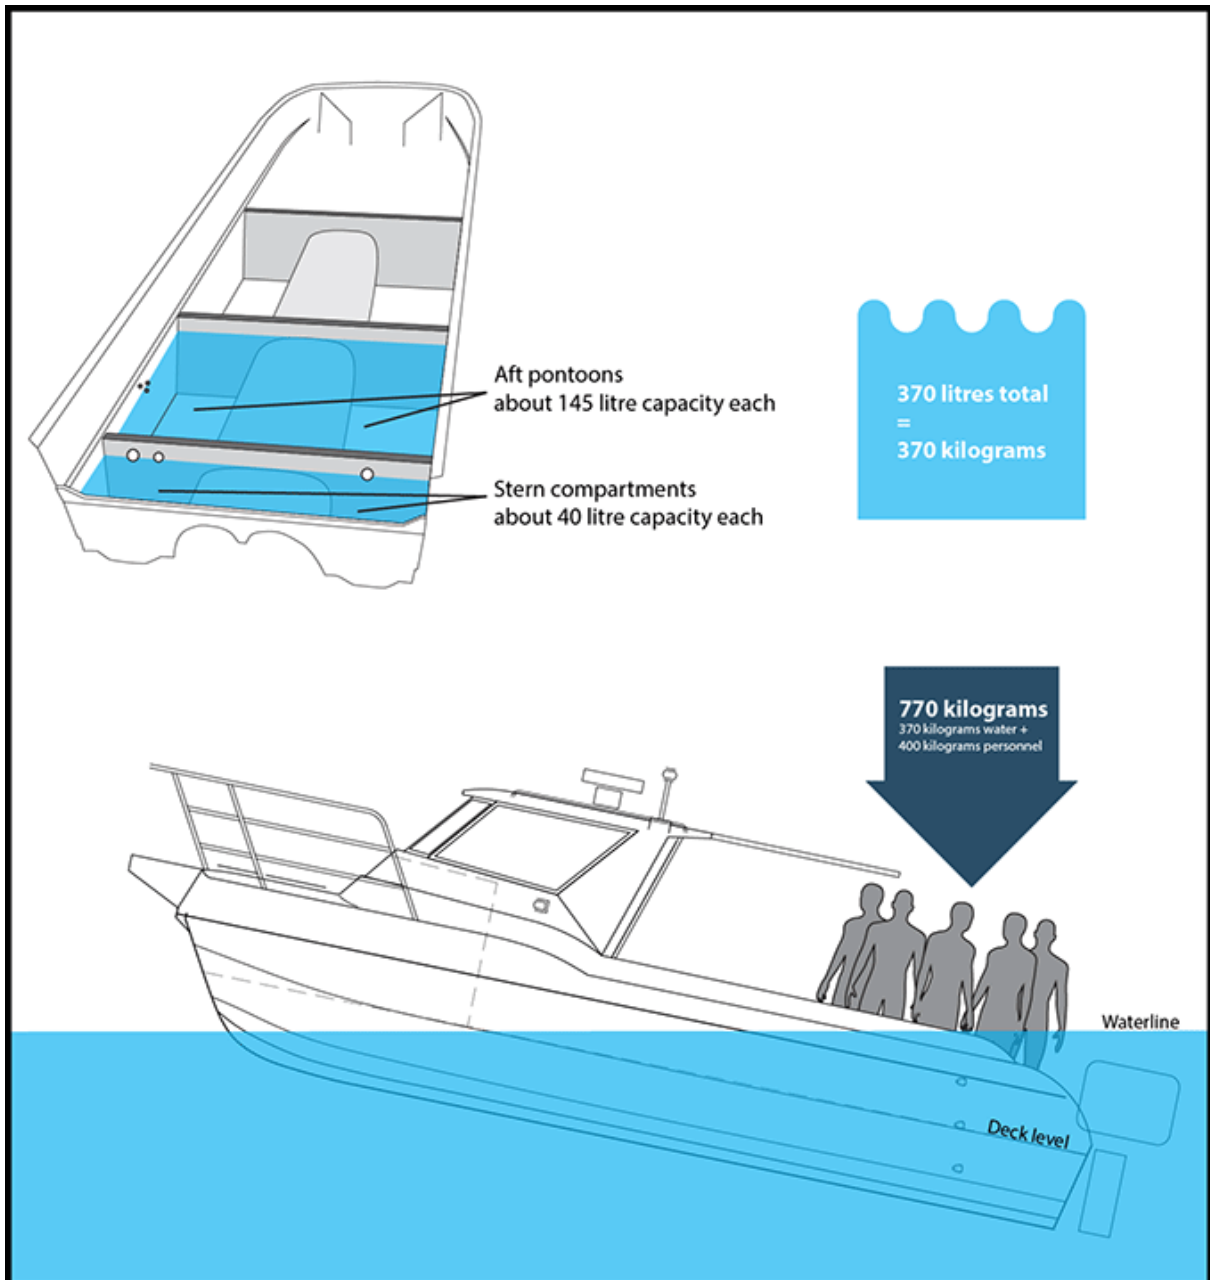
## Appendix H – Effect of water ingress and weight of people standing at the stern of the vessel

with the shipping seas, this caused the deck to fill with water and contributed to the stern's sinking (Appendix H). Eventually, the vessel could not maintain its upright aspect, and everyone on board abandoned the vessel into the water.
