The Effect of Coating Propellers: the Impact on the Integrity of Nickel Aluminum Bronze as a Function of Cathodic Protection

Trisha Huber
Brad Noren, Vincent Drover, Heather Smiley
DRDC – Atlantic Research Centre

Scientific Report
DRDC-RDDC-2018-R154
August 2018

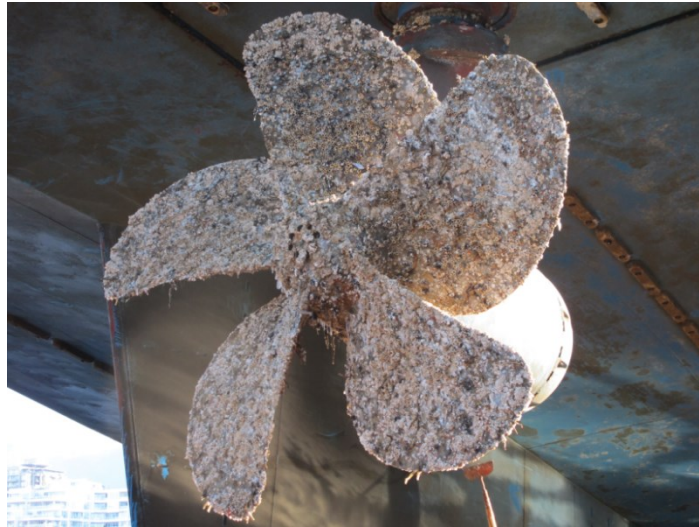
The biofouling is significant and covers all surfaces of the propellers. Mechanical means was necessary to remove the biofouling, ultimately risking damage to the propeller.

Figure 2: This vessel sat alongside for 18 months in Victoria, BC, resulting in significant biofouling of the propellers that required removal by mechanical means. Such mechanical methods increase the risk of propeller damage. Photo credit: S. McLaughlin, DRDC – Atlantic Research Centre.

In order to mitigate biofouling on vessels destined to sit alongside for extended periods, the propellers can be coated. The coating can be either a permanent coating, comprised of a complete coating system (primer + tie coat + top coat), or it can be temporary, such as a single coat of antifouling top coat. The intent of the permanent coating would be to provide biofouling mitigation, drag reduction, and optimize the hull potential [4] for the life of the propellers (or at least until the next docking work period); whereas, the intent of the temporary coating would be to provide biofouling mitigation until the ship is in active service. An optimal permanent coating system would be a foul release (FR) system, in which the top coat is a low surface energy coating that facilitates removal of biofouling. FR coatings do not contain a biocide, thus biofouling will occur; however, the biofouling adhesion is relatively low, and the growth is expected to slough off once the vessel is underway. Unlike ablative biocidal coatings, which must be replenished every few years, the FR coating is designed to maintain functionality for up to 10 years (depending on the product), barring mechanical damage. It is expected that the FR coating will sustain damage at the blade tips where cavitation is extremely high; however this is not a concern with respect to biofouling, as any growth will also be removed by the cavitation forces. An optimal temporary propeller coating to mitigate biofouling while the ship is alongside is a biocidal ablative antifouling coating. This type of coating will mitigate biofouling during the initial idle time, and slowly wear away when the ship becomes more active.

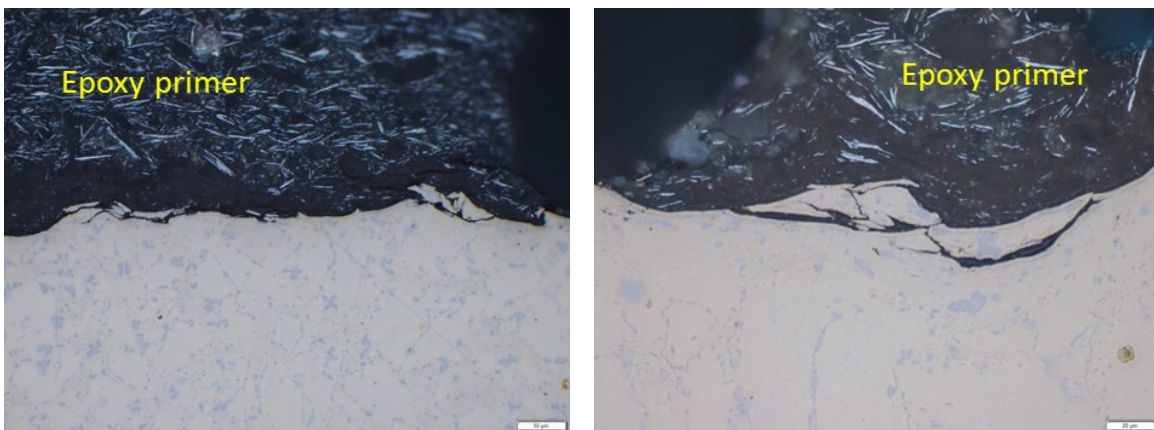
To adequately replicate propeller surface preparation, the NAB specimens were grit blasted, in order to achieve the desired surface profile of 50–75 μm . The grit-blasting, however, caused superficial mechanical damage (Figure 6), which could influence SPC.

Figure 6: Mechanical damage noted on epoxy specimens, attributable to the grit blasting used to prepare the surface. Scale bars are 50 μm and 20 μm for left and right image, respectively.

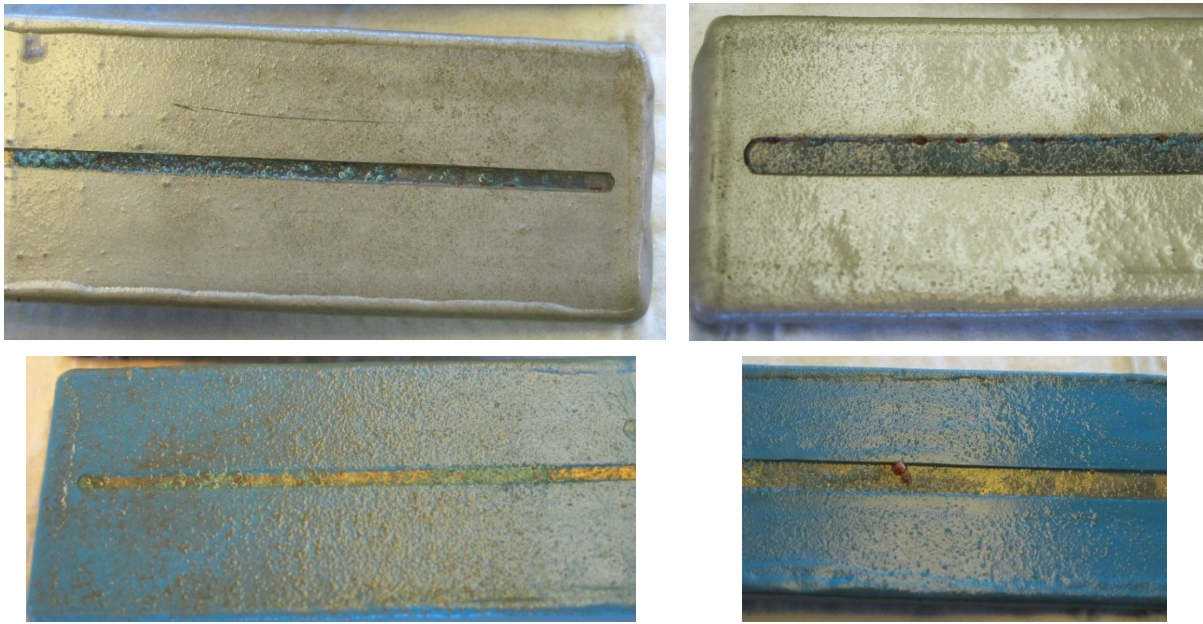
Within 3 months of immersion, surface tarnishing (oxidation) of NAB and the formation of blue-green copper-based corrosion products were evident within the score line of the unprotected specimens (Figure 8). Red-brown deposits immediately adjacent to the coating were also noted. Although the formation of red-brown copper (I) oxide (Cu_2O) has been noted in previous studies [3], SEM-EDS analysis indicated that the red-brown corrosion product is primarily iron-based.

Figure 8: Unprotected epoxy (top) and antifouling (bottom) specimens exhibiting evidence of tarnishing as well as blue-green copper-based and red-brown iron-based corrosion products.

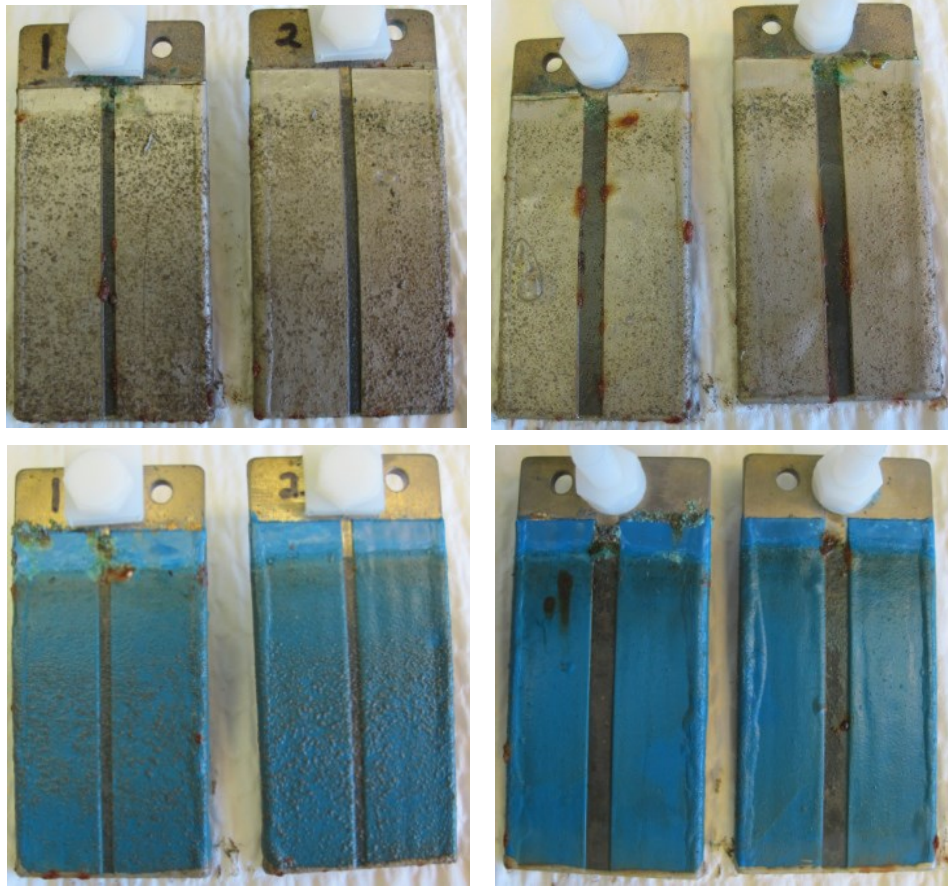
The exposed NAB in the score line was observed to darken with time. Figure 9 shows the specimens after 18 months of immersion. The epoxy specimens exhibited significant blistering adjacent to the crevice, and well under the coating, demonstrating considerable water ingress (Figure 10).

Figure 9: Front and back of unprotected epoxy (top) and antifouling (bottom) coated NAB specimens after 18 months.

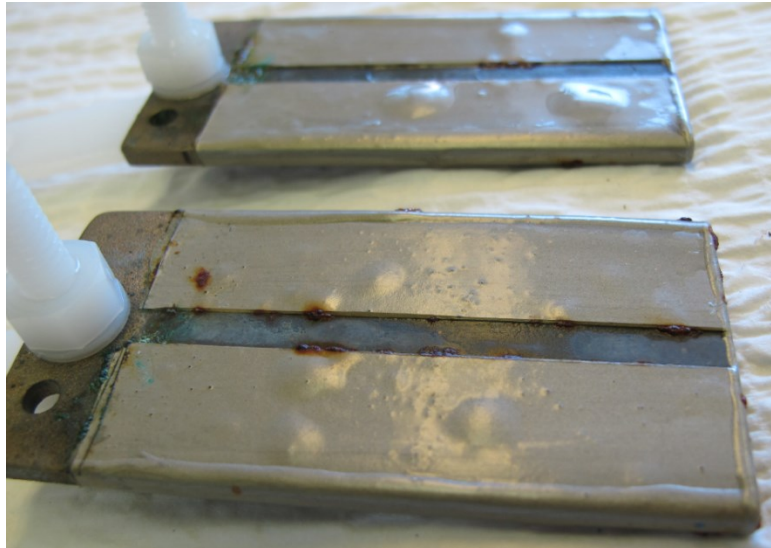
Figure 10: Unprotected epoxy specimens after 18 months of immersion, showing significant blistering at numerous locations.

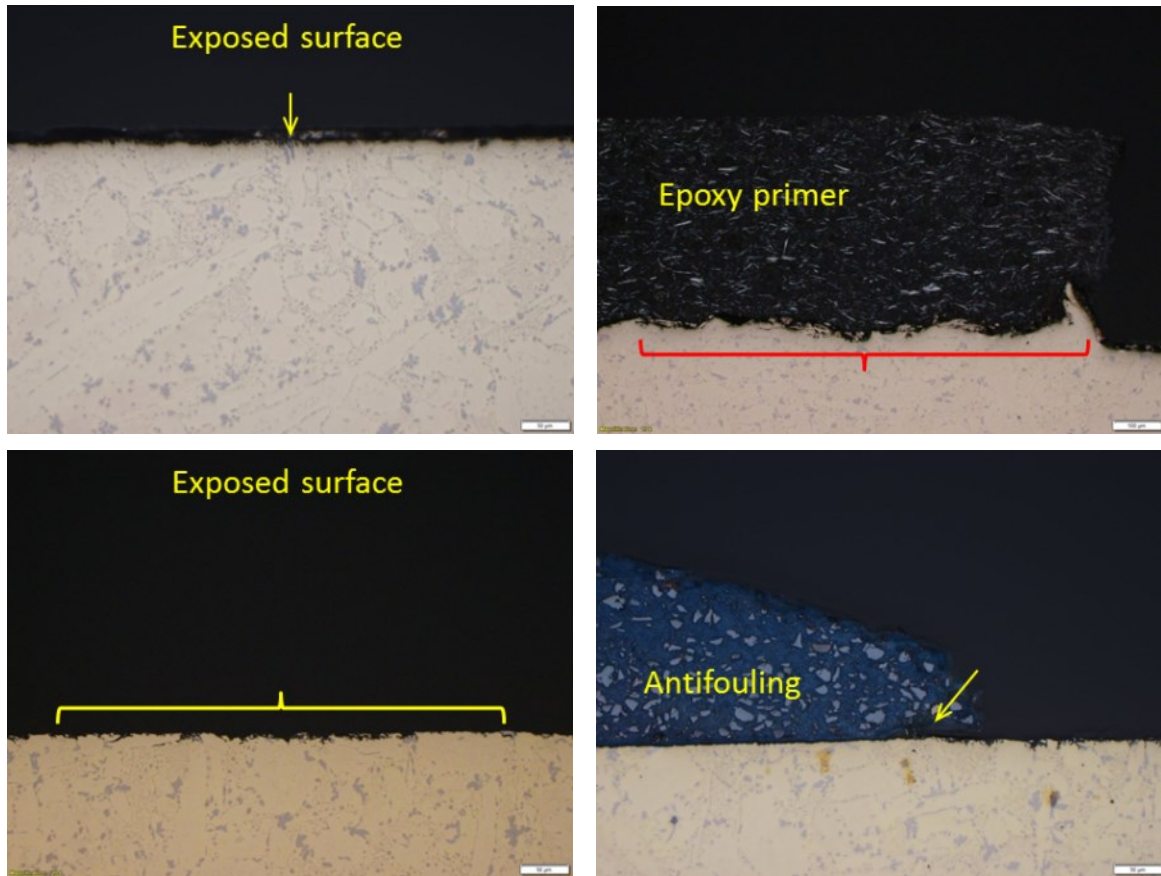
At the 3 month examination, the epoxy specimens exhibited a small amount of early SPC (oxidation of the α -phase) within the score line, in addition to advanced SPC (i.e. copper re-deposition was evident) in one of four crevices, on each epoxy specimen (Figure 11). The antifouling specimens exhibited α -phase oxidation within the score line; however, no crevice corrosion was observed (Figure 11).

Figure 11: Images showing a small amount of SPC (just α -phase corrosion, yellow arrows and bracket) within the score line of epoxy (top left, scale bar 50 μm) and antifouling (bottom left, scale bar 50 μm). Advanced crevice corrosion (red bracket) was observed in the epoxy specimen (top right, scale bar 100 μm); however, very little crevice corrosion (α -phase) was observed in the antifouling specimen (bottom right, scale bar 50 μm).

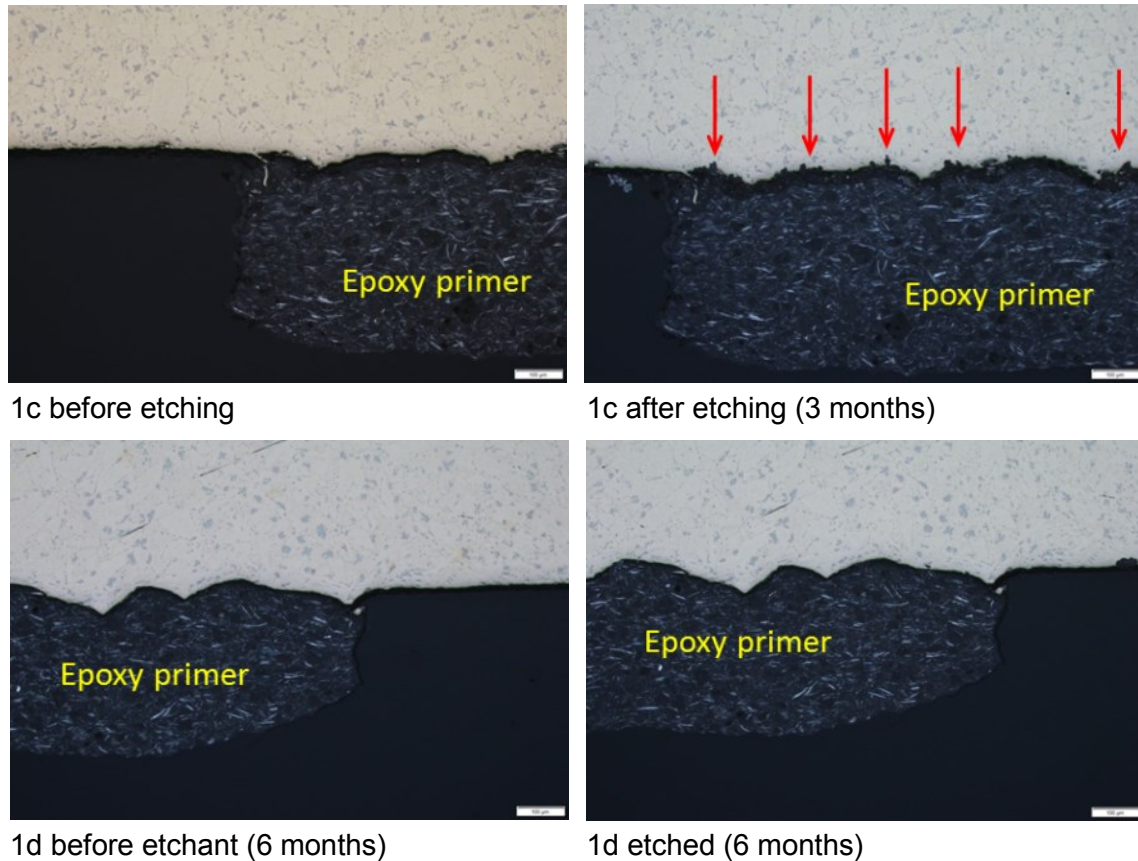
In order to assess the extent of SPC on all unprotected epoxy specimens, freshly polished specimens were etched with silver nitrate solution to emphasize areas of SPC. This is a rough method for revealing SPC, although it is only effective if the SPC has advanced to the copper re-deposition stage. The silver, which oxidizes the re-deposited copper, is reduced and forms a dark deposit on the surface, rendering the SPC-affected areas more visible. To demonstrate the effect of the silver nitrate etchant, before and after images are presented in Figure 12. The areas that appear dark and “chewed up” were considered to be those with advanced SPC. The region exhibiting this effect continuously along the coating-NAB boundary was measured. In addition to the continuous areas of undercutting, some random dark spots at the coating-NAB boundary as well as within the bulk of the NAB were noted; thus it seems that some of

the κ -phases were also subject to oxidation. The silver nitrate etch should be considered a rough, but not definitive test for SPC. Dark spots that were noted along the boundary, but did not form part of the continuous area of effect were not included in the measurement; thus it is possible that the extent of SPC is greater than the values indicate.

Figure 12: Images taken before and after etching demonstrate the effectiveness of using silver nitrate to better view advanced SPC. Until the SPC has progressed sufficiently for the re-deposited copper to be visible, it is very difficult to see the evidence of SPC on unetched samples. The top right image shows a distinct effect of the silver nitrate etch (red arrows), indicating advanced SPC; however, the lower images demonstrate no difference, before and after etching, indicating no advanced SPC. Scale bars are 50 μ m.

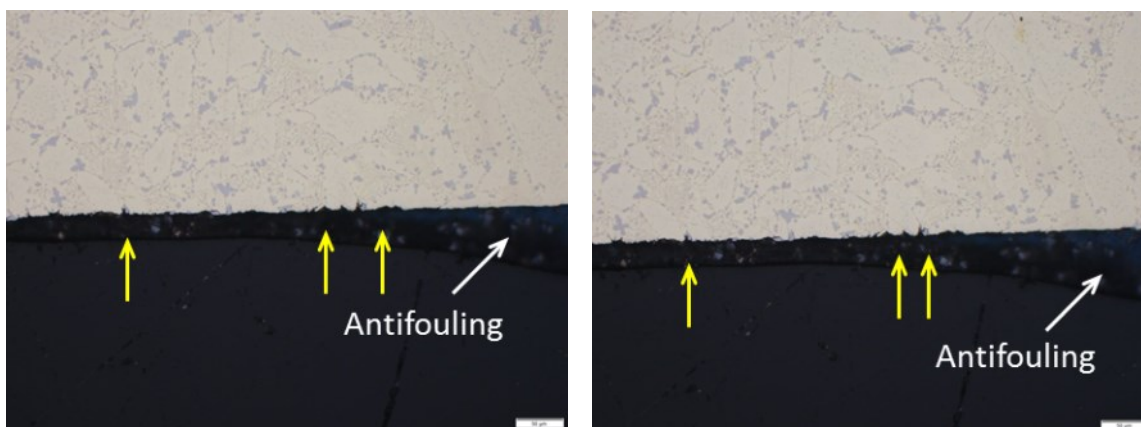
The silver nitrate etchant did not alter the appearance of the antifouling specimens (Figure 14), suggesting that the small amount of crevice corrosion observed had not yet progressed to the copper re-deposition stage. The significant degree of advanced SPC within approximately half of the epoxy specimens crevices, in contrast to the very slight early SPC crevice corrosion noted on one quarter of the antifouling specimens suggest that the epoxy coating is a much better crevice-former than the antifouling coating. The results are consistent with the epoxy exhibiting excellent properties, and strongly suggest that the in-service conditions should be carefully considered when selecting coatings for use on NAB.

Figure 14: Images of crevice corrosion (early SPC) noted on an antifouling specimen after 18 months of immersion, before (left) and after (right) silver nitrate etch. The etchant does not indicate advanced SPC (copper re-deposition); however, early SPC is quite obvious. Scale bars are 50 μm .

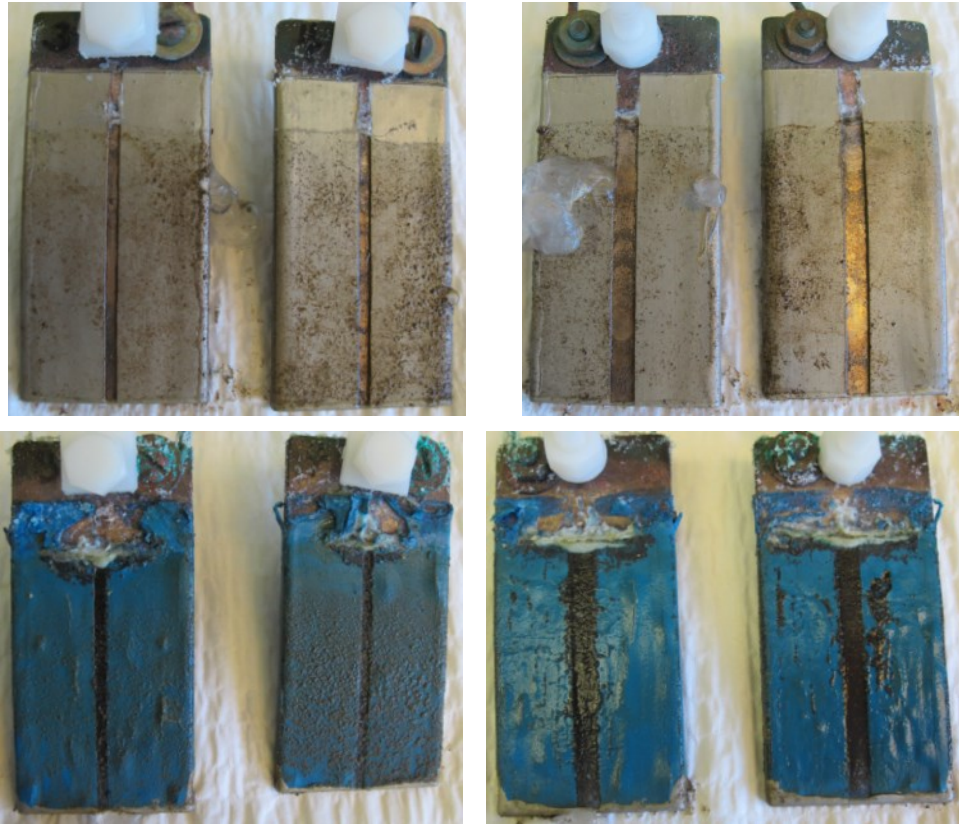
Figure 15 shows the protected specimens after 18 months of immersion. For the most part, the protected epoxy specimens retained the shiny appearance of exposed NAB, consistent with unoxidized NAB, over the 18 months of immersion. In contrast, the protected antifouling specimens exhibited darkening at exposed NAB, which became progressively darker with time. Considering that the specimens had been subjected to the same conditions,³ it is reasonable to conclude that the observed differences in their appearance must be attributed to differences in the coatings. A viable explanation of the NAB darkening with the antifouling specimens is that the leached biocidal copper ions undergo electrodeposition onto the exposed NAB regions. This phenomenon has been observed previously⁴ when antifouling-coated NAB was immersed in a large beaker of seawater and cathodically protected; copper was observed on the surface of the NAB, and did not arise from SPC.

Figure 15: Front and back of cathodically-protected epoxy (top) and antifouling (bottom) specimens after 18 months.

With the cathodically protected specimens, the integrity of NAB appeared to be maintained with the epoxy system, for the duration of the experiment. In the event that epoxy is to be applied to NAB, it is critical that cathodic protection be adequately maintained. The effect of the grit-blasting on the mechanical integrity of NAB, in conjunction with the possible limitation of cathodic protection deep within a crevice, could result in long-term issues. It is highly recommended that long term (minimum five years) experiments be performed to fully gauge the impact of the presence of coating on the integrity of cathodically—protected NAB.

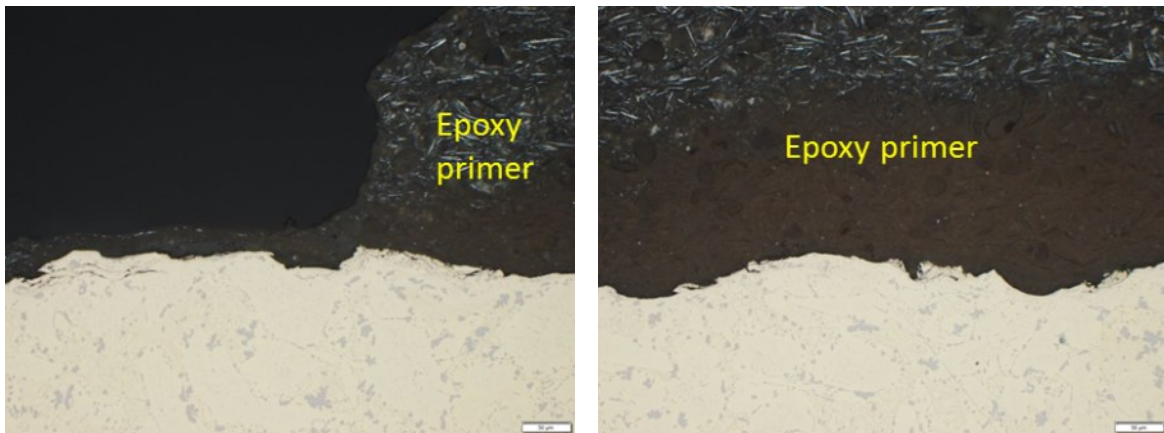
Although the protected specimens did not exhibit evidence of crevice corrosion, the surface of the epoxy-coated NAB appears to have suffered some degradation. In comparison with the mechanical damage attributed to grit-blasting (Figure 6), the damage seems to be more extensive and on a smaller scale (Figure 16). The NAB surface seems less well-defined, with several small cracks visible. The silver nitrate test did not modify the appearance, ruling out advanced SPC; however, early SPC should not be precluded. Unfortunately these experiments could not be continued⁵ as monitoring further development of the damage would have allowed a definitive assessment of the effect of grit-blasting on the integrity of NAB.

Figure 16: Protected epoxy after 18 months of immersion. Note the presence of micro-cracks near the surface, in contrast to the larger scale damage noted after grit blasting (see Figure 6). Scale bars are 50 μm .

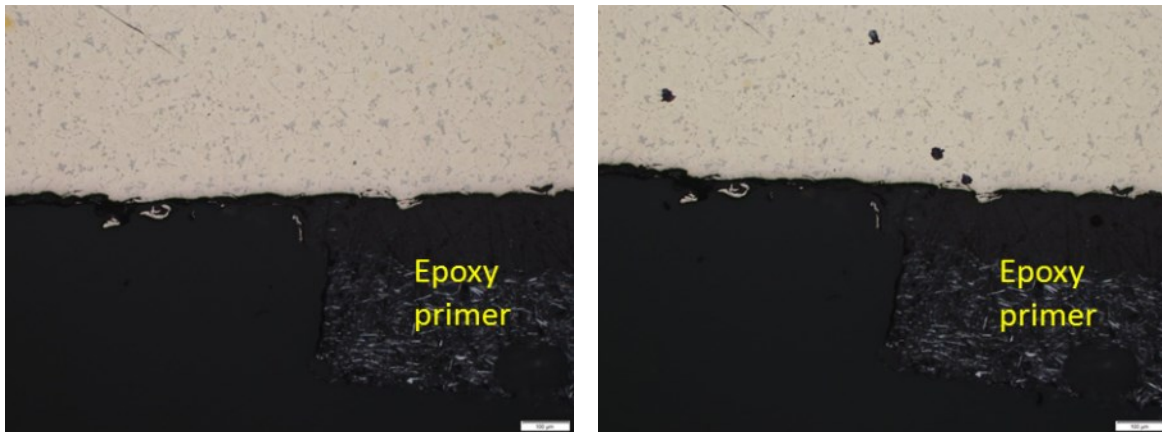
Attempts to determine whether SPC is occurring deep within a crevice, where the cathodic protection may not be adequate⁶, involved the use of the silver nitrate test. The application of the etchant on epoxy specimens, after 18 months of immersion, did not result in any change in appearance (Figure 17). Although this likely means that SPC has not occurred, it does not preclude the existence of early SPC, as the silver nitrate provides indication of advanced SPC, as noted with the unprotected antifouling specimens discussed earlier (see Figure 14).

Figure 17: Protected epoxy after 18 months before (left) and after (right) silver nitrate etchant, showing no evidence of advanced SPC. Scale bars are 50 μ m.

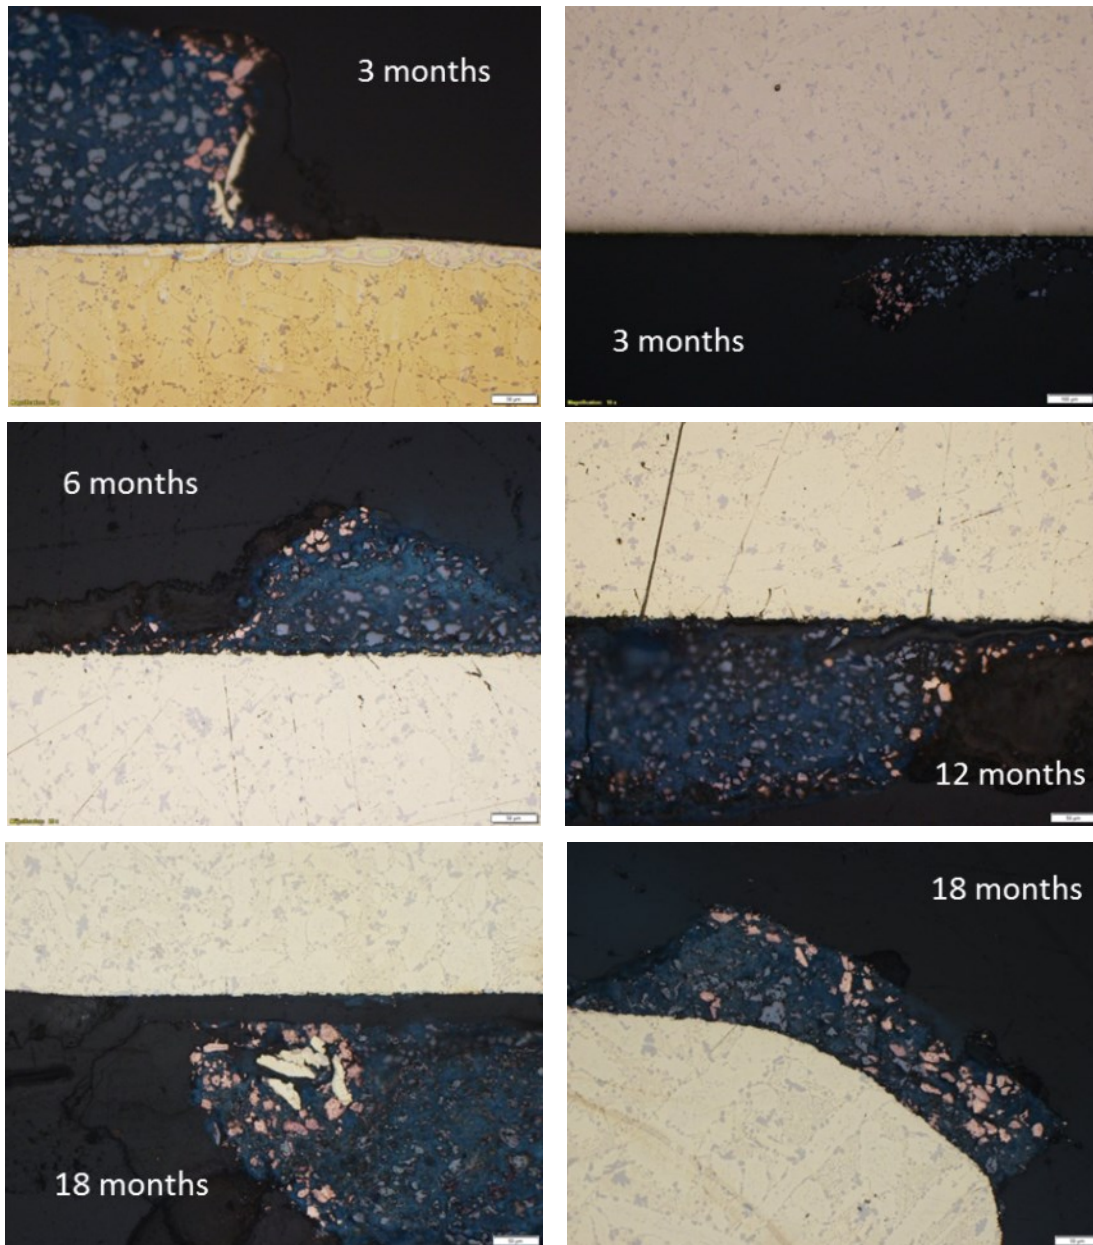
This phenomenon was noted in these experiments as early as the 3 month mark, and the degree of copper conversion was found to roughly increase as a function of time (Figure 18). These regions are either adjacent to the score line, or at the edge of the specimen where the coating is thinner.

Figure 18: Images of protected antifouling-coated specimens showing evidence of copper conversion as early as 3 months, and roughly increasing in degree as a function of time (top—3 months, middle—6 and 12 months, lower—18 months). Copper conversion refers to the process by which the copper oxide particles in the antifouling coating undergo reduction to metallic copper, as a result of the cathodic protection current. Areas most susceptible to copper conversion are areas where the coating is very thin, such as at corners (lower right), are areas adjacent to a breach in the coating (all other images). Scale bars are 50 μm .

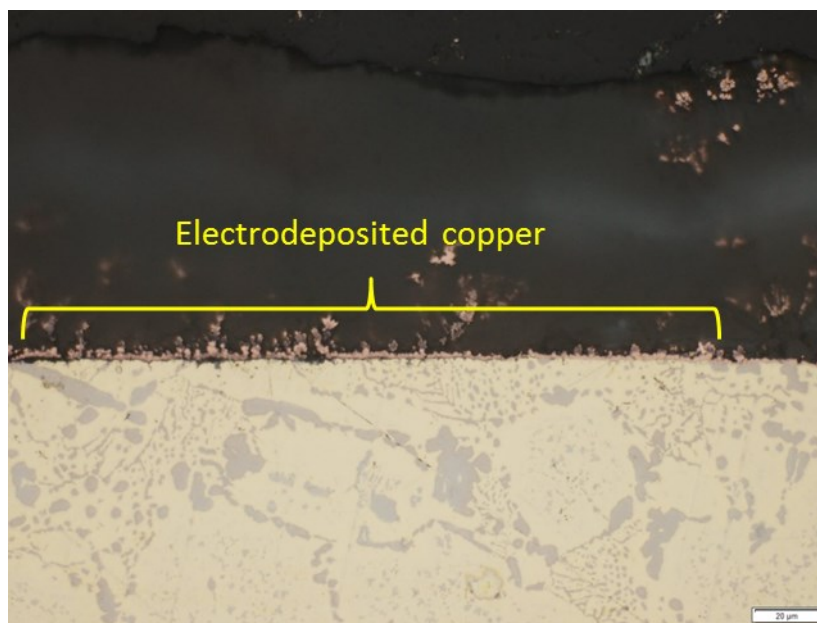
In addition to copper conversion within the coating, reduction of the leached biocidal copper ions onto the surface (electrodeposition) can also occur. This phenomenon was noted on protected antifouling specimens after 18 months of immersion (Figure 19). This process clearly modifies the surface of the substrate, and is likely detrimental to a propeller surface, as it could impact drag and noise.

Figure 19: Copper deposition visible on exposed area of NAB after 18 months of immersion. Scale bar is 20 μm .

The copper ablative antifouling coating, however, was found to result in the undesirable electrodeposition of copper onto the surface of the NAB, increasing its roughness, and could potentially cause issues with drag and noise. This method could be a viable means of mitigating biofouling for a short period (less than 12 months); however, long-term use of antifouling on cathodically protected NAB is not recommended, due to the possibility of electrodeposition of copper onto NAB.
