**PERFORMANCE MONITORING OF A
BRICK VENEER/STEEL STUD
WALL SYSTEM
- PHASE 2 RESULTS -**

- PHASE 2 RESULTS -

SUBMITTED BY: KELLER ENGINEERING ASSOCIATES INC.
1390 PRINCE OF WALES DRIVE, SUITE 107
OTTAWA, ONTARIO
K2C 3N6

REPORT DATE: 1995 02 17

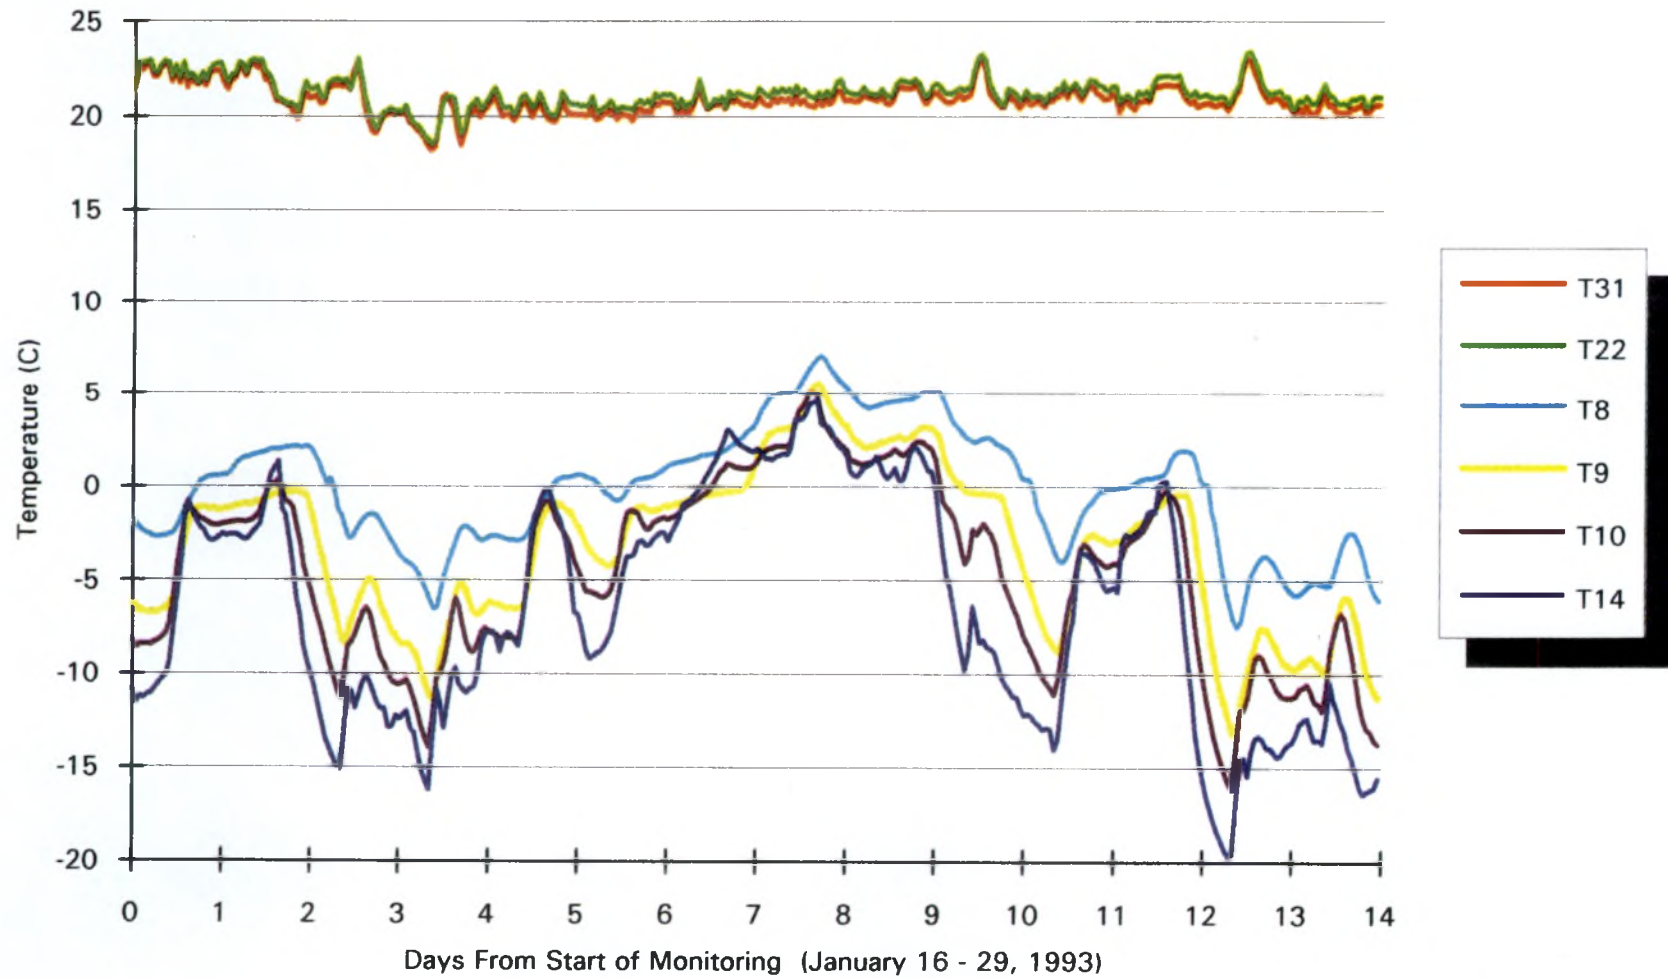
Fig. 7 Temperature Profile Across Test Wall at Insulation

Fig. 7 illustrates the temperature profile across the wall at the insulation. This profile demonstrates that good thermal performance can be expected from a "typical" brick veneer/steel stud wall since all surfaces on the exterior of the fiberglass batt insulation are at temperatures much lower than the interior gypsum board. However, surface temperatures between the interior and exterior drywall are more widely distributed at the steel stud (Fig.8) than at the insulation. This temperature profile, caused by thermal bridging through the stud, indicates that the wall does not perform as well, thermally, at stud locations as it does at the insulation.

In comparing the data presented in Figs. 7 and 8, it is noted that the temperature at the exterior surface of the sheathing is an average of 5°C warmer at the steel stud than at the insulation. Thermal bridging also causes the interior surface of the interior gypsum board to be typically about 2.5°C colder at the steel stud than at the insulation. Occasionally, the surface temperature of the interior drywall is up to 3.5°C colder at the stud than at the insulation. Thermal bridging of this magnitude can cause dusting of the drywall at the stud locations. As discussed in Section 4, severe dusting was, in fact, observed during the visual observations made in March 1994.

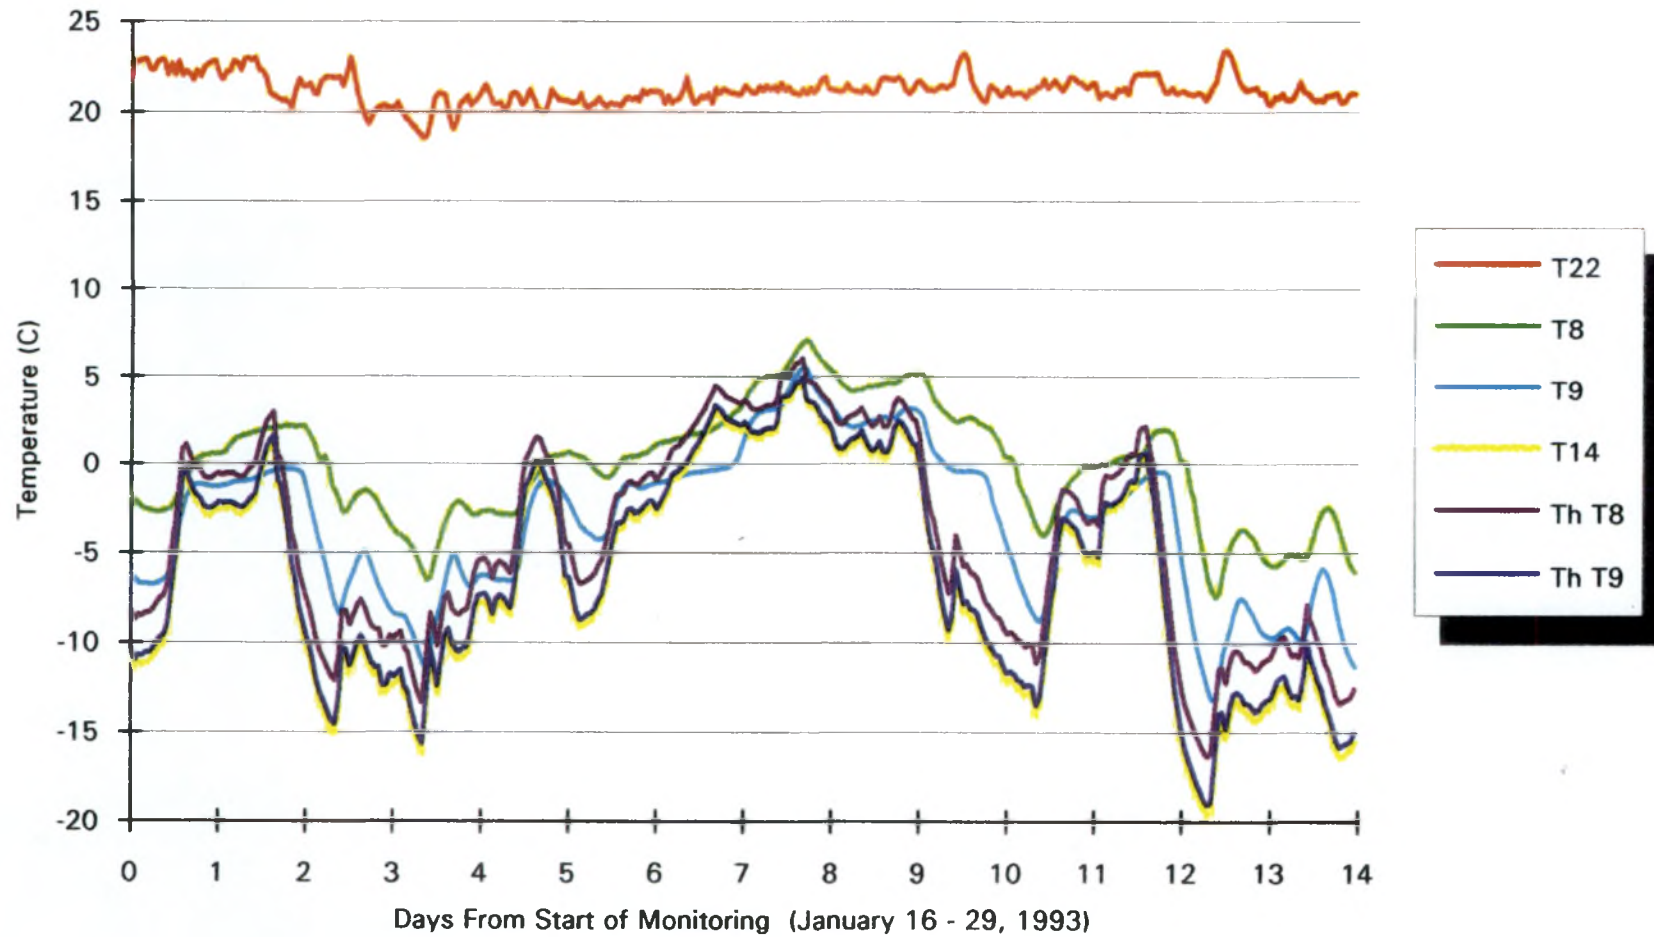
Fig. 9 Comparison of Actual and Theoretical Surface Temperatures in Cavity

It was observed that the measured thermal profile of the backup wall often differed significantly from the theoretical thermal profile. In-situ conditions such as wind pressure, air leakage through the wall system, wet masonry and the sun shining on the brick veneer cause the test wall to behave differently from the manner assumed in a theoretical calculation of the temperature profile, which uses steady-state conditions. In general, the measured temperature profile is more likely to correspond to a theoretical calculation if there is no wind, the temperature has not been fluctuating, the brick veneer is dry and the sun is not shining on the test wall.

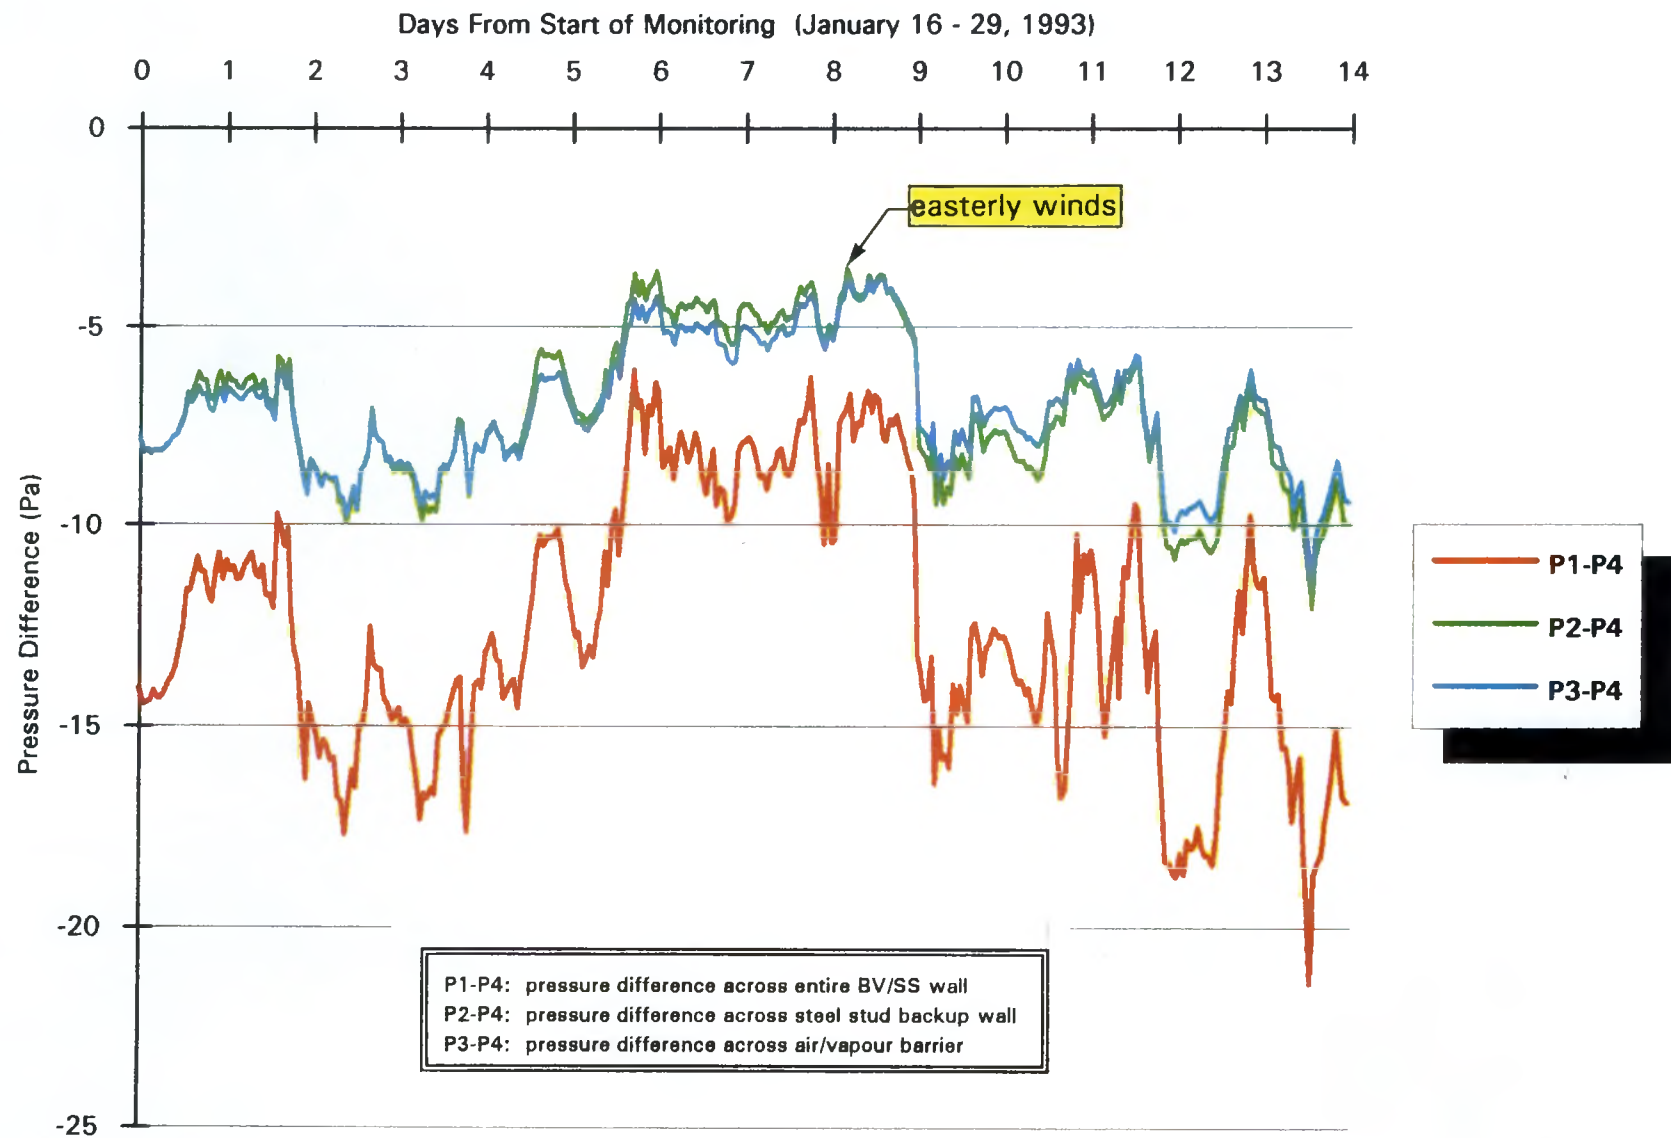
Fig. 11 Hourly Average Pressure Differences Across Test Wall

As was found from the 1991/92 data, Figs. 11 and 13 illustrate that there is a simultaneous increase in pressure on the exterior and within the cavity, indicating that pressure equalization does occur to some degree. However, the graphs also illustrate that when wind speeds and wind directions change, there is a greater change in P1-P4 than in P2-P4. Since the changes in the pressure difference between the interior and exterior air tend to be greater than changes in the pressure difference between the cavity air and the interior air, pressure equalization is not fully effective. Therefore, this data also indicates that a certain portion of the wind load is carried by the brick veneer rather than solely by the steel stud backup wall.

The magnitude of P1-P2 not only indicates that pressure equalization is not fully effective, this data also indicates that air leakage occurs through the air barrier since air leakage partially "releases" pressure on the air barrier. The existence of air leakage through the air/vapour barrier system was discussed earlier in the report and is illustrated by Fig. 10, which shows that the thermal performance of the backup wall is reduced, due to air leakage, under high pressure differences across the test wall.

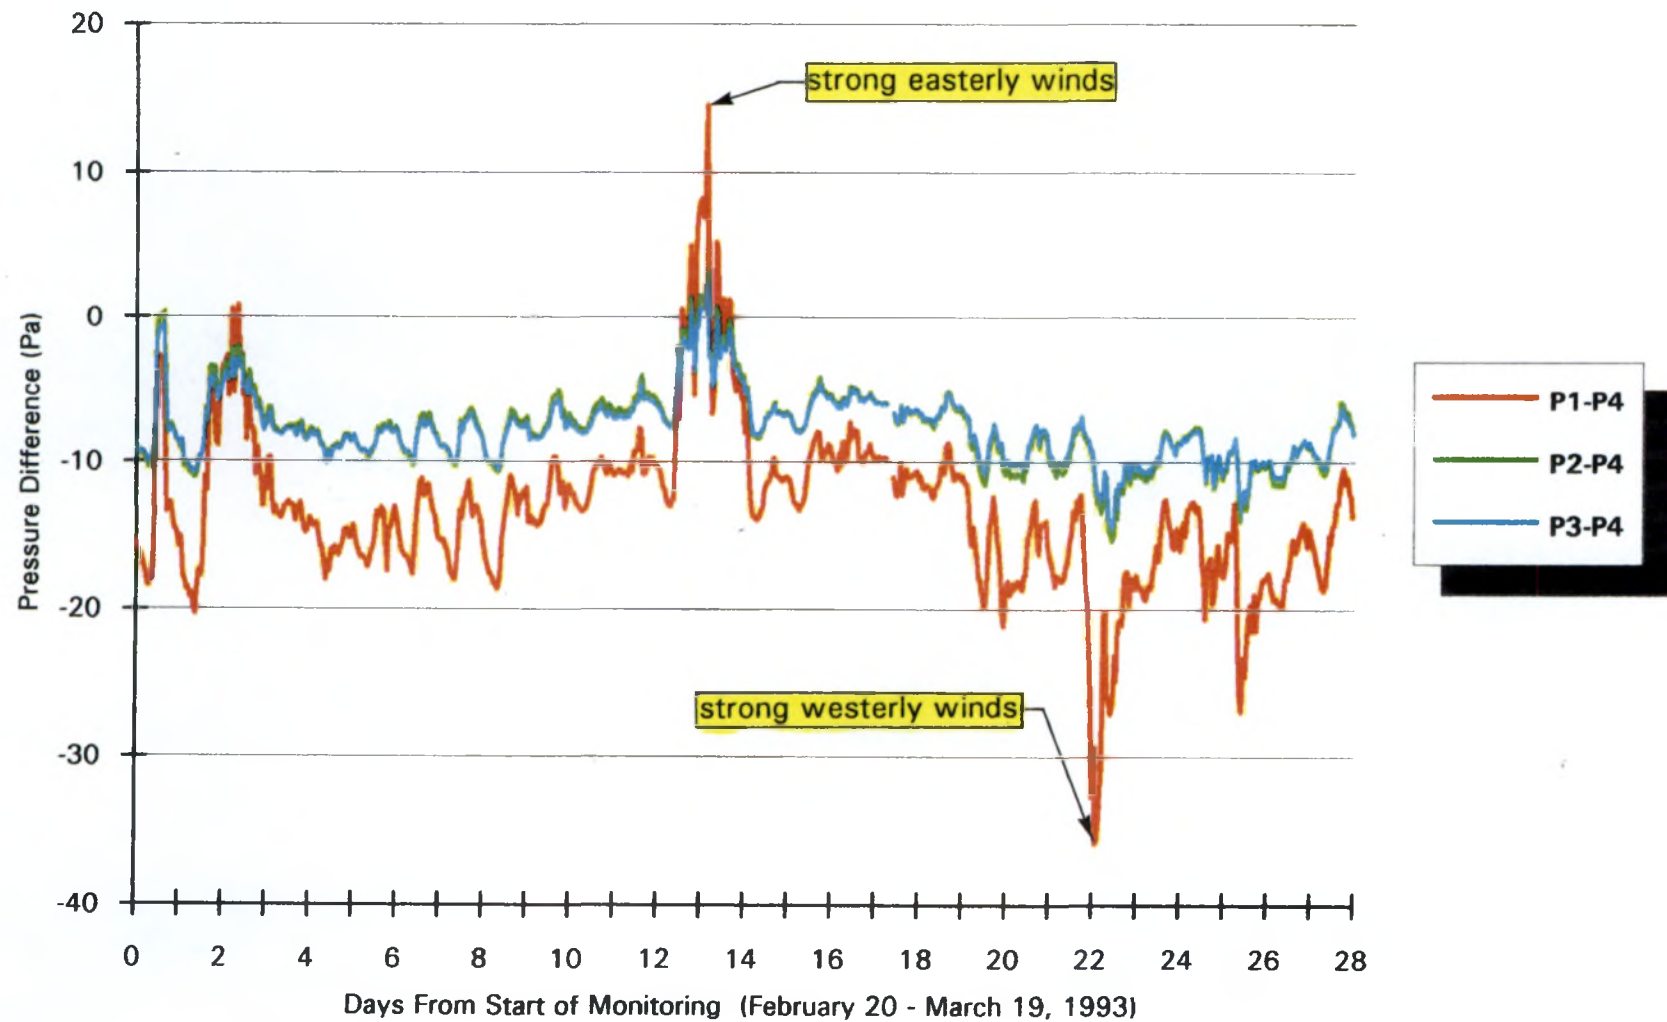
Fig. 13 Hourly Average Pressure Differences Across Test Wall

Note that the pressure difference is still negative (i.e. outwards, as viewed from a structural engineering application) during mild easterly winds, due to building pressurization and stack effect. However, strong easterly winds sometimes cause positive pressure differences. The positive pressure differences on Days 13 and 14 of Fig. 13 (March 4 and 5, 1993) are due to easterly winds in the 30 to 50 km/h range. Similarly, high values of P1-P4 occur when strong winds occur from a direction that causes high suction pressures at the test wall. For example, negative pressure differences greater than 30 Pa occurred in the early morning of March 14, 1993 (Day 23 of Fig. 13) during northerly winds of about 40 km/h.

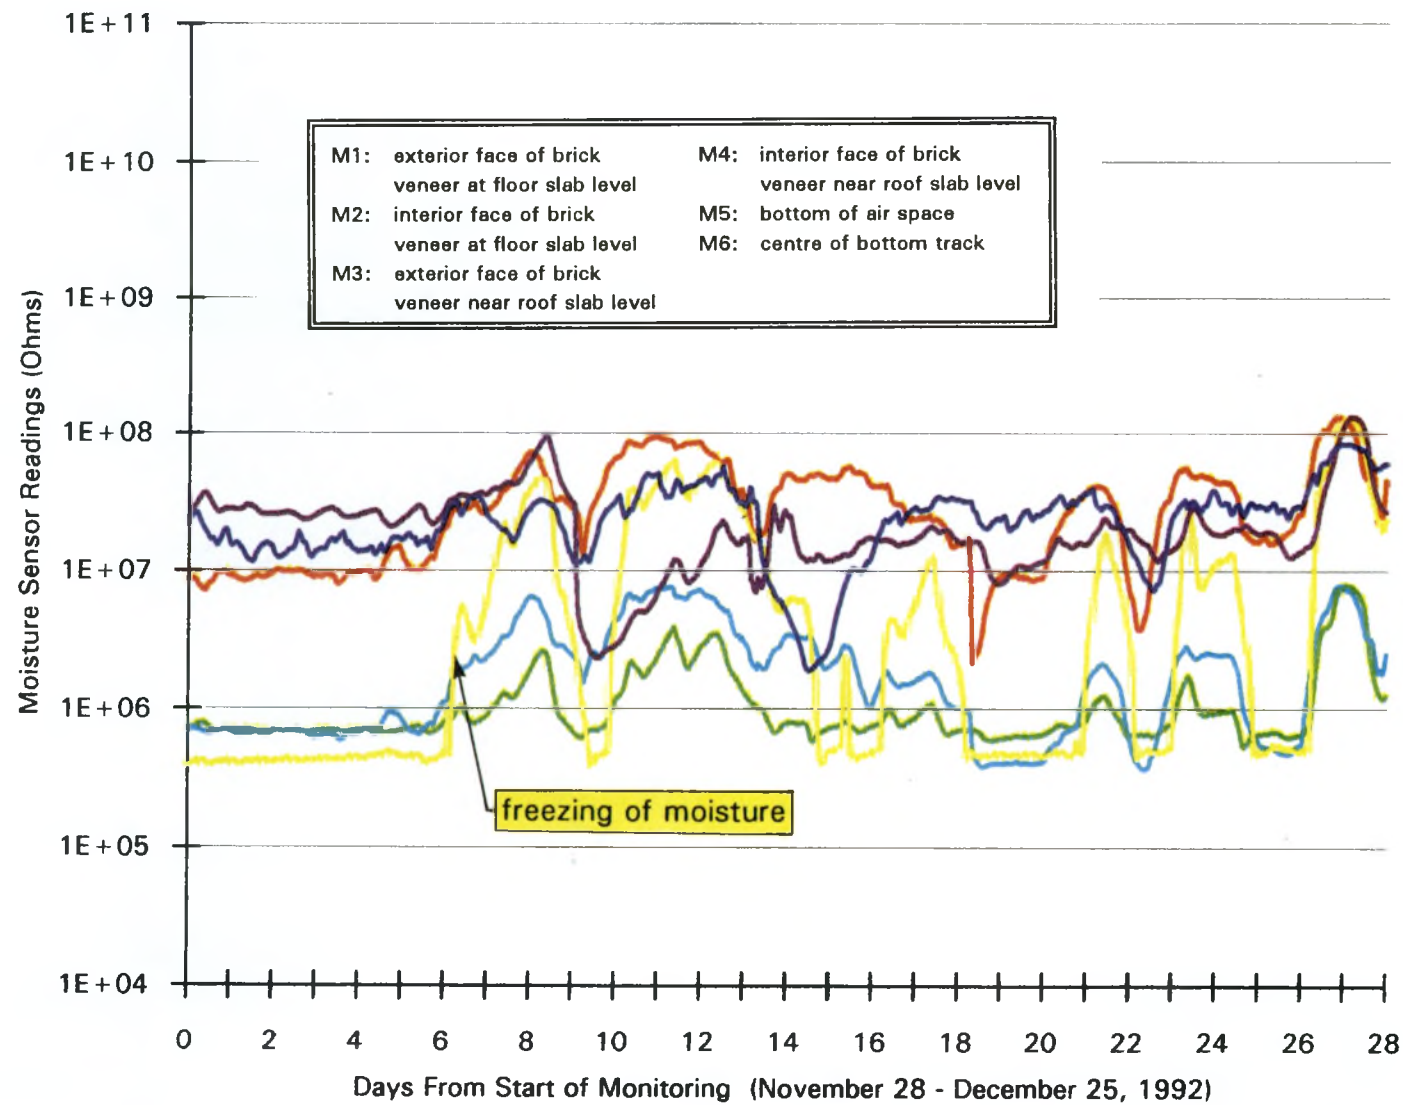
Fig.14 Moisture Sensor Readings - During Late Autumn/Early Winter

The wetness of the brick surface at monitoring points M1, M2, M3, M4, M5 and M6 is shown in Figs. 14, 15 and 16 for the first, fourth and sixth monitoring periods, respectively. Note that the electrical resistance moisture sensors in the test wall were not calibrated to determine the specific moisture content in the brick. Therefore, the readings indicate relative wetness. Higher resistance readings are obtained when the brick is drier and, conversely, lower readings are observed when the brick becomes wetter. Note that during freezing temperatures, freezing of water in the brick will result in higher readings, giving a false indication of the brick being drier and, therefore, this point must be kept in mind when reviewing the graphs.

This point is illustrated in Fig. 14 as the readings indicate very wet conditions at M2, M3 and M4 for the first six days until readings suddenly increase. These increased readings occurred simply because the weather became much colder on Day 7 and the moisture in the brick froze. An example of drastic changes in readings that does reflect wetness levels is shown in Fig. 16, where the brick became much wetter on Day 6 due to rainfall.

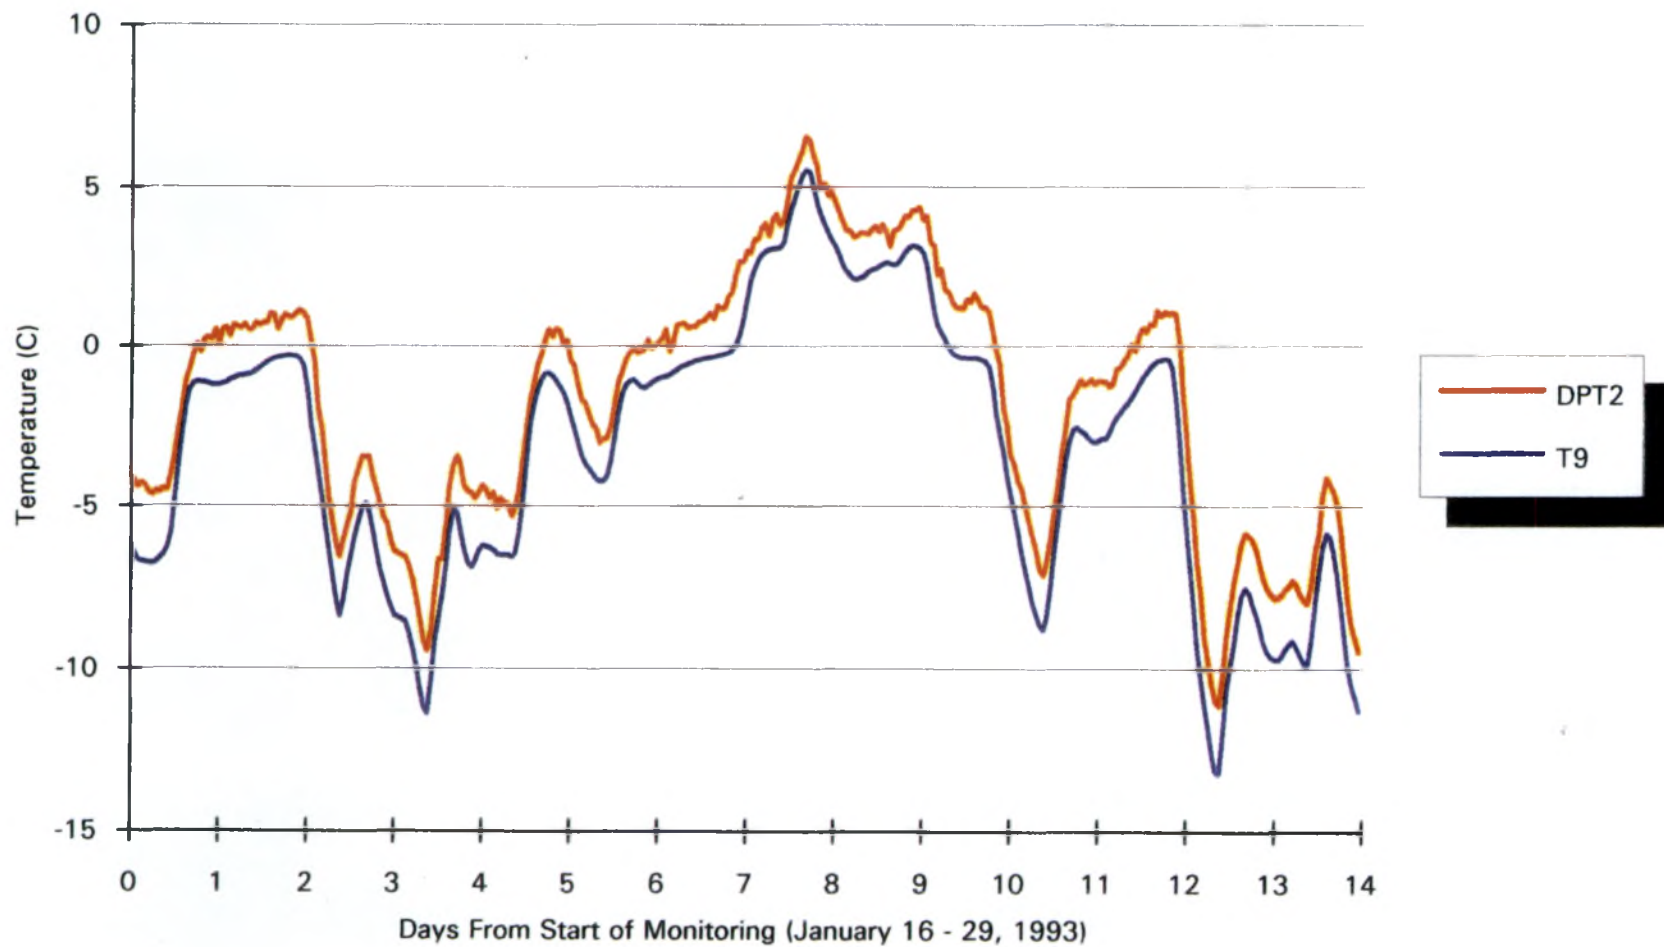
Fig. 17 Comparison of the Surface Temperature on the Interior Face of the Brick Veneer to the Dew Point Temperature of the Cavity Air

Fig. 17 is a plot of the dew point temperature of the cavity air (DPT2) versus the temperature of the interior surface of the brick veneer (T9). As shown in Fig. 17, cavity moisture was continuously condensing on the back face of the brick veneer during the period of January 16 - 29, 1993. Fig. 18 illustrates the dew point temperature within the backup wall as compared to the surface temperature on the exterior sheathing and on the exterior flange of the steel stud. The data plotted in Fig. 18 indicates that, on the interior of the exterior gypsum board, condensation does not occur at the steel stud but minor condensation may occasionally occur on the gypsum board. While "corrected" data was used for these plots, it is important to note that a properly calibrated RH sensor is only accurate to within 2% RH and, therefore, even the "corrected" data may not be precise. Therefore, plots of relative humidity or dew point temperature data must be compared to moisture sensor data to determine how frequently condensation is occurring at a given location.

6. Water vapour levels within the cavity were very high in comparison to exterior water vapour levels, except during the summer. The high water vapour content not only caused condensation to occur regularly, but drying of the back face of the brick veneer could not occur until late spring.

7. The primary source of moisture in the cavity air is the leakage of moist interior air into the cavity.
8. At temperatures of approximately 5°C or lower, condensation occurred on the back face of the brick veneer, on the exterior surface of the exterior sheathing and on brick ties.

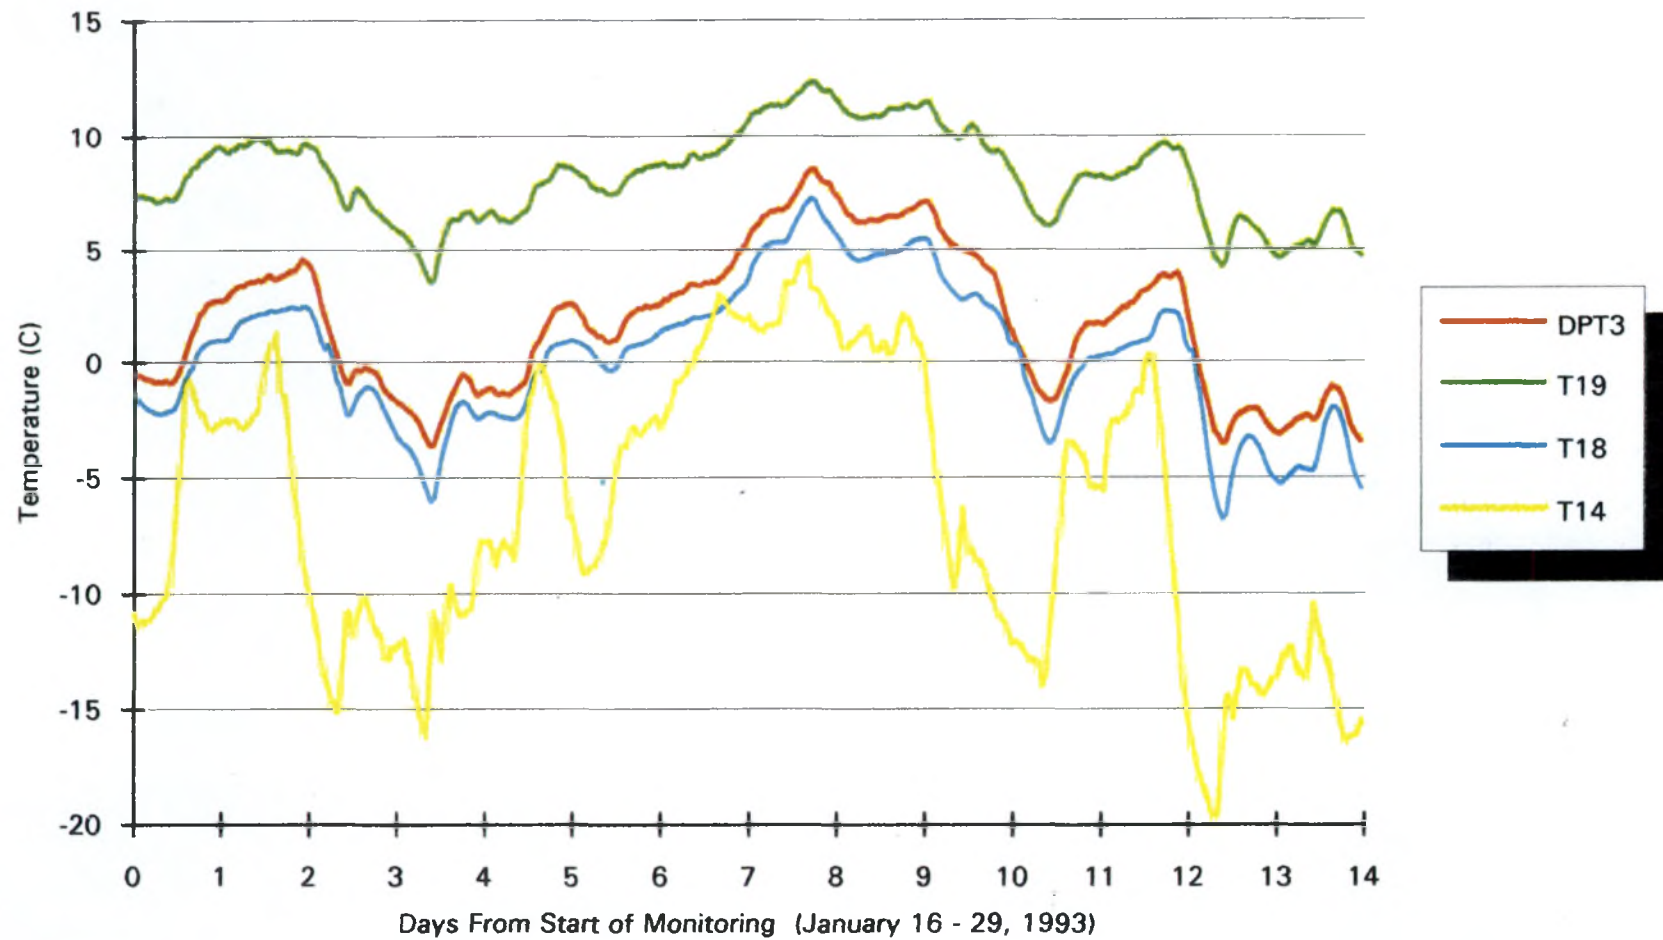
Fig. 18 Comparison of Surface Temperatures at the Exterior Gypsum Board to the Dew Point Temperature of the Air in the Stud Space

For all six monitoring periods, the moisture sensor readings were compared to the weather data and plots such as Figs. 17 and 18, and this review provided the following findings:
