**Defect Prevention
Research Project
for Part 9 Houses**

Final Report

**Proctor & Redfern Limited
45 Green Belt Drive
Don Mills, Ontario
M3C 3K3**

**October, 1993
Revised - November, 1994**

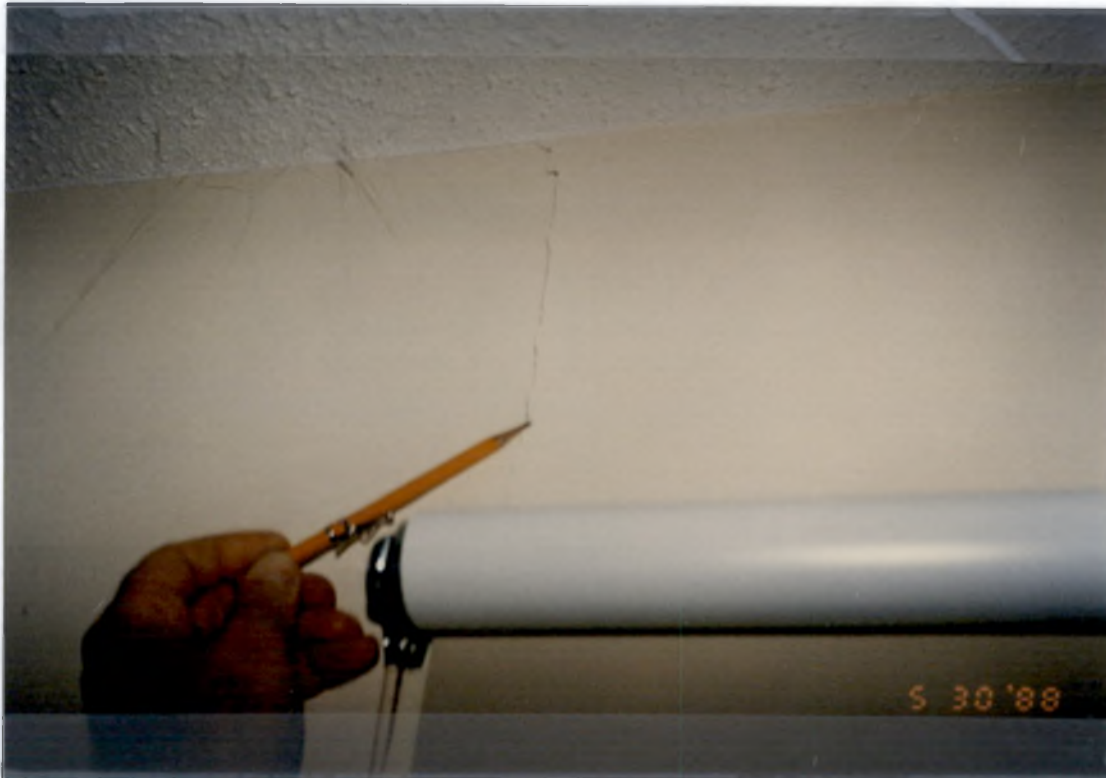
PHOTOGRAPH #1 DRYWALL DEFECT

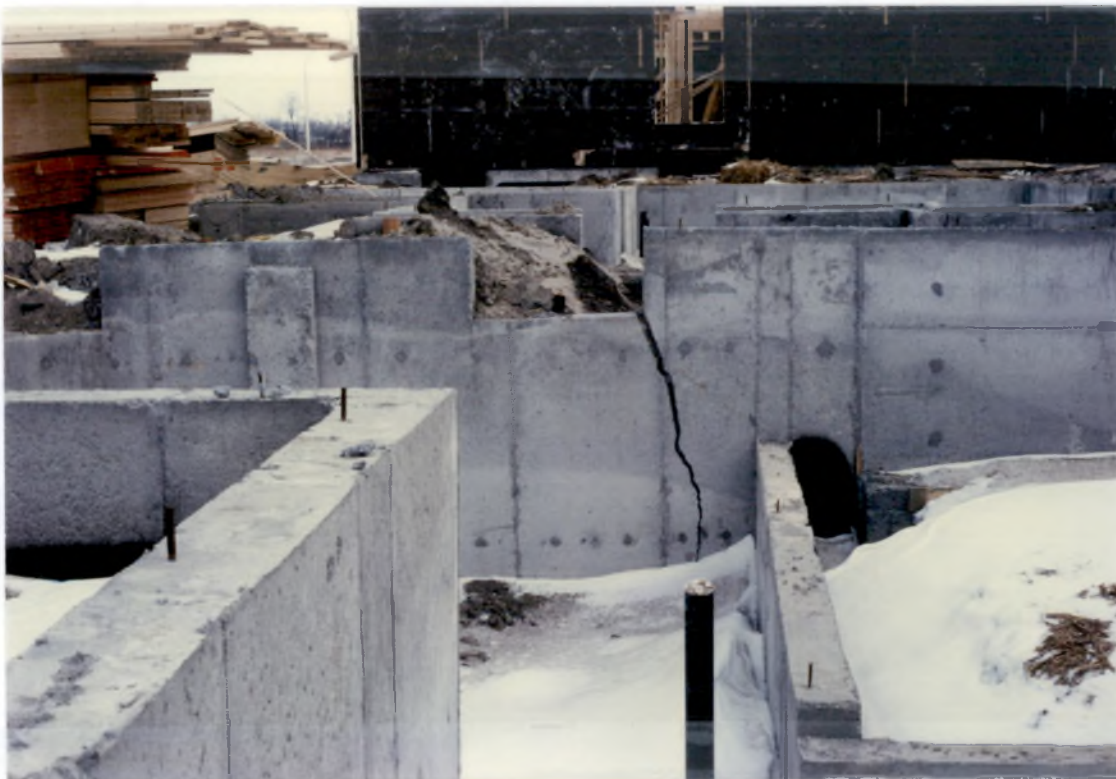
PHOTOGRAPH #2 FOUNDATION WALL DEFECT

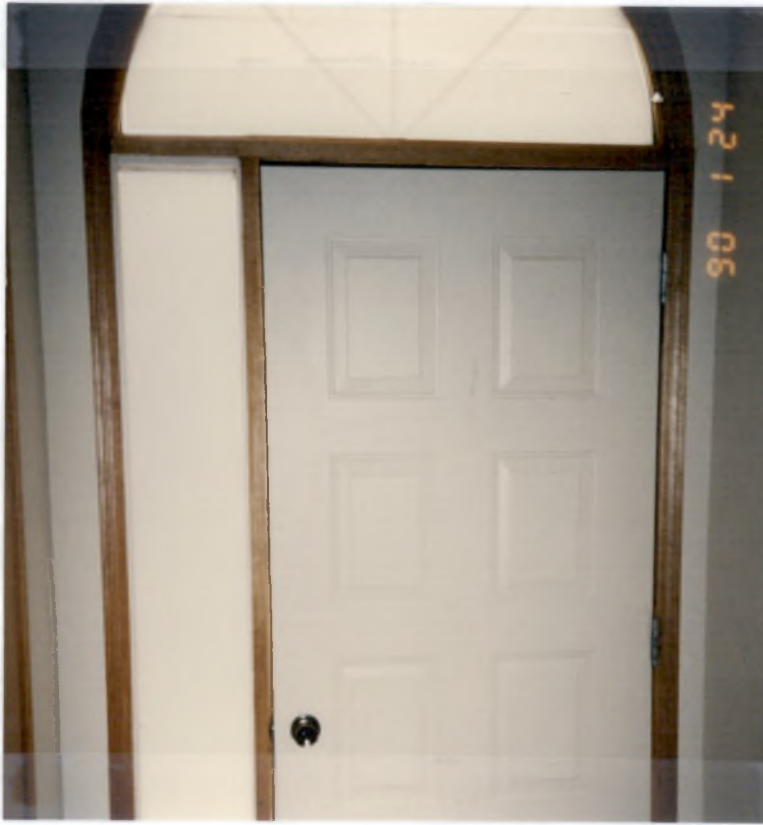
The fifth most costly component is "other window/door/skylight". Improper installation of door and frame assemblies, causing them to be inoperable, is the most common complaint of this component. **See photo #3**

PHOTOGRAPH #3 WINDOW/DOOR/SKYLIGHT INSTALLATION DEFECT

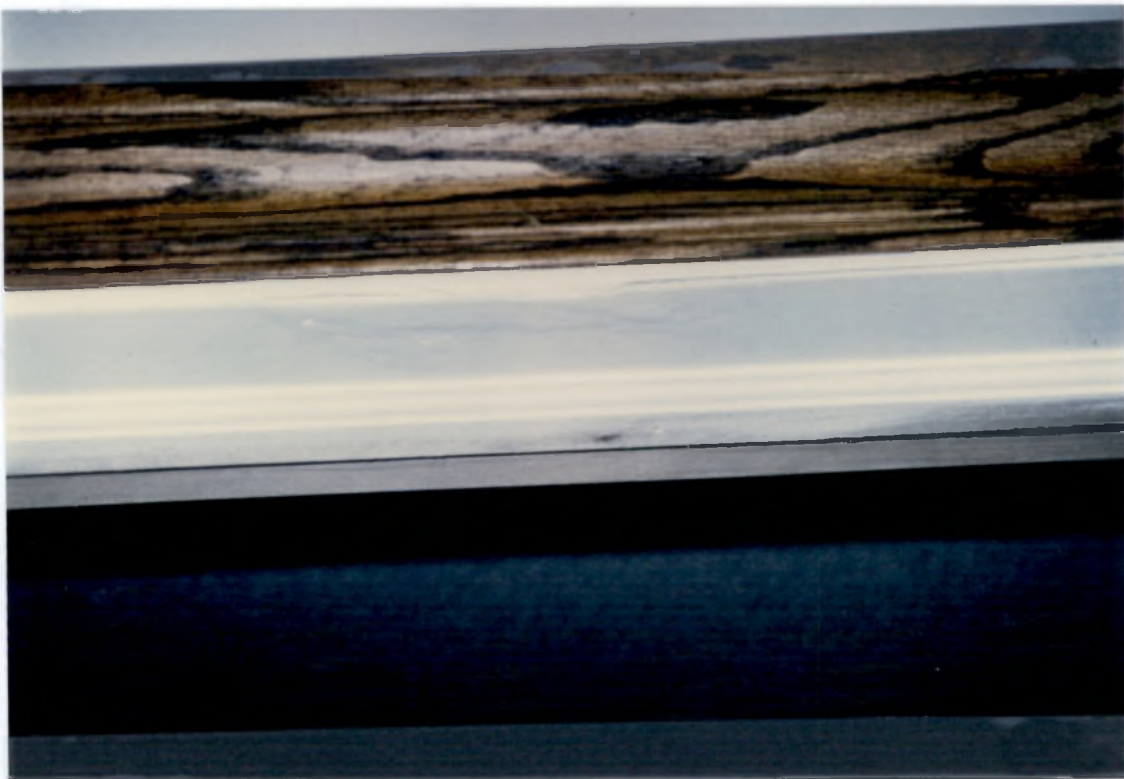
PHOTOGRAPH #4 TRIM AND MOULDING DEFECT

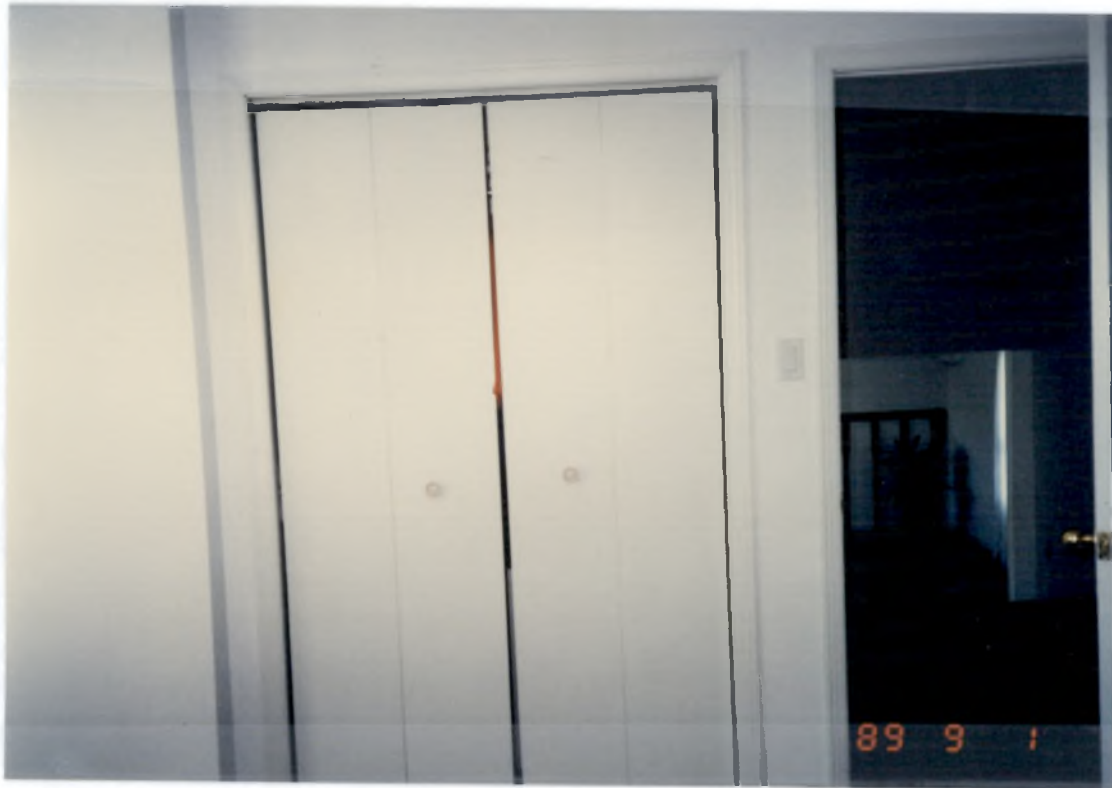
PHOTOGRAPH #5 WINDOW/DOOR/SKYLIGHT INSTALLATION DEFECT

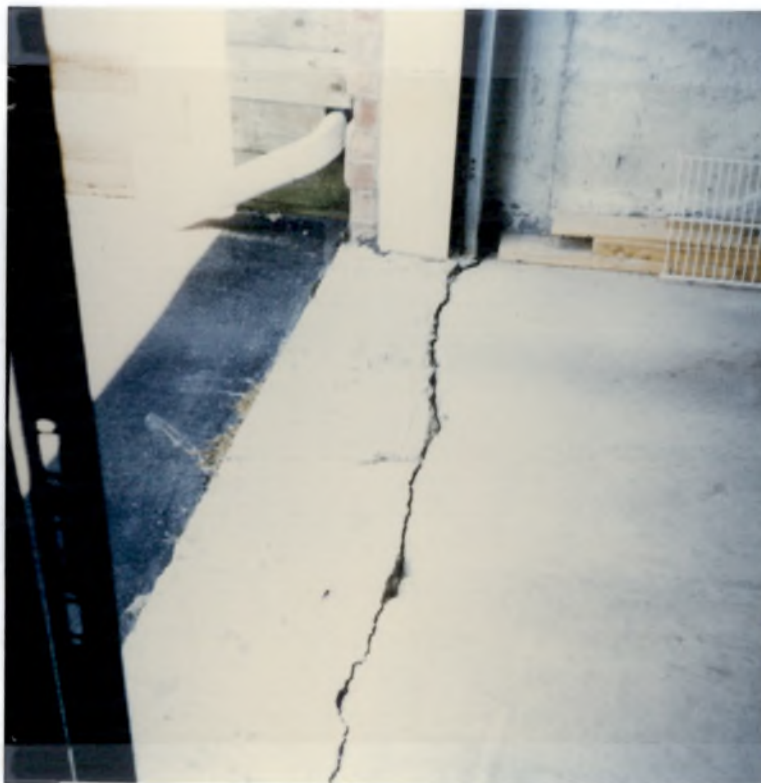
PHOTOGRAPH #6 GARAGE FLOOR SLAB DEFECT

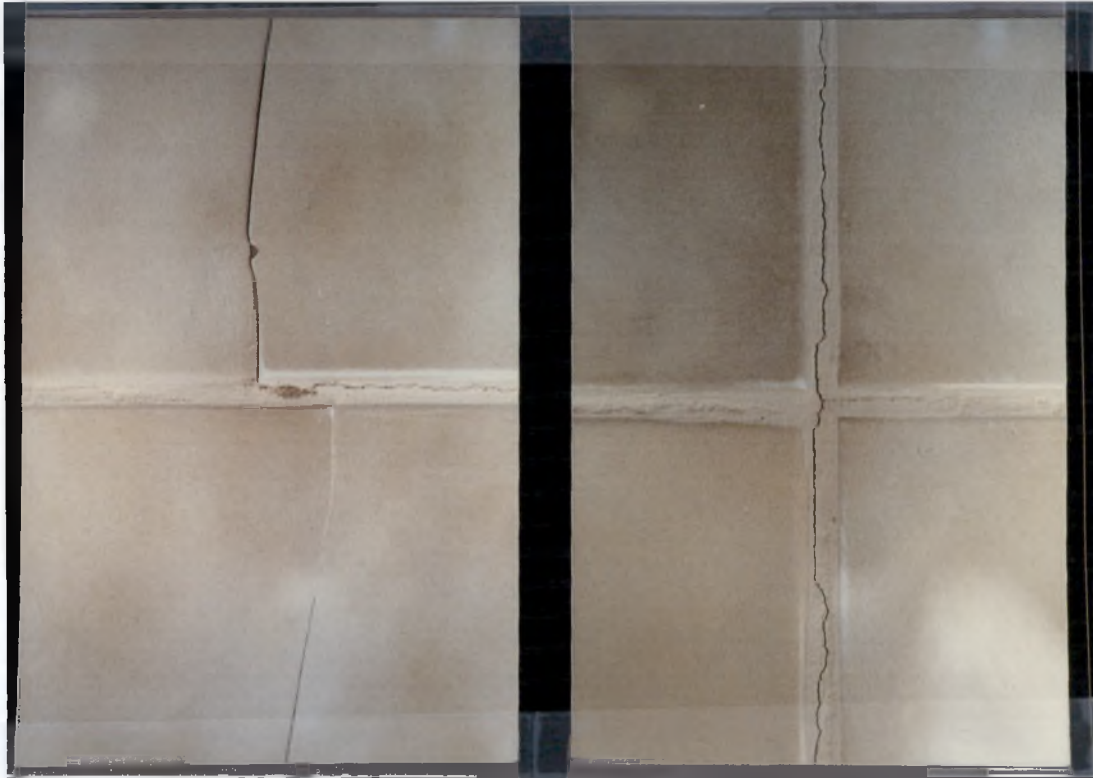
PHOTOGRAPH #7 CERAMIC TILE DEFECT

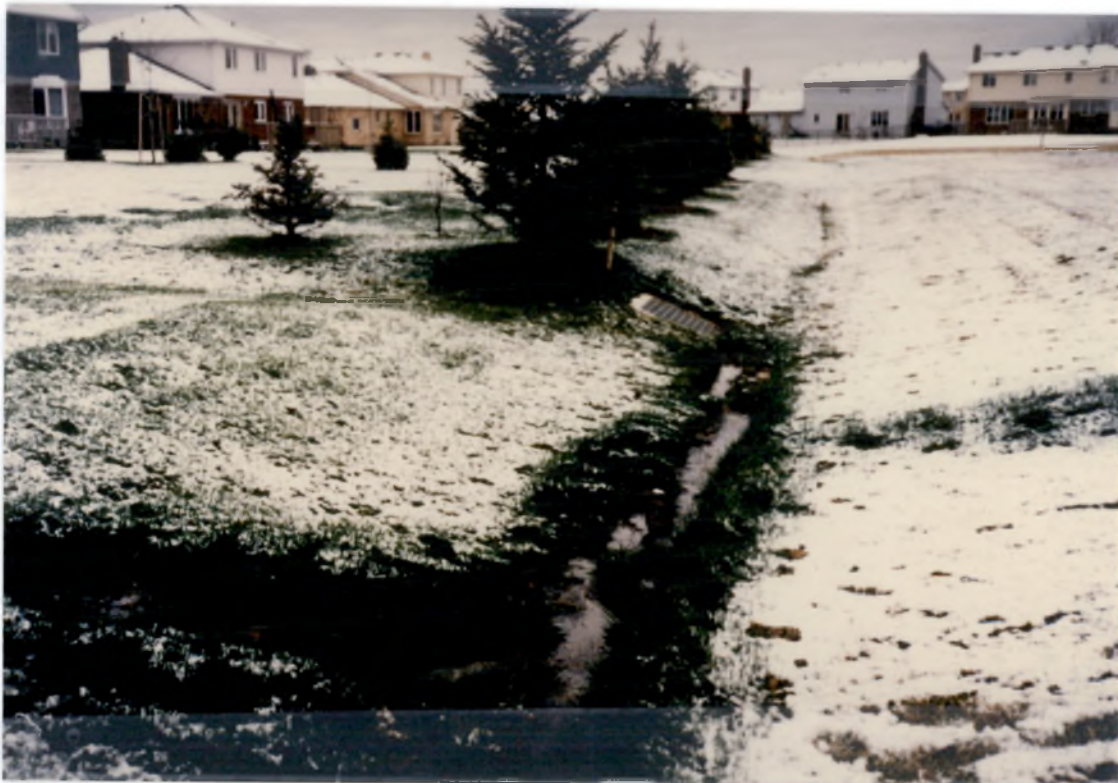
PHOTOGRAPH #8 LEACHING BED DEFECT

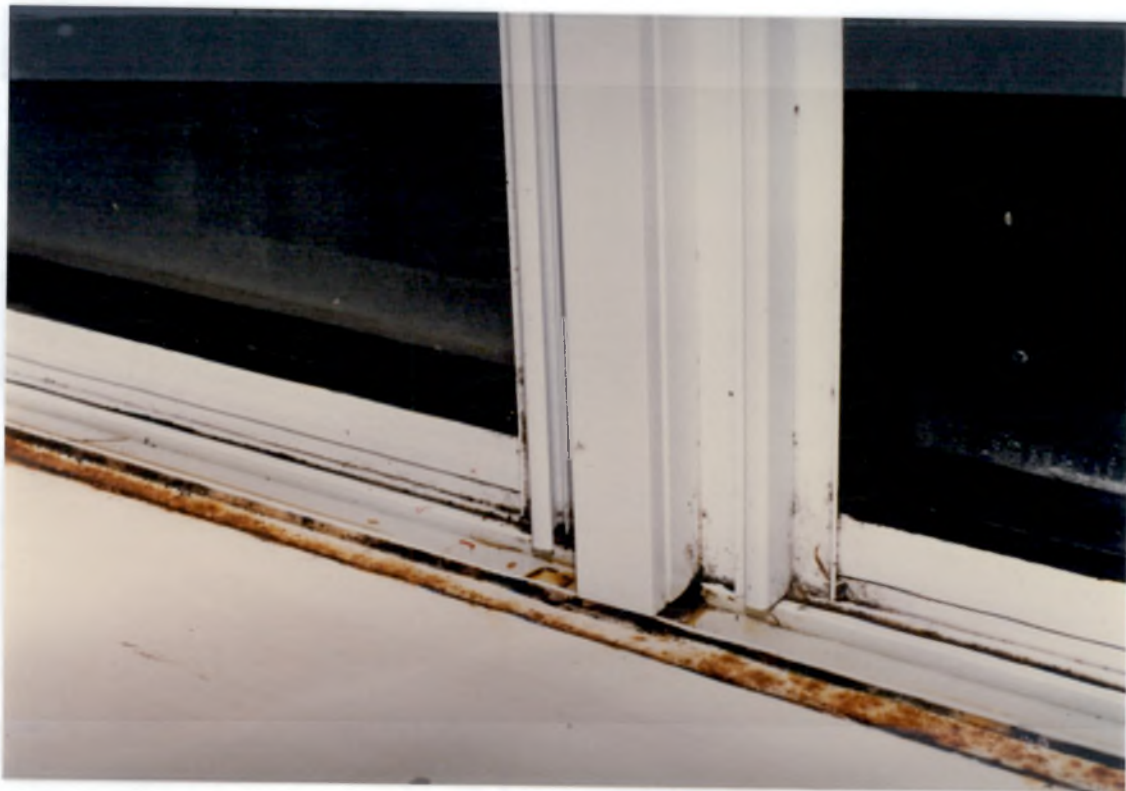
PHOTOGRAPH #9 INSULATION/AIR BARRIER DEFECT

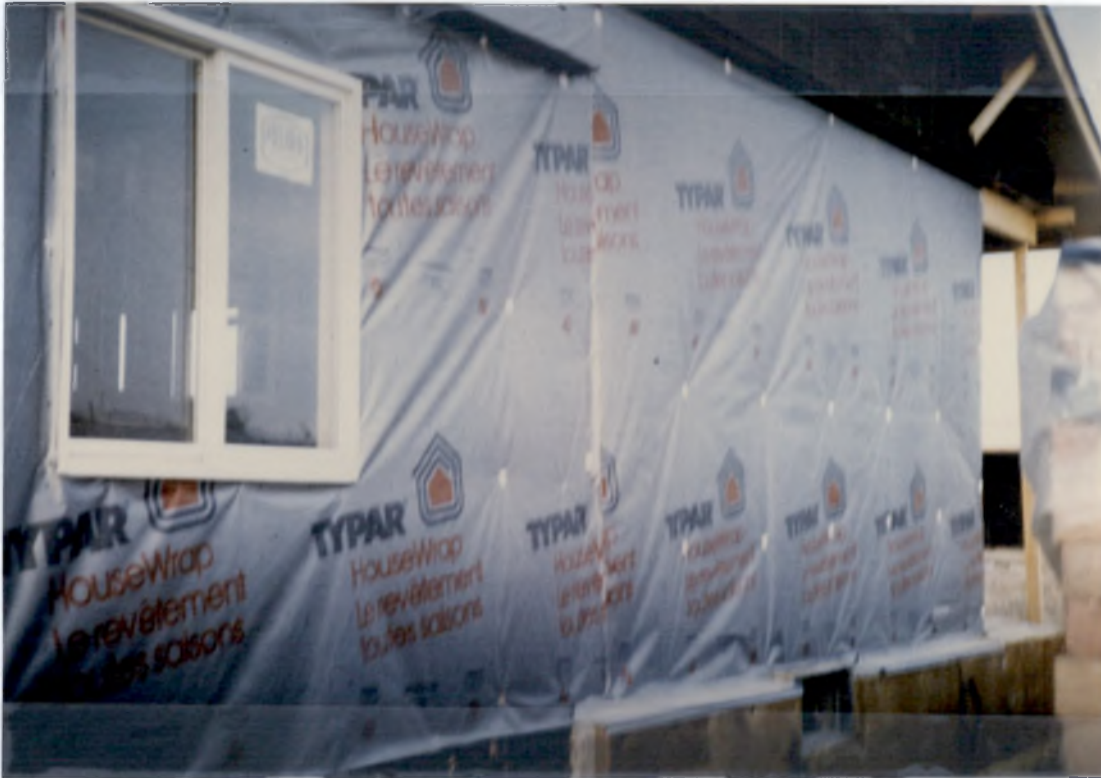
PHOTOGRAPH #10 CAULKING/SEALANT DEFECT

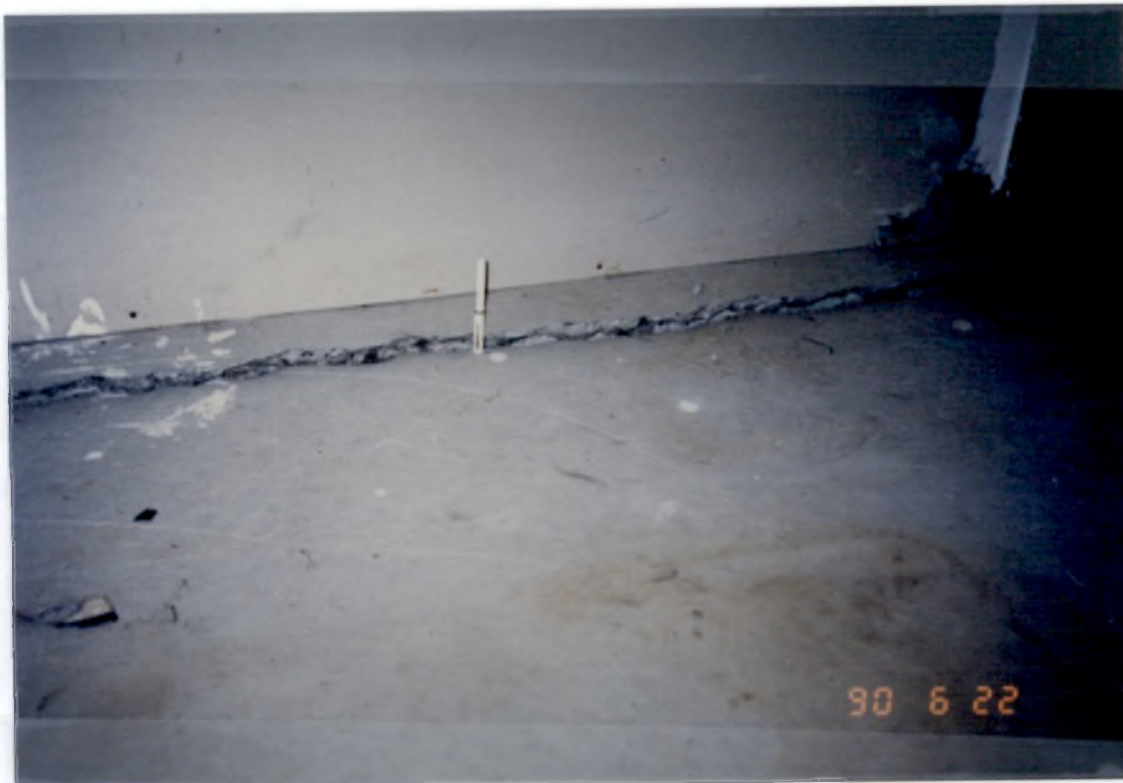
PHOTOGRAPH #11 GARAGE SLAB DEFECT

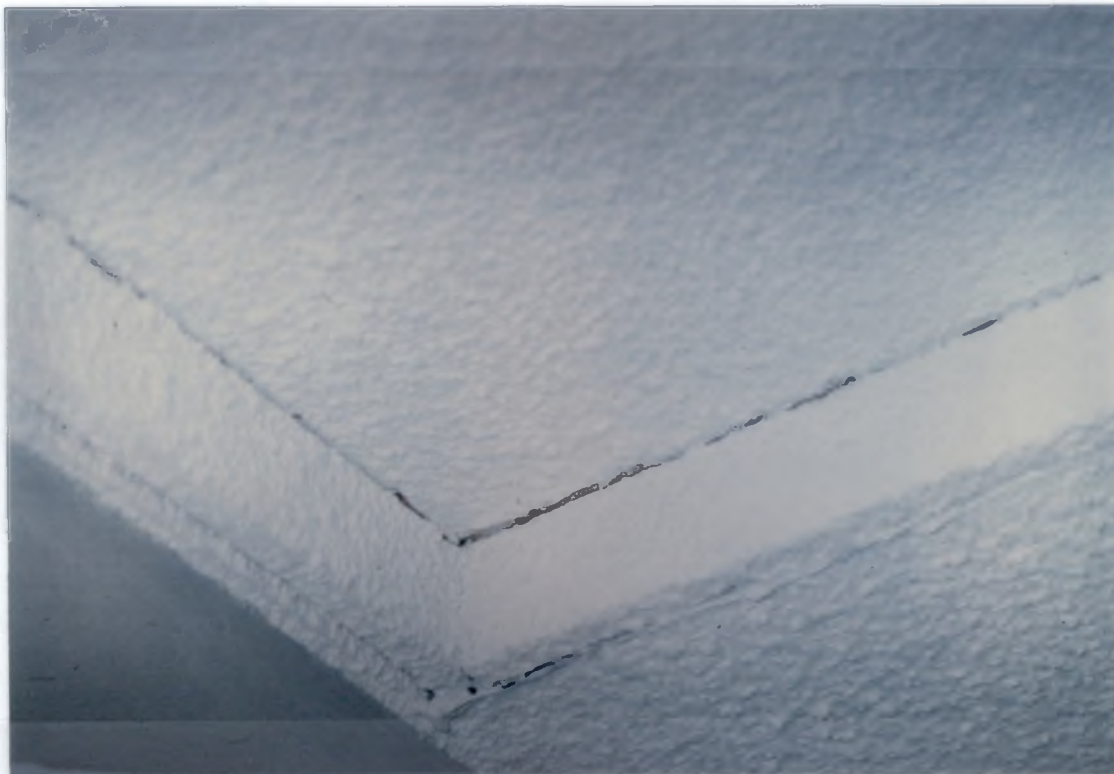
PHOTOGRAPH #13 ACCESS HATCH DEFECT

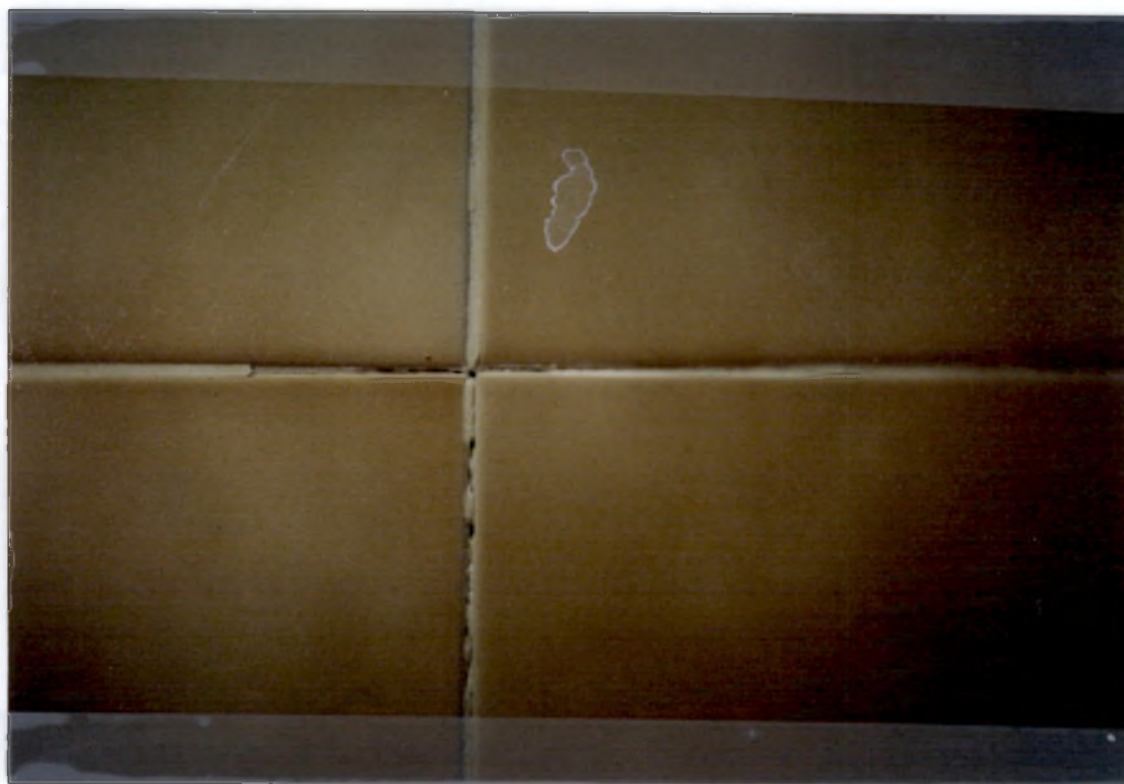
PHOTOGRAPH #15 CERAMIC TILE DEFECT

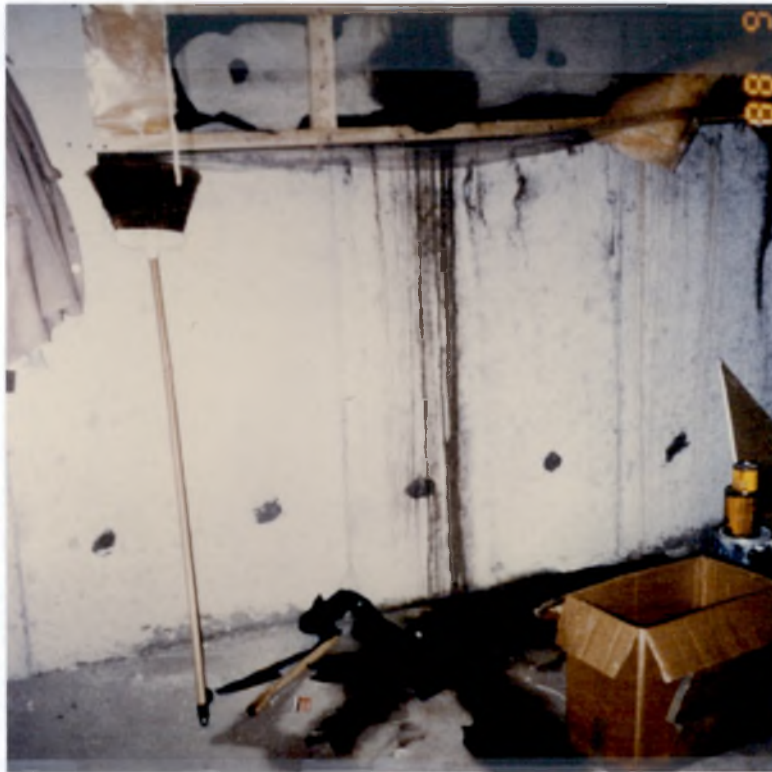
PHOTOGRAPH #16 FOUNDATION WALL DEFECT

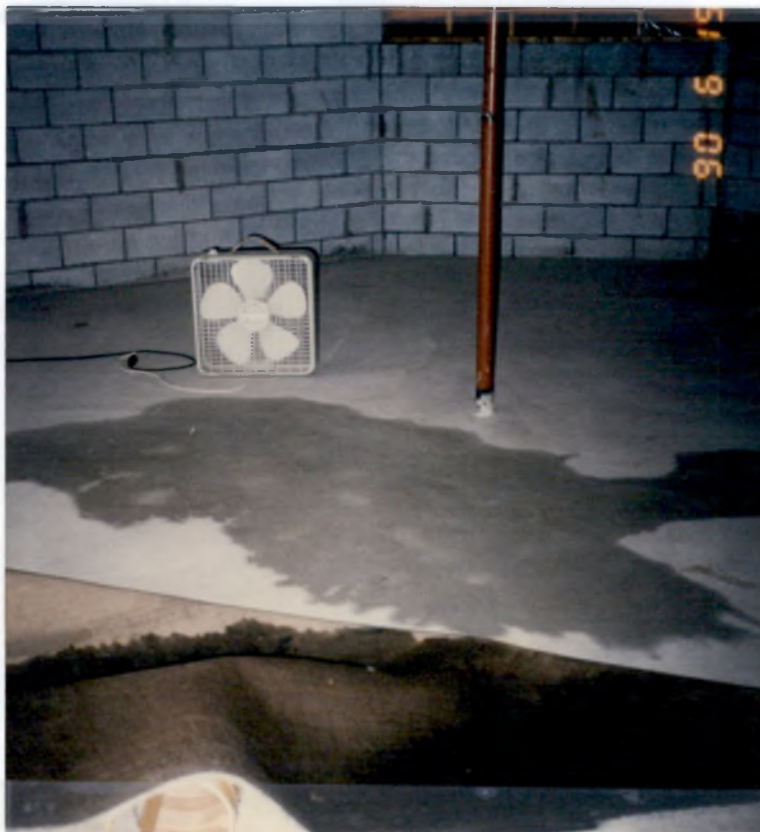
The fifth item on the list is a damp/moist/wet poured concrete subfloor. The cause was insufficient granular beneath the slab. **See photo #17**

PHOTOGRAPH #17 FOUNDATION FLOOR DEFECT
