OTTO TOWNSHIP CONTOUR TRENCH

SEWAGE SYSTEM

By H.J. Hawken, P.Eng., H. Sutcliffe Ltd

FINAL REPORT: October 2nd, 1996.

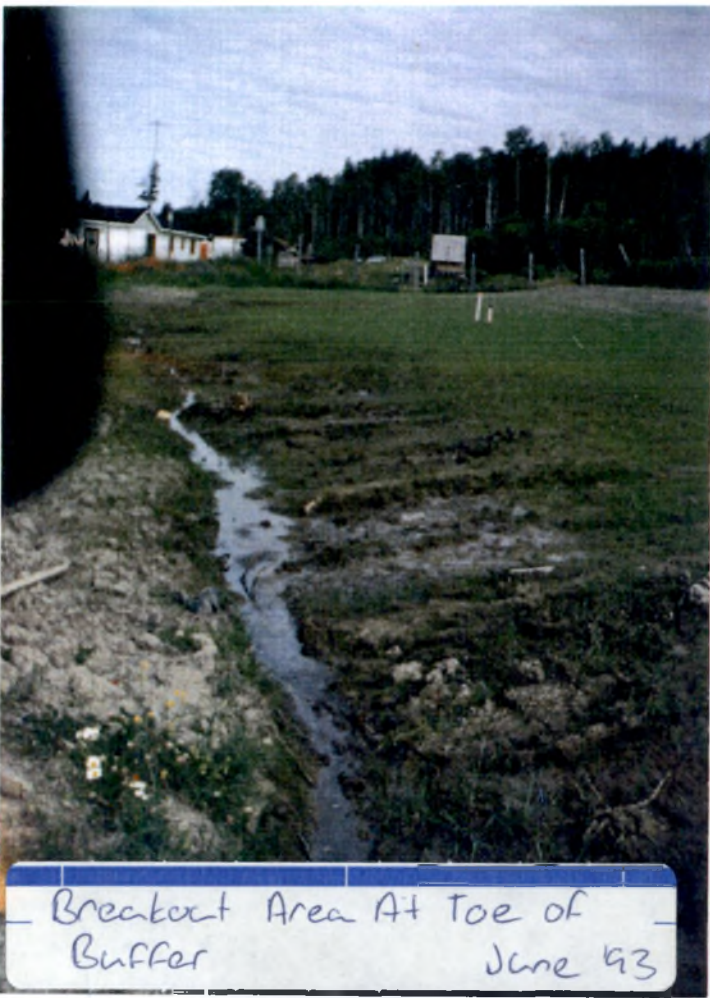
The presence of a seepage area along the toe of the mantle indicates that the mantle has failed. Additional material should be added to the mantle to contain the breakout. The addition to the mantle may also reduce the E. Coli count in the surface runoff.

northern portion of the bed indicates that the mantle has failed that area. The mantle should be extended to prevent seepage from the toe. The failure may be the result of uneven effluent distribution in the trench. Monitoring of the system should continue especially to monitor bacterial levels.

Breakout Area At Toe of Buffer
June 93

Remedial work to extend the mantle to control the breakout is necessary.

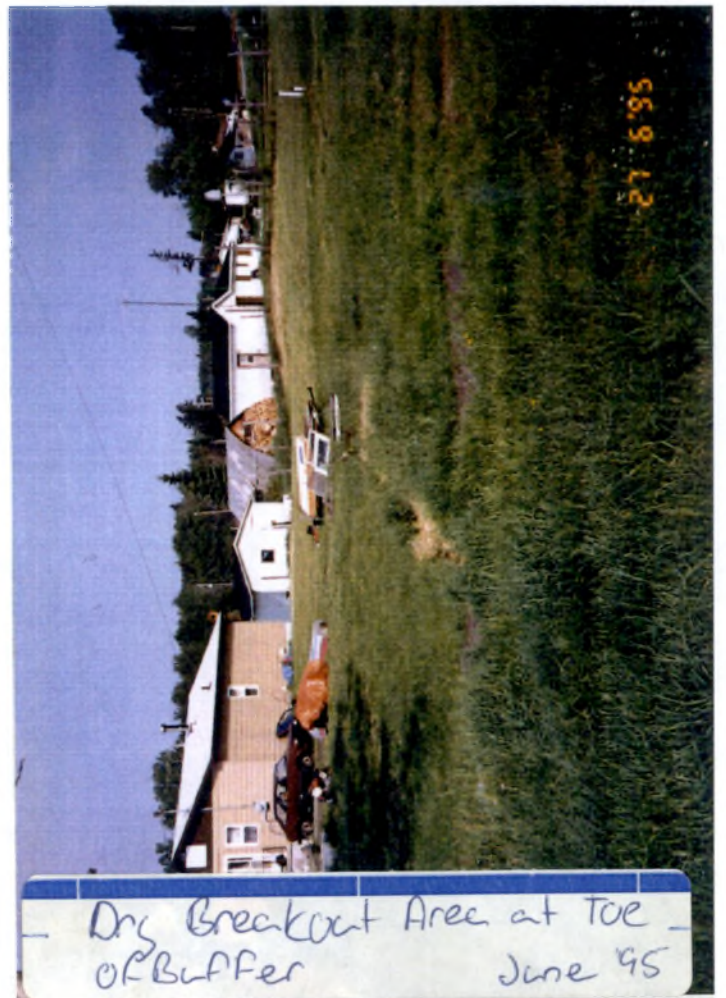
The only major problem with the system has been the effluent breakout. Recent hydraulic data has indicated that the hydraulic gradient no longer exists. It is believed that full development of the biomat in the trench has equalized trench levels and has led to more even flow distribution. This is supported by recent field observations wherein no effluent breakout was evident.

Dry Breakout Area at Toe of Buffer
June 95

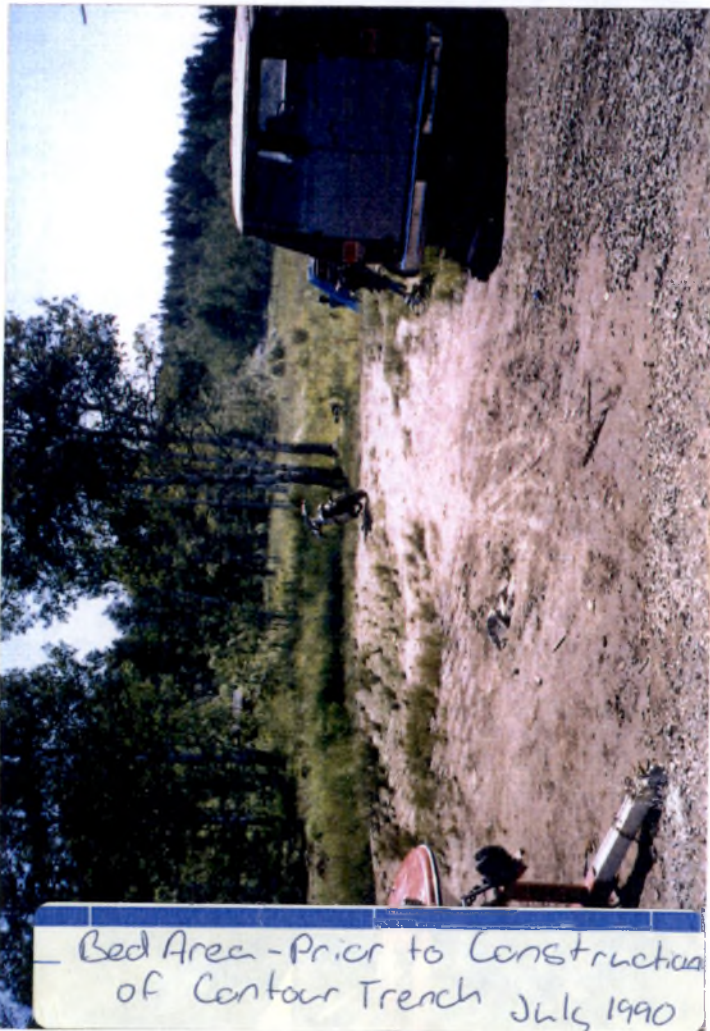
Bed Area - Prior to Construction of Contour Trench July 1990

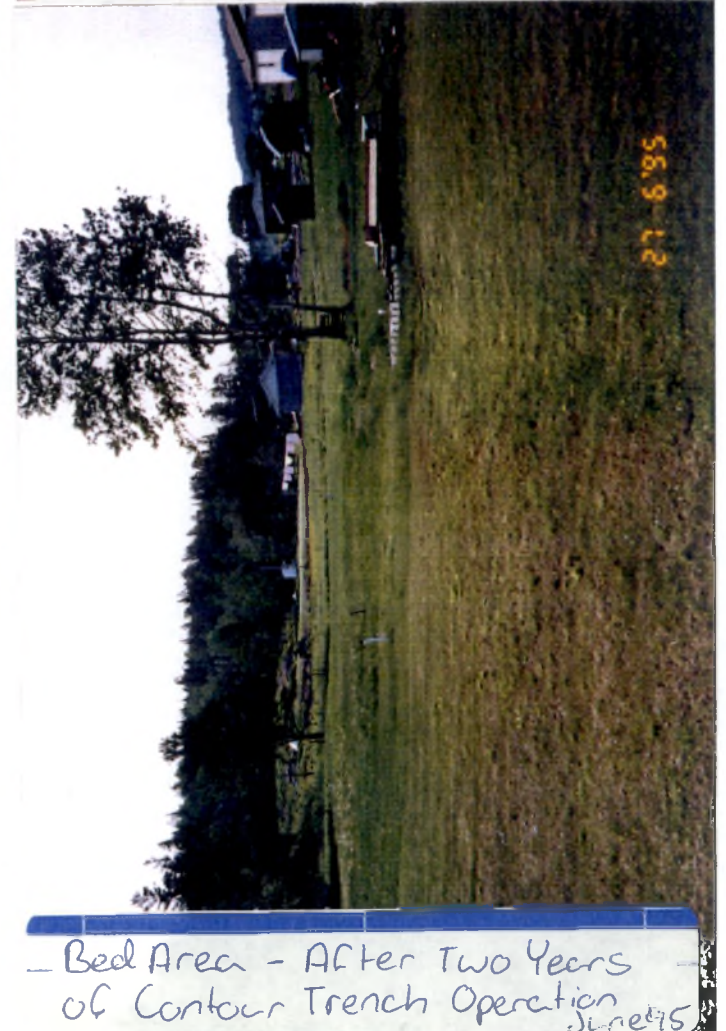
The maintenance of the system is a concern. Residents have used the bed area for recreational uses, snowmobiling, ATV's and a dog house (with dog), have all been observed on the bed. Some residents cut the grass on the bed, some do not. An educational program initiated by CMHC would assist in addressing this problem.

Bed Area - After Two Years of Contour Trench Operation
June 95
