TP 185E
Issue 4/2017

AVIATION SAFETY LETTER

TSB Final Report A15Q0126—Loss of Directional Control and Collision with Terrain

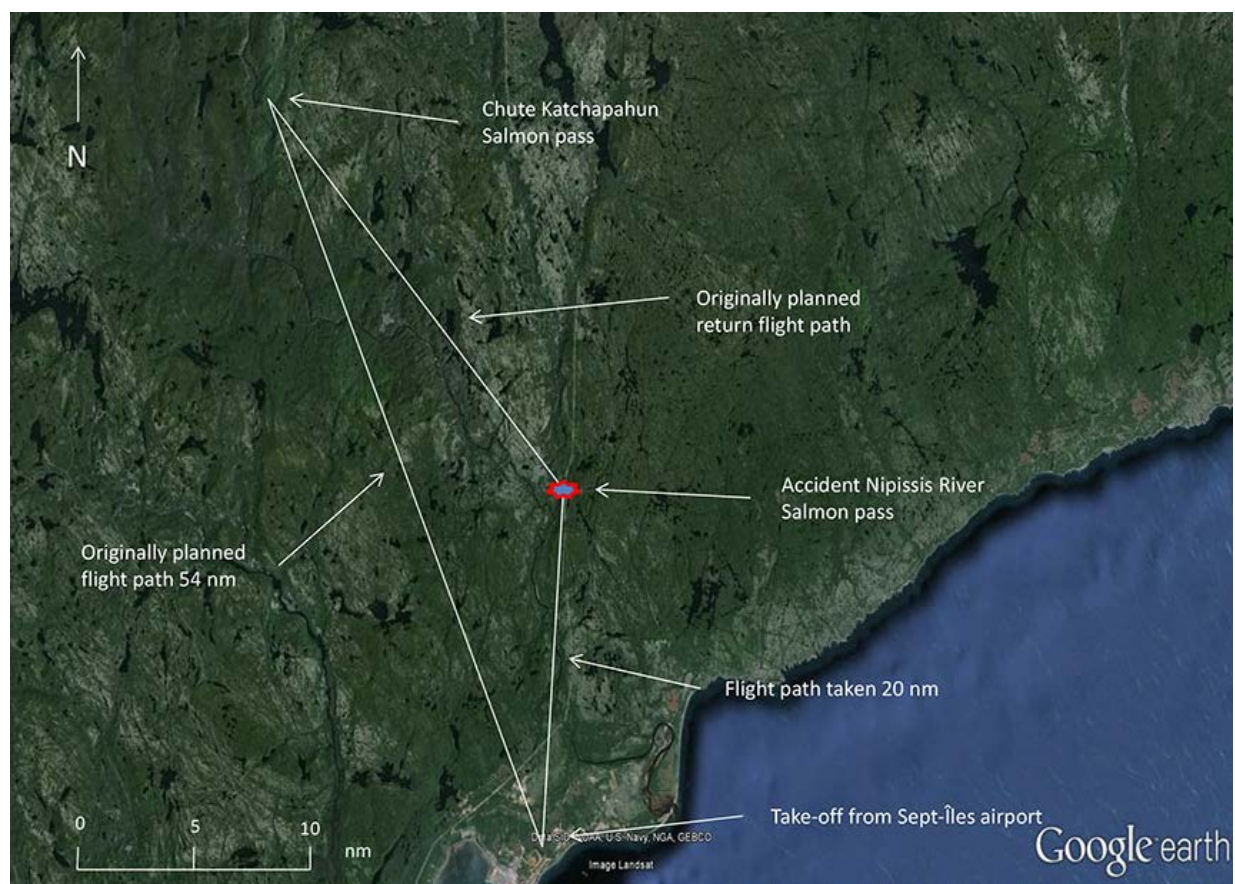
Figure 1. Flight path of helicopter (Source: Google Earth, with TSB annotations)

The takeoff and the flight of the second helicopter to the site were without incident, and all aircraft parameters were normal. During the final turn leading to the landing site, the pilot saw the chief pilot, who was standing on a rock. The pilot could see the other aircraft parked. The pilot positioned the aircraft to face the place indicated, and during the final approach, noted that engine torque was at 110% and that the nose of the aircraft was turning to the right. The pilot then lowered the collective to reduce the torque while applying full left anti-torque pedal to counteract the yaw. However, the nose of the aircraft continued turning to the right and the helicopter kept losing altitude. The pilot again increased the torque by raising the collective to reduce the rate of descent. He pushed the cyclic to initiate a recovery and gain speed, but the yaw increased very quickly. Realizing that he had lost control of the aircraft, the pilot cut engine power to reduce the rate of yaw and prepare for the impact. The aircraft was in a nose-down attitude to the right before it crashed violently into the rock. According to available information, an alarm sounded in the aircraft shortly before the accident. However, it was not possible to determine which alarm sounded.

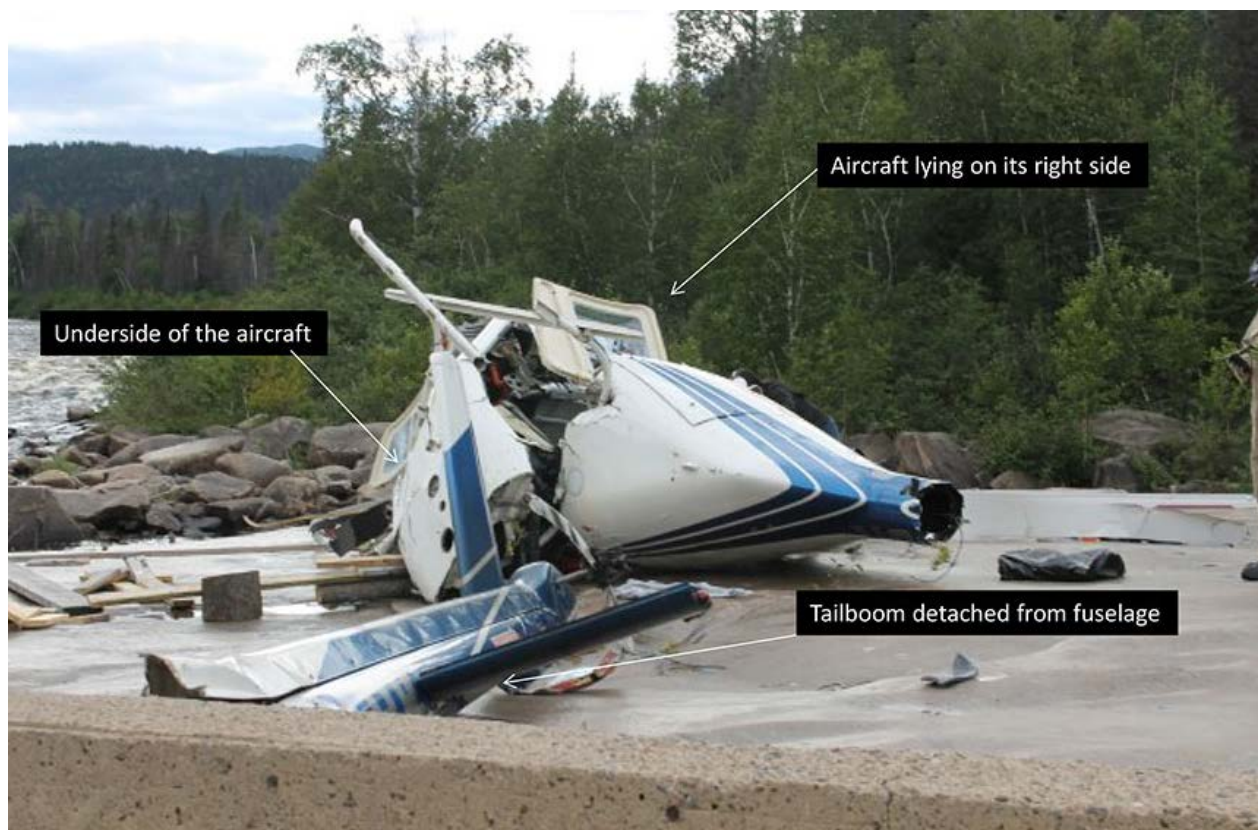
Figure 2. Aircraft wreckage

The helicopter collided with the rock nose down and rotating to the right. The engine did not stop immediately, and a minor fire broke out in the tailpipe but it was immediately extinguished by persons on site. On impact, the tail boom detached and came to rest behind the aircraft. Severe damage to the skin on the rear of the right-hand side and the rear stabilizer was noted. Damage to the skids confirmed impact on the right side, with the nose of the aircraft pointing toward the ground. All damage resulted from the impact with the rock. The floor of the aircraft was severed at the rear of the cabin, causing the fuel tank to split.

During this occurrence, the aircraft experienced a loss of directional control near the ground, without any mechanical failure. Two conditions can cause a loss of directional control:

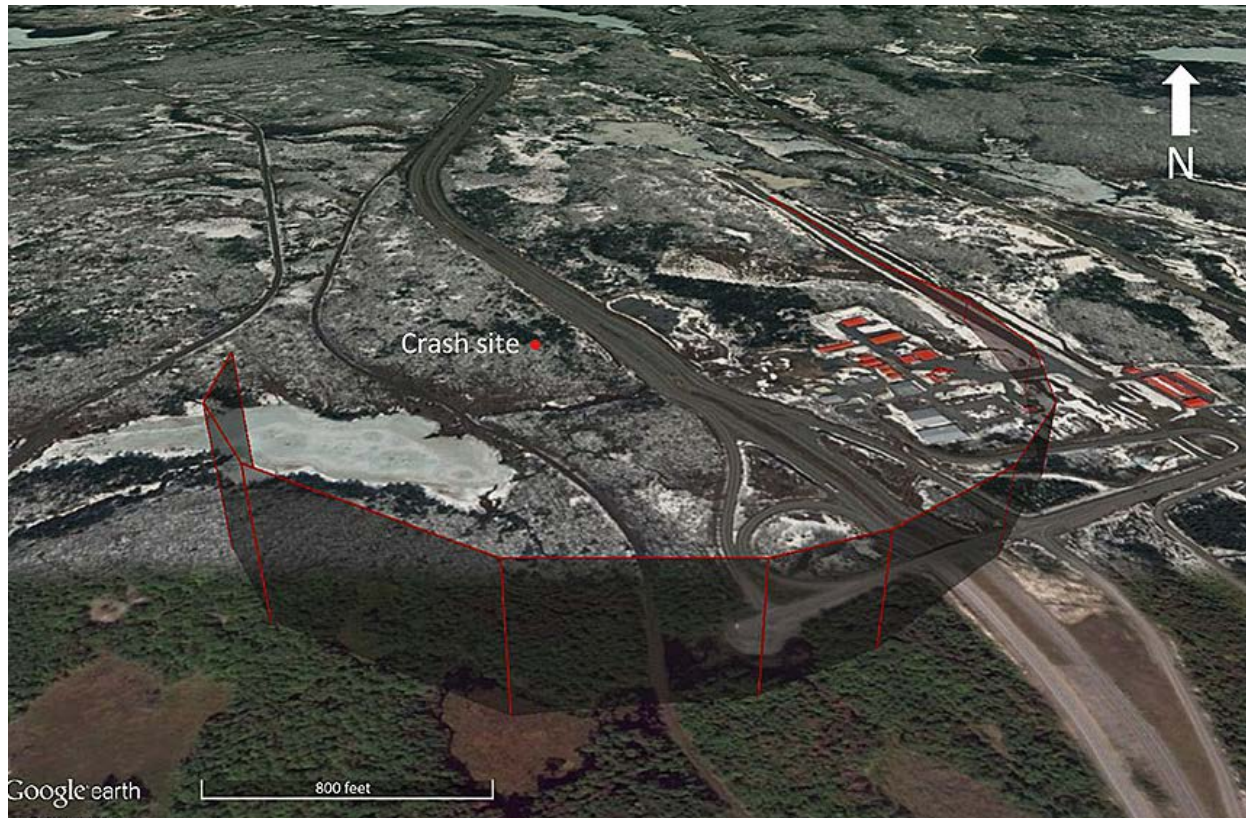
Figure 1. Flight path using recovered GPS data (Source: Google Earth, with TSB annotations)

On this day, the aircraft departed from Parry Sound (CNK4) at 19:17 EST under night VFR for a flight to Tillsonburg (CYTB), Ont. The pilot did not file a flight plan prior to the flight, and there is no record of him requesting a weather briefing from NAV CANADA. Data recovered from an onboard portable global positioning system (GPS) showed the aircraft taxied on Runway 35 before it took off from Runway 17. The aircraft became airborne just prior to the mid-point of the runway at 19:25:15.²

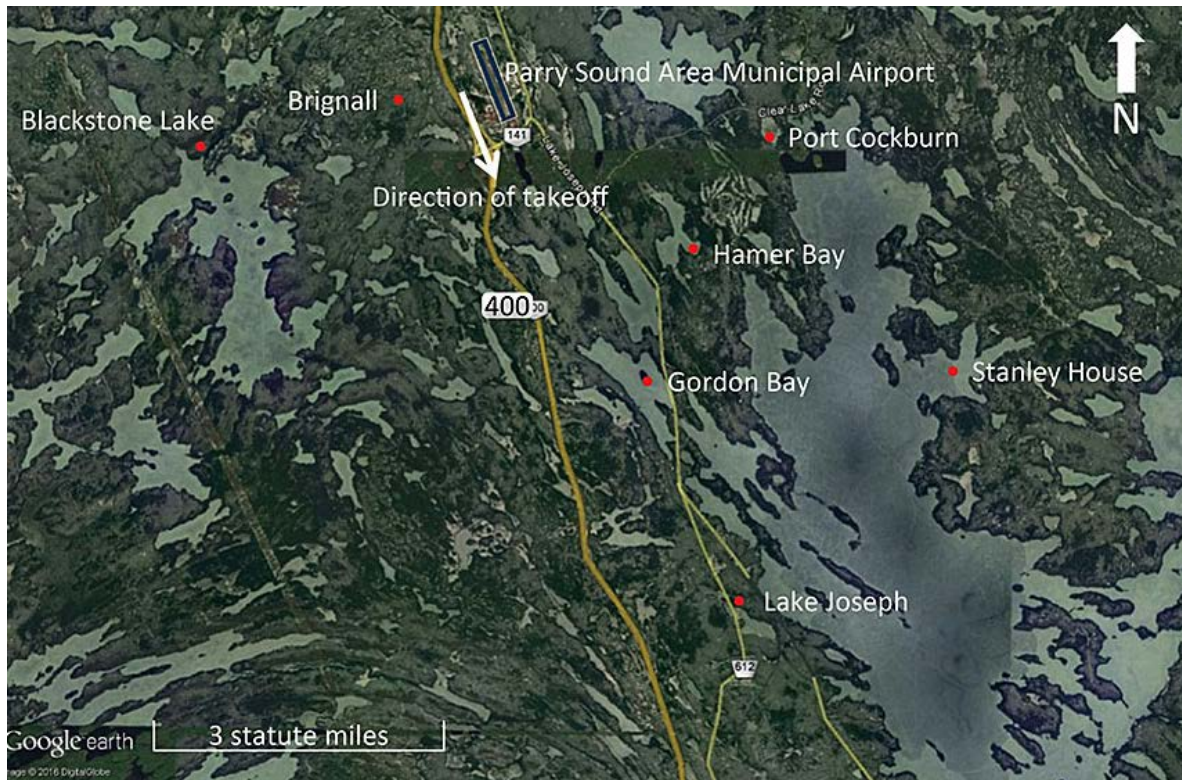
Figure 2. Departure airport and surrounding area (Source: Google Earth, with TSB annotations)

Once the airport lighting was lost from view, there would have been few visual cues available outside the aircraft. There were not many lit ground features on the flight path, particularly to the west of the airport in the direction of the turn, and limited ambient illumination would have been available from the waning crescent moon. After takeoff, visual references would have been greatly reduced, and the pilot would have found himself in a black hole situation.
