Air Transportation Safety Investigation Report A18Q0100

COLLISION WITH TERRAIN

Air Saguenay (1980) inc.
de Havilland DHC-2 (Beaver), C-FYYT
Manic-Cinq, Quebec, 44 nm WSW
01 July 2018

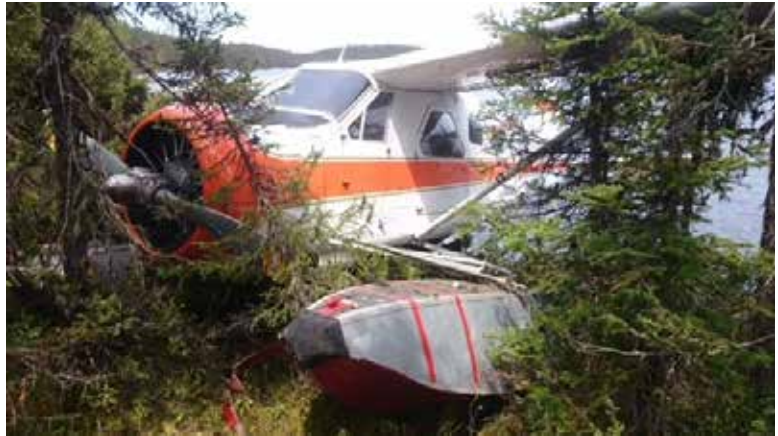
Once take-off speed was reached, the pilot manoeuvred to lift the floats off the water. However, the pilot considered that the remaining distance on the lake was insufficient to complete the takeoff and climb safely, and therefore decided to shut off the engine to reject the takeoff. The aircraft continued straight ahead and could not be stopped in time to avoid colliding with trees (Figure 1).

Figure 1. The aircraft after colliding with trees (Source: Air Saguenay)

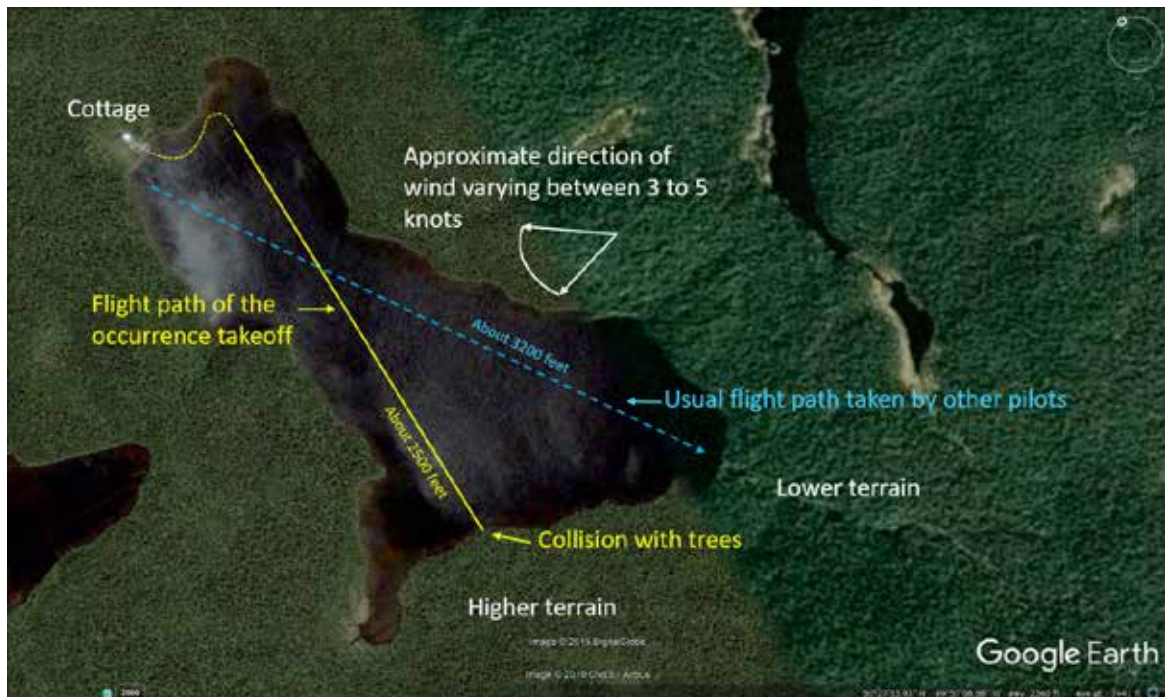
In this occurrence, the initial intention was to take off in an arc from the bay northeast of the cottage toward the lower terrain. However, according to the information gathered, the actual take-off path was largely in a straight line until the point of impact. The flight path toward the higher terrain required the aircraft to fly over the higher terrain at low altitude or to turn left immediately after takeoff to avoid the higher terrain. Furthermore, a greater take-off distance may have been required because the aircraft was heavier.

Calculations based on the take-off performance chart for an aircraft equipped with floats (as published by the manufacturer, de Havilland Aircraft of Canada Ltd., in the DHC-2 flight manual^{8,9}) indicate that the total take-off distance to clear a 50-foot obstacle is 1590 feet.^{10,11} Of this distance, about 1100 feet are with the floats touching the surface of the water (Point A, Figure 2).

The investigation determined that when the winds are from the southeast, as in this occurrence, the flight path taken by other company pilots is oriented differently to provide a greater take-off distance and fly over the lower terrain, allowing them to avoid having to make a turn during the initial climb (Figure 2).

Figure 2. Diagram showing the flight path of the occurrence takeoff on Jules Lake in relation to the usual flight path taken by other pilots, as well as estimates of the minimum distance required for takeoff from the surface of the water (A) and the optimal point for a rejected takeoff (B) according to the performance tables (Source: Google Earth, with TSB annotations)

flight manual^{12,13,14} (Point B, Figure 2). However, this distance may be shorter if drag is increased, for example by orienting the aircraft into the wind or by deliberately shifting the attitude forward to increase the resistance of the floats on the water, while remaining within the prescribed limits. In this occurrence, the engine was shut off after the aircraft had passed the rejected-takeoff point, and the aircraft could not be slowed down sufficiently to avoid a collision with the shore and trees.
