# Air Transportation Safety Investigation Report A18W0113

## COLLISION WITH TERRAIN

Kasper Kootenay Wings MS Special (basic ultralight), C-ITMF  
Grande Prairie, Alberta  
31 July 2018

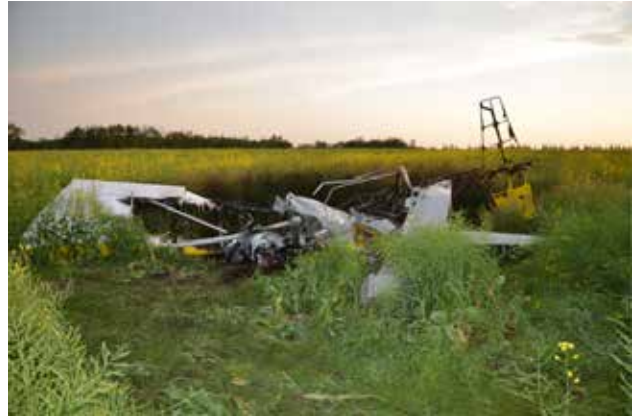
Figure 1. Accident site, looking west

When the aircraft was approximately 1 nm from the airfield, on the runway heading, it was seen at an altitude of 300 to 500 feet above ground level (AGL). The engine rpm was heard slowly increasing and decreasing but was not running rough. Moments later, the left wing dropped, and the aircraft entered a steep nose-down attitude. During the descent, the engine rpm increased rapidly, and the rpm remained high until the aircraft struck the ground (Figure 1).

The pilot was fatally injured and the aircraft was destroyed in an intense post-impact fire. The aircraft was not equipped with an emergency locator transmitter nor was one required by regulation; however, a portable SPOT Satellite GPS [global positioning system] Messenger was on board.

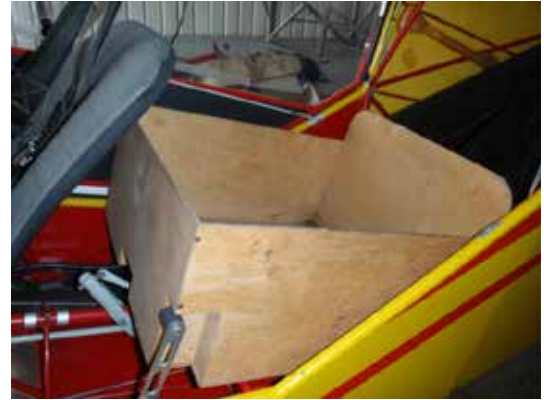
Figure 2. Wooden storage box (Source: Previous owner of the aircraft)

During preparations for the return flight, the rear seat of the aircraft was removed and a wooden storage box, which had been used many times by the previous owner, was installed (Figure 2). The box was secured to the aircraft floor structure at 4 attachment points matching those of the removed seat. All of the aircraft's historical records were placed in a backpack and secured in the box, along with the pilot's personal travel items.

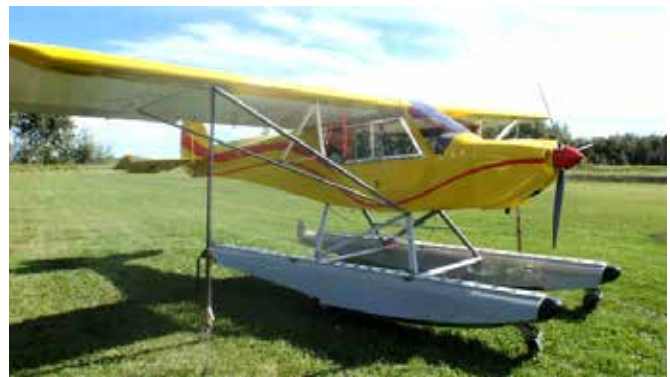
Figure 3. Kasper Kootenay Wings MS Special (Source: Previous owner of the aircraft)

The Kasper Kootenay Wings MS Special is a high-wing, 2-seat aircraft of steel tubing and fabric (Figure 3). The occurrence aircraft was built from plans and raw materials in 2001. All of the aircraft's records were destroyed in the post-impact fire.

The aircraft had no known deficiencies before the occurrence flight. Continuity of the engine controls was verified. An examination of the engine at the TSB facility in Edmonton, Alberta, was completed with the engine manufacturer present. There were no indications that the engine was not capable of producing power. The investigation determined that there was flight-control continuity before the accident.

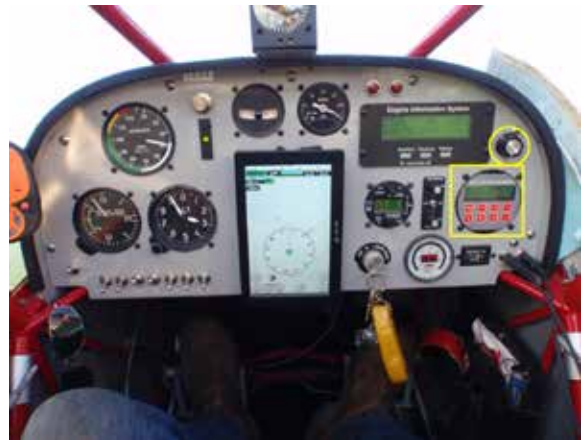
Figure 4. The occurrence aircraft's instrument panel showing the Simple Digital System programmer (yellow square outline) and mixture control knob (yellow circle outline) on the right of the panel (Source: Previous owner of the aircraft)

The SDS EFI system has a mixture control knob, which is located on the aircraft's instrument panel (Figure 4).

Mixture control allows the fuel injection system to be pre-programmed and also to be manually adjusted within a range of 50% more or less than the pre-programmed setting, giving the pilot independent control in the event of certain sensor failures. There can, however, be a loss of engine power at the leanest and richest settings of the adjustment range. Some pilots prefer to manually make the fuel mixture leaner using the knob once cruise power is set. The investigation was unable to determine whether the mixture control was manipulated during the flight, and, due to the intense post-impact fire, the final mixture setting could not be determined.
