Air Transportation Safety Investigation Report A1800150

MID-AIR COLLISION

Cessna 150G, C-FGMZ (privately owned)
and
NLG Air Inc.
Piper PA-42 Cheyenne III, C-FCSL
Ottawa/Carp Airport, Ontario, 1.3 nm S
04 November 2018

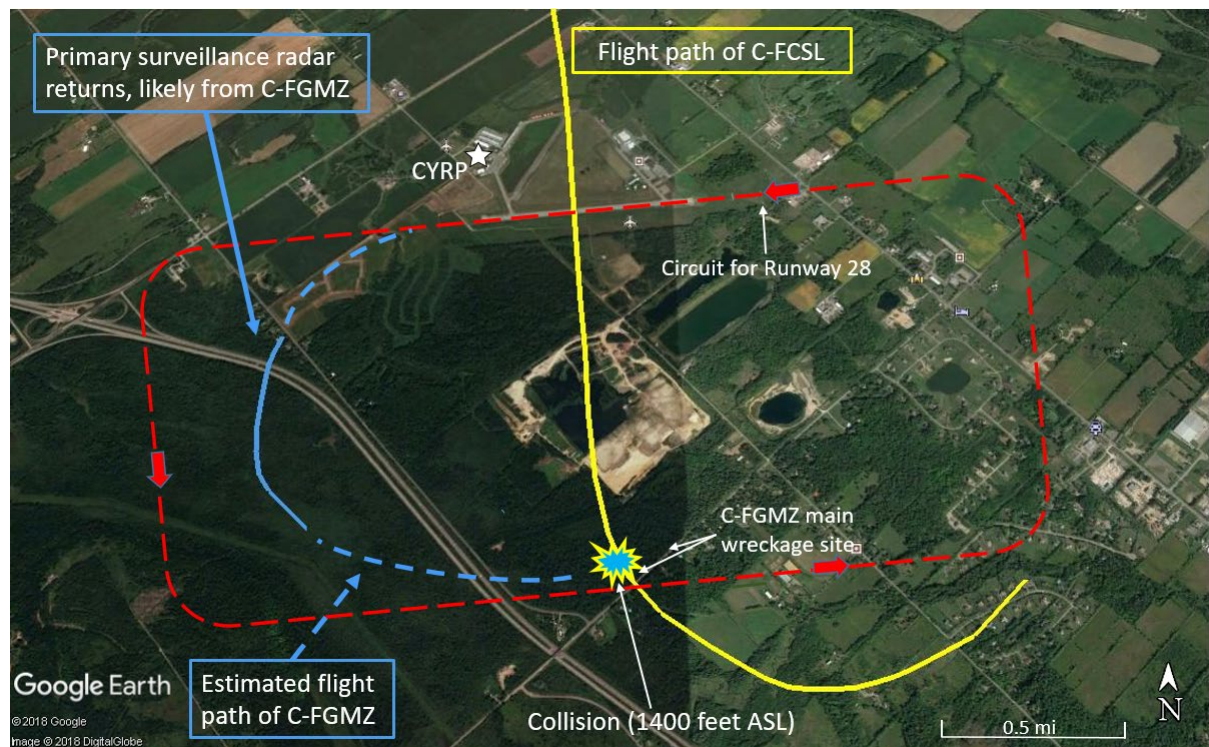
At 1010, the Piper was on approach to the airport from the north. It had flown over Runway 10/28 at circuit altitude to join the circuit at the midpoint of the downwind leg for Runway 28, when the 2 aircraft collided at approximately 1400 feet ASL, about 1.3 nautical miles (nm) south of the airport (Figure 1). The pilot of the Piper did not see the Cessna while crossing over the airport. The investigation was unable to determine whether the pilot of the Cessna saw the Piper or took evasive action prior to the collision.

Figure 1. Flight paths of the Piper (C-FCSL) and the Cessna (C-FGMZ). The left-wing outboard section of C-FGMZ was found 635 feet southwest of the main wreckage site. (Source: Google Earth, with TSB annotations)

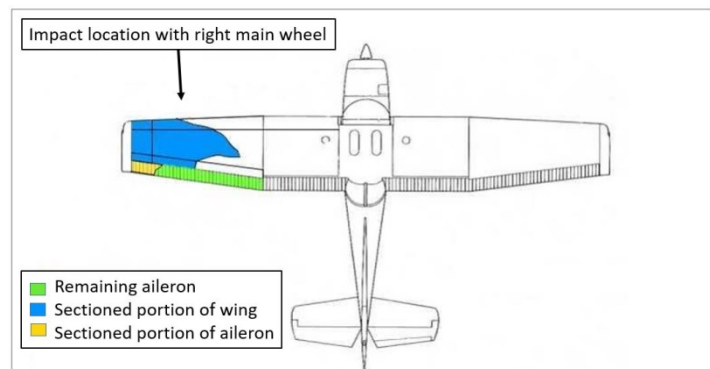
The investigation determined that, as the 2 aircraft collided, the Cessna's left wing struck the Piper's extended right main-wheel assembly at a point 5.75 feet from the Cessna's outer left-wing rib. The impact damage to the leading edge of the wing indicates that it struck the outboard face of the Piper's wheel assembly, nearly perpendicular with the Piper's longitudinal axis.

The damage sustained by the wing structure caused the failure and subsequent separation of the outer section of the wing and aileron (Figure 2). The aircraft became uncontrollable and rapidly entered a steep dive, striking the ground in a near-vertical attitude. The aircraft was destroyed by the impact forces and post-impact fire.

Figure 2. The Cessna's in-flight damage (Source: Cessna Aircraft Company, with TSB annotations)

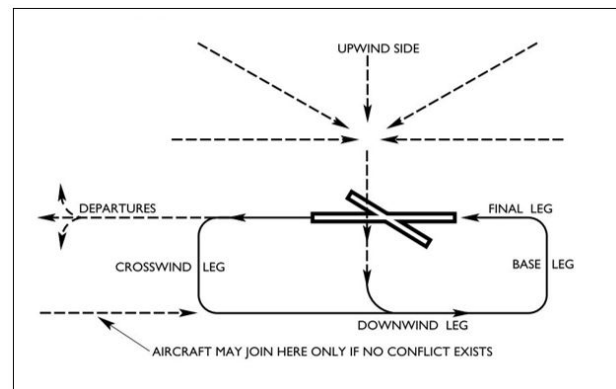
CYRP is an uncontrolled airport located 1.2 nm south of the village of Carp. It is owned and operated by West Capital Developments. CYRP has 1 paved runway (Runway 10/28) and 1 gravel runway (Runway 04/22). At the time of the occurrence, Runway 28 was in use, with a standard left-hand circuit pattern (Figure 3). The circuit altitude for Runway 28 is 1400 feet ASL.⁵ The airport lies within an aerodrome traffic frequency (ATF) area with a radius of 5 nm that is centred on the airport and extends vertically up to and including 1800 feet ASL. Transport Canada (TC) establishes an ATF “to ensure that all radio-equipped aircraft operating on the ground or within the area are listening on a common frequency and following common reporting procedures.”⁶

All pilots “operating at or in the vicinity of an aerodrome shall observe the aerodrome traffic for the purpose of avoiding a collision”⁷ and “are expected to approach and land on the active runway.”⁸ In addition, at aerodromes that are not within a mandatory frequency (MF) area,⁹ aircraft “should approach the traffic circuit from the upwind side”¹⁰ (Figure 3).

Figure 3. Standard left-hand circuit pattern at an uncontrolled aerodrome (Source: Transport Canada, TP 14371E, *Transport Canada Aeronautical Information Manual* [TC AIM], RAC—Rules of the Air and Air Traffic Services [11 October 2018], Figure 4.6.)
