## **RAIL TRANSPORTATION SAFETY INVESTIGATION REPORT R17D0123**

### **EMPLOYEE FATALITY**

Canadian Pacific Railway  
Yard assignment FS23  
Mile 46.9, Adirondack Subdivision  
St-Luc Yard  
Montréal, Quebec  
08 November 2017

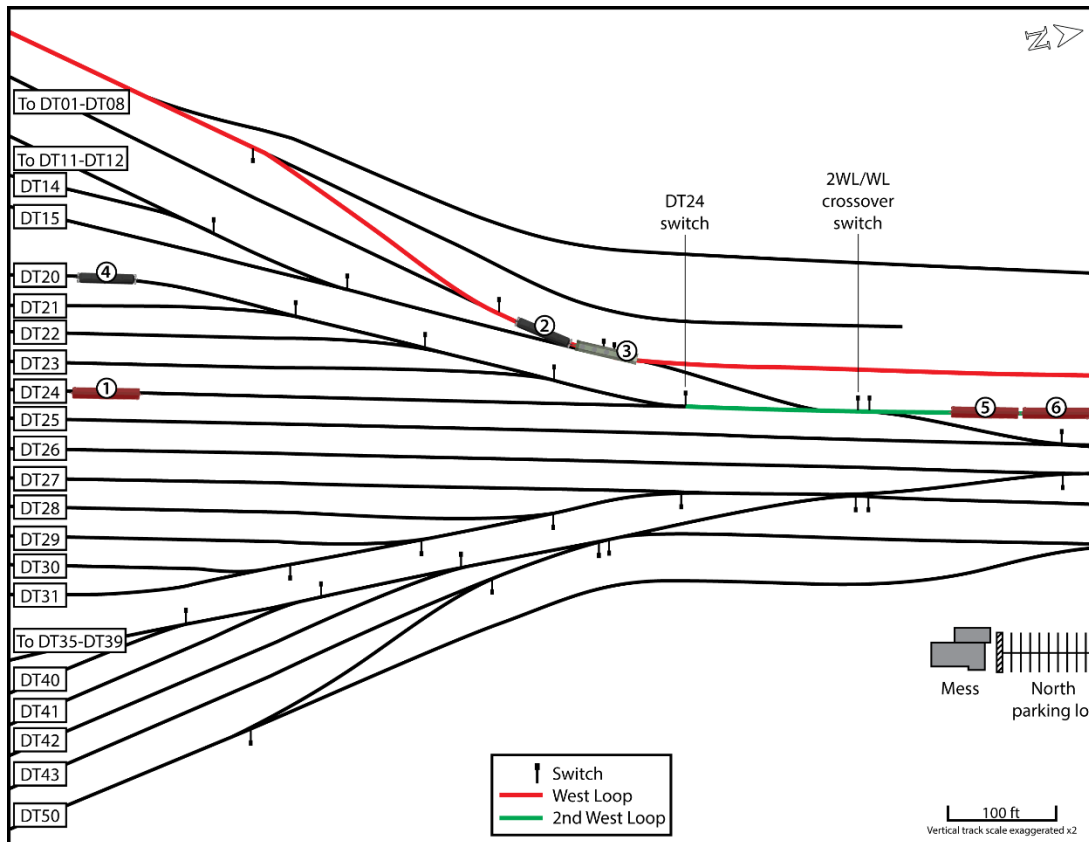
Figure 2. Position of cars from the yard assignment before the last movement (Source: TSB)

Shortly thereafter, the yard helper exited the mess building and returned to the 2WL/WL crossover switch. At that time, the yard assignment had completed the placement and securement of the 4th car (NOKL 570177) onto track DT20, and was proceeding northward out of that track on the 2nd West Loop.

In preparation for the next movement, where the 5th and 6th cars (CP 214036 and CP 215379) would be placed onto track DT24, the yard foreman headed toward that track while the yard helper instructed the locomotive engineer by radio to stop the yard assignment with the last car positioned approximately 100 feet north of the 2WL/WL crossover switch.

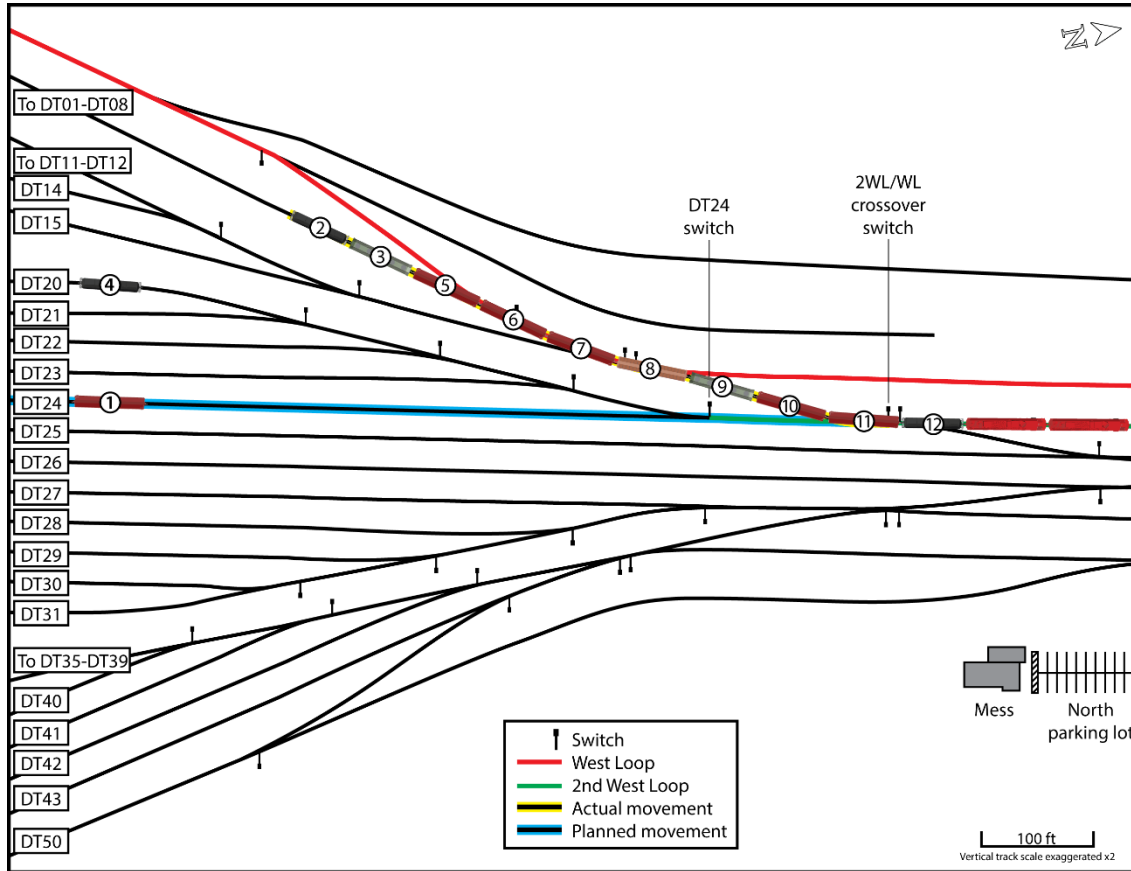
Figure 3. Final position of the yard assignment after the accident (Source: TSB)

approximately 0600, after having travelled 315 feet and reaching a speed of 10 mph, the yard assignment collided with car INEX 145. The locomotive engineer immediately applied the brakes to stop the movement (Figure 3).

Radio communication was established between the locomotive engineer and yard foreman. They determined that the yard assignment had not been routed toward track DT24 as intended. After repeated attempts to contact the yard helper by radio, the yard foreman walked up and began inspecting the yard assignment. The yard helper was located under car CP 215379, having been struck and fatally injured by the yard assignment.

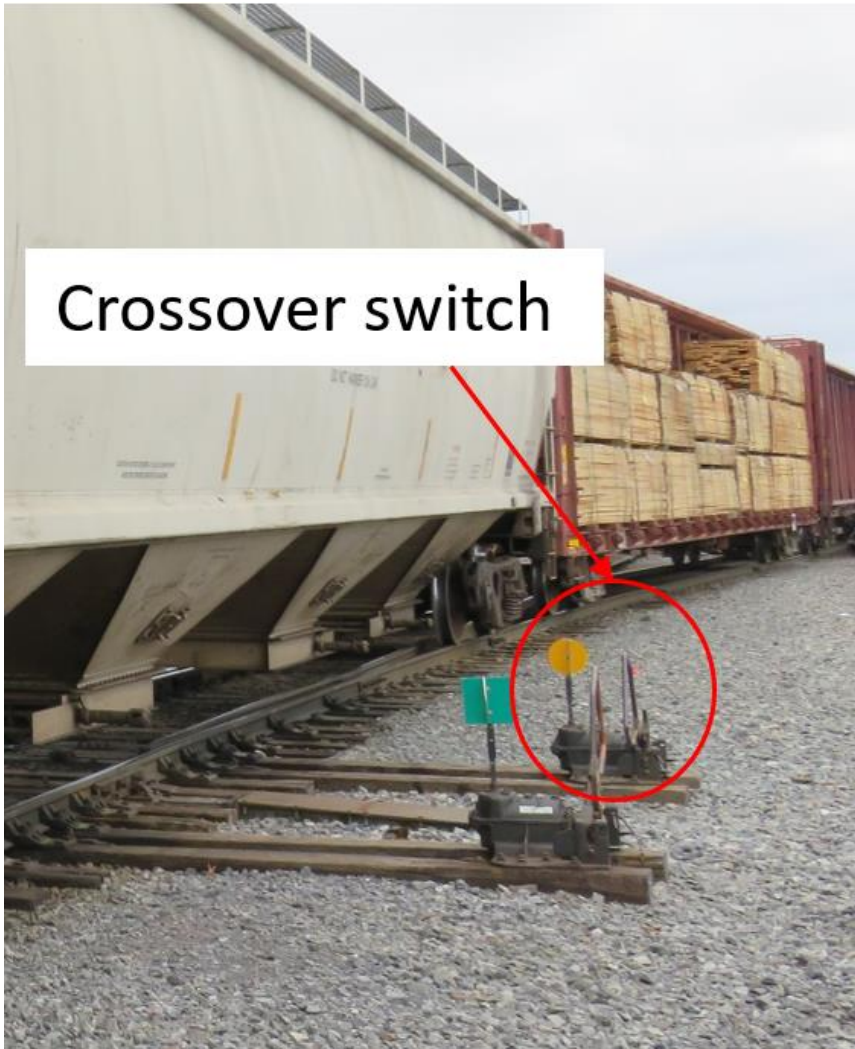
Figure 5. 2WL/WL crossover switch connecting the 2nd West Loop to the West Loop, in the reverse position (Source: TSB)

At the southern extremity of the 2nd West Loop, a crossover connects the 2nd West Loop to the West Loop (2WL/WL crossover). When the 2WL/WL crossover switch is in the reverse position (displaying a yellow target) (Figure 5), a yard assignment travelling southward is diverted onto the crossover and toward the West Loop (adjacent track). When the 2WL/WL crossover switch is in the normal position (displaying a green target), a yard assignment travelling southward is directed toward the lead of tracks DT20 to DT24.

Following the accident, the 2WL/WL crossover switch was found in the reverse position, lined for the West Loop. No switch identification markings were present. The switch handle was secured with the foot lock, and its keeper was in the keeper hole. The switch points showed no signs of damage. The switch was inspected and tested; no exceptions were noted. The DT24 switch was found in the reverse position, lined for track DT24 (Figure 6).

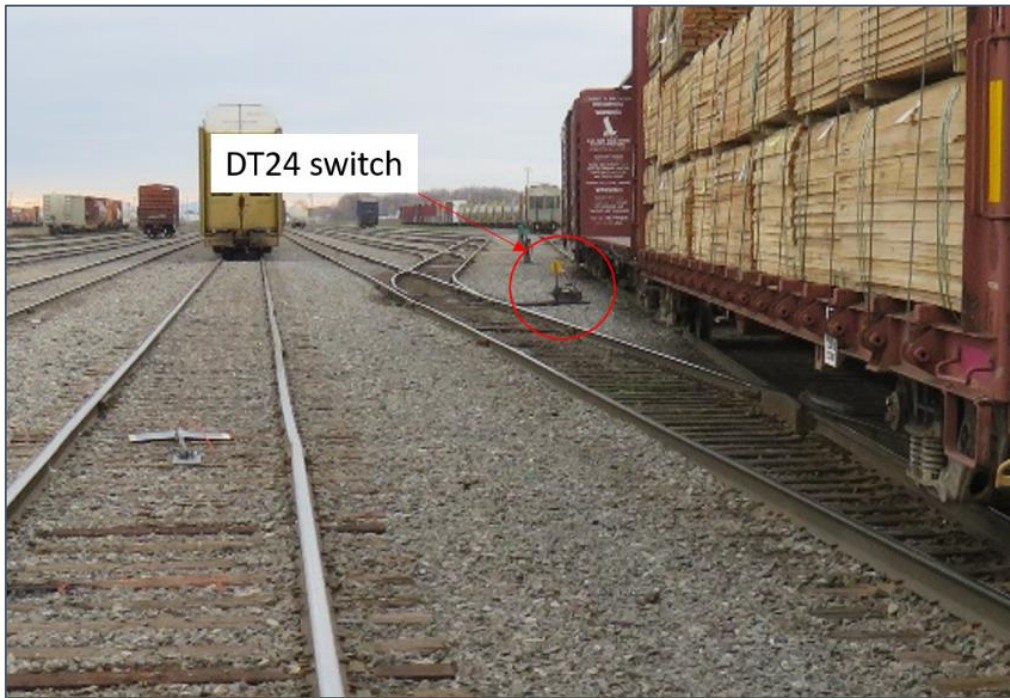
Figure 6. DT24 switch in the reverse position (Source: TSB)

The side of the DT24 switch had a non-reflective marking indicating the switch number.

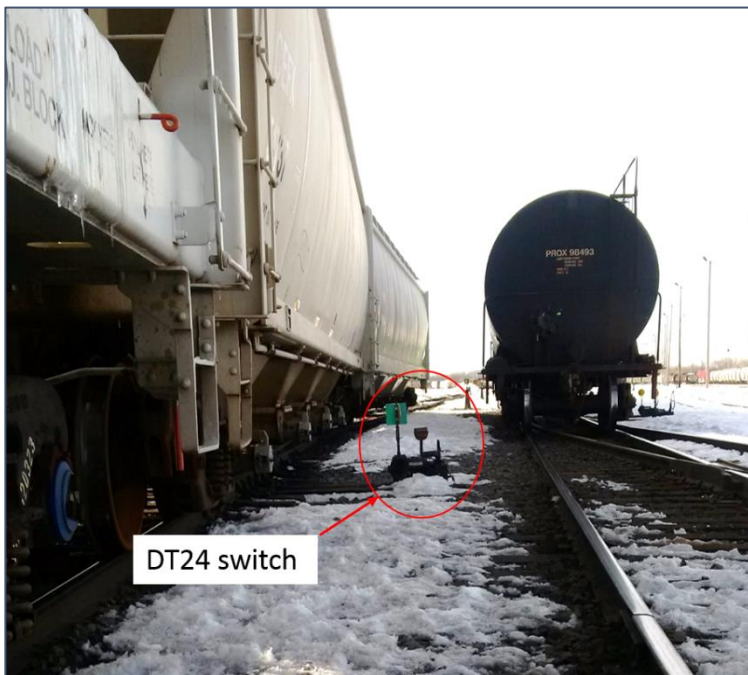
Figure 8. Position of DT24 switch (circled) relative to the adjacent tracks (Source: TSB)

At St-Luc Yard, most of the switches at the north end of the departure yard are located on the outside of the ladder. However, at the northern extremity of the departure yard, the ladders for tracks DT20-DT24, DT11-DT15, and DT01-DT08 are in close proximity to each other and are bordered by the West Loop (Figure 2). The close proximity of the tracks results in reduced clearance around some switches, which does not allow an employee to handle switches without moving foul of an adjacent track. For example, the DT24 switch is positioned approximately 2½ feet from the adjacent track (Figure 8).

Routine exposure to workplace hazards without negative consequences can desensitize an employee to the risk associated with those hazards.<sup>15</sup>

Employees are required to remain vigilant while working on or around tracks at all times. However, the switches on the diamond are bordered by other tracks, which causes employees to place themselves foul of the tracks when handling switches. Routine exposure to working foul of an adjacent track can desensitize an employee to the hazards of rail yard operations.

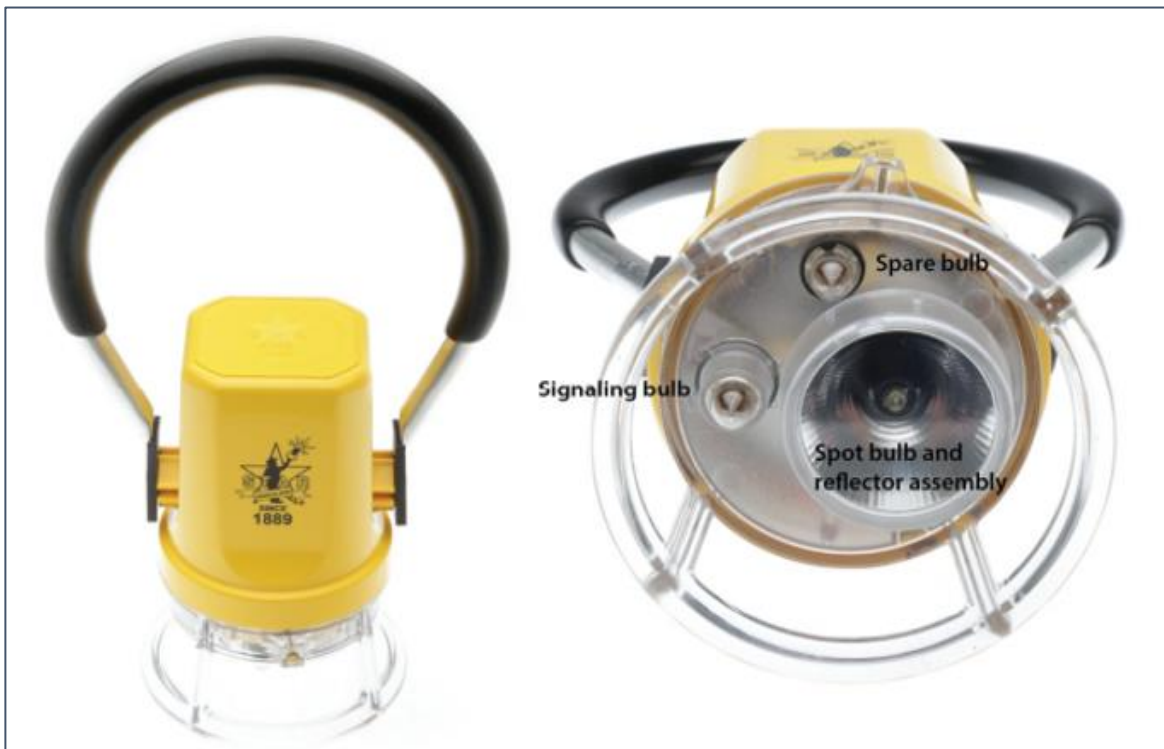
Figure 10. Handheld lantern (Source: TSB)

The yard helper's safety glasses, work gloves, switch list, and lantern were found on the west side of the yard assignment, adjacent to the DT24 switch. The lantern used by the yard helper was damaged during the accident, and examination of its functionality could not be performed.

CP issues handheld lanterns to all yard employees. On the night of the occurrence, both the yard foreman and the yard helper were provided with a handheld lantern equipped with an incandescent signalling bulb and an LED spot bulb housed in a reflector assembly (Figure 10).

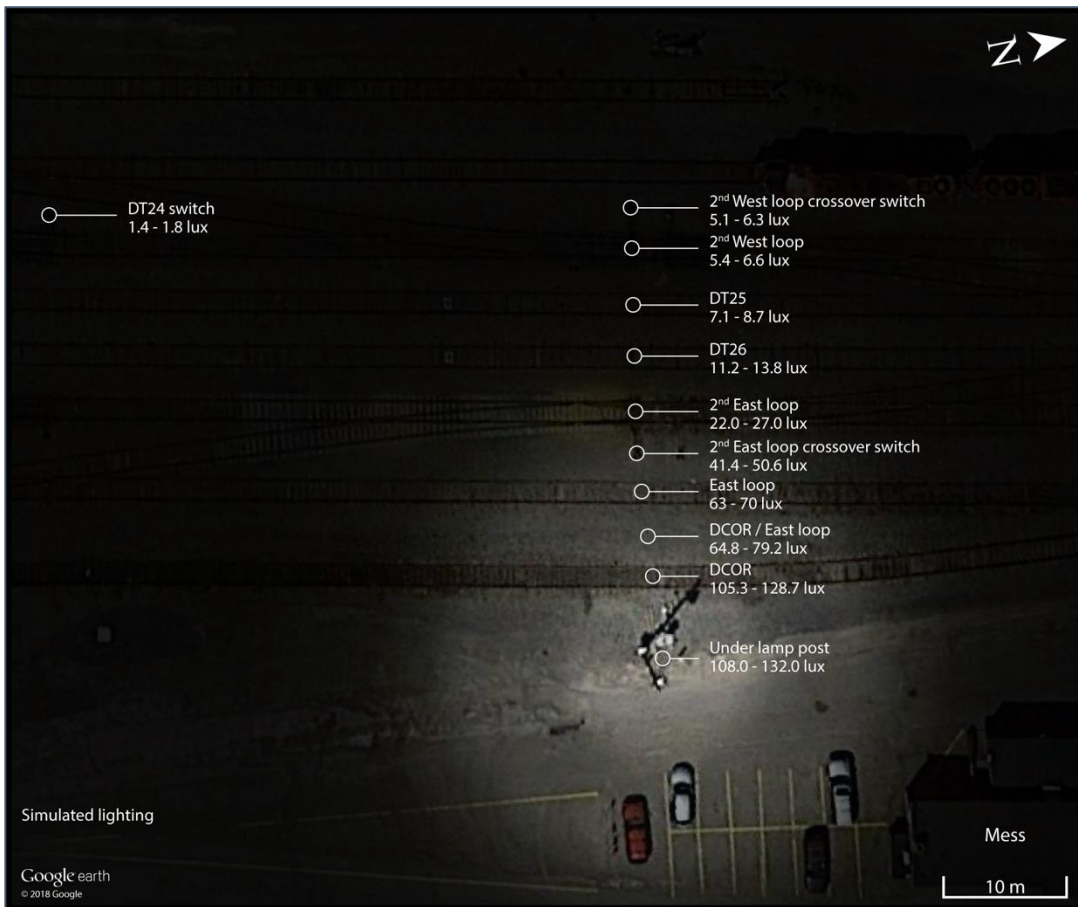
Figure 11. Rendering of the lighting conditions in the diamond area (Source: Google Earth, with TSB annotations)

In the diamond area, there was one fixed lamp post located on the east side (east lamp post). The TSB measured the levels of lighting under different conditions<sup>18</sup> at various task locations in the yard.<sup>19</sup> It was determined that with the area's fixed lighting system,

With the use of a portable lantern with only the signalling bulb lit, the average level of lighting at the task locations<sup>20</sup> was increased by 4 lux. As a result,

- The average level of lighting for the 2WL/WL crossover switch task location was 9.7 lux.
- The average level of lighting for the DT24 switch task location was 5.6 lux.

While both the yard foreman and the yard helper were using handheld lanterns on the night of the occurrence, as provided for in the regulations, this auxiliary lighting does not replace the illumination provided by a fixed system in the yard. Some railway employees had also identified the insufficient lighting in St-Luc Yard as a concern.
