Rail Transportation Safety Investigation Report R18C0076

MAIN-TRACK DERAILMENT

Canadian Pacific Railway
Freight train A13-31
Mile 50.7, Montana Subdivision
Stirling, Alberta
30 July 2018

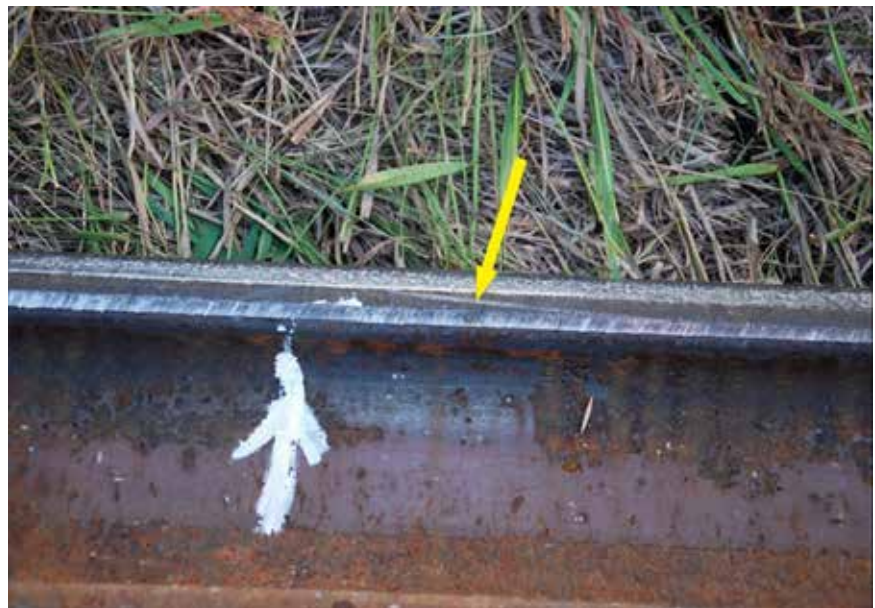
Based on the wheel flange marks across the rail head (Figure 2), the high rail had likely canted outwards, allowing the wheel on

the inside rail to drop into the gauge. For lateral forces of 10 to 12 kips¹² to cause the gauge to spread, weakened securement of the rail (e.g., poor tie condition) was likely present.

Figure 2. Wheel flange marks across the rail head at the point of derailment (indicated by the yellow arrow)

¹² Lateral forces of 10 to 12 kips are consistent with normal train operations. This amount of lateral force would not be expected to exceed the gauge restraint capability of well maintained track in moderate curvature.

Although only a small section of track (between Mile 50.53 and Mile 51.01) had been identified by the track evaluation car as having wide gauge, the gauge of the track can spread if defective ties are clustered rather than being evenly distributed.

In this occurrence, the track met the requirements of the TSR and CP's Red Book with respect to the allowable percentage of defective ties. However, the track was still vulnerable to lateral in-train forces in the range of 10 to 12 kips. This occurrence illustrates the importance of performing timely replacement of defective ties, particularly on curves.
