Marine Transportation Safety Investigation Report M18A0002

VESSEL GROUNDING AND SUBSEQUENT FATALITY

Fishing vessel *Fisherman's Provider II*
Canso, Nova Scotia
06 February 2018

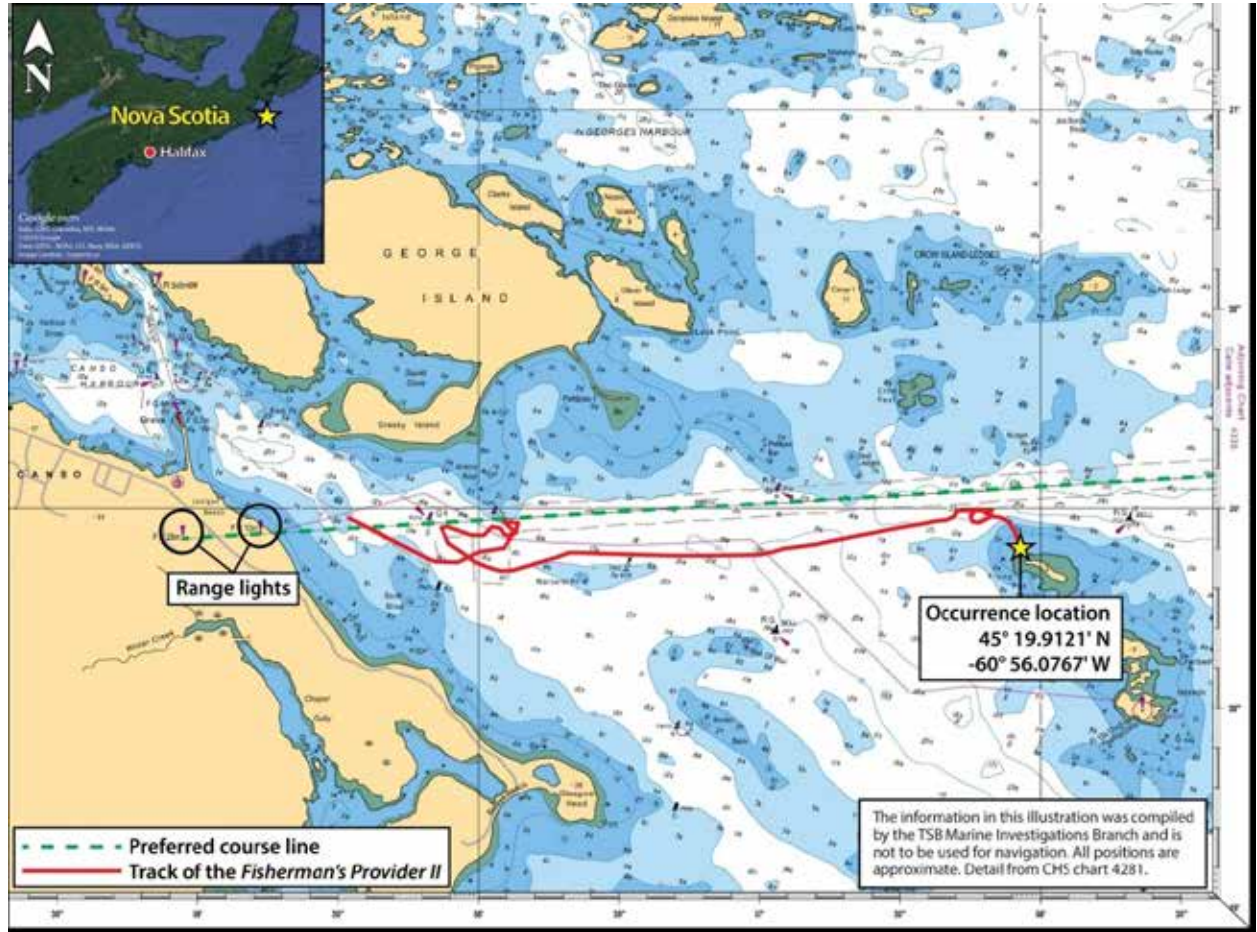
Figure 1. Area of occurrence and vessel track

At 1823, the vessel began to broadcast an AIS signal. The AIS track indicates that, at 1824, the vessel began to move erratically through the water (in circles, in shoal water, and back and forth across the harbour) and did not follow the preferred course line to exit the harbour.

At 1828, the vessel's speed decreased from 7 knots to 2 knots, and the vessel continued making irregular movements until it went aground at 1945 on Frying Pan Shoal, Nova Scotia.

In this occurrence, the vessel deviated from the preferred course for exiting the harbour. While transiting the harbour, the vessel travelled in an erratic manner and eventually ran aground.
