Marine Transportation Safety Investigation Report M18C0030

LIQUEFIED NATURAL GAS FUEL EQUIPMENT FAILURE

Roll-on roll-off passenger ferry *F.-A.-Gauthier*
Matane, Quebec
08 April 2018

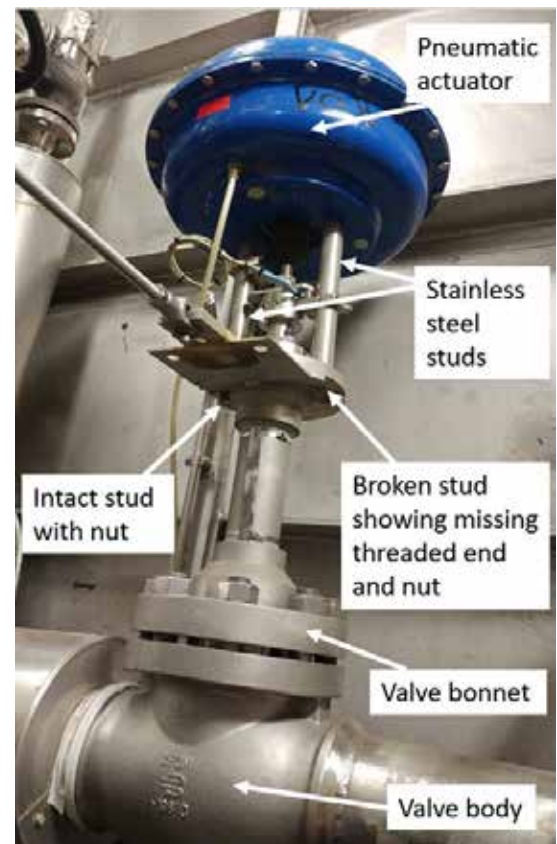
Figure 2. Valve V08 on the port-side LNG fuel supply system

The part of the valve that failed is 1 of the 2 stainless steel studs that fasten the valve's pneumatic actuator over the valve bonnet (Figure 2).

The investigation determined that vibrations within the LNG storage tank's connection space, which may have acted on the space since the vessel had been commissioned, likely caused the stud to fail and break apart and resulted in the small gas leak. More precisely, although a vibration damping arrangement was securing the body and bonnet of valve V08 against an adjacent platform, the pneumatic actuator was oscillating freely and transmitting these stresses to its fastening studs, gradually causing one of them to fail.

Following this occurrence, the system manufacturer and the valve manufacturer initiated a joint study to prevent this particular failure from happening again. Specifically, the manufacturers are focusing on either redesigning the support stud with a different material, or redesigning the supporting arrangement of the pneumatic actuator, using 3 studs instead of 2.
