MARINE TRANSPORTATION SAFETY INVESTIGATION REPORT M17P0244

BOTTOM CONTACT

Tug Ocean Monarch
Princess Royal Channel, British Columbia
09 July 2017

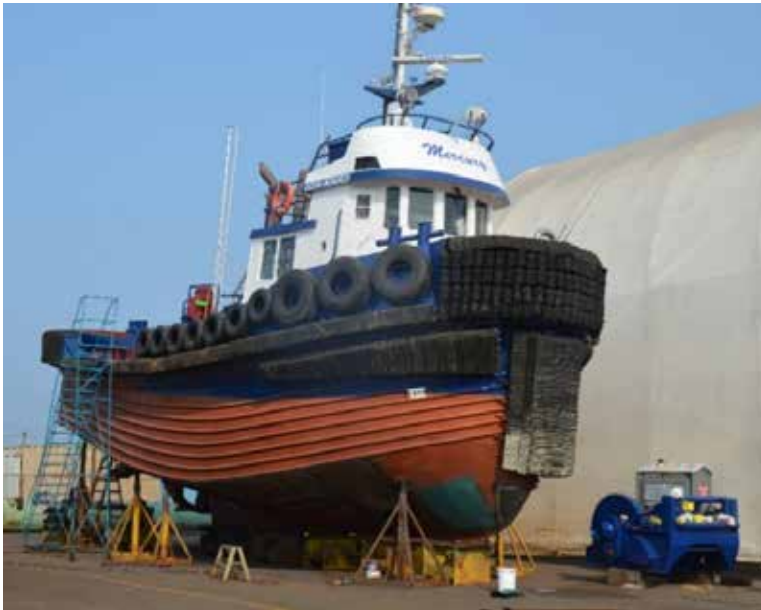
Figure 1. The Ocean Monarch at the shipyard after the occurrence

On 11 August, Transportation Safety Board of Canada (TSB) investigators were deployed to the shipyard.⁸ The investigation found that the stem and the starboard side of the tug's steel hull had numerous scrapes, fractures, deformations, and indentations below the waterline.

The starboard propeller and rotating nozzle had major damage and required replacement. The starboard forward fuel oil bulkhead had an internal crack.
