COMPLIANCE ASSESSMENT REPORT
ON WOOD PROTECTION (ANTI-SAPSTAIN)
FACILITIES IN BRITISH COLUMBIA (1984)

Regional Program Report 86-08

D.M. Wilson
and
S. Liu

JUNE 1986

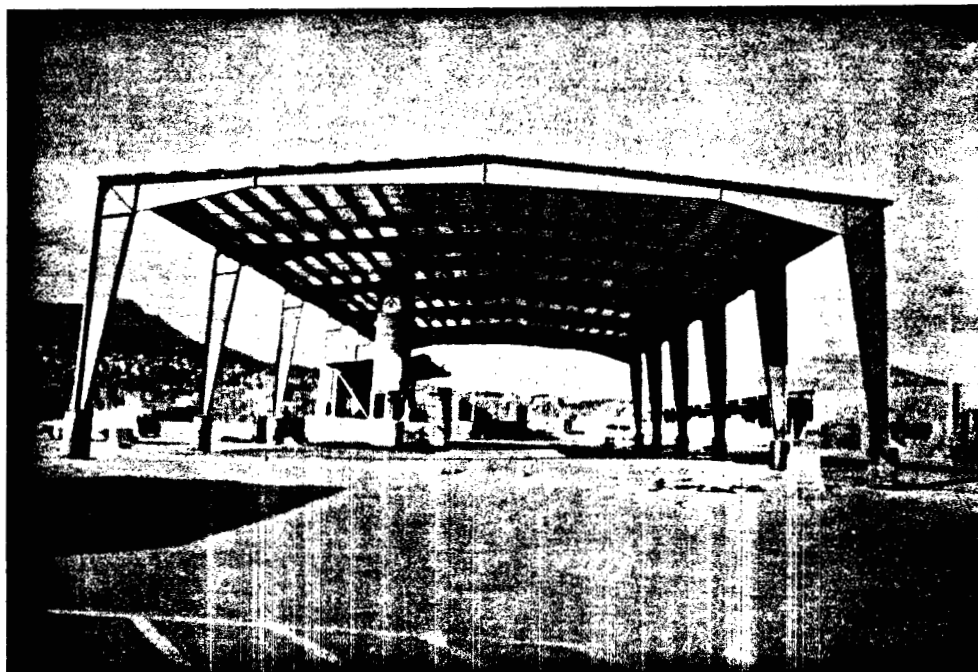
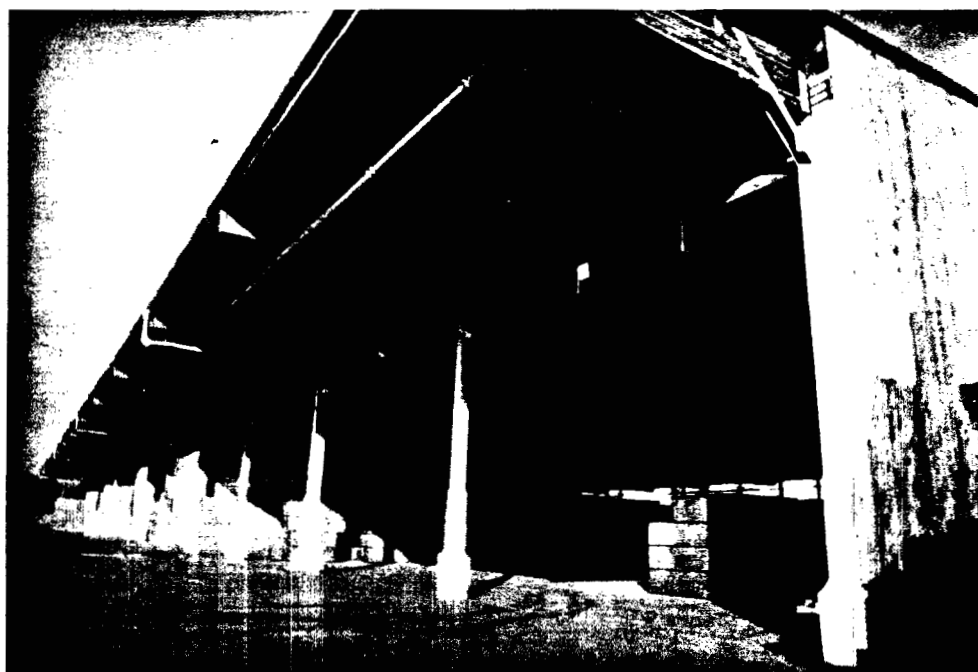
FIGURE 2

EXAMPLES OF COVERED STORAGE OF ANTI-SAPSTAIN TREATED LUMBER

Table 2 indicates that only 8% of sawmills and lumber export terminals have covered final storage of treated lumber. As noted earlier, uncovered lumber storage is suspected as a source of low-level releases of chlorophenates into the environment. However, the cost of providing covered storage can be high and this recommendation remains a controversial topic with the forest products industry. EPS and the B.C. Ministry of Environment will undertake a study in 1986 to better define stormwater contamination at selected mills. Releases of chlorophenates in stormwater will be compared at selected dip and spray facilities with and without covered storage of lumber.
