**ENVIRONMENTAL CONCERNS AND RECOMMENDATIONS:
ALASKA HIGHWAY RECONSTRUCTION AND MAINTENANCE
KILOMETRE 1008-1635**

Robert Baker
Federal Activities Branch - EICD
Environmental Protection Service
Environment Canada

EPS 8-PR-80-1

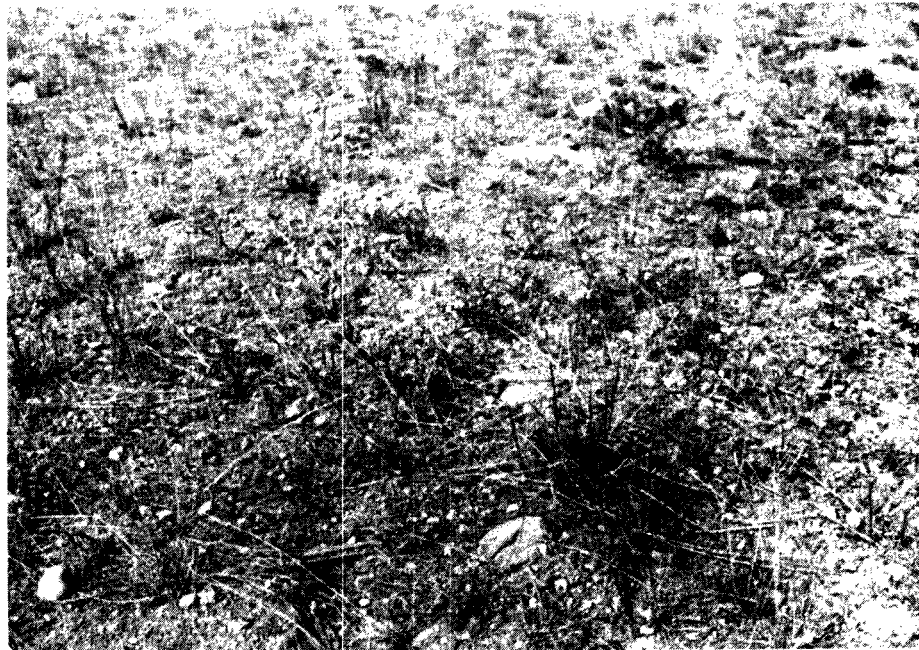
PLATE 1 Cleared right-of-way, reconstructed section of Alaska Highway, km 1022, sparsely vegetated.

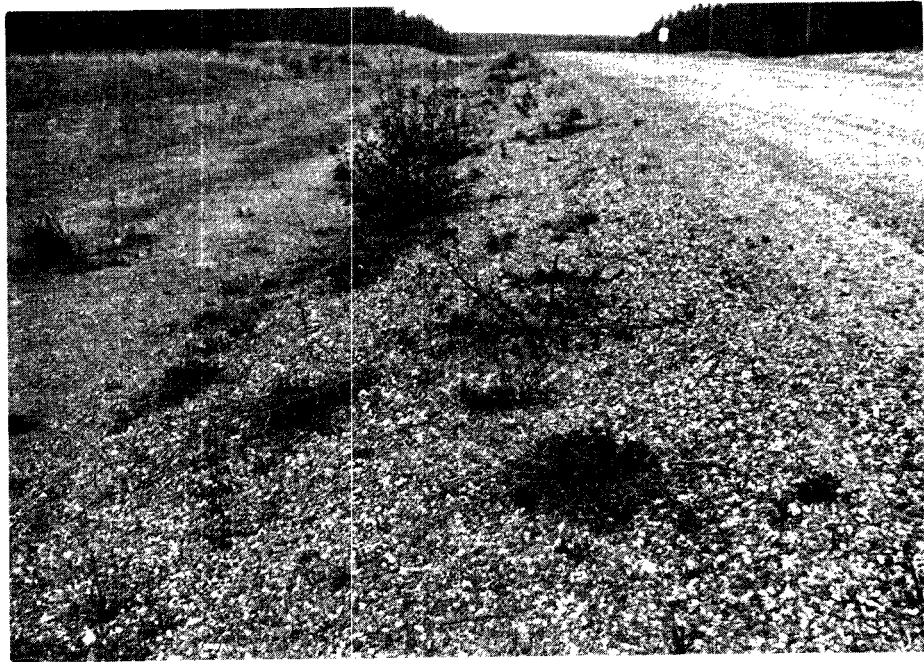
PLATE 2 Location as for Plate 1, sparsely vegetated cleared right-of-way.

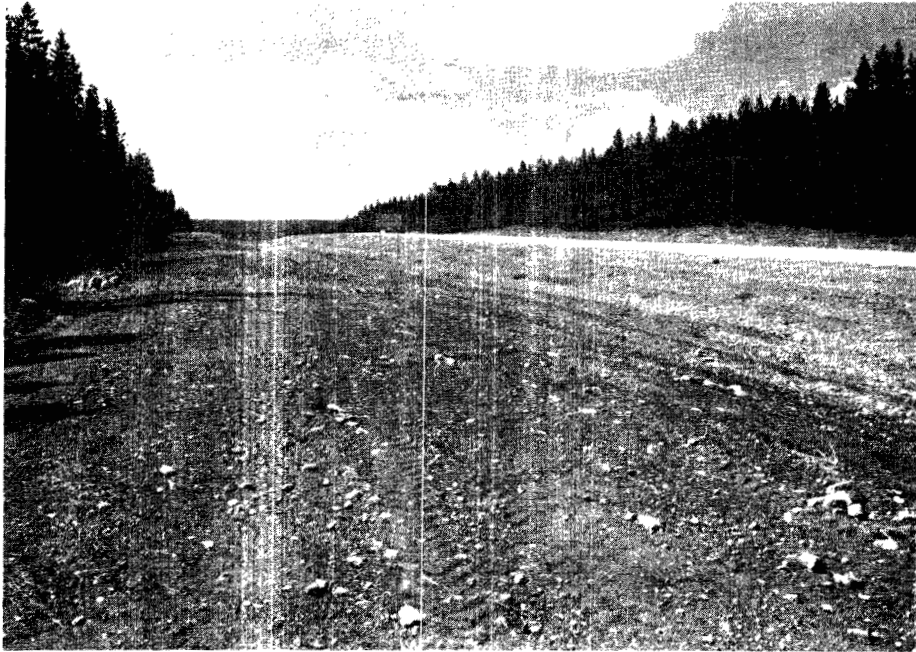
PLATE 4 Location as for Plate 1, maintenance staff use of road graders to clear vegetation from road-sides in the Yukon.

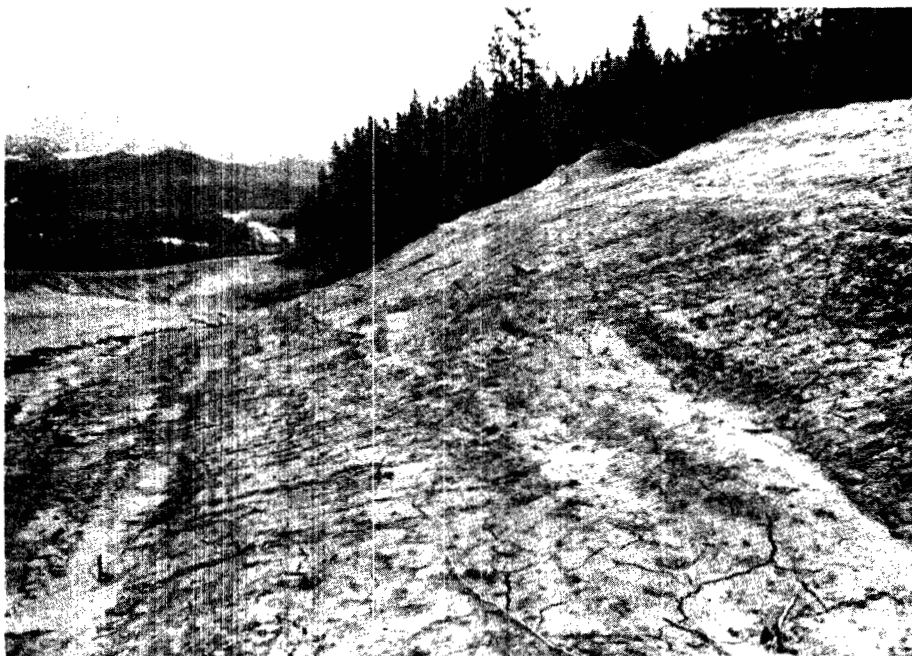
PLATE 8

Gully erosion can result when silty soils are not allowed to revegetate. The most vulnerable areas are at the bottoms of ditches. Alaska Highway, km 1628, reconstructed section.

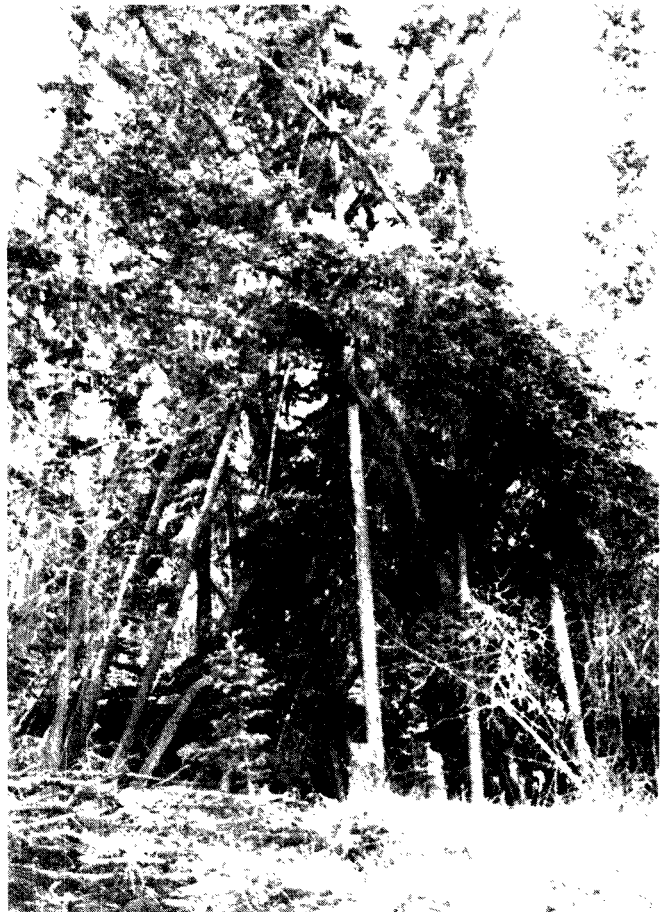
PLATE 13

Trees at the edge of a cleared right-of-way can be damaged and may not be removed during reconstruction operations (Plate 13).

Cowley Creek, trees pushed over by having equipment adjacent to creek, some will die and many will eventually block creek. Alaska Highway, km 1457, reconstructed section.

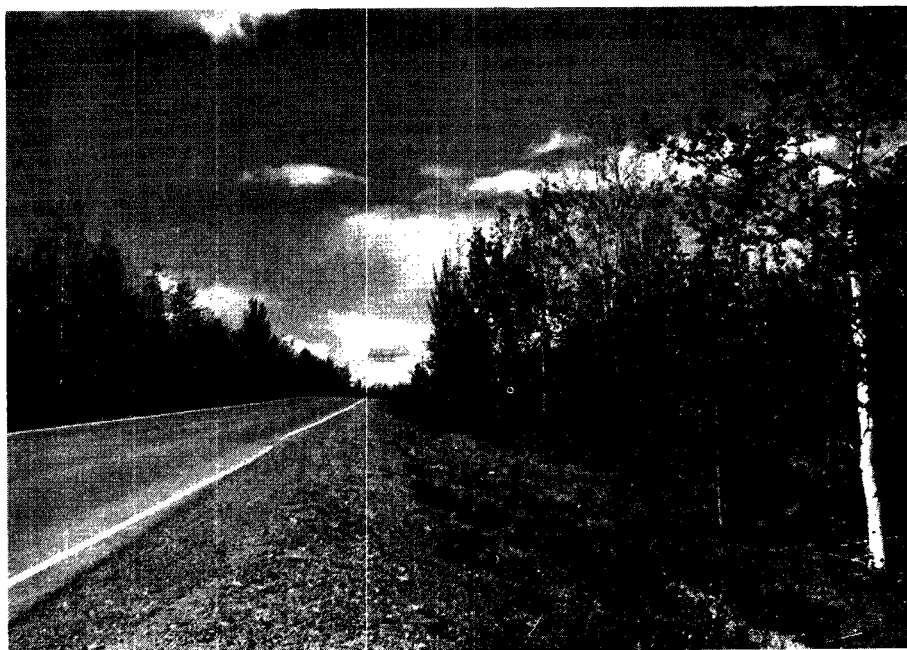
PLATE 14

Right-of-way cleared with a vegetation cutter. The cutter clears a 4 m swath on each side of the highway. One cutter clears approximately 640 km of highway per year. Soils are sandy and hence erosion-prone. Alaska Highway in State of Alaska, vicinity of Tok.

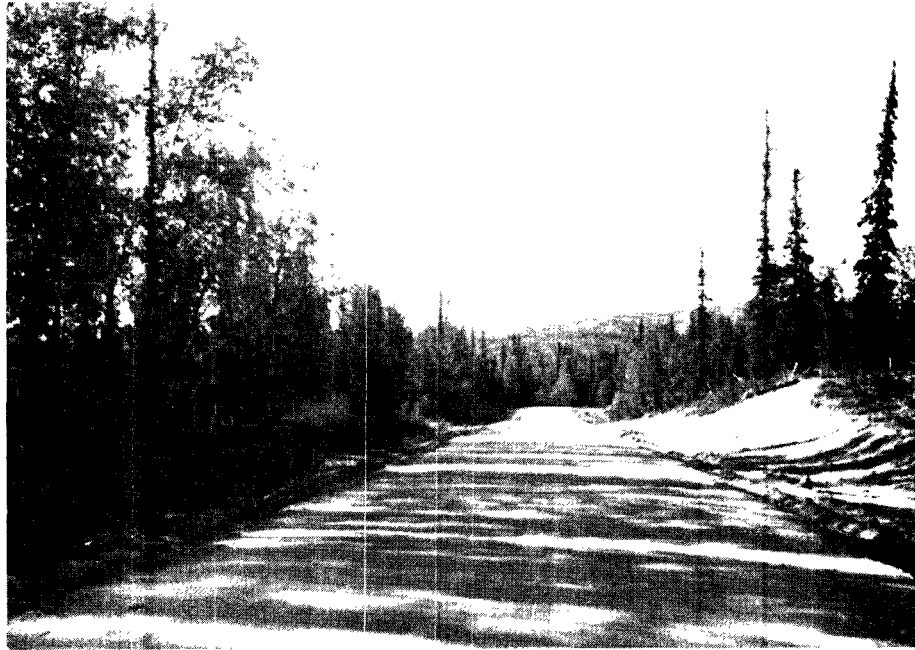
PLATE 15

Right-of-way cleared with a vegetation cutter. Care has to be taken to keep the rights-of-way cleared of rocks and other obstacles. The cutter used on this highway has to be repaired a great deal. If the "down-time" could be reduced a single cutter could clear much more than 640 km of highway per year. Alaska Highway, vicinity of Tok, Alaska.

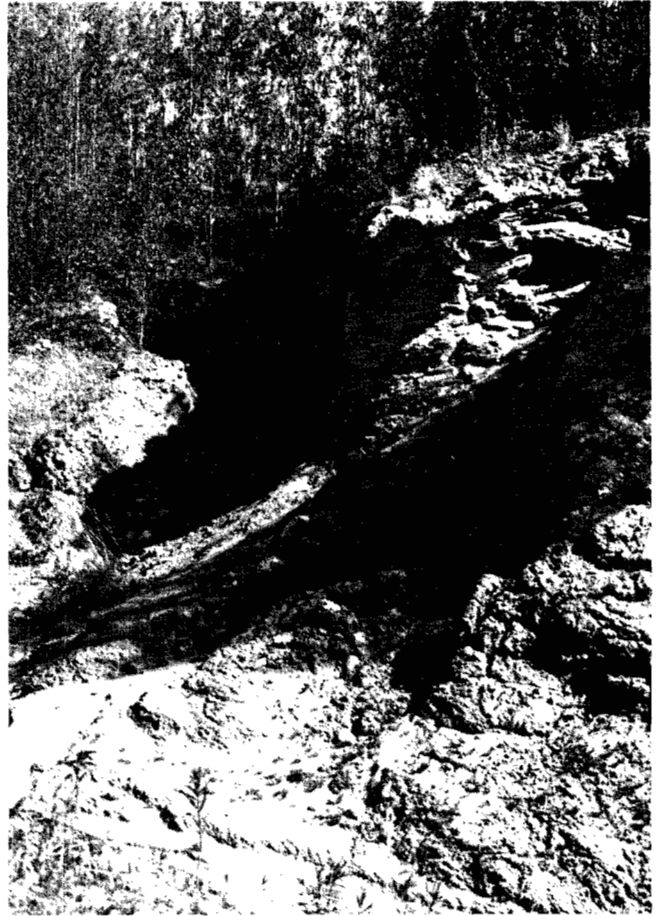
Backslope nearly vertical, silty soil, extensive slumping. Robert Campbell Highway, km 85.

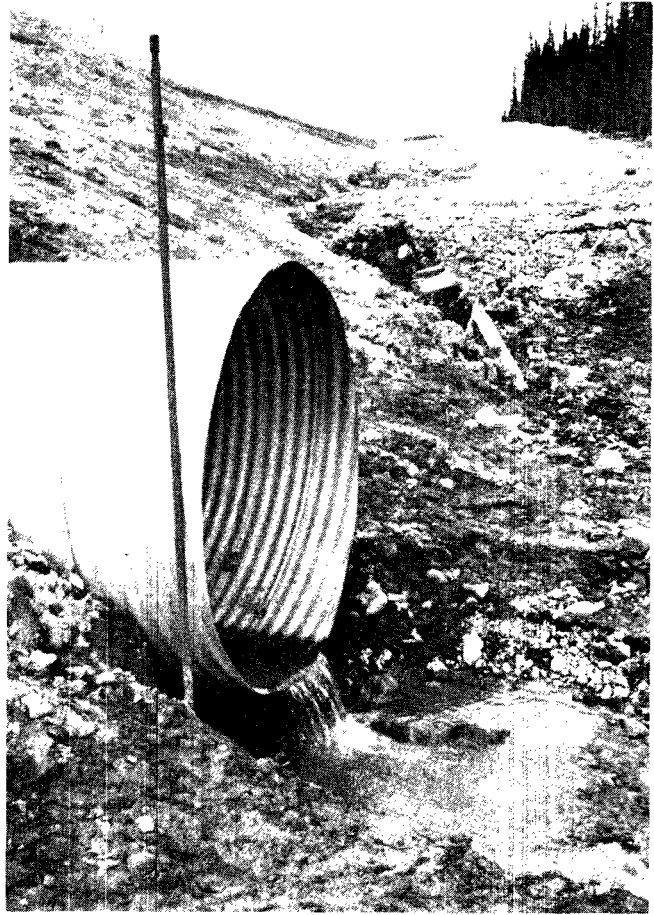
Top soil and vegetation removed at stream crossing during reconstruction. Erosion evident. Alaska Highway, km 1418.3 Reconstructed section.

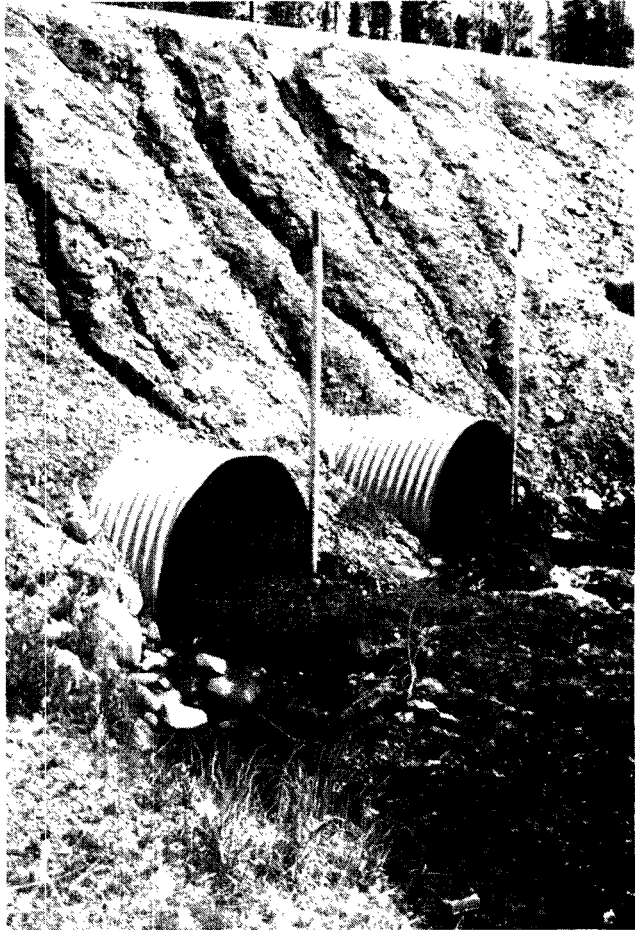
Foreslope too steep. Eroded material ends up in stream. This problem can arise if the highway is widened and if the culverts used in the old highway are not replaced with longer ones or if sections are not added to the ends of the culverts already in place. Alaska Highway, km 1071. Reconstructed section.

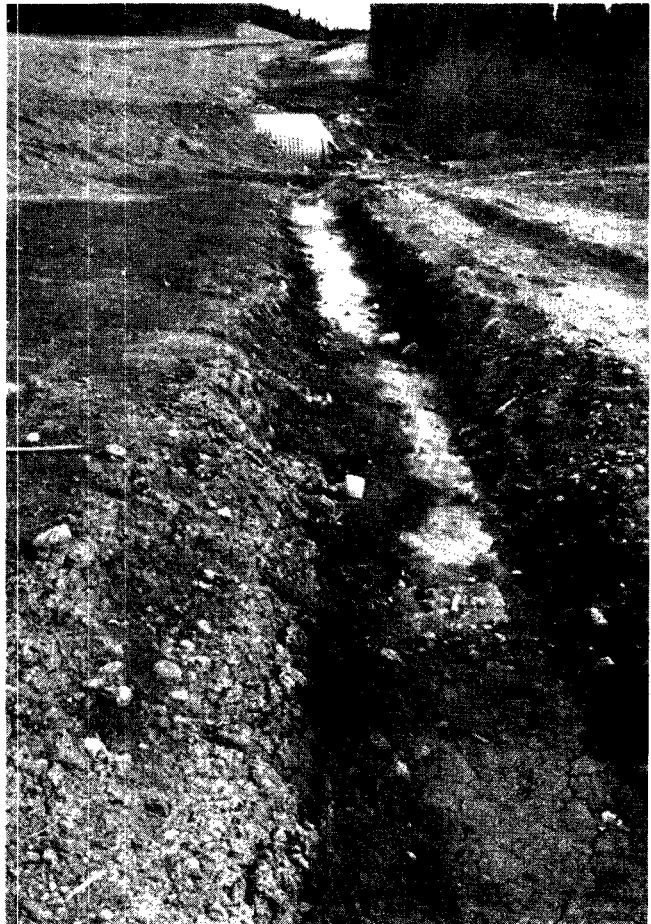
PLATE 47

For problem description, see Plate 44. The lack of rip-rap in the ditch and the fact that this area is cleared periodically with road graders adds to the environmental impact at this crossing. Alaska Highway, km 1418.3. Reconstructed section.

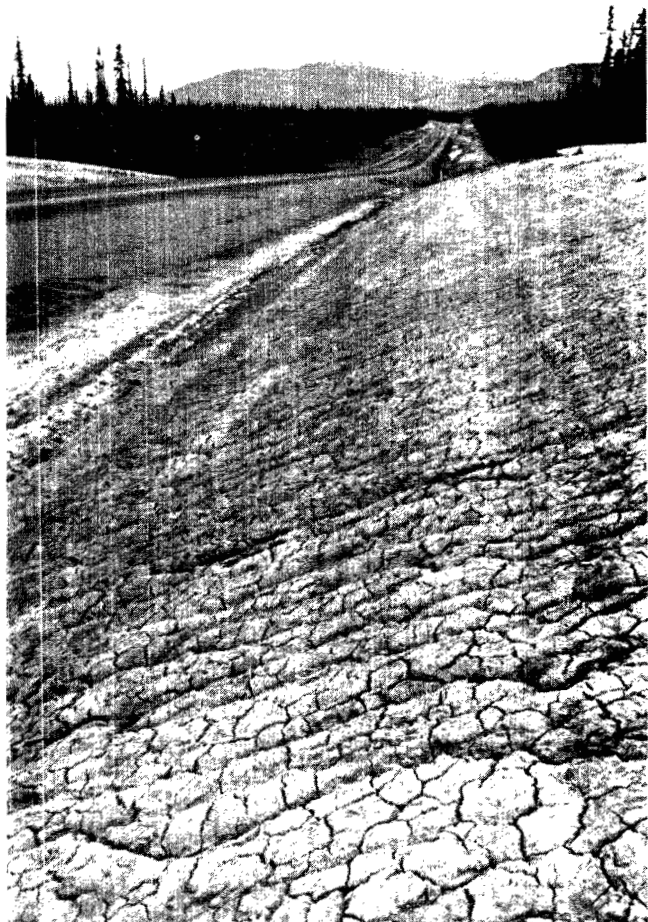
Ditch lacks rip-rap. Sediment in run-off may clog minor drainage culverts (one is located at bottom of hill), erosion-prone silty soils. Alaska Highway, km 1415. Reconstructed section.

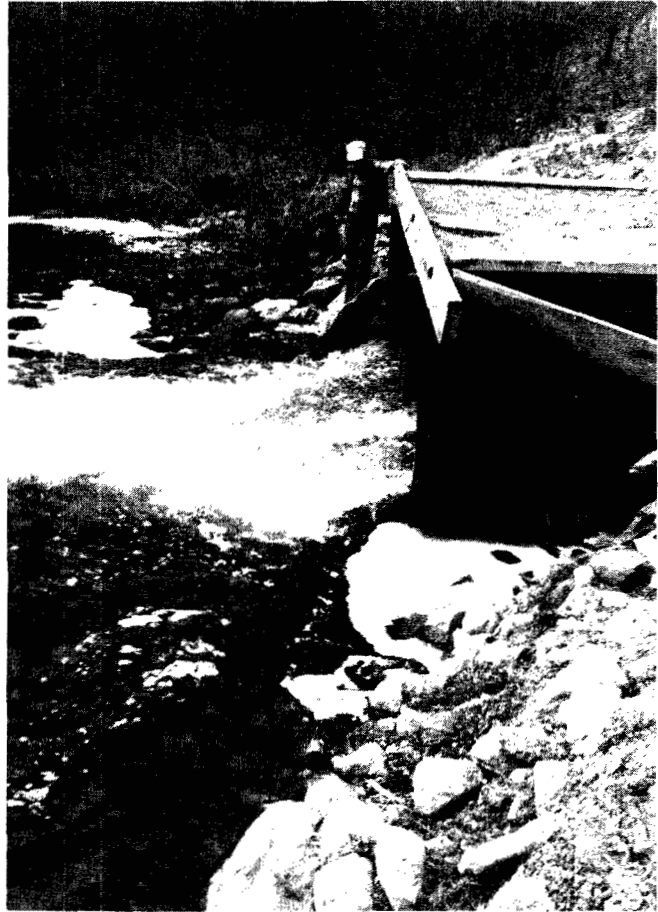
Wooden box culvert installed in early 1940s. Culverts should have been replaced when this section of highway was reconstructed. In some instances old and poorly installed culverts may not be removed in abandoned sections of highway. Hays Creek, Alaska Highway, km 1274. Reconstructed section.

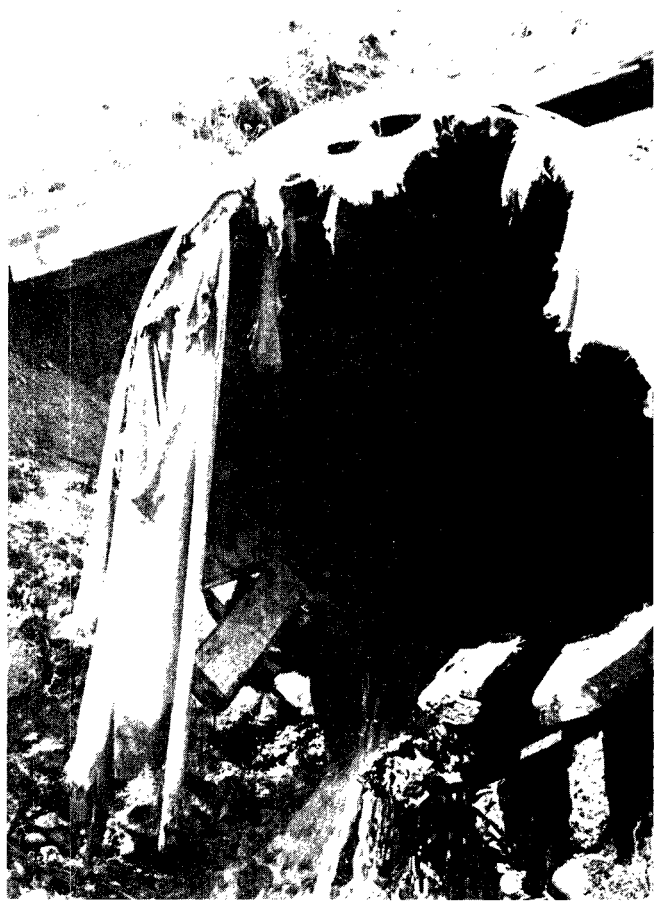
Deteriorating wooden culvert installed in early 1940s. Alaska Highway, km 1387. Section to be reconstructed.

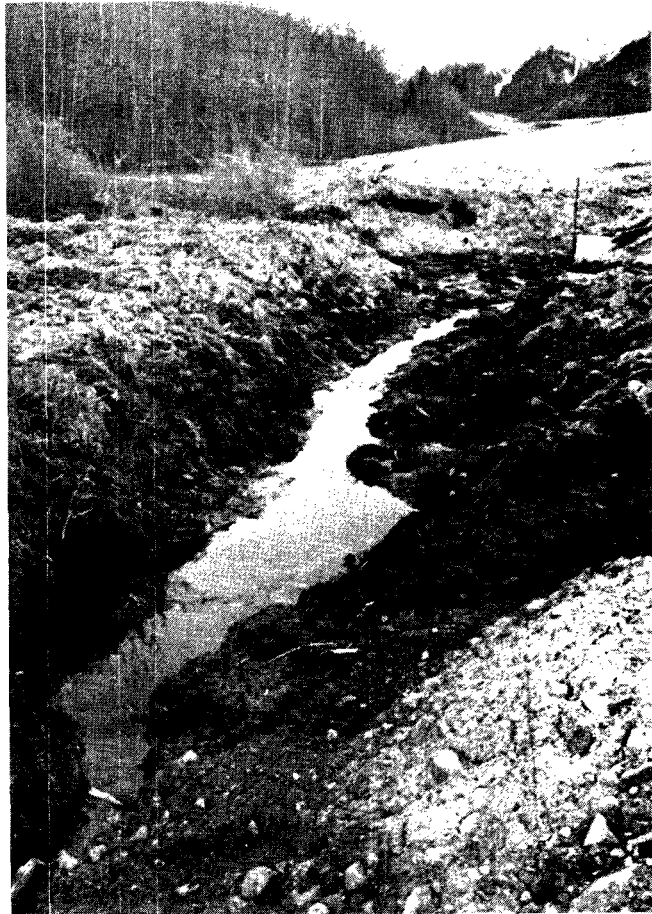
Wetland drainage and associated stream bank vegetation adversely affected by highway reconstruction practices. Alaska Highway, km 1393. Reconstructed section.

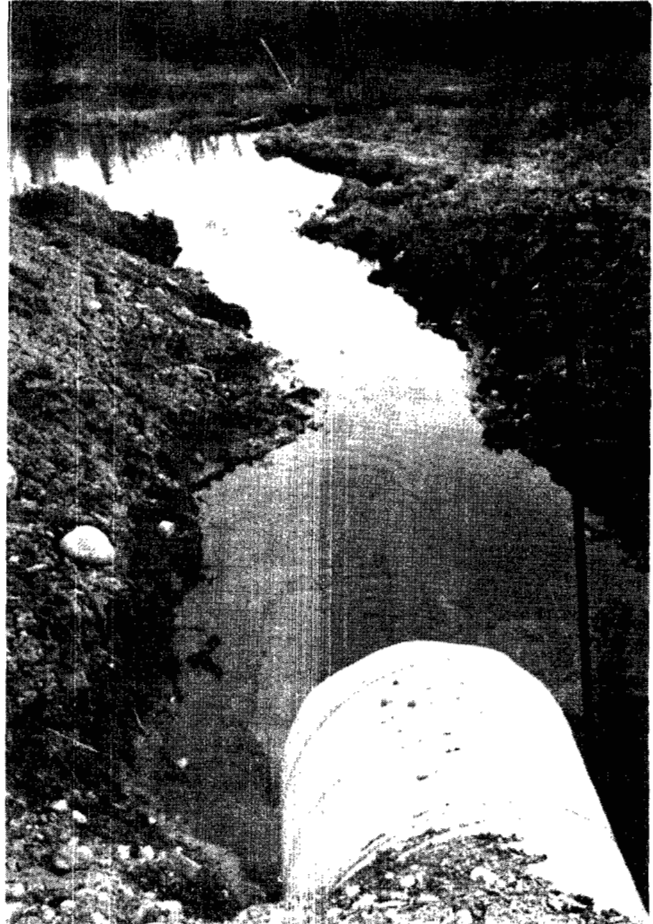
PLATE 97

Stream bank vegetation associated with wetland drainage destroyed during highway recent reconstruction operations. There are also ditch drainage problems. Alaska Highway, km 1397. Reconstructed section.

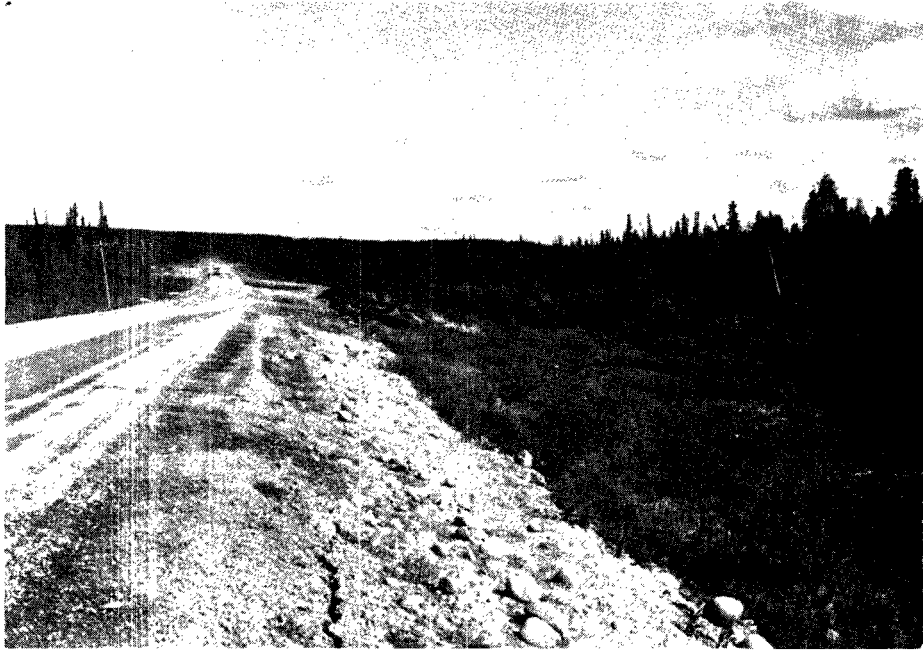
PLATE 98

Disturbed organic material and a drainage problem caused by construction equipment. Robert Campbell Highway, km 333.5.

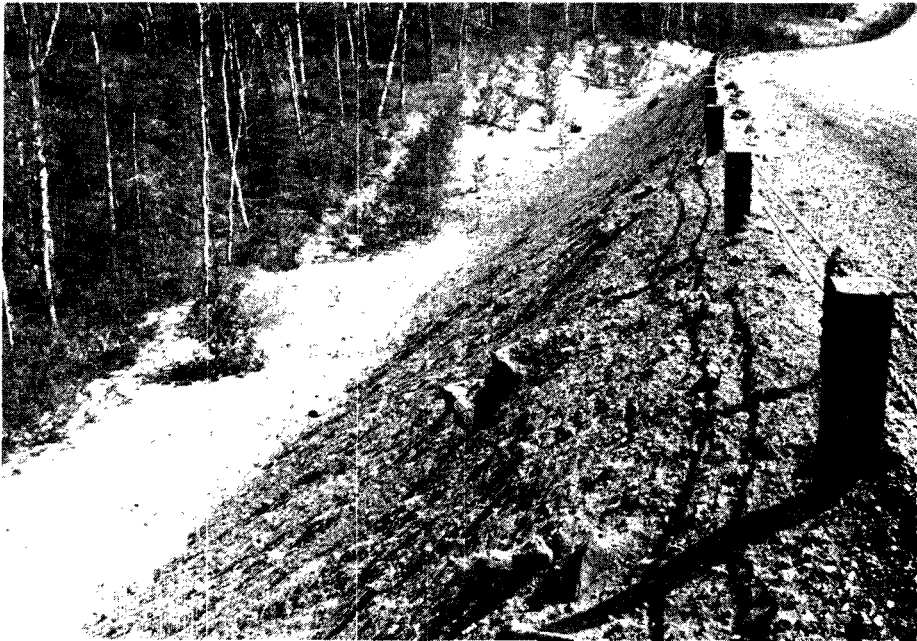
PLATE 99

Drainage problem caused by construction equipment. The problem continues although the disturbed organic material (ridge on right hand side of picture) has since revegetated. Alaska Highway, km 1097.5.

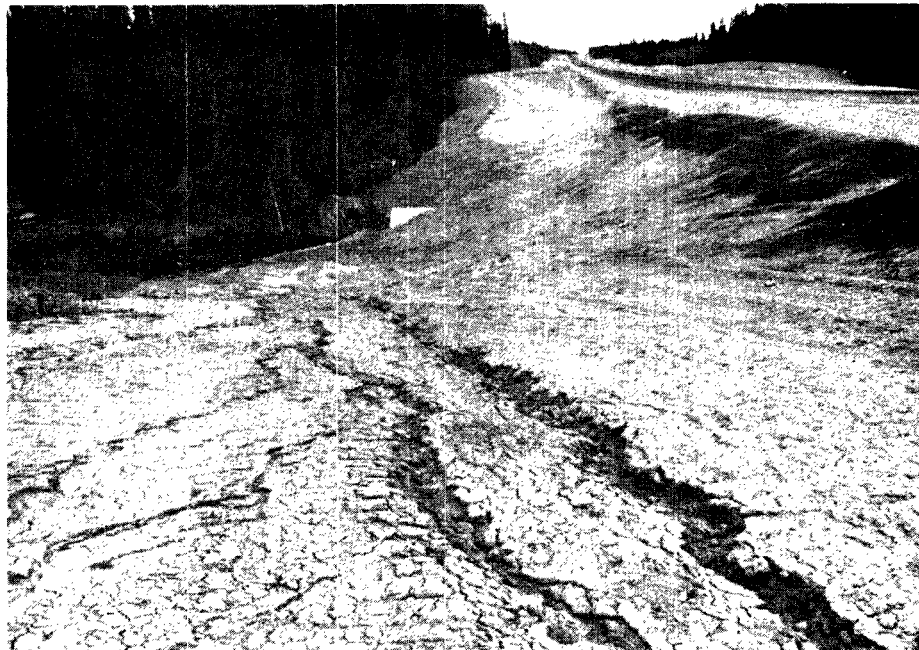
PLATE 100

Foreslope at 45°, bench not provided at top of slope. No rip-rap at base, silt from highway run-off spreads out from base of slope. Robert Campbell Highway.

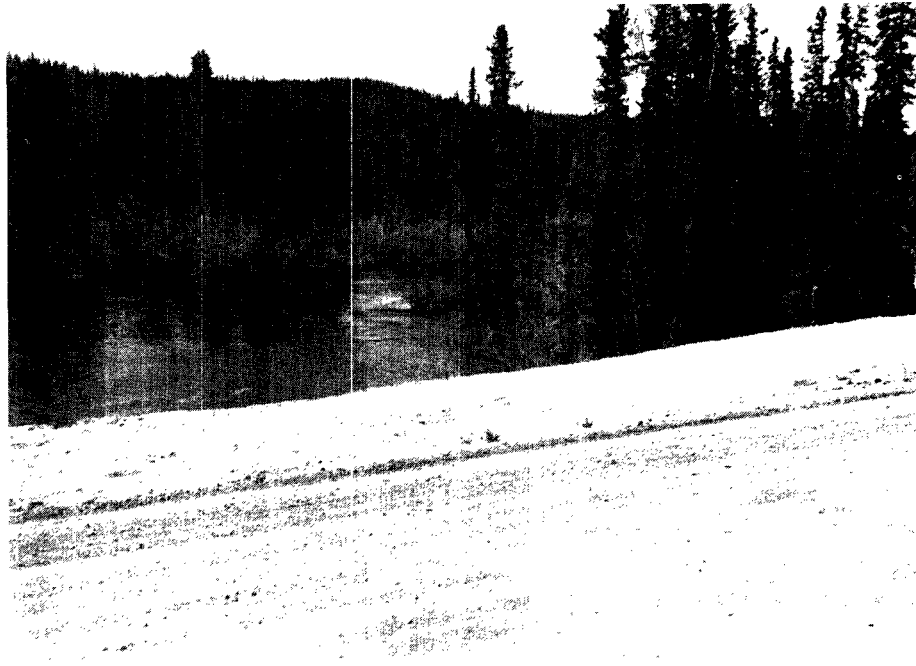
PLATE 118 Service road/right-of-way maintenance clearing between Alaska Highway and Morley River. No vegetated buffer zone.

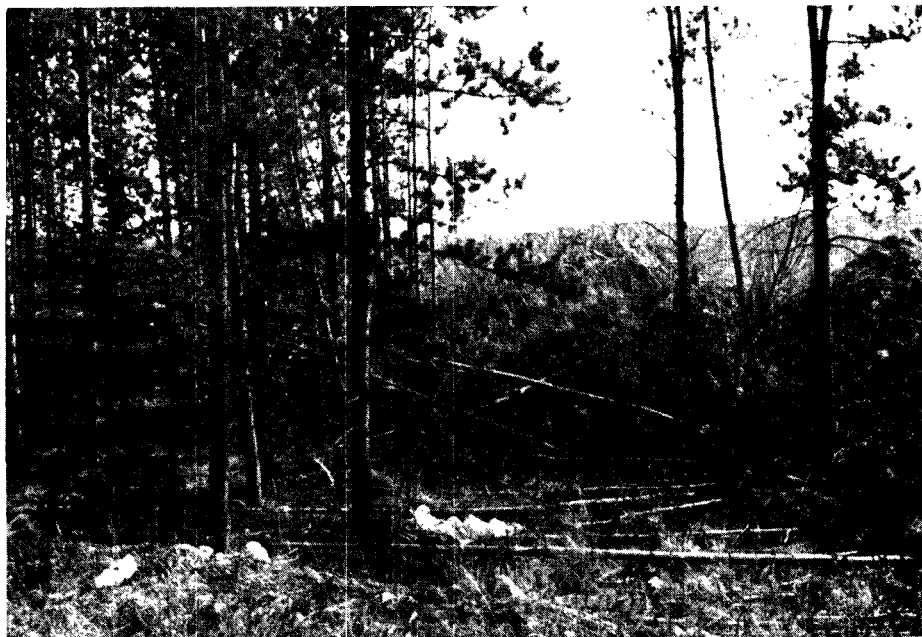
PLATE 138 Slash around perimeter of borrow pit not removed. Alaska Highway, km 1470. Reconstructed section.
