Field Evaluation of Plastic Film Liners for Petroleum Storage Areas in the Mackenzie Delta

Economic and Technical Review
Report EPS-3-76-13

EPS 3-EC-76-13

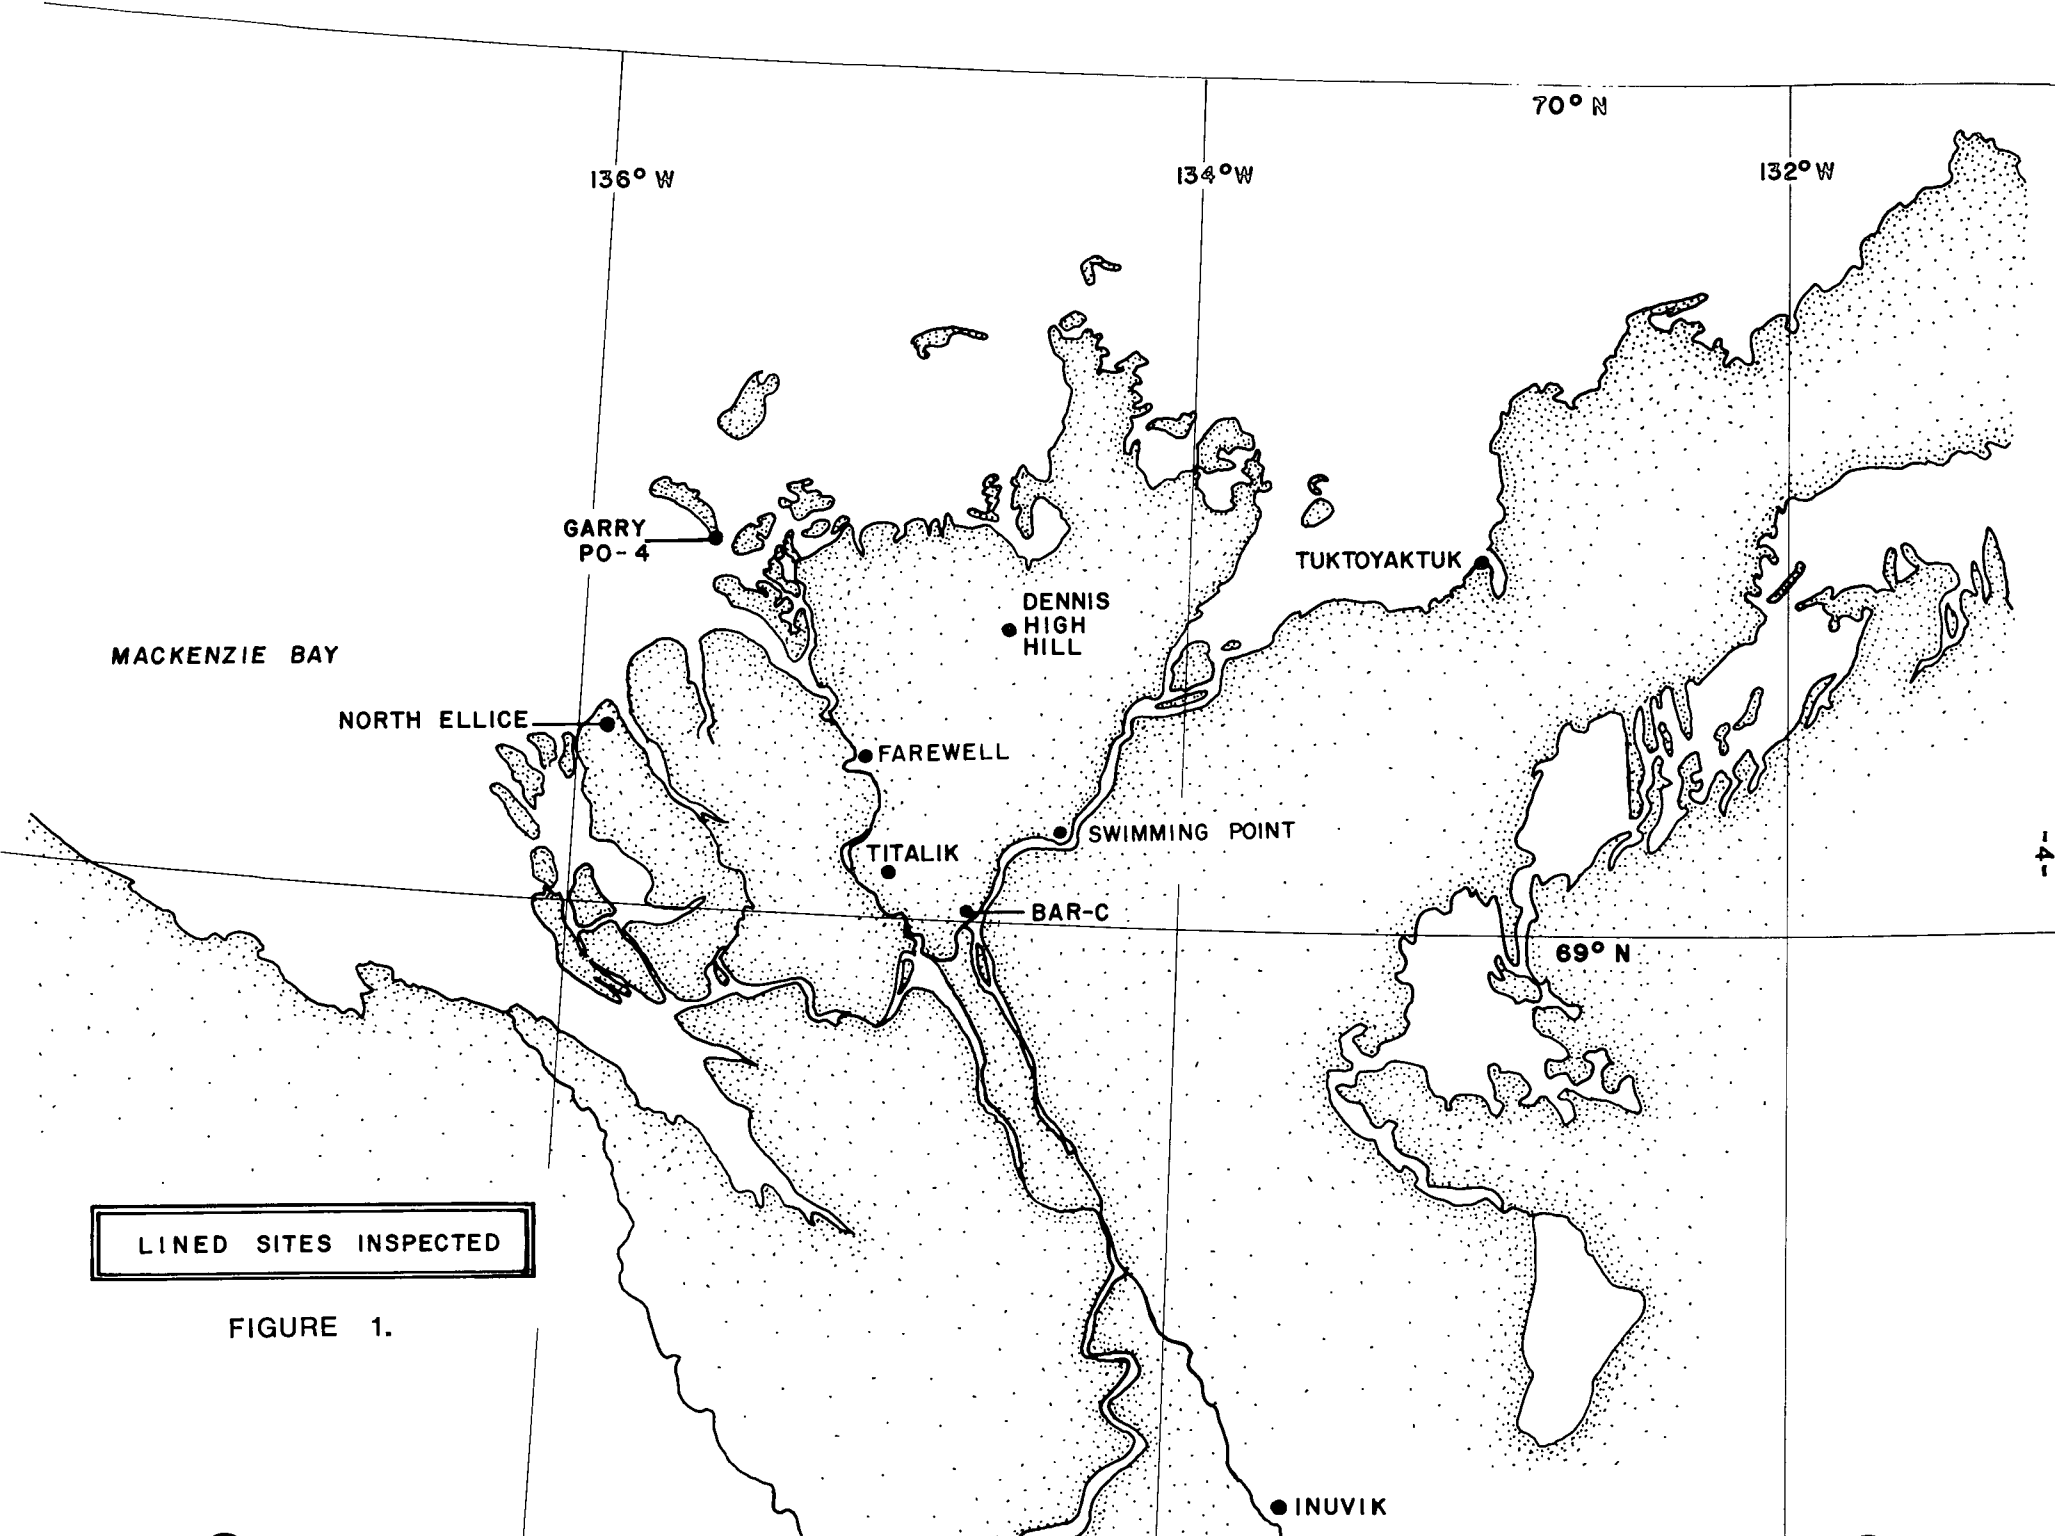
FIGURE 1.

The overburden consisted of 0.5 ft. to 1.5 ft. of Ya-Ya Lake gravel compacted with vibratory packers. During the inspection of this site by IOL personnel in 1974, a total of 13 sq. ft. of membrane was exposed in a series of 5 excavations. At that time a total of three small pinholes and three 0.25 inch long cuts were uncovered by two of the excavations. During the EPS inspection in 1975 a total of 5 sq. ft. of liner was exposed at two locations. Photo 1 illustrates the indentations in the oil PVC liner caused

by the underlying gravel base. However, no punctures were observed. Apparently, melt-water is retained in the tank lot for a lengthy period of time during the spring indicating that losses through flaws in the membrane are small.

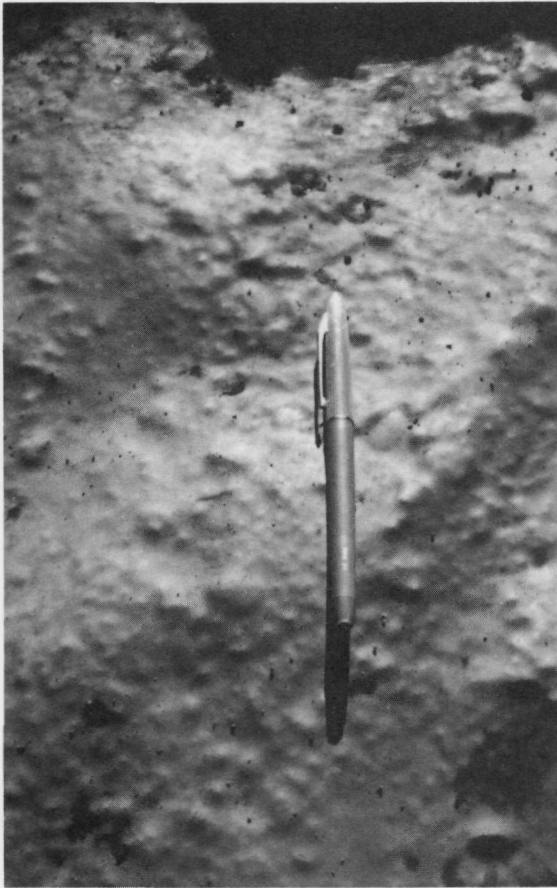
Photo 1: IOL Bar C (30 mil. oil PVC)

- installed under .5 - 1.5 ft. gravel on a gravel foundation. Note the indentations caused by the gravel particles and chunks below. No punctures are visible, however.

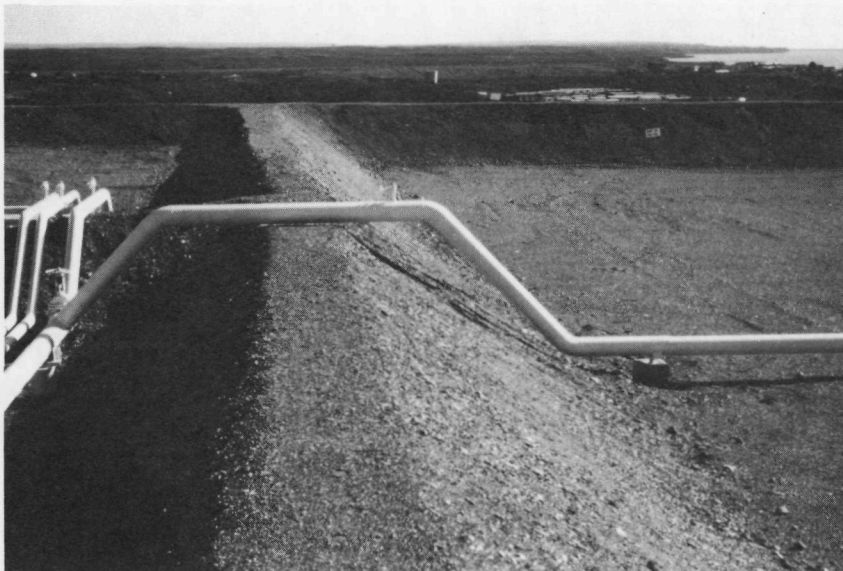
Photo 2: IOL Bar C (30 mil. oil PVC)

- liner extends into these well formed dykes. A little minor sloughing can be seen on the inside surface of the dykes in the upper right. Note the pipeline passes over the dyke--a preferable practice to placing it through the dyke wall.

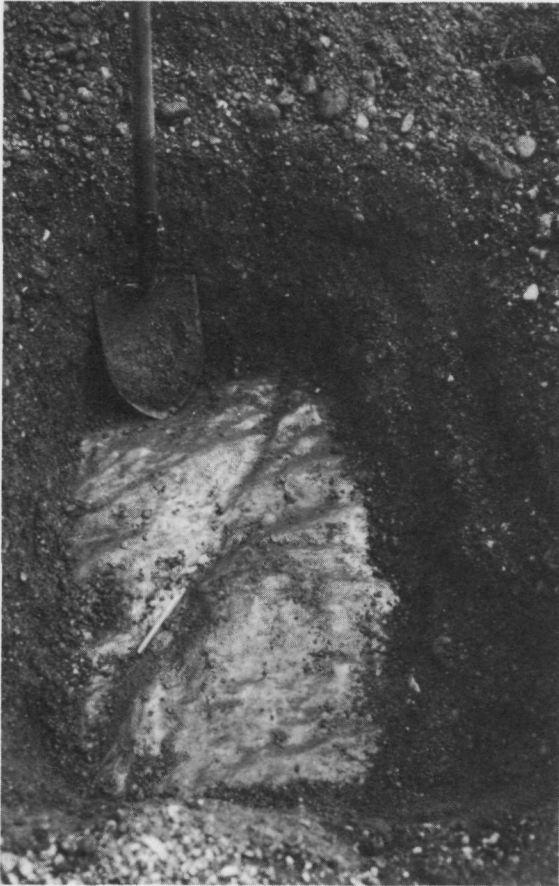
Photo 3: Gulf Swimming Point
(10 mil. polyethylene)

A total of 12 sq. ft. of membrane were exposed at three locations, two of which are illustrated in Photos 3 and 4, and no punctures were observed. Clearly, careful preparation of the bedding and a substantial cover of relatively fine-grained overburden had admirably protected a rather thin membrane. Such protection is vital for this particular material since it is subject to deterioration if exposed to the weather, and has a poor puncture resistance.

- installed under 1-2 ft. gravel overburden on about 2 inches of polyurethane foam bedding. The colour and texture of the polyurethane foam can be seen through the transparent liner. The line has been well protected by the overburden and no flaws are visible

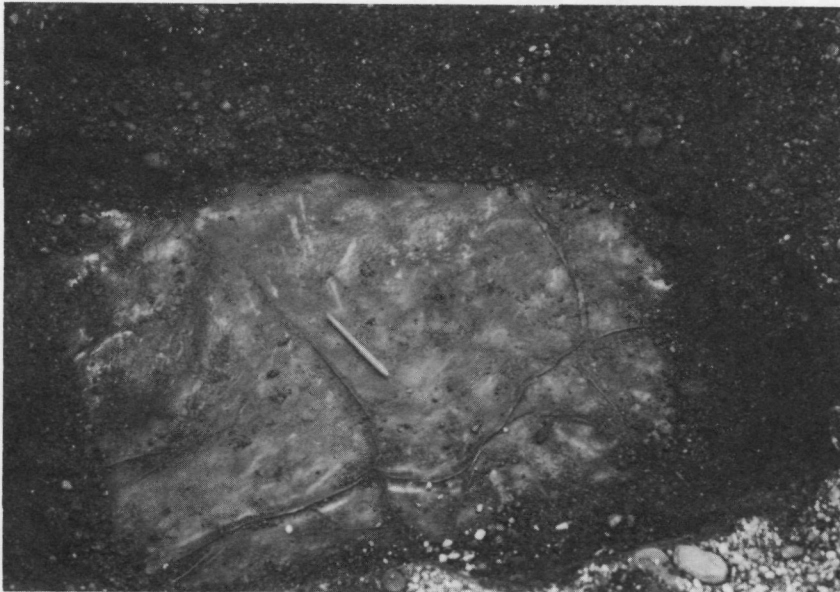
Photo 4: Gulf Swimming Point (10 mil. polyethylene)

- creases are visible in the liner, but no punctures.

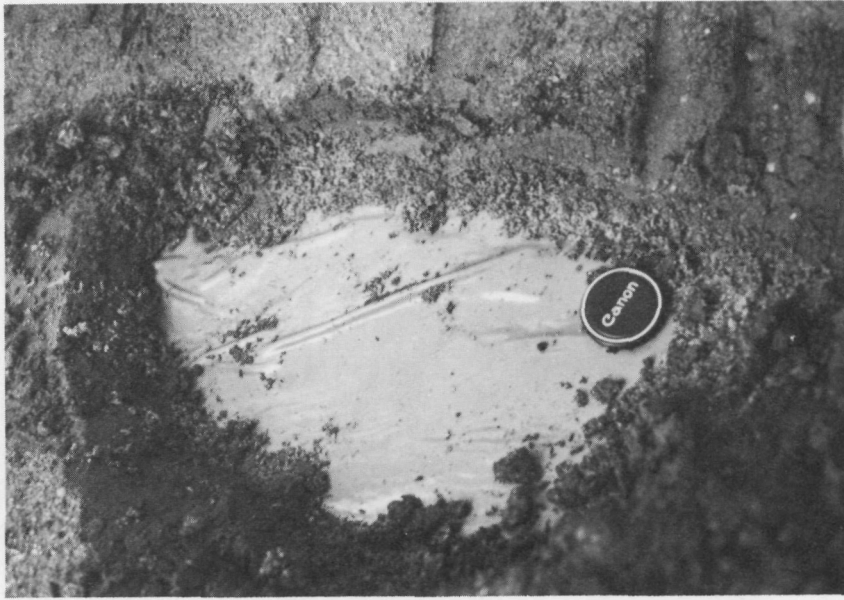
Photo 5: Shell Farewell (20 mil. urethane)

At this tank lot a urethane liner was sandwiched between two layers of sawdust, each a few inches thick; (see Photo 5) to protect the membrane from a fine, sandy gravel base and overburden of 0.5-2 ft. in thickness. This procedure would appear to have been successful since no flaws were detected in 6 sq. ft. of membrane exposed at three points on the storage area floor. In fact, as shown in Photo 6, at the excavation with the lowest elevation water began to seep immediately into the hole. Apparently, it is necessary to pump out pooled meltwater from the lot during spring.

- liner installed between layers of sawdust about 2 inches thick and buried under 0.5-2 ft. of sandy gravel. The liner has been well protected.

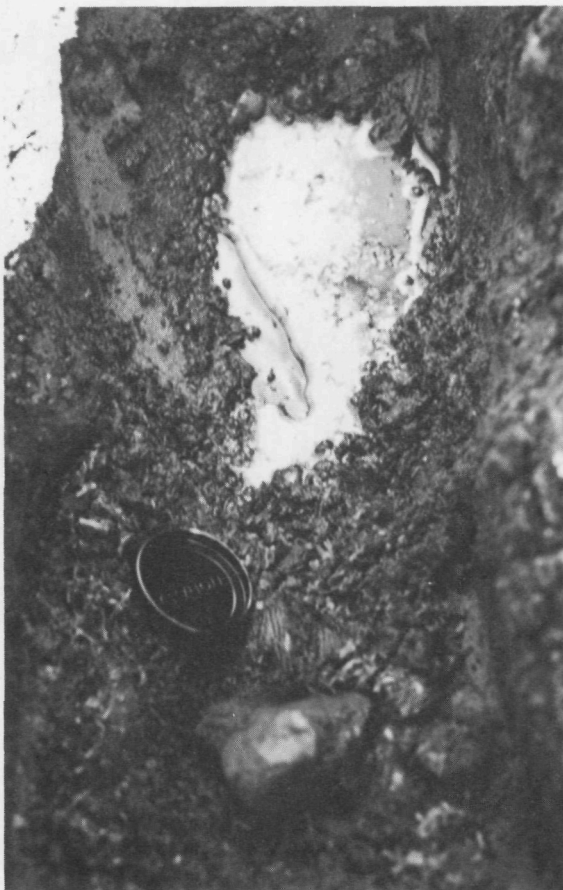
Photo 6: Shell Farewell (20 mil. urethane)

- note water seeping into the excavation indicating that little seepage occurs through the liner.

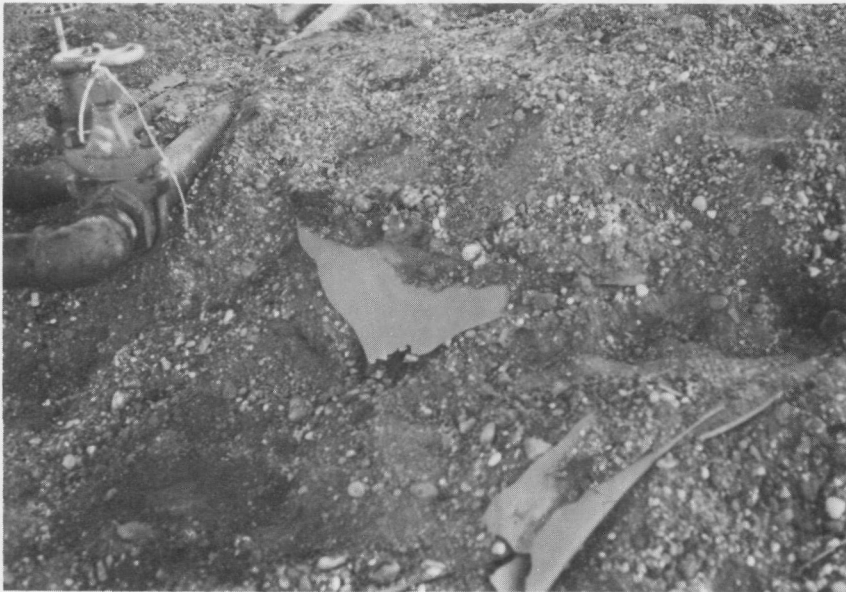
Photo 7: Shell Farewell (20 mil. urethane)

A portion of damaged liner was visible in the dyke wall adjacent to valves on piping through the dyke as shown in Photo 7. Presumably the liner had become exposed due to some sloughing of the dyke wall caused by increased activity in the area, and consequently been damaged.

- a portion of liner in the dyke wall has been exposed and damaged. The liner is adjacent to valves on piping passing through the dyke wall and, presumably, this area receives a fair amount of traffic.

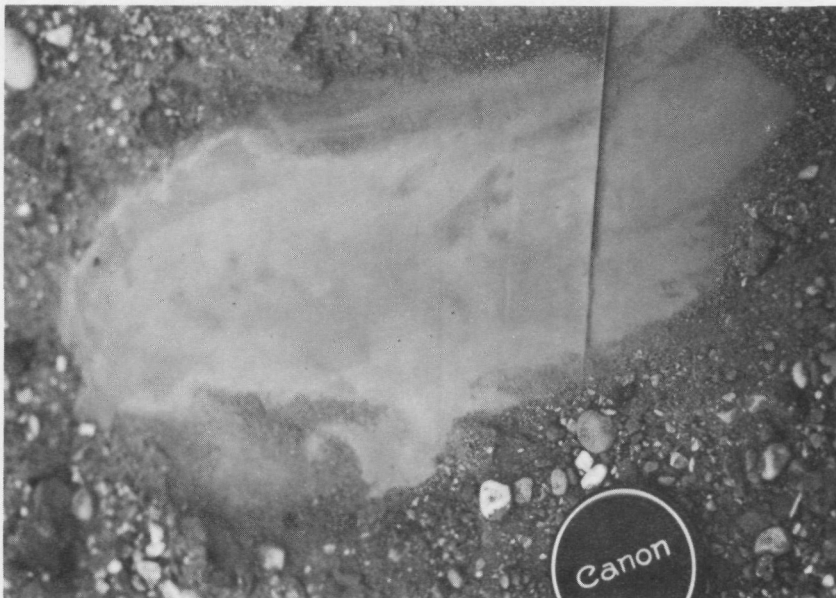
Photo 8: Shell Farewell (20 mil. urethane)

- an excavation in the exterior wall of the dyke uncovered this portion of the liner, showing a seam.

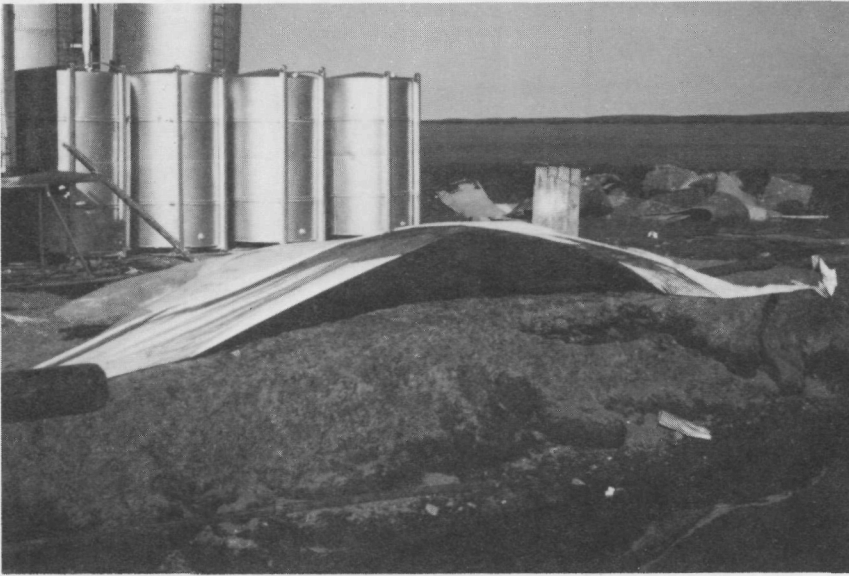
Photo 9: Shell Titalik A-16
(6 mil. Rufco)

Additional polyurethane blankets and a thin cover of gravel had been placed over the liner where equipment was placed or where activity was expected. At the time of the visit much of this cover had been removed by the billowing action of the wind under the liner, as shown in Photo 9. The liner

- The billowing action of the wind is lifting one edge of the liner and a section of the polyurethane foamed sacking which was used as a bedding under the liner can be seen. Many other blankets which were originally emplaced on top of the liner for protection have been displaced by the wind and are resting against the unconsolidated silt dykes on the right of the picture. Note the drill rig sump on the lower right which forms a spill catchment basin along one side of the fuel storage area. Despite the punishment afforded by the action of the wind, the liner is remarkably intact.

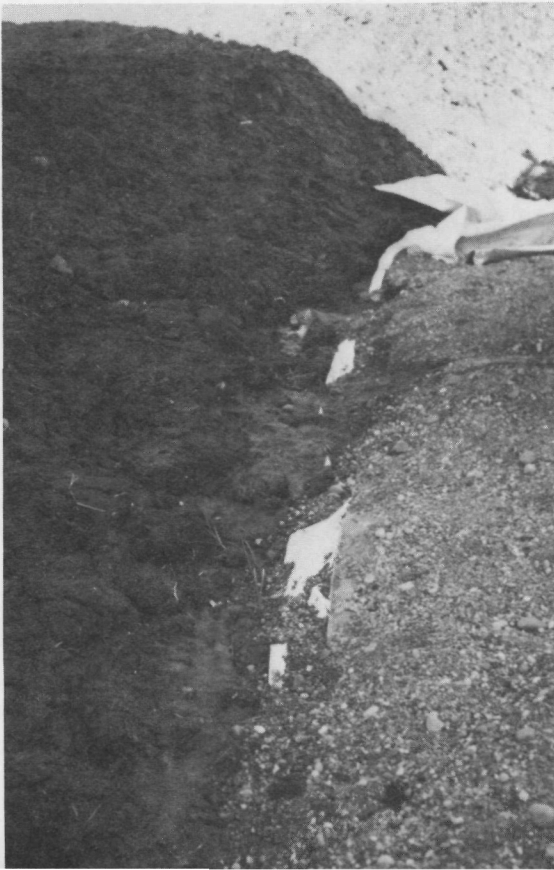
Photo 10: Shell Titalik A-16 (6 mil. Rufco)

did not extend into the uncompacted silt dykes (Photo 10) present on three sides of the storage area. Generally, a liner installed on a storage area floor in this manner would encourage a spill to flow to the unconsolidated dykes, from where it may be nearly impossible to recover the spilled product. However, serving to reduce this possibility, the drilling sump provided a boundary on the fourth side, as is common practice at northern drill sites, and would have served as a catchment basin in the event of a spill. Considering the exposure of the membrane, as shown in Photo 9, it was in remarkably good condition. The high puncture resistance of the liner is evidenced by the lack of holes despite the deep indentations shown in Photo 11 caused by particles and chunks of gravel which had been pressed into the surface by human activity. However, despite the considerable strength of the membrane, numerous tears were visible. Examples are shown in Photos 12 and 13. Moreover, since the liner material is polyethylene, it cannot be expected to function effectively for more than approximately one year when exposed to the degrading effects of direct sunlight. Laminated, prestressed polyethylene apparently exhibits good low temperature ductility, since the liner at this site was installed during the winter at temperatures around -30°C . In order to reduce the possibility of damage due to brittleness at low temperatures, the folded liner was heated using forced air heaters and rolled quickly into position.

- the liner does not extend up into the uncompacted silt dyke on the left. Note the protective cover of polyurethane blankets just showing under a thin layer of gravel.

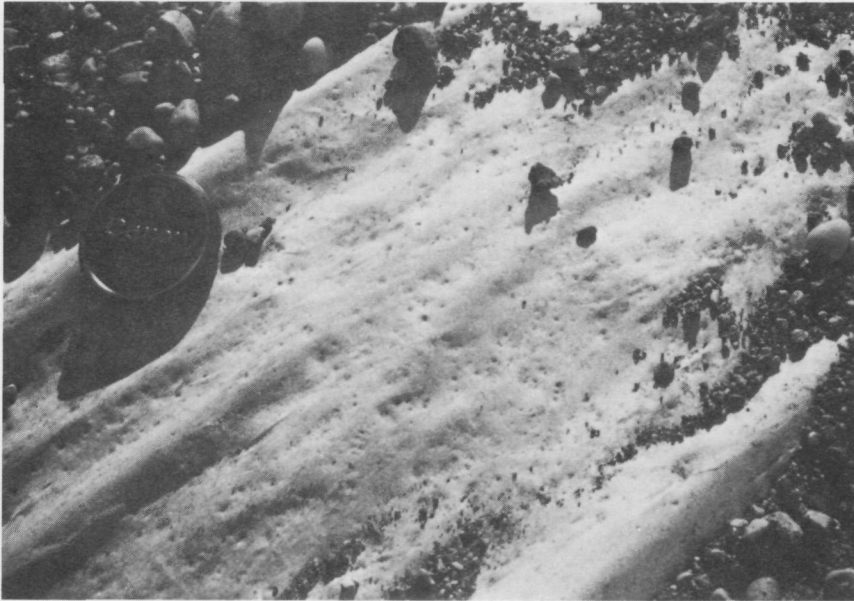
Photo 11: Shell Titalik A-16 (6 mil. Rufco)

- Pedestrian activity has pressed the particles and chunks of gravel into the liner producing marked indentations, but no punctures.

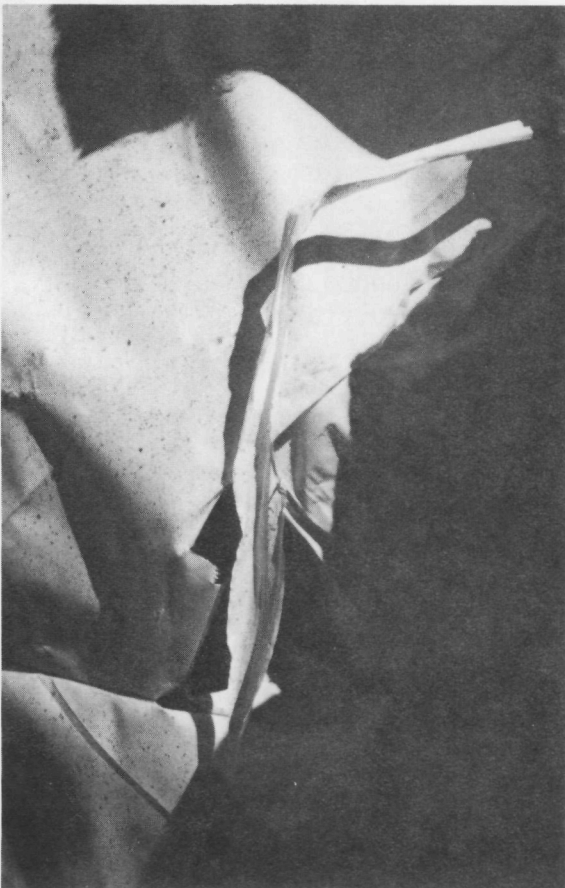
Photo 12: Shell Titalik A-16
(6 mil. Rufco)

- a section of liner torn along a seam. The damage was probably caused by wind action.

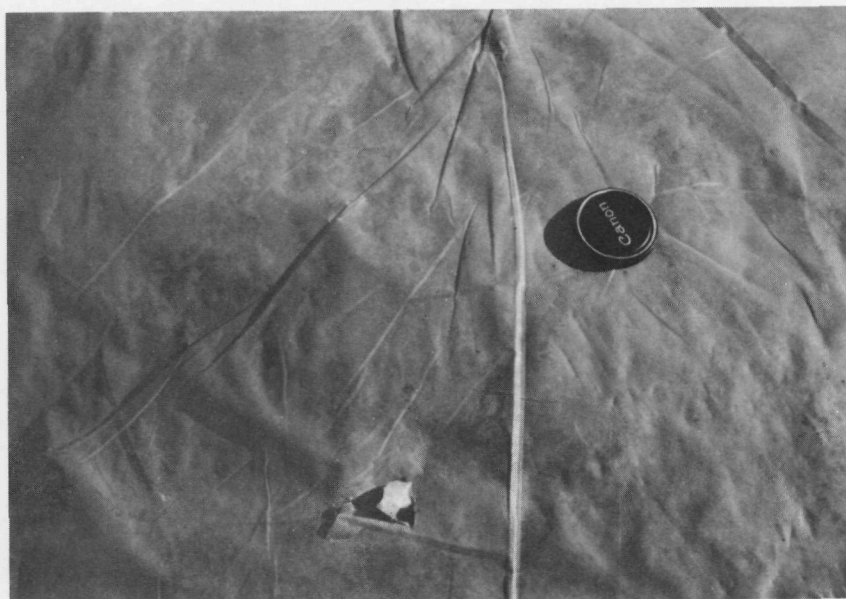
Photo 13: Shell Titalik A-16 (6 mil. Rufco)

- possibly a snag tear

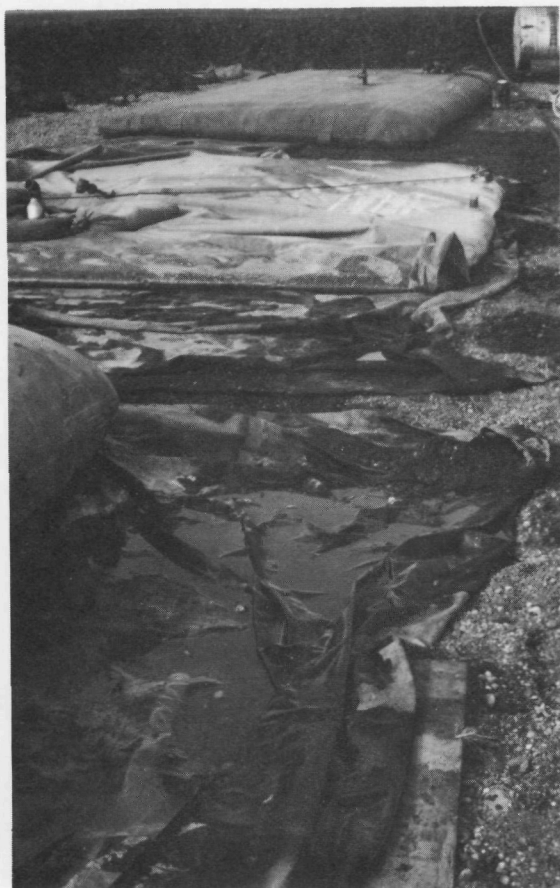
Photo 14: Sunoco Garry P-04
(Polyfabric 1855)

Sheets of fibre-reinforced polyurethane had been placed over a gravel foundation under some fuel storage bladders as shown in Photo 14. The spill retention effectiveness of this limited application of liner is extremely doubtful.

- this fibre-reinforced liner is deployed in blankets under bladders, directly on top of a gravel base. It is doubtful that this limited use of lining material would serve effectively in the event of a spill. Uncompacted silt dykes around the fuel storage area can be seen in the background.

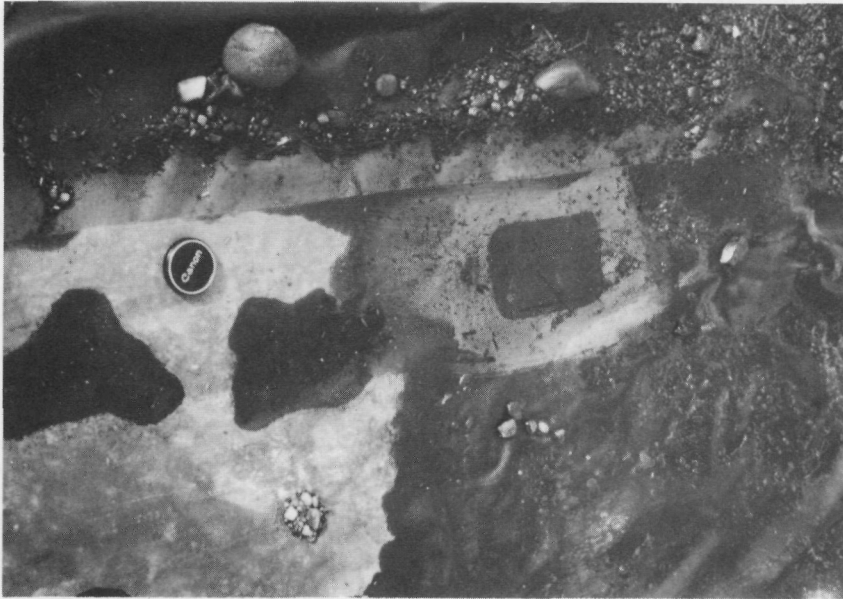
Photo 15: Sunoco Garry P-04 (Polyfabric 1855)

The sheets of reinforced polyurethane had previously been used at other locations over a period of years, and had even been returned to the factory for repair, and a patch is shown in Photo 15. A number of tears were evident in the exposed sheets, and an example is shown in Photo 16. However, the age of the sheets and their frequent reuse testifies to the strength of material. Although such fabric-reinforced films tend to be stronger than their unreinforced counterparts, they tolerate very little deflection before failing.

- showing a puncture at the lower left and a patch installed at the factory. The liner had been reused on a number of occasions.

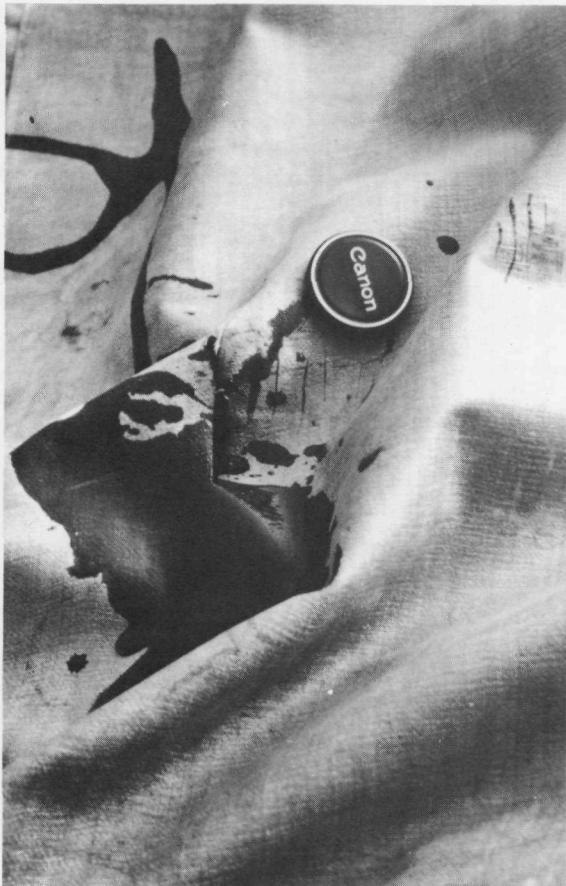
Photo 16: Sunoco Garry P-04
(Polyfabric 1855)

- a tear in the fibre-reinforced liner

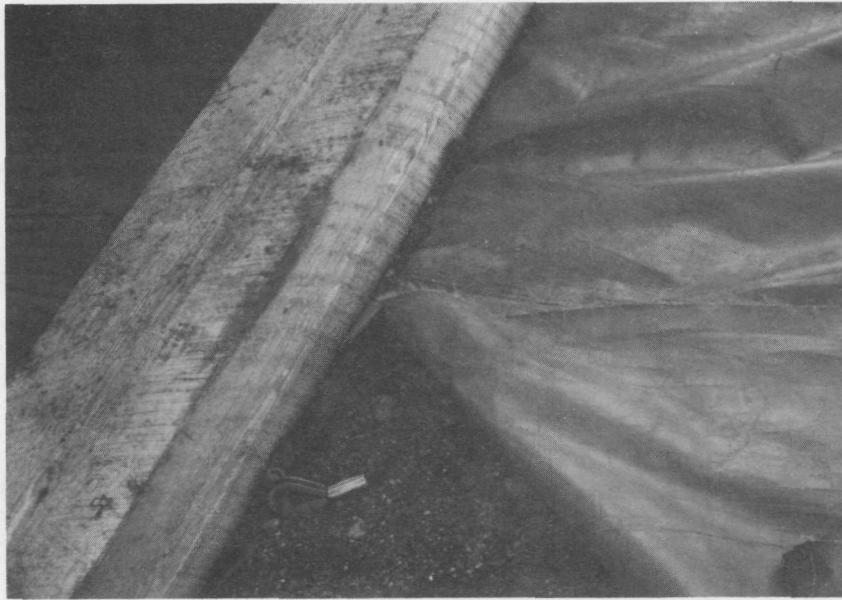
Photo 17: Sunoco Garry P-04 (Polyfabric 1425)

A small sheet of fibre-reinforced polyethylene was installed on the gravel surface under a skid mounted tank. As shown in Photo 17, the skid had sunk into the uncompacted gravel, pinning the liner and causing it to be torn under the action of wind.

- a tear caused by a skid sinking into uncompacted gravel and the action of wind.

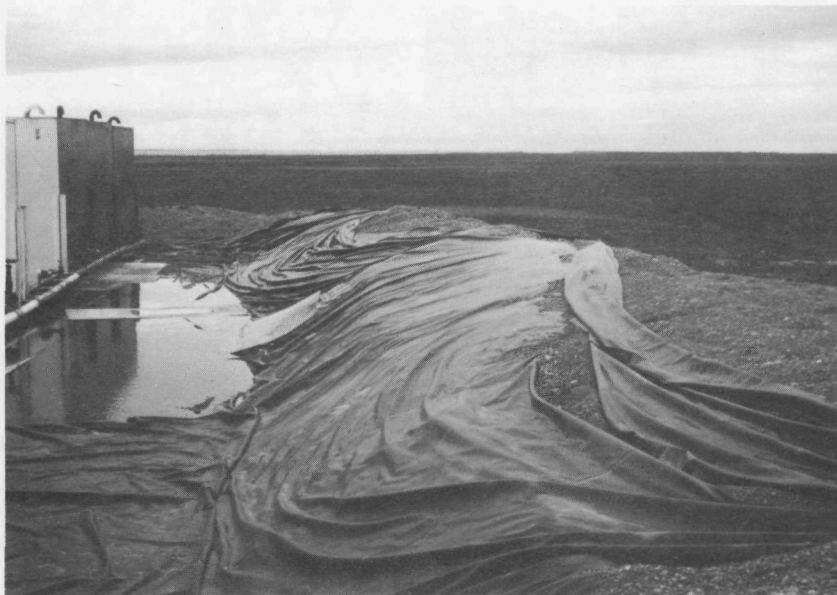
Photo 18: Chevron North Ellice (20 mil. polyurethane)

As shown in Photo 18, a large sheet of polyurethane liner was draped loosely over the gravel floor and dykes of the fuel storage area at this rig site. Prior to installation the liner had been left lying on the ice and had been successfully unfolded and installed at temperatures of -35°C . No brittle fractures were apparent during the inspection, indicating excellent low temperature ductility. The pooling of water on the liner, visible in Photo 18, indicates generally the overall integrity of the liner. However, as might be expected with an exposed liner, a number of flaws were apparent, and examples are shown in Photos 19 and 20. Merely walking on the liner overlaying the gravel was insufficient to cause damage, so that

- liner installed on the surface of uncompacted gravel dykes and pad. The inadequate anchoring of the liner into the dyke crests could cause problems resulting from wind action. The water pooling in the storage area floor indicates the general integrity of the liner.

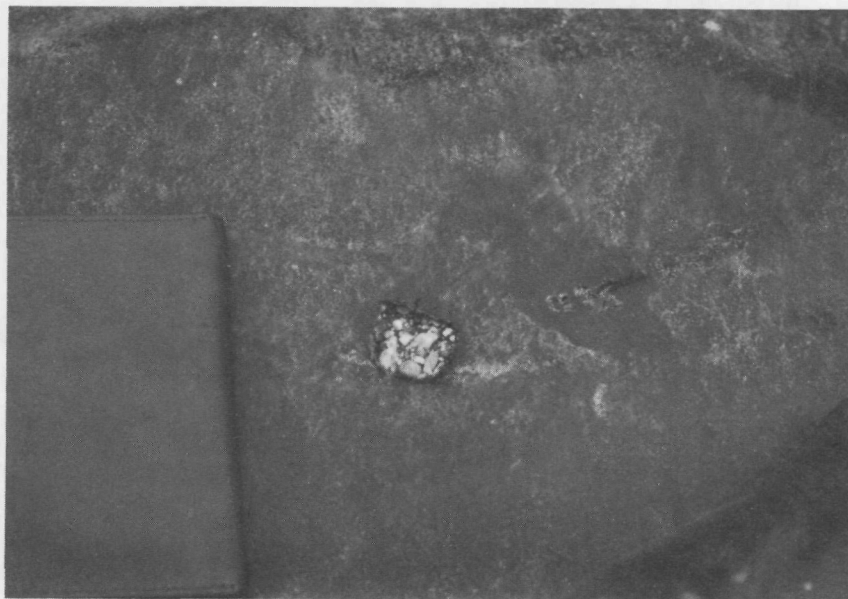
Photo 19: Chevron North Ellice (20 mil. polyurethane)

- a severe puncture in the centre of the picture, showing the poorly sorted gravel beneath. A scar on the liner with pinhole punctures is visible just to the left. This damage was probably associated with the movement of equipment over the liner as foot traffic apparently made little impression, at least at a temperature of about 5°C. For scale, the pocket-book on the left measures 6 inches.

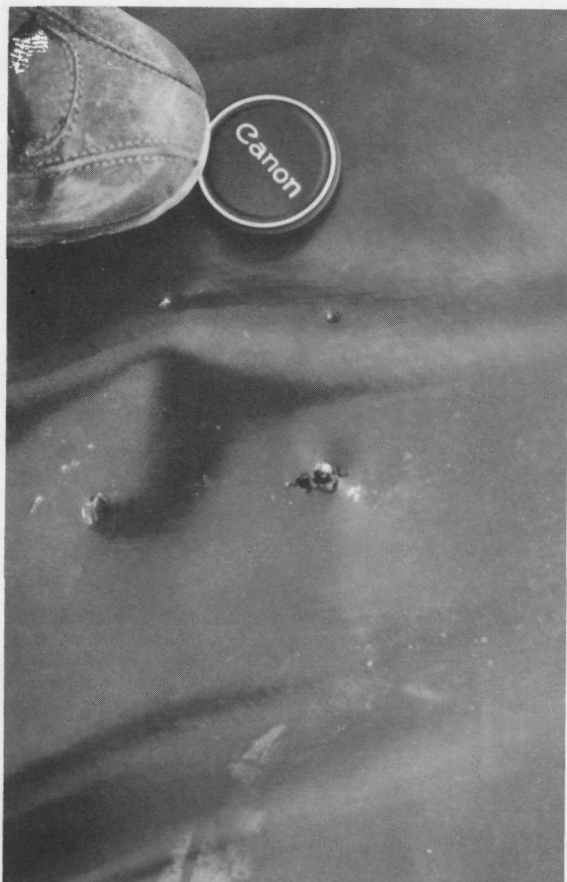
Photo 20: Chevron North Ellice
(20 mil. polyurethane)

- a number of small punctures in the liner produced by surface activity and gravel particles penetrating from below. Even this particularly strong lining material is subject to damage when installed on an unprepared surface.

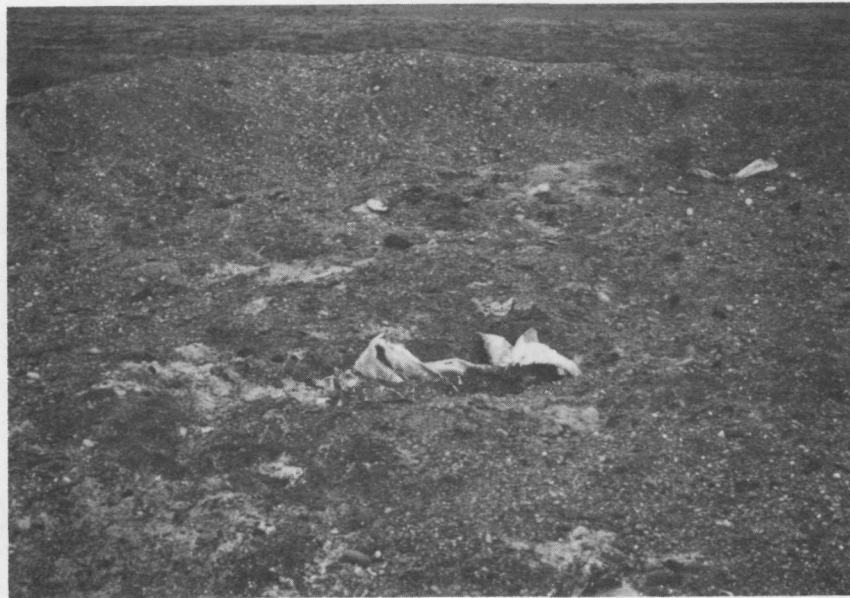
Photo 21: IOL Garry Repeater, Dennis High Hill (6 mil. Rufco)

A liner of prestressed, laminated polyethylene had been installed in a small gravel fuel storage area at this unmanned repeater station. Sawdust had been used to cushion the membrane from the coarse bedding and overburden. At the time of the visit, the fuel tanks were empty and had been removed from the lined area. Upon examination of the liner, it was apparent that a fire had occurred previously and had consumed considerable portions of the membrane and sawdust (see photos 21 and 22). Little evidence of damage caused by other mechanisms was apparent on examination of unburned segments of material.

- the liner has been installed between two layers of sawdust and given a thin cover of gravel for protection. Apparently a fire had occurred at some time and damaged the liner.

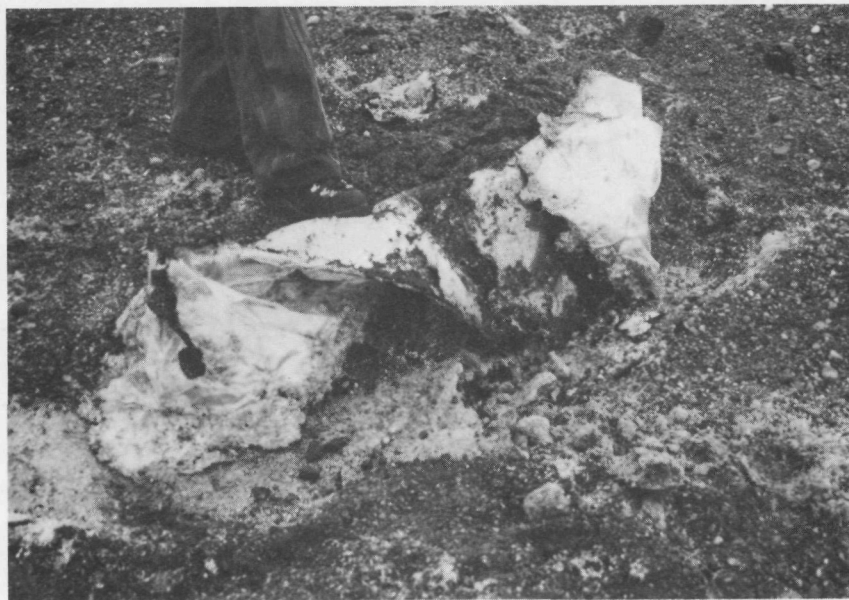
Photo 22: IOL Garry Repeater, Dennis High Hill (6 mil. Rufco)

- a close-up of the fire-damaged liner.
