# Performance Assessment of Test Liners for Petroleum Product Storage Areas in Northern Canada

Technology Development Report

EPS 4-EC-78-6

EBA Engineering Consultants Ltd.  
Edmonton, Alberta

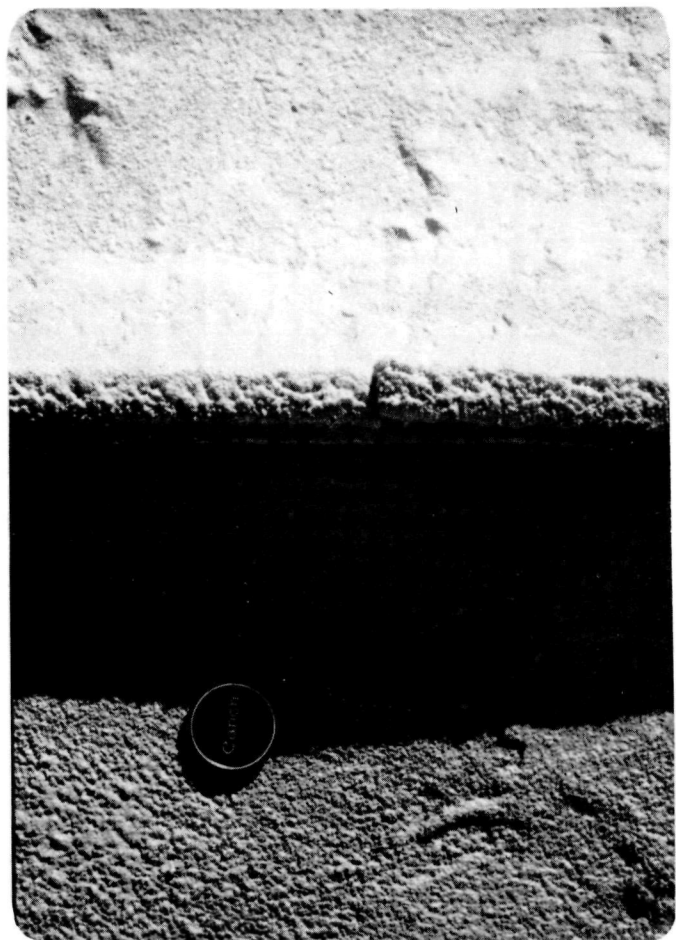
Plate 10      Cracks along the wooden forms, resulting from shrinkage upon initial cooling.

Initial shrinkage upon cooling often resulted in formation of cracks along the wooden forms, as shown in Plate 10. When the panels had cooled, the wooden forms were removed, as illustrated in Plate 11; sand was poured in to within 1 cm (0.5 in) of the surface of the lining, and sealant was trowelled into the joint. Joint details are depicted in Figure 3. An asphalt-based sealant, Domtar Fibregum Plastic Cement, was used in the majority of the joints. Oil-based DAP Architectural Grade Caulking compound was used between panels 2 and 4, and DAP Butyl Gutter and Lap Sealer was used between panels 2 and 6.

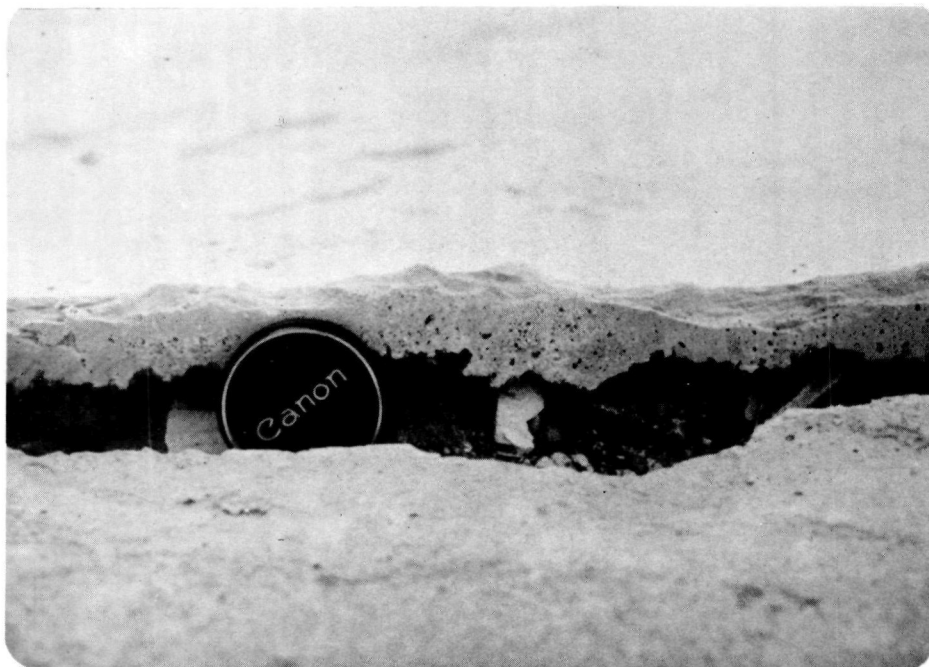
Plate 11      Panel edge, exposed after removal of a wooden form. Joints such as this were partially filled with sand, then covered with an elastic sealant.

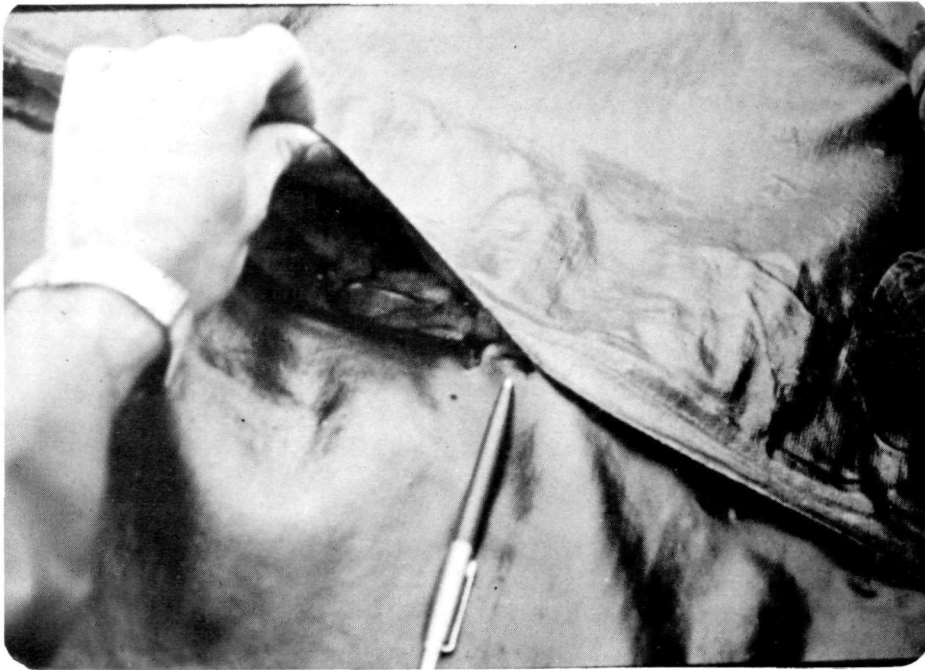
Plate 15      Localized areas of the joints did not adhere properly, leaving loose edges. The use of an adhesive compatible with the backing fabric would probably be more appropriate than urethane material.

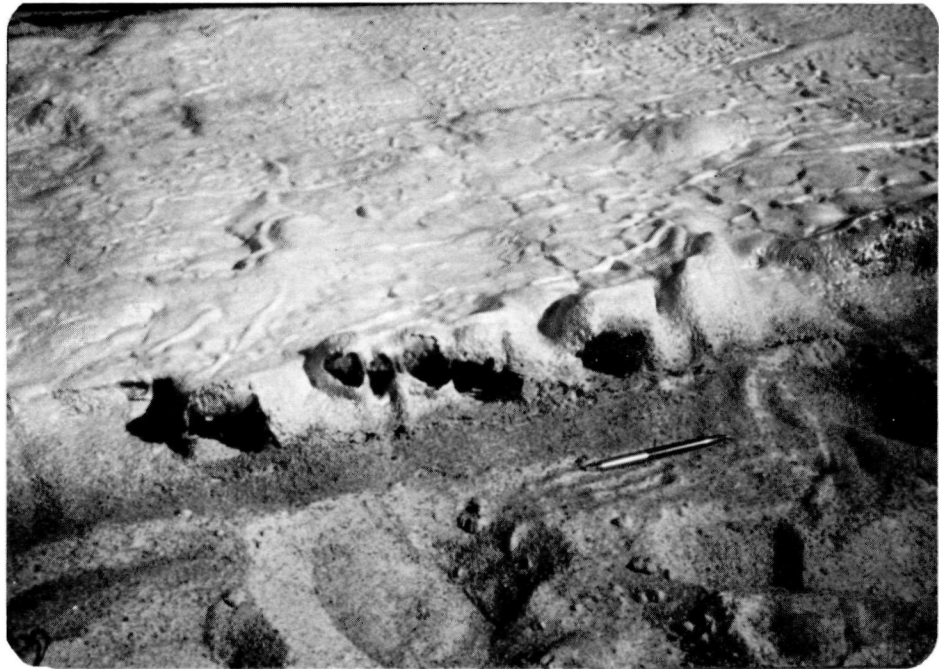
Plate 16 The weight of beach sand adhering to the underside of the foam layer was not sufficient to hold the liner down; such raised areas could sustain fatigue cracking under repeated foot traffic.

Fatiguing damage could result from traffic on urethane foam liners applied over relatively fine-grained materials. For this reason, the use of a sufficiently large granular base would be considered advantageous in securely anchoring the liner.

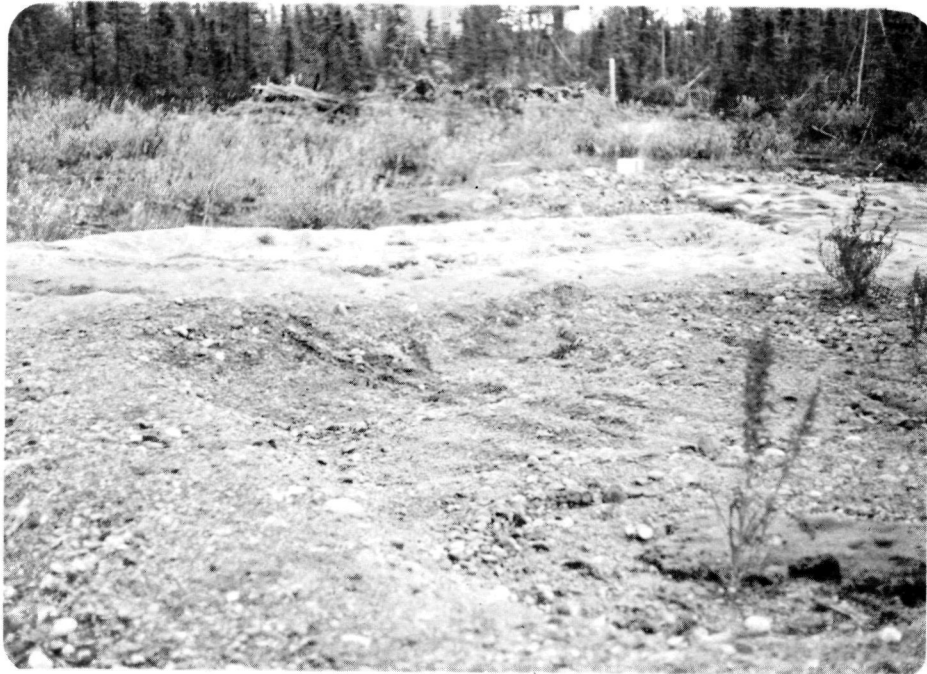
Several weeds were growing in each cell, with roots generally extending through the protective soil cover and into the bentonite layer, presumably to tap the available moisture. Plate 19 shows a variety of weeds growing in the 4 cm crush cell. Root systems of the larger weeds penetrated through the liner and into the base soil, as shown in Plate 20. All of the test cells felt soft underfoot (see Plate 21). In the beach sand cell one could sink 15 to 20 cm (6 to 8 in) into the extremely soft bentonite layer. This did not happen in the other cells because they were somewhat drier and because the gravel protective cover distributed foot pressure somewhat more evenly than the beach sand cover.

Plate 19 A variety of weeds grew in the 4 cm crush test cell, in some cases, penetrating completely through the protective soil cover and bentonite liner.

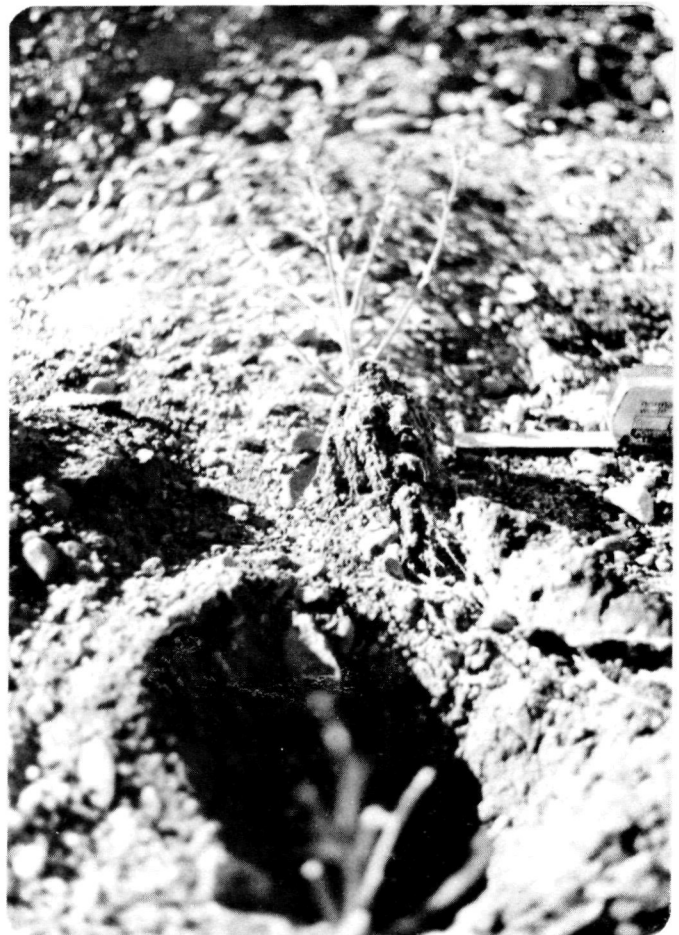
Plate 20 The deepest root tendrils of the weed shown above had penetrated through the bentonite layer. A high density of such weeds with roots in the bentonite layer may affect liner integrity through biological desiccation.

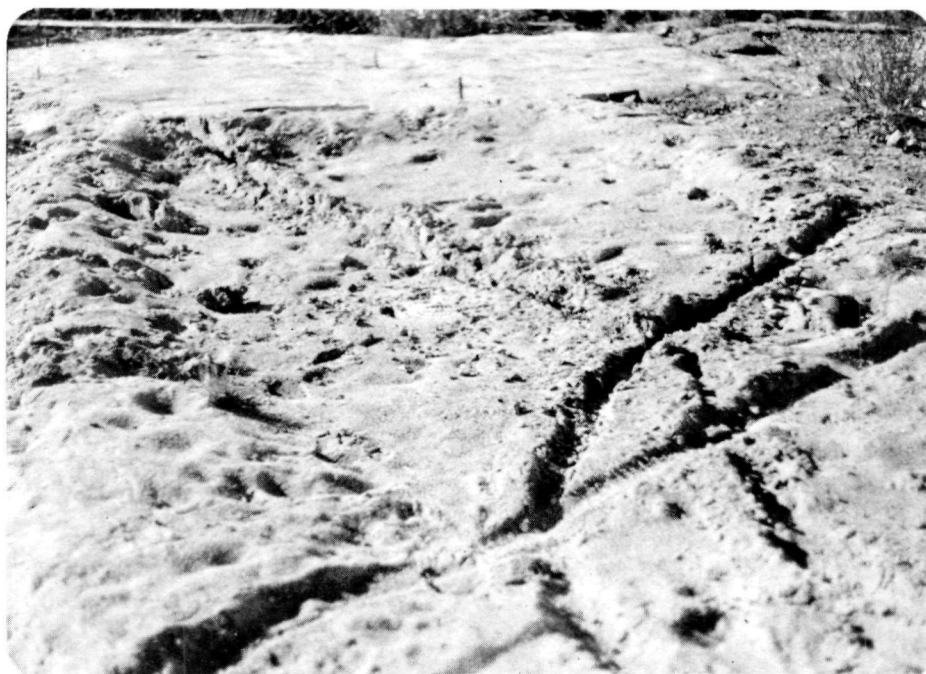
The three bentonite test cells were in relatively good condition, except for 15 cm (6 in) deep motorcycle tire ruts in the beach sand and 4 cm crush cells. None of the cells developed ponds of water.

Plate 21      The beach sand cell was the softest of the three test cells: foot and motorcycle traffic penetrated through the soil cover and into the bentonite layer.

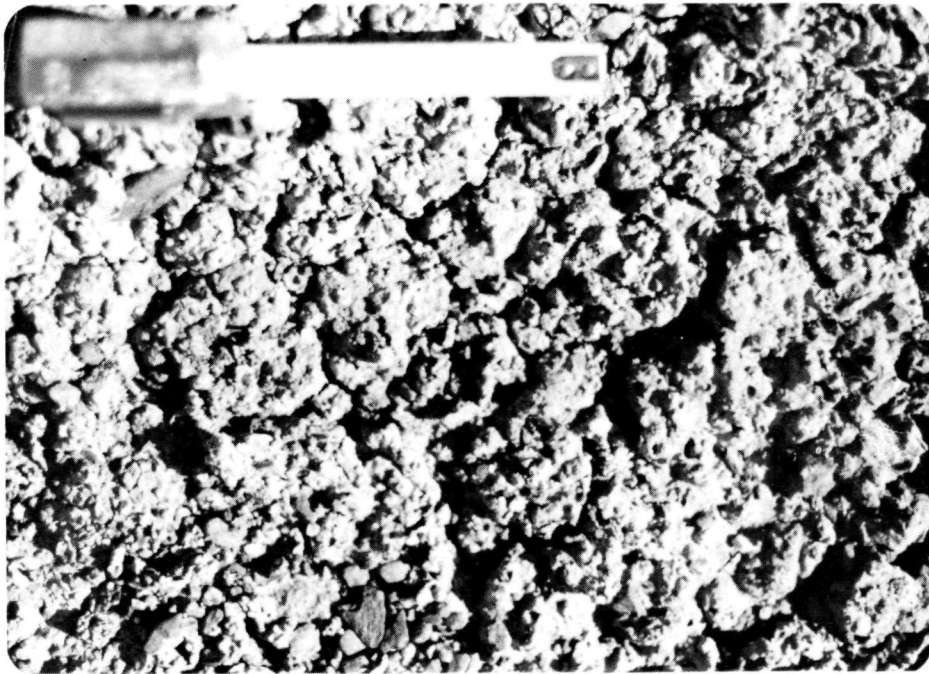
One portion of the 4 cm crush cell was left without any protective soil cover. The exposed surface had desiccated and cracked, but only to a depth of a few millimetres despite relatively low levels of precipitation in the preceding months. Plates 22 and 23 show this surface layer beneath as damp but not saturated bentonite. In contrast, the bentonite layer beneath the protective soil cover on the remainder of the cell was saturated and extremely soft. The cover material was dry at the surface, and damp but not saturated at depth. The base soil was also damp, but not saturated. The thickness of the bentonite layer ranged from 5 to 12 cm (2 to 5 in); the top surface was relatively flat, as shown in Plate 24, but the bottom surface was undulating with nodules of unmixed substrate material protruding upward as much as 7 cm (3 in). Except for these nodules, the bentonite layer appeared to be uniformly mixed with no evidence of streaking. Compaction of this layer appeared to be relatively even: voids were not apparent.

Plate 22      On the portion of the 4 cm crush test cell without any protective cover, the surface was desiccated, but the resulting cracks penetrated less than a centimetre.

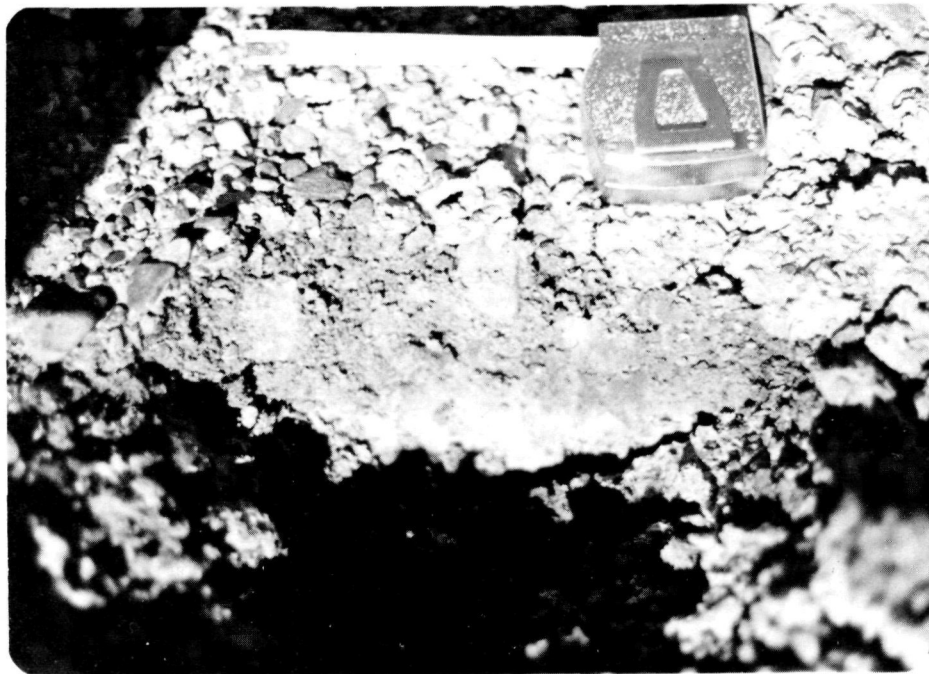
Plate 23      Intact, moist bentonite gel was present immediately below the desiccated layer despite relatively low levels of precipitation in the preceding months.

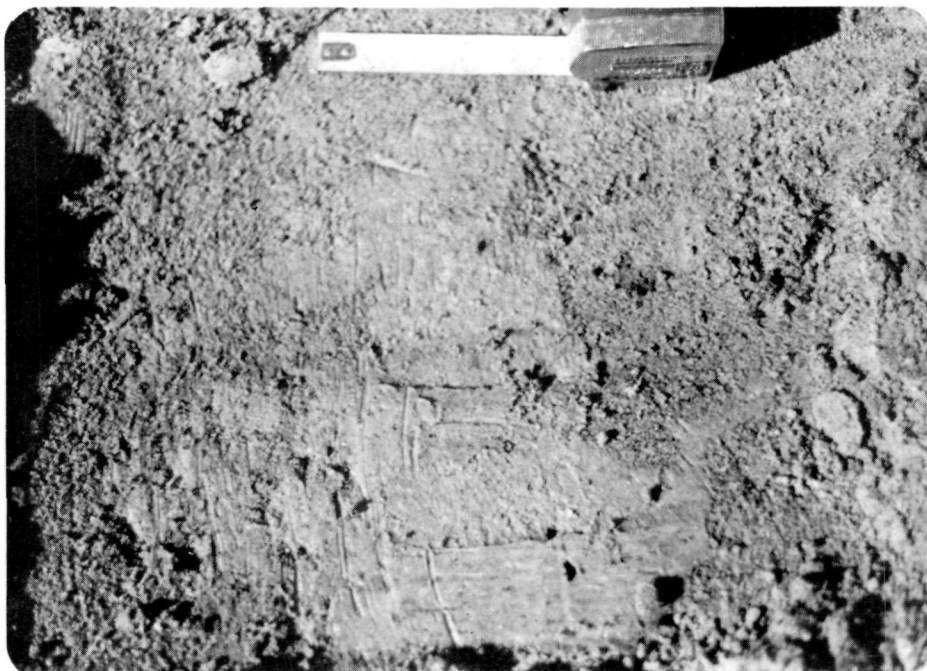
Plate 24 The upper surface of the bentonite layer was relatively planar, but the lower surface undulated. Nodules of unmixed base soil protruded into the bentonite, reducing the thickness by as much as 7 cm (3 in).

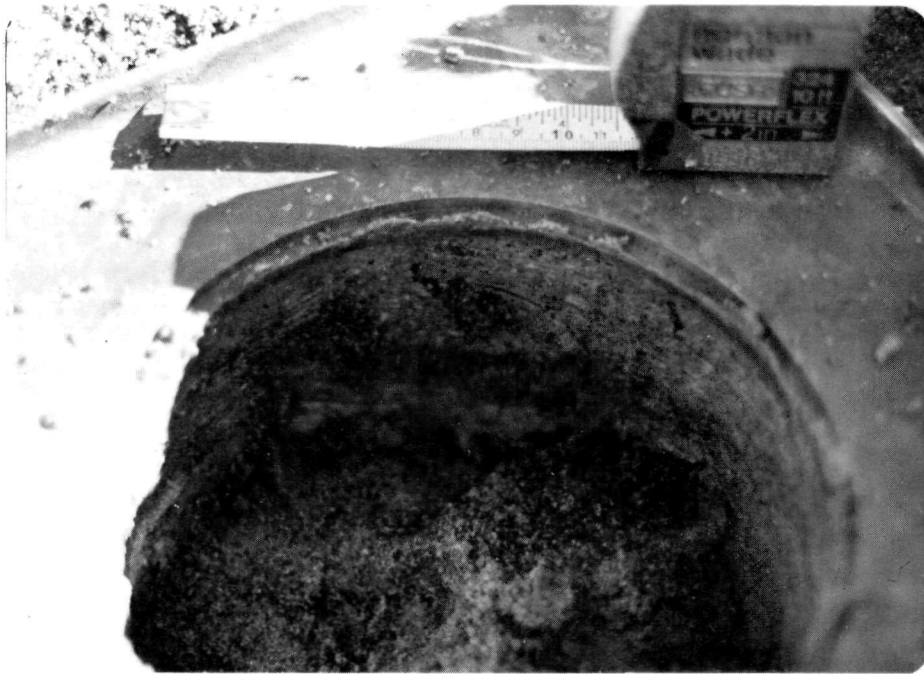
Field permeability tests (utilizing water as the test fluid) in the beach sand cell indicated that losses of 5,000 to 25,000 cm<sup>3</sup>/m<sup>2</sup>/hr (0.1 to 0.5 gal/ft<sup>2</sup>/hr) could occur in the initial hours. Loss rates would be expected to decrease as substrate soils become saturated. It may be theoretically demonstrated that permeable sand "pipes" through an otherwise relatively impermeable blanket could allow such losses, even if the cumulative area of the "pipes" is only 1 to 2% of the total area. Thus, these seemingly very minor imperfections in the bentonite liner profoundly affect overall integrity.

Plate 25      Note nodule of unmixed sand which reduces effective thickness of the bentonite to approximately 2 cm (1 in).

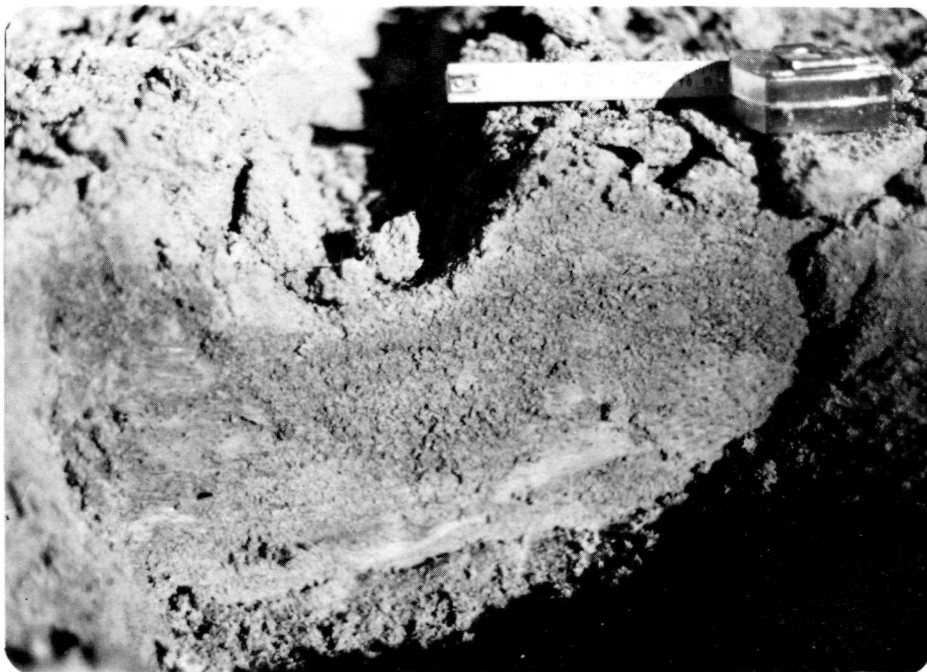
Plate 26      Cross-section showing rutting from motorcycle tires which sheared into the bentonite layer, reducing the effective depth of the liner by approximately one-half.

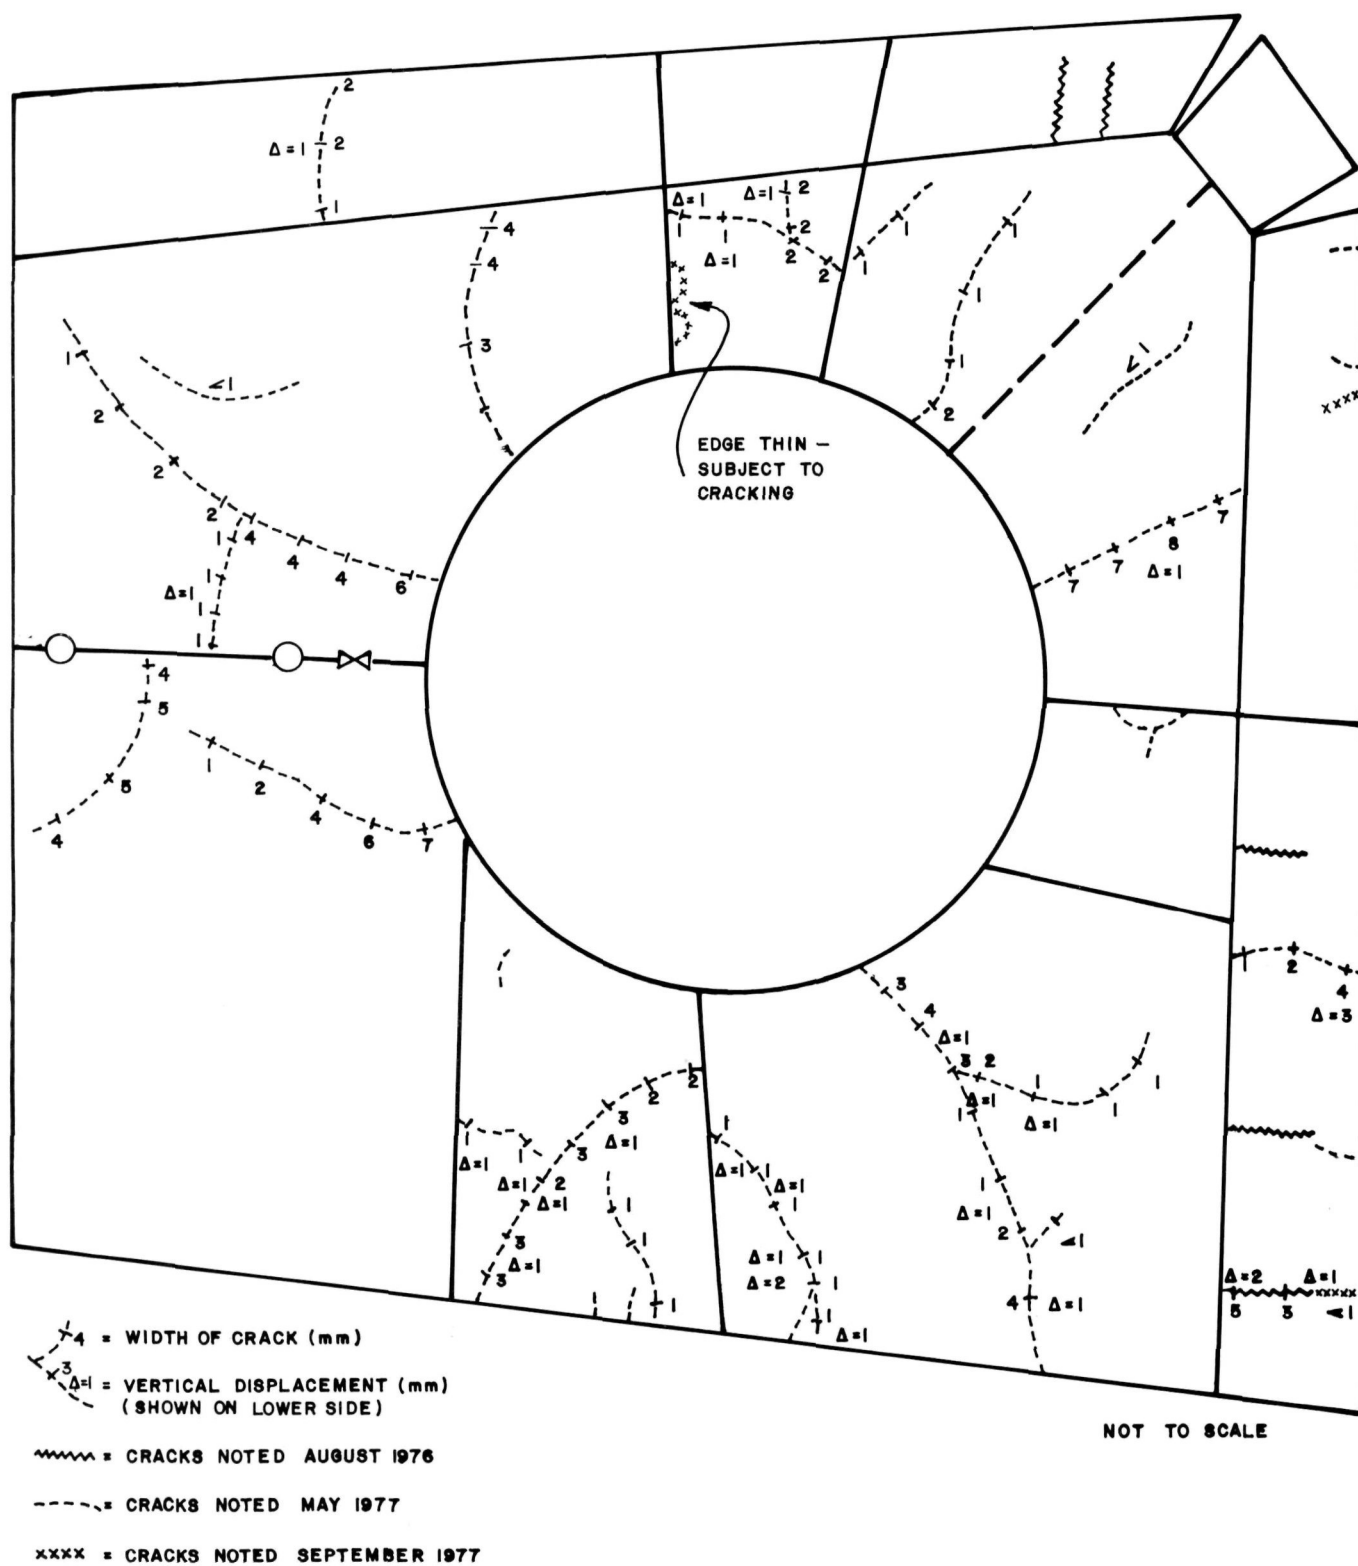
Fig.6 - Crack Configuration in Sulphur Test Section

The most notable difference in the sulphur liner after one year was a number of cracks through various panels. Figure 6 gives the locations and widths of these cracks, while Plate 27 shows a typical panel. Plate 28 shows one of the wider cracks and Table 6 gives details of cumulative crack lengths and panel areas. These cracks were in the range of 1 to 3 mm (0.05 to 0.1 in) wide and extended through the full depth of the sulphur lining. Some cracks completely crossed a panel, others only did so partially. There seemed to be no clear-cut relationship between panel thickness or size - panel 12, the thickest, had the most cracks and panel 13, the largest, had fewer cracks than panel 10. Very small panels such as 3 and 5, did not appear to be cracked. Disregarding external causes, Table 6 suggests that Types III and IV formulations have a lower propensity to crack than do Types I and II (refer to Table 1 for type formulations).

The two phenomena which may be responsible for the cracking are vertical differential movement of the ground due to thaw settlement or frost heave, or relief of stresses induced by thermal contraction. The thaw settlement explanation seems unlikely for three reasons:

Frost heaving is more plausible - the early winter timing is right. Although the Gulf Agent did not notice visible heaving of the panels, it would have been possible for the panels to settle back into their original, unheaved position by the fall of 1977. The silty soils underlying the tank farm are frost susceptible, but over a metre of gravel pad between the silt and the sulphur lining would distribute point loading. Differential heaving would be expected between the pad and the tank, creating cracks parallel to the edge of the tank. The actual configuration of the majority of the cracks is radial. The general perpendicularity of the cracks to the long dimension of the panels suggests tensile stress relief. Although the panels are not restrained at the edges, adhesion to the gravel may develop enough resistance to induce significant tensile stresses upon thermal contraction.

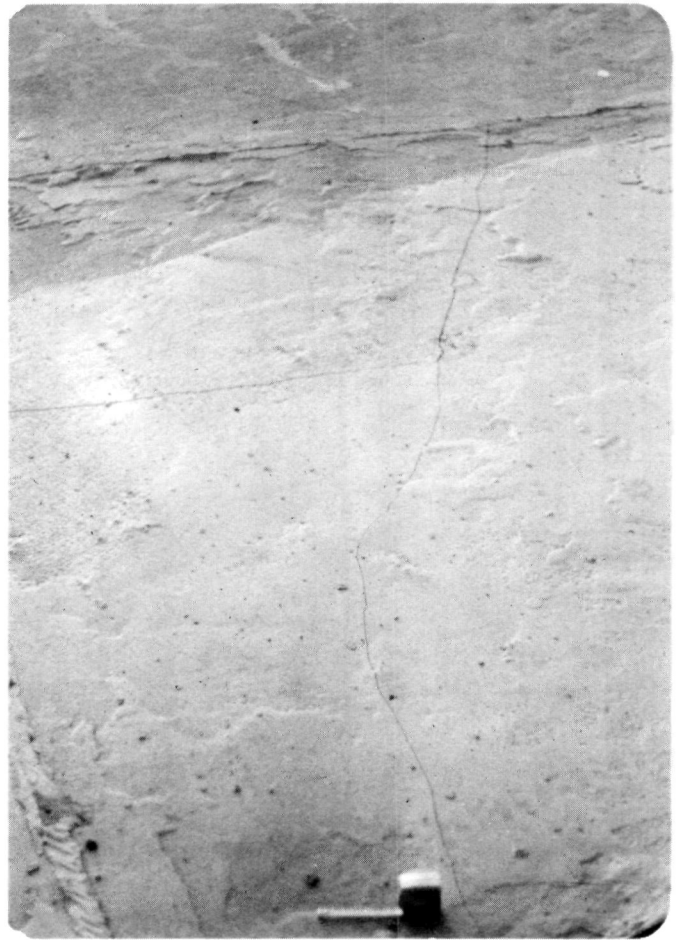
A typical crack transversing the full width of the panel; width is 1 to 3 mm (0.05 to 0.1 in).

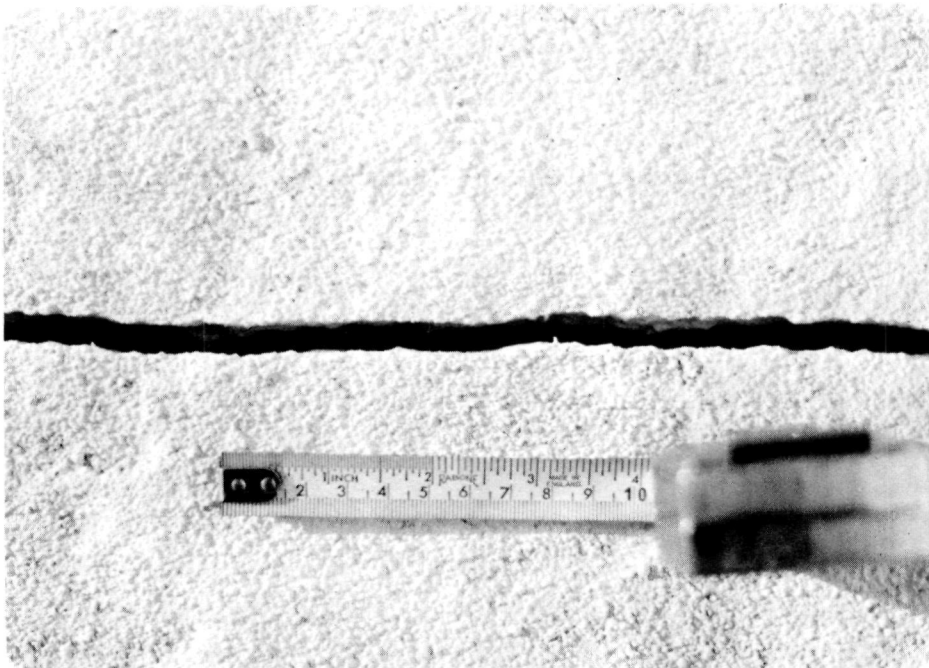
Plate 28

The above crack at 5 to 6 mm (0.15 in) was somewhat wider than average; all cracks penetrated the full depth of the panels.

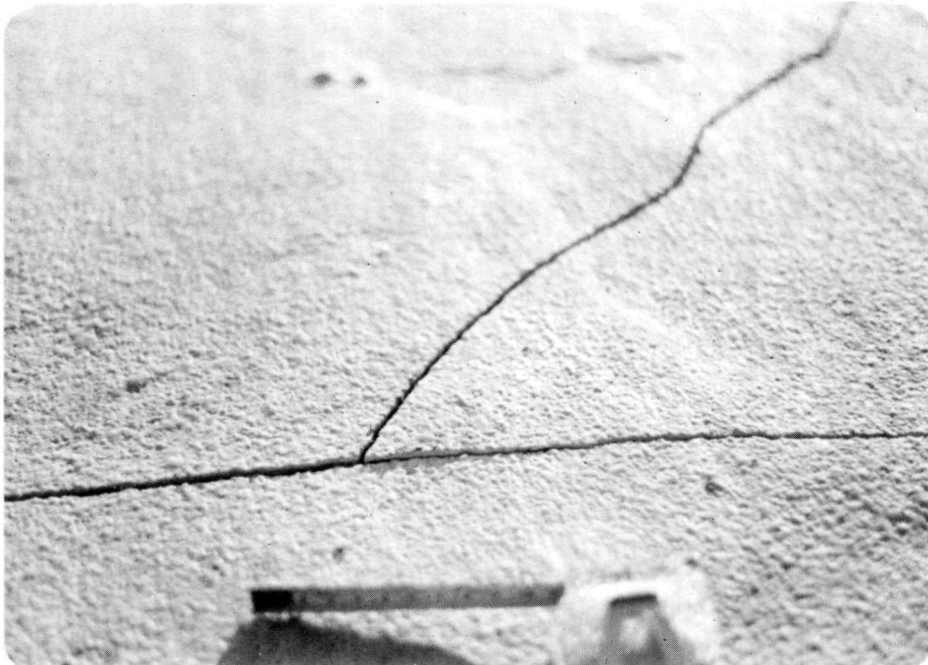
Plate 29

1. There is no evidence of differential settlement of tanks or pipe galleries.
2. The panels themselves do not appear to have sagged or heaved (Plate 29 shows one of the few vertically displaced cracks).
3. According to the Gulf Agent at the site, the cracks first appeared in the early winter, an unlikely time for thaw settlement to be occurring.

In general, no vertical displacement across cracks existed, and where differential movement was noted, magnitudes were very small. The above shows the most extreme example of displacement, approximately 3 mm (0.1 in).

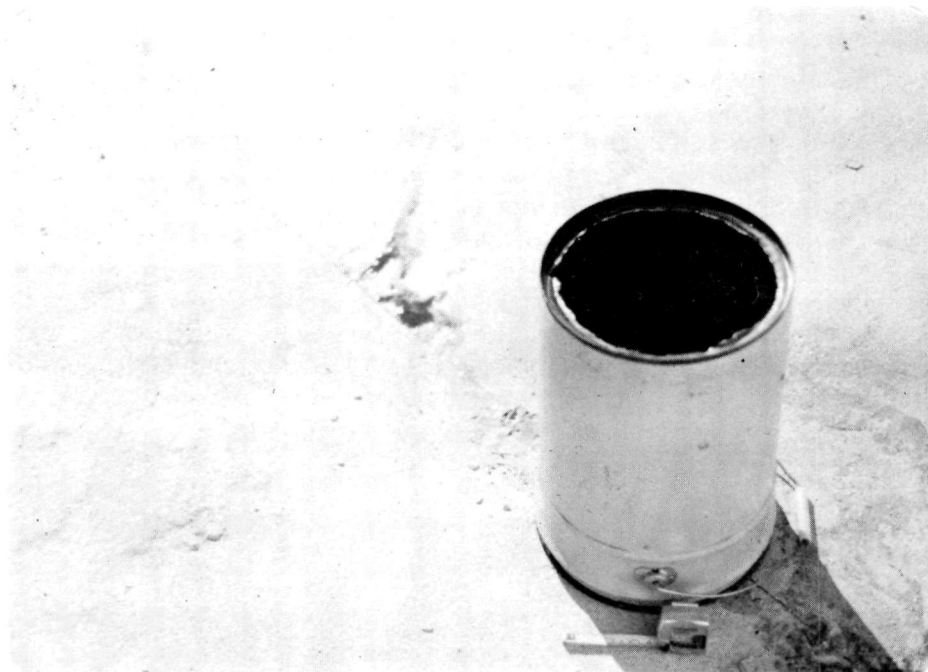
Plate 30

Three "permeability" tests were run on representative cracks. The first two were run on a 3.5 mm (0.13 in) crack in panel 9, and the third on a 3.0 mm (0.10 in) crack in panel 12. A bucket 28.5 cm (11.2 in) in diameter was sealed over each crack. In the first test, 16.1 l (3.5 gal) of water drained in four minutes under an average head of 12.5 cm (5 in). The main mechanism appeared to be piping along the crack, exiting onto the surface about 25 cm (10 in) from the bucket, as shown in Plate 30.

Field permeability tests demonstrated that water flowed along the crack, existing with sufficient velocity to carry sand and smaller soil particles. A second test on a completely sealed crack indicated that water would escape almost as quickly along the liner-soil interface when no surface exit was available.

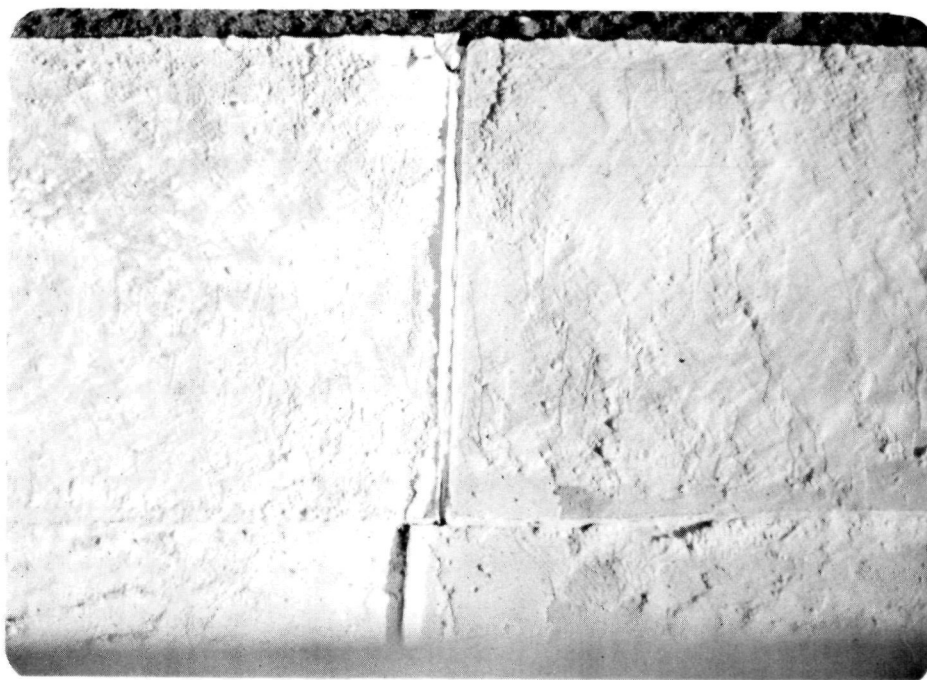
Plate 31      The fire-resistant paints appeared to be 0.1-0.2 mm (5-10 mils) thick and well bonded to the sulphur. At left is the Albi 107X/144 system, at right the Diathon system.

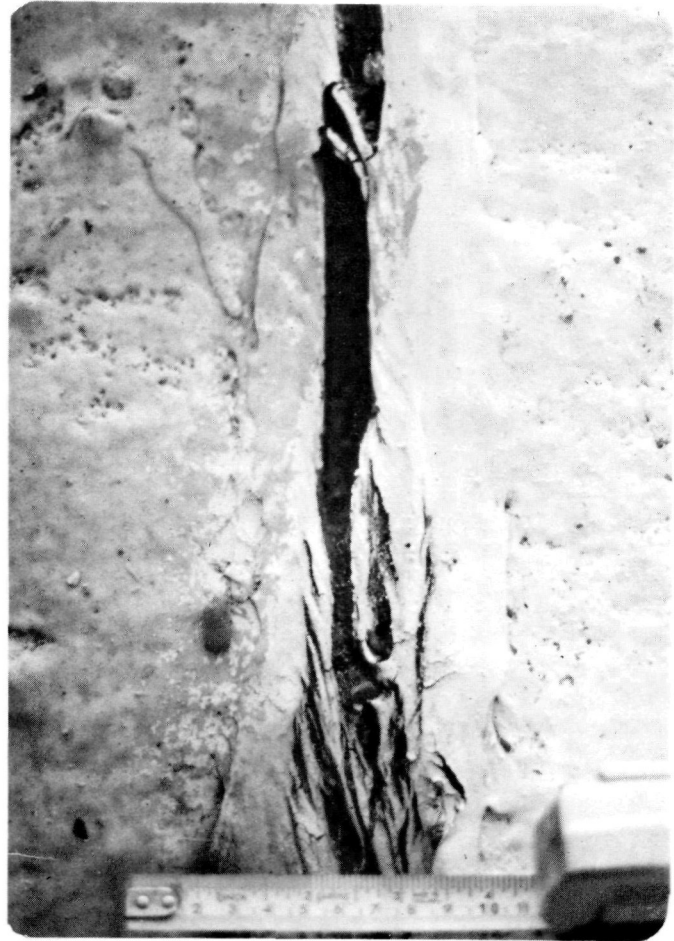
Plate 33      Typical joint failure originated from loss of adhesion to sulphur panel.

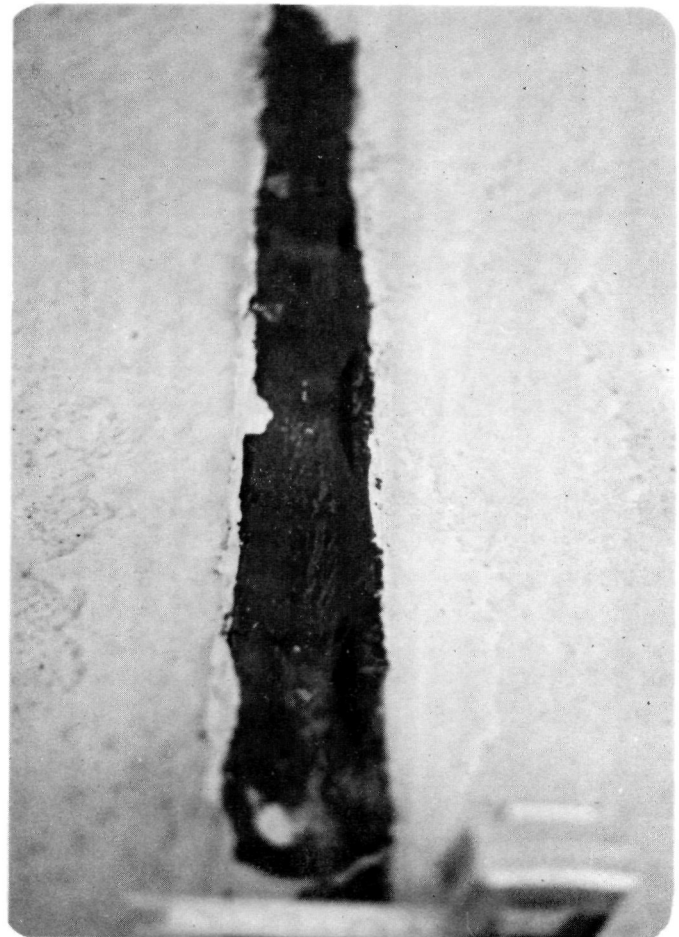
Plate 34

The joint at the tank base apparently accommodated some differential movement, but failure of the sealant were evident.

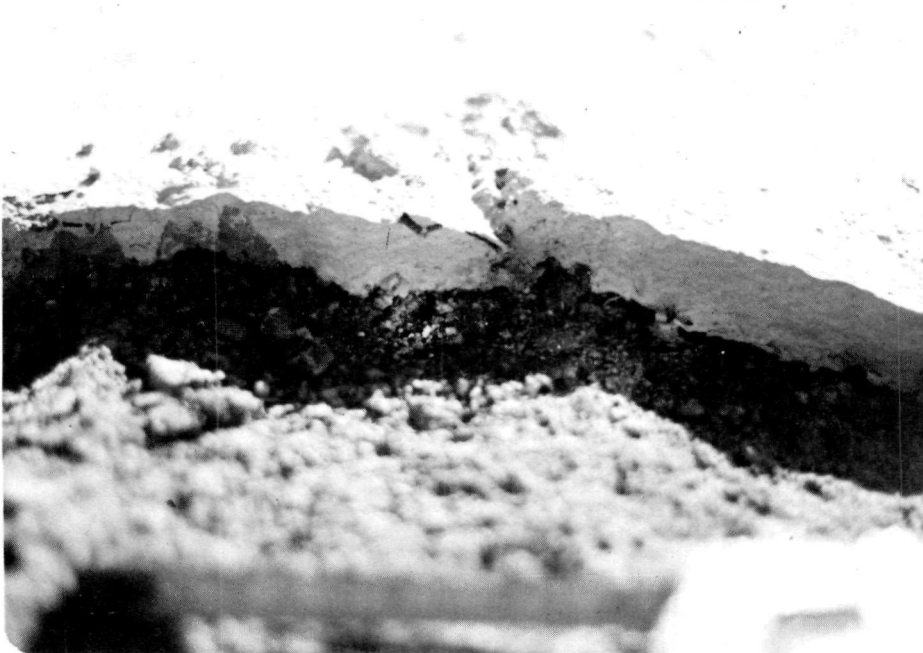
Plate 35

Anomalies in panel thickness may have acted as initiation points for cracking.

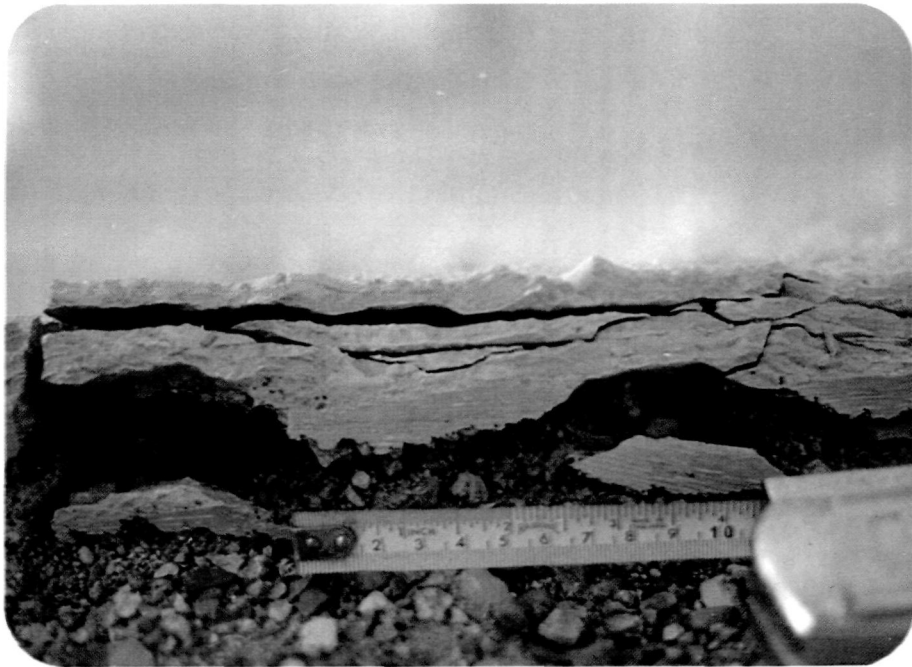
Plate 36 In a number of locations the edges of sulphur panels could be delaminated by forcing a wedge between layers.

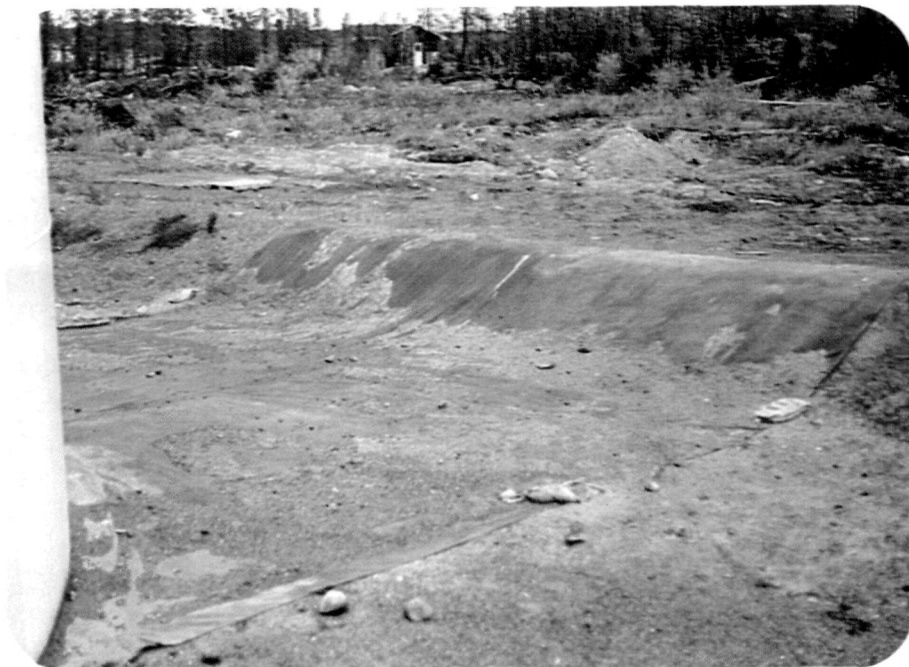
Plate 37 Elastuff 504 bleached significantly, but Carboline weathered to a slightly darker shade of green; compare with Plate 14.

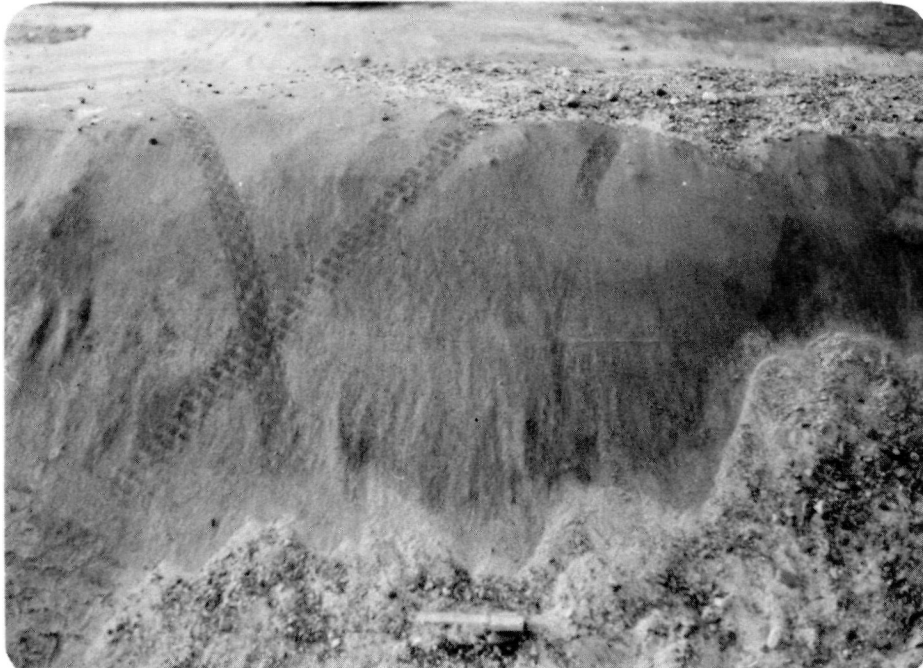
Plate 38 Both urethane coatings withstood damage from motorcycle traffic very well. Note also that this section of liner moved downslope, placing it in tension; no adverse effects were apparent.

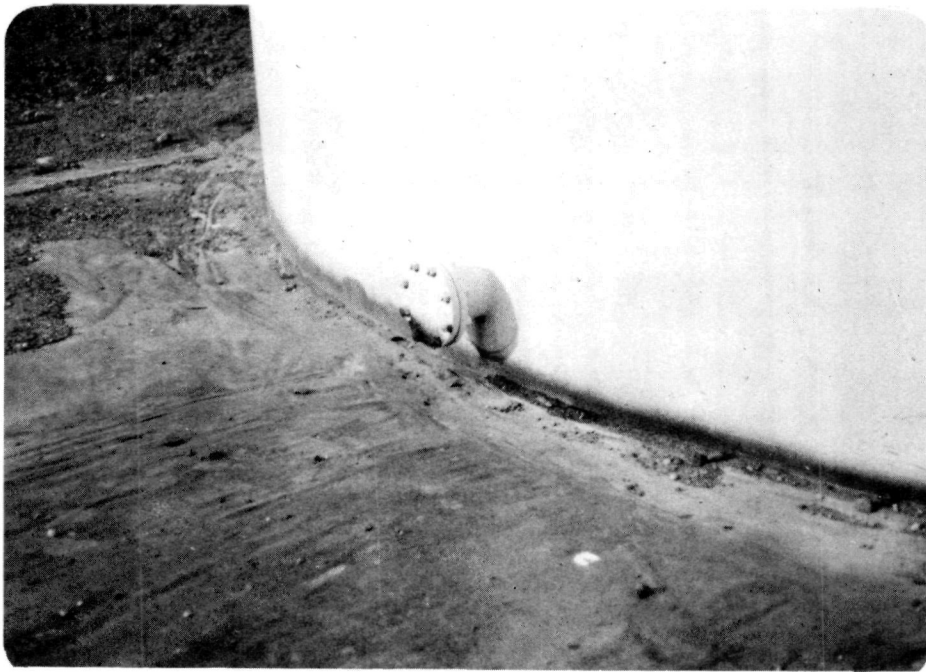
Plate 39      The urethane foam seal between the urethane coating test sections and the tank showed no signs of loss of integrity.

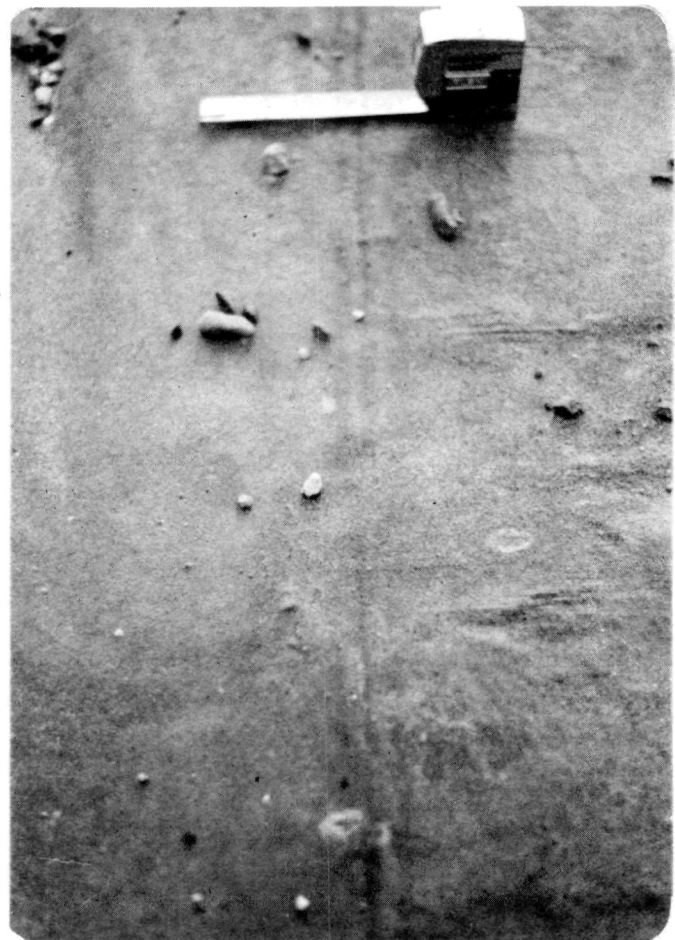
Plate 40      Transverse double-lap joint:  
no wrinkles, loose edges or  
other signs of poor performance.

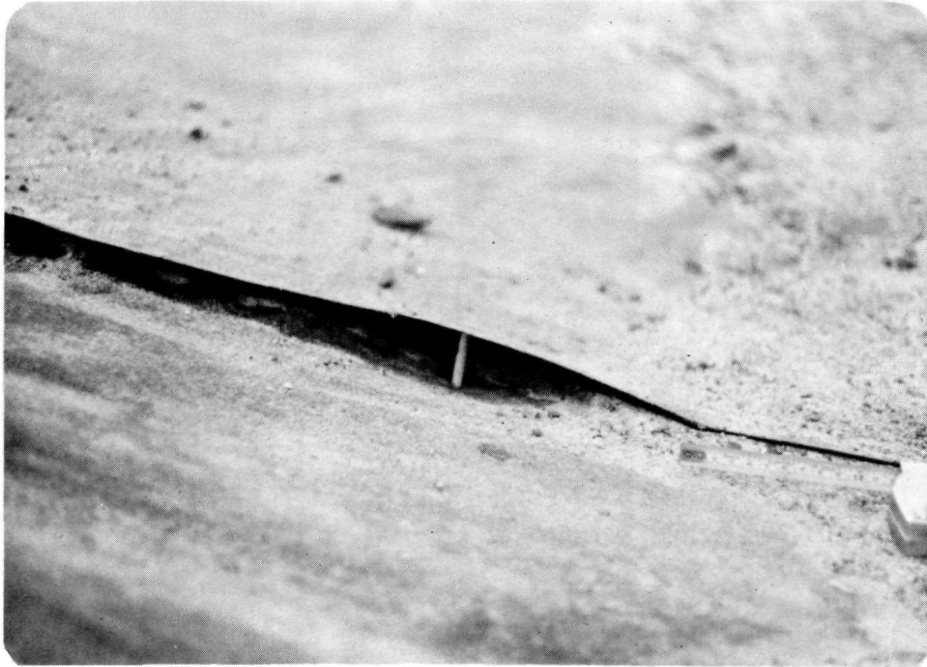
The transverse double-lap joints appeared to have performed well in both materials, without developing wrinkles or loose edges, as shown in Plate 40. However, Plate 41 shows that in the longitudinal single-lap joint, several wrinkles were evident extending across the joint one-quarter to one-half of the way. Although there was still an effective seal of 10 cm (4 in) the loose edge formed a potential weak point for tearing or damage by wind.

Plate 41 Several wrinkles and loose edges were present in the longitudinal single-lap joint; these reduced the width of bond in the joint by several centimetres, and created weak points with potential for tearing or wind damage.

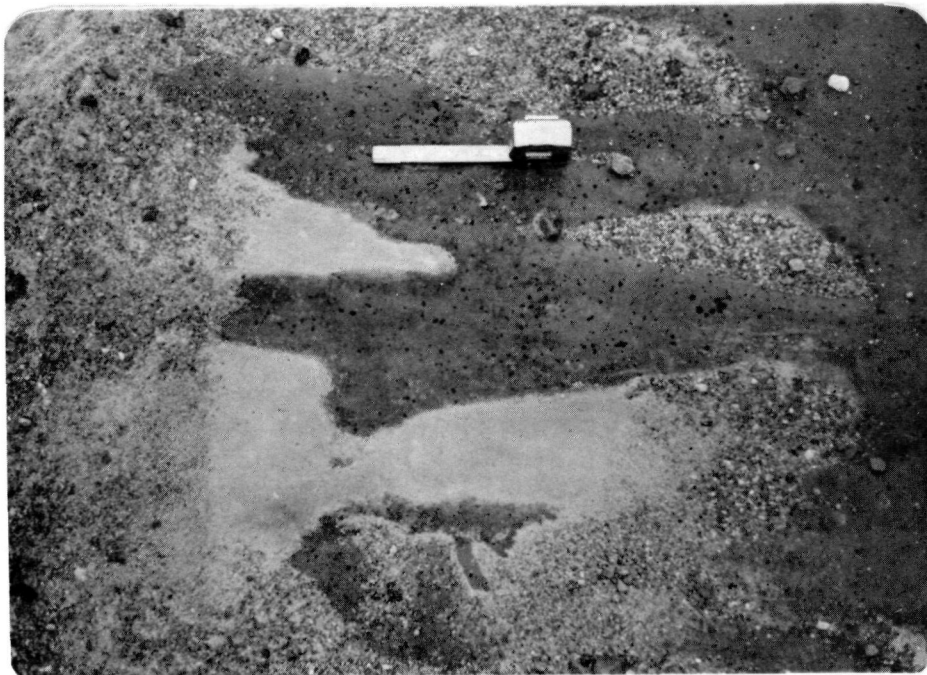
Plate 42 The tack coat and sand course had peeled off both coatings, except where they had been protected against weathering by a layer of sand several centimetres thick.

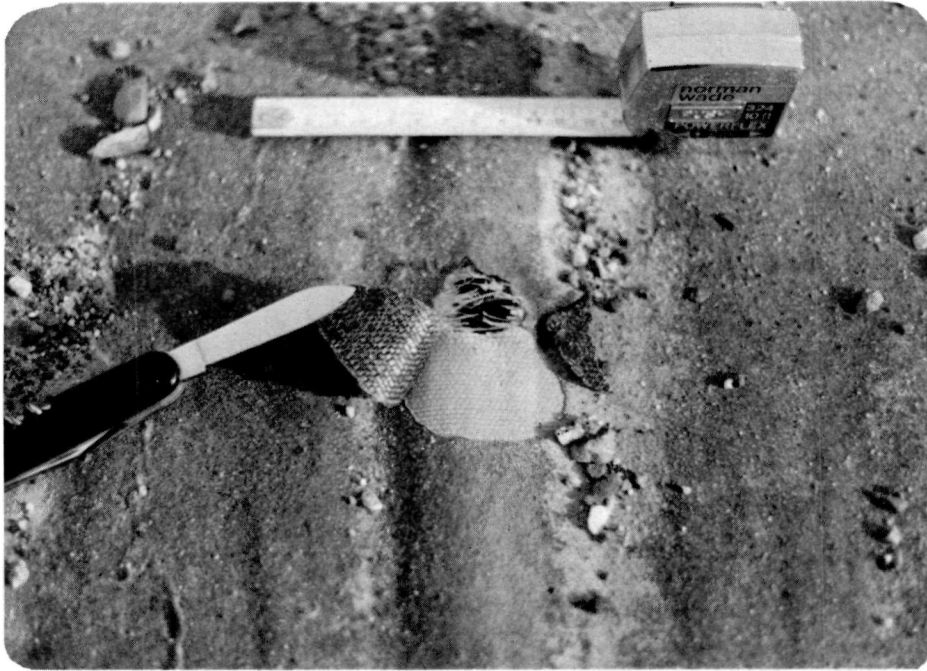
Plate 43 It was possible to peel the Carboline film back from a puncture in the liner (puncture was of indeterminate origin).
