# Performance Assessment of Test Liners for Petroleum Product Storage Areas in Northern Canada

Technology Development Report

EPS 4-EC-78-6

EBA Engineering Consultants Ltd.  
Edmonton, Alberta

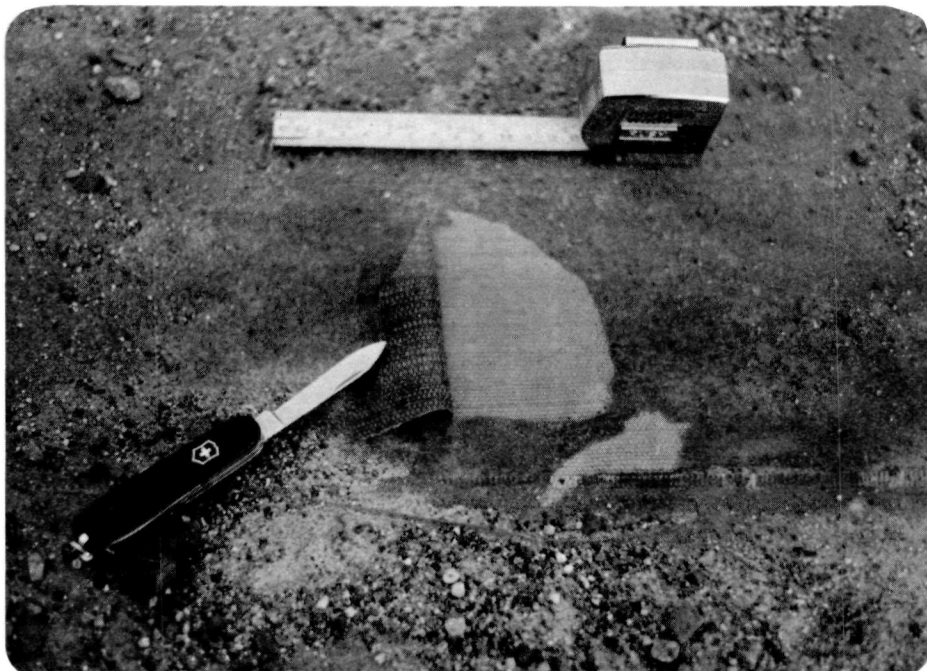
Plate 44 It was possible to peel the Elastuff 504 away from the backing fabric; thus, even small anomalies in the liner have the potential of developing into larger flaws.

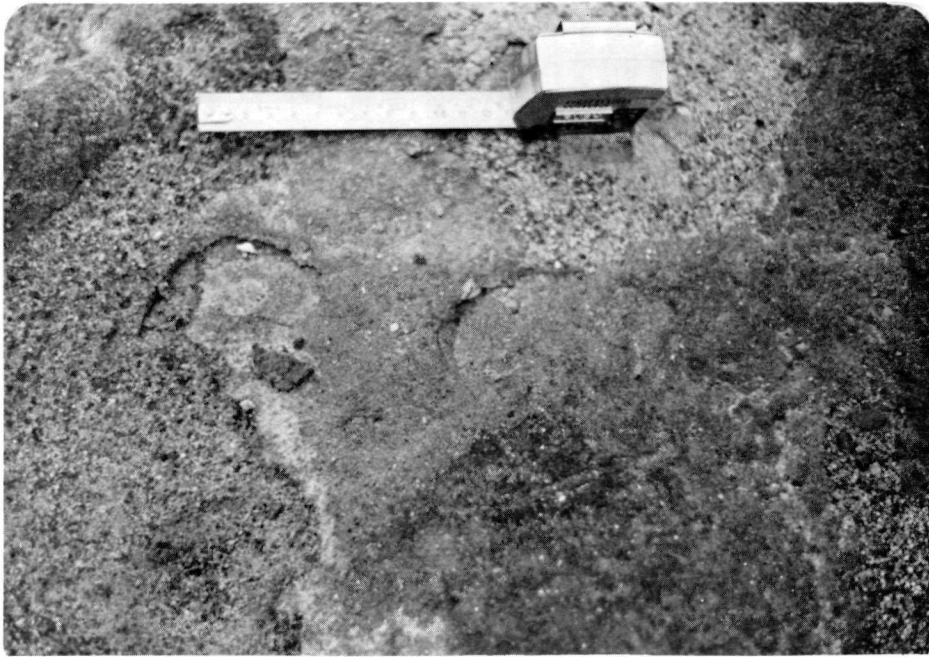
Plate 47 By stamping a heel on the normal foam, it was possible to create localized shear failures in the surface of the foam.

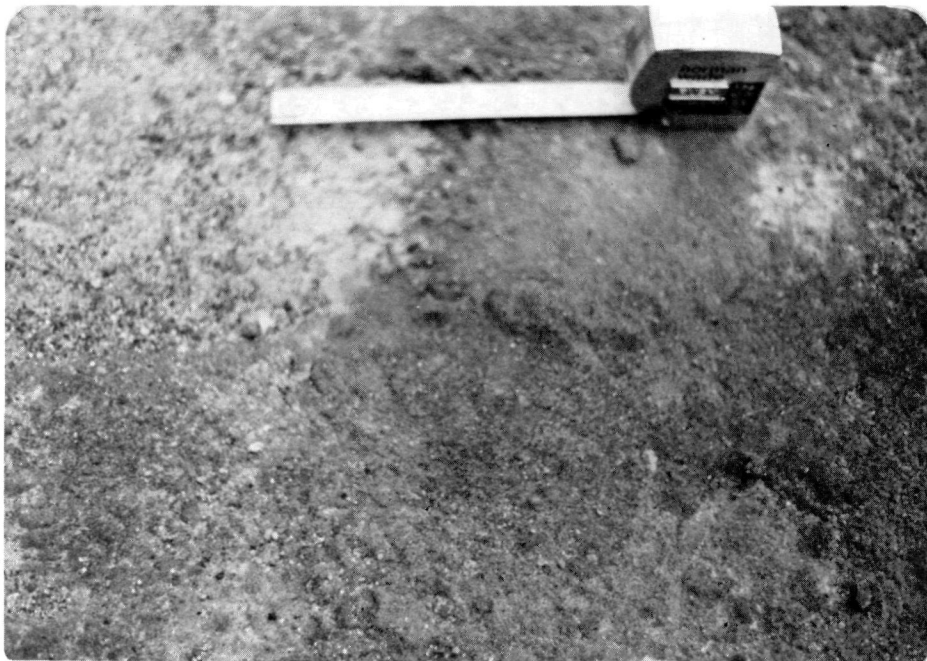
Plate 48 Similar "heel tests" yielded much smaller shear failures in the higher density slow foam - the crescent-shaped mark is barely visible in the centre of the above picture. The higher density foams are more resistant to damage and are thus more suitable for the surface layer.

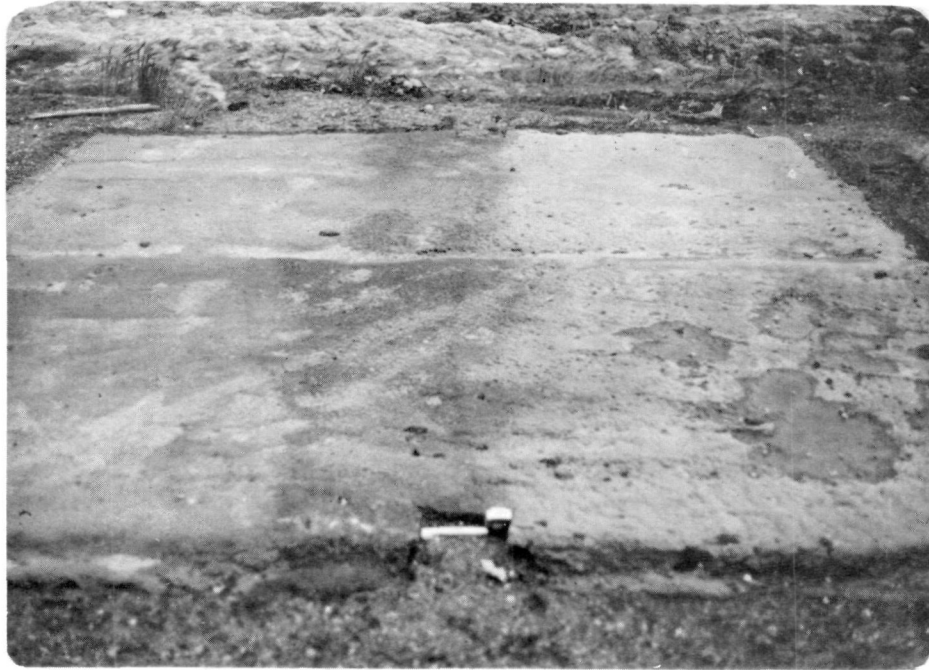
Plate 49 Where a motorcycle tire had been spun on normal foam, the upper 1-2 cm (0.5 in) of foam had crumbled. The Carboline-covered section and the slow foam appeared to be more resistant to such damage.

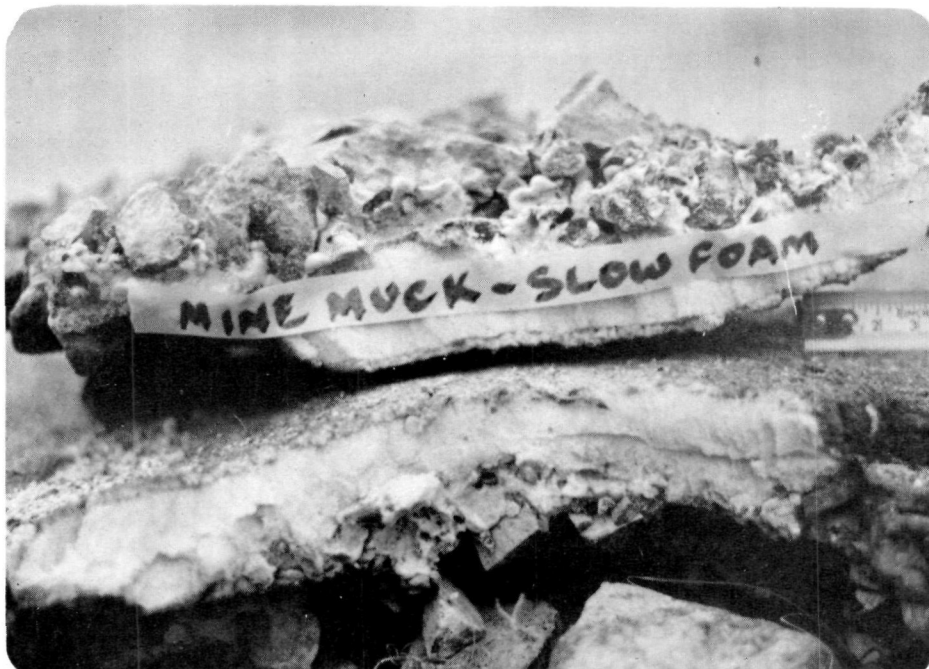
Plate 50 Adhesion of foam to the substrate aggregate was excellent. Also, no signs of weathering or discolouration were visible on the bottom surfaces of the test pads.
