DRYWALL STAINING

FINAL REPORT

**PREPARED BY: INSTITUTE FOR RESEARCH AND CONSTRUCTION
NATIONAL RESEARCH COUNCIL**

JANUARY 1992

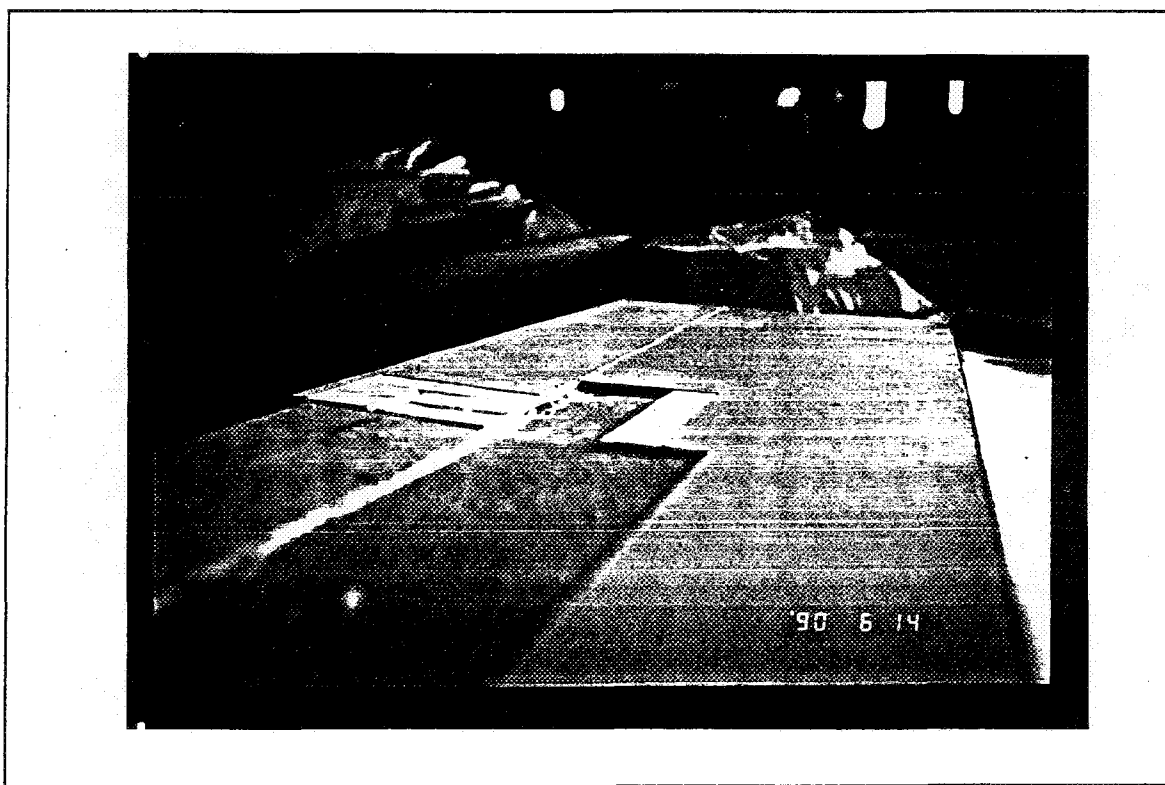
Figure 2. Stained drywall specimen showing the various layers of the drywall system.

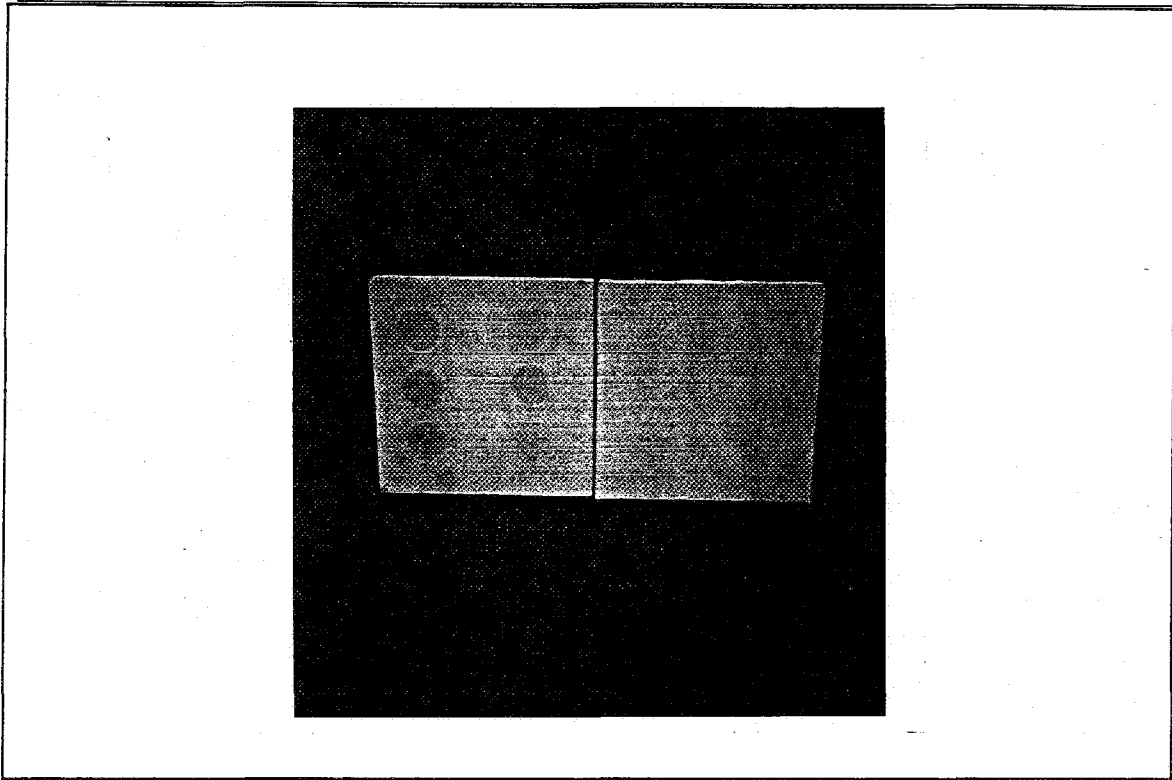
A second set of four boards was produced in like manner, but in this instance, the boards were allowed to dry for 24 hours prior to being placed into the environmental chamber. These boards were also conditioned for two months. The specimens were monitored on a daily basis. (An example of these specimens is shown in Figure 6).

Figure 6. Specimen board showing PMA loaded jointing compound plugs after staining has occurred (left board showing stain, right board repainted with latex paint).

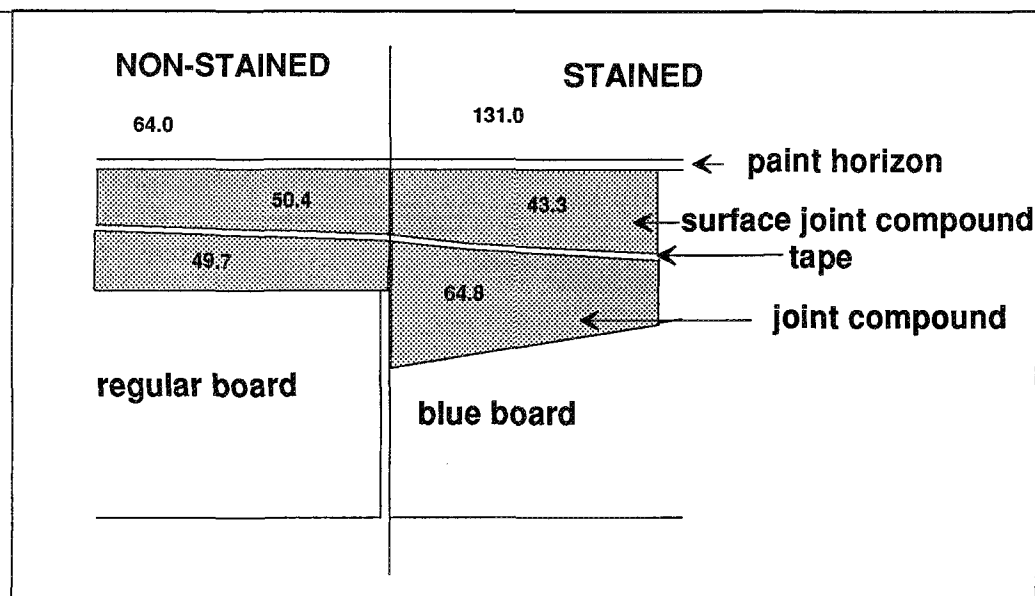
Figure 10. Cross section of drywall system showing concentrations of elemental mercury present (ppm) in various portions of the wall..

A high concentration of mercury was found in the stained paint chips and the underlying joint compound in both the stained and the reference drywall samples. However, the stained paint layer had more than twice the level of mercury compared to the reference paint layer, or any of the other layers. This result indicated that mercury may be involved in the staining. Of interest is the fact that only trace levels of mercury were found in the samples of unused paint, primer and new (1990) joint compound, whereas elevated concentrations were found in the old (1988) sample of unused jointing compound. Discussions with the formulator of the jointing compound producer, revealed that a mercury containing organic (organomercuric) compound, phenyl mercuric acetate (PMA), had previously been used as a fungicide.

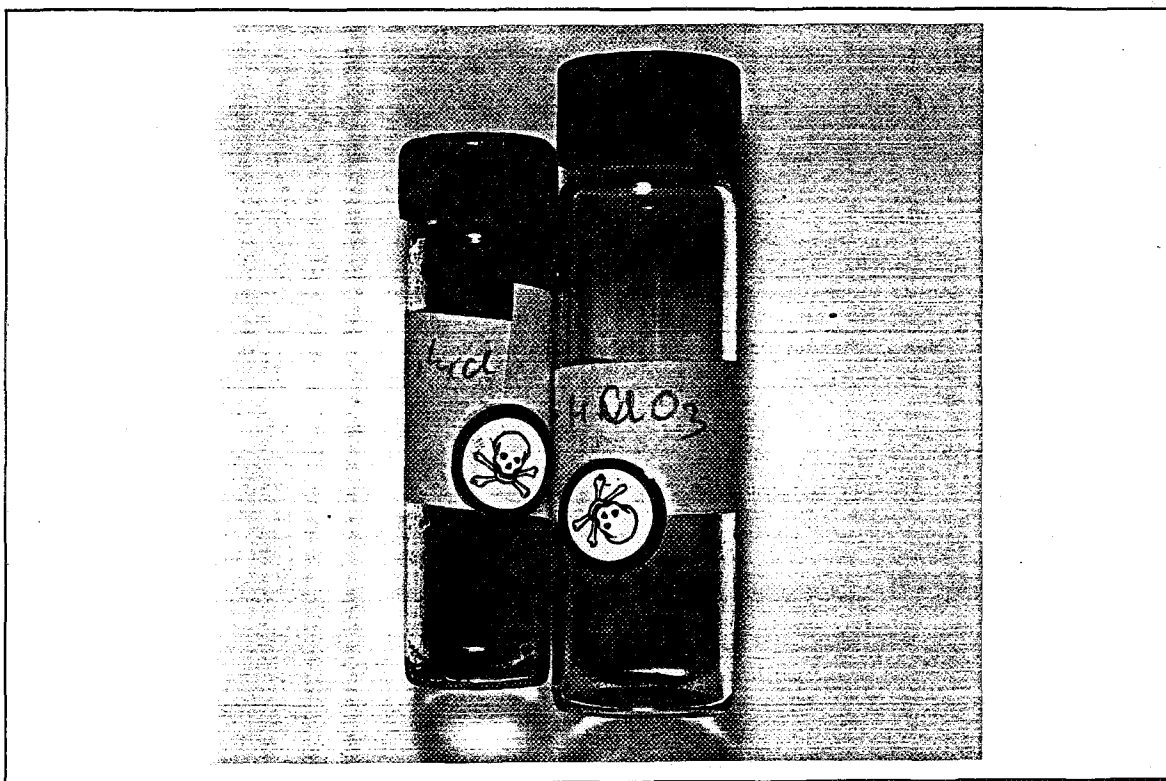
The investigation of the mechanism provide the following information. Reaction of ionic (inorganic) mercury and sulphide forms the black stain. This is shown when an aqueous solution of mercuric chloride (a clear solution) was added to a solution of sodium sulphide (which is also colourless). The insoluble black precipitate of mercuric sulphide formed is seen in the left vial of Figure 14. Bleach (5 ml) was added to an aliquot (2.5 ml) containing the heavy black precipitate and the precipitate disappeared. The result was again a colourless solution shown in the right vial of Figure 14. This correlates well with field tests where the drywall stain was shown to be soluble with a bleach wash [28].

Figure 14. Vials containing mercury sulphide, (left vial) and bleach dissolved mercury sulphide (right vial).

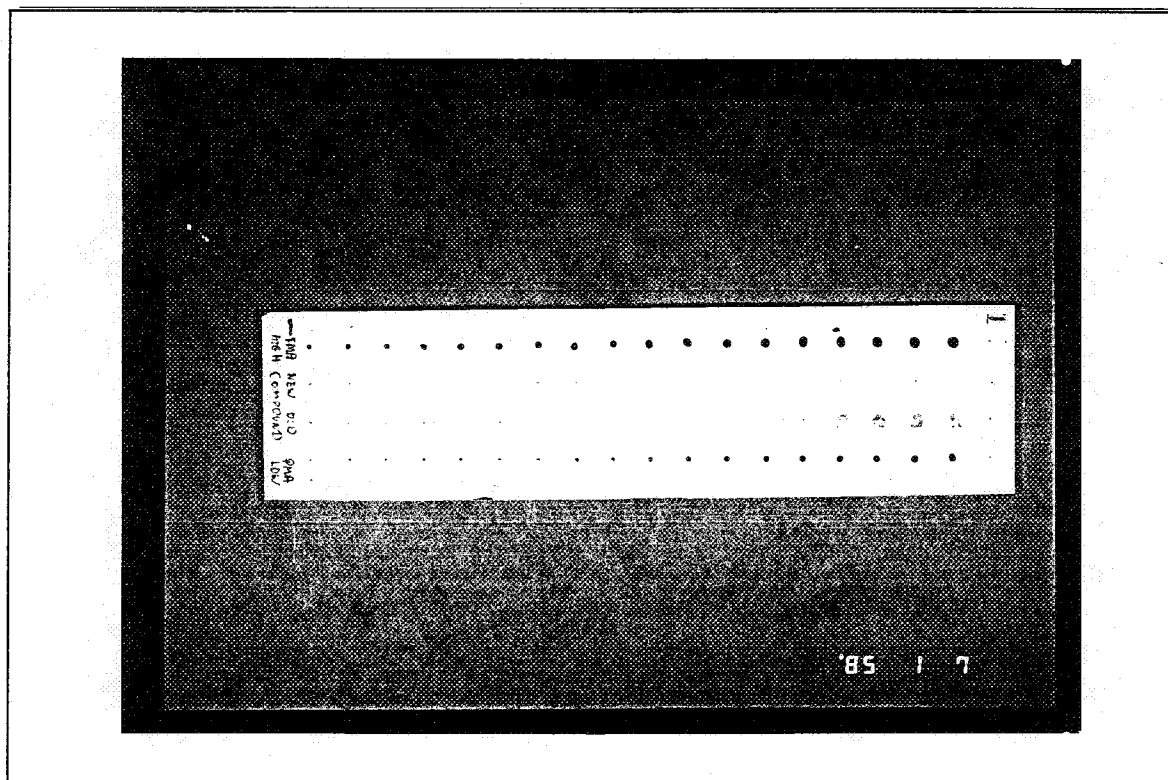
Plate I, after simultaneous exposure to UV light and hydrogen sulphide, developed staining in less than one hour, and is shown in Figure 16.

Figure 16. Plate I showing the simulation of the stain after exposure.

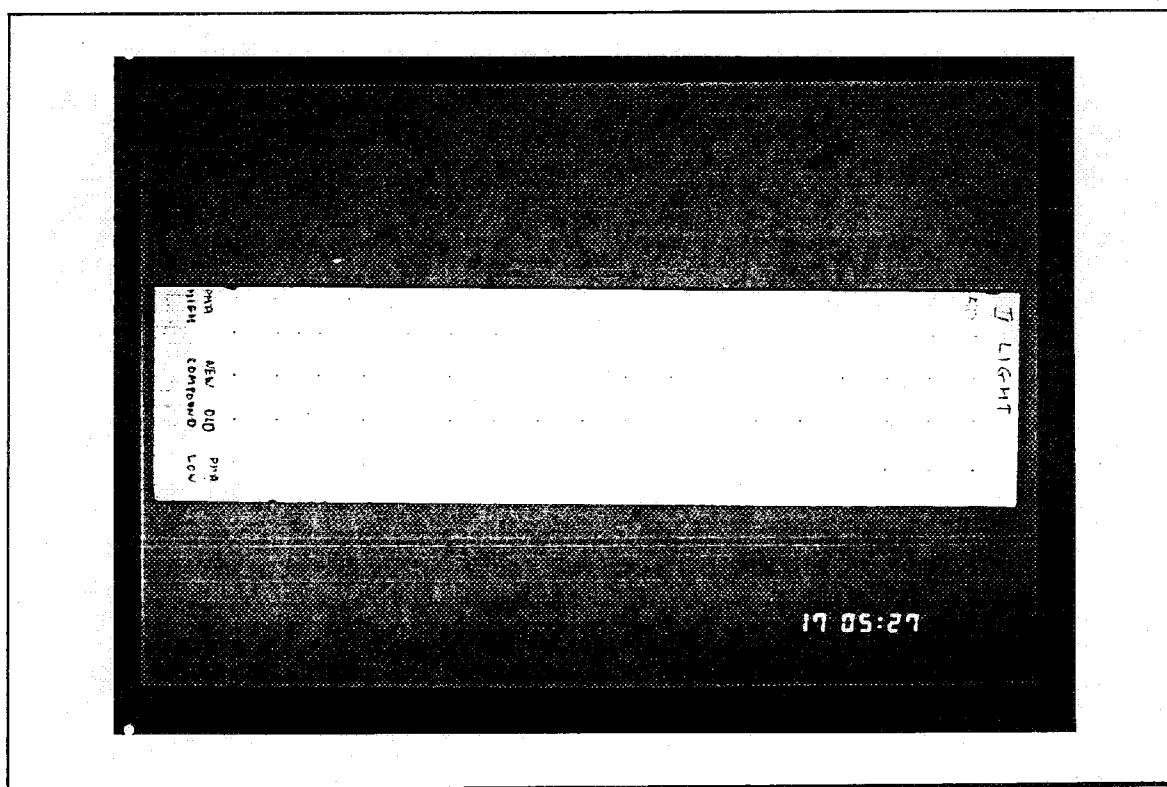
Figure 17. Plate II after exposure to UV irradiation only.

Plate II which was exposed to UV radiation only, did not form a stain, although photo-decomposition had converted the organic mercury in the PMA into the inorganic form (Figure 17).

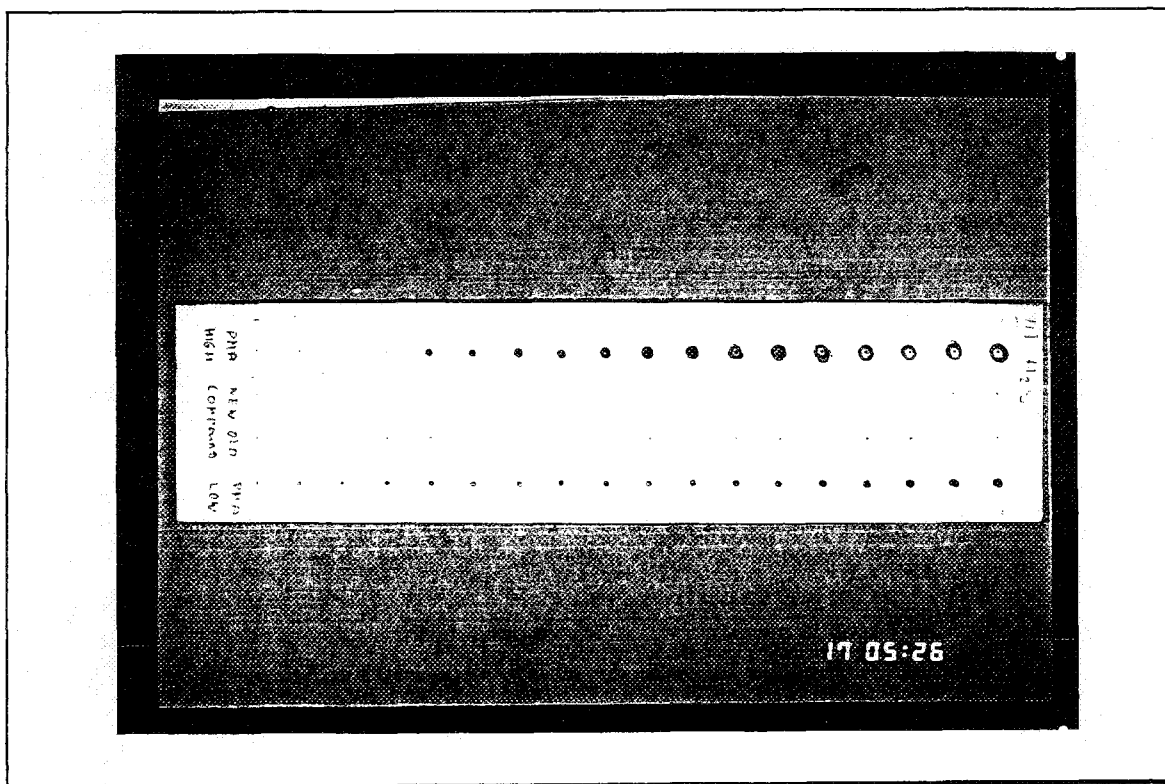
Plate III, exposed to hydrogen sulphide only, formed a stain thus indicating that hydrogen sulphide is one of the chief factors involved in stain formation. However, it can be seen that the stain intensity was less than that seen in Plate I which was exposed simultaneously to UV radiation and hydrogen sulphide (Figure 18) indicating the synergistic effects brought about by their combined action.

Figure 18. Plate III after exposure to hydrogen sulphide only.

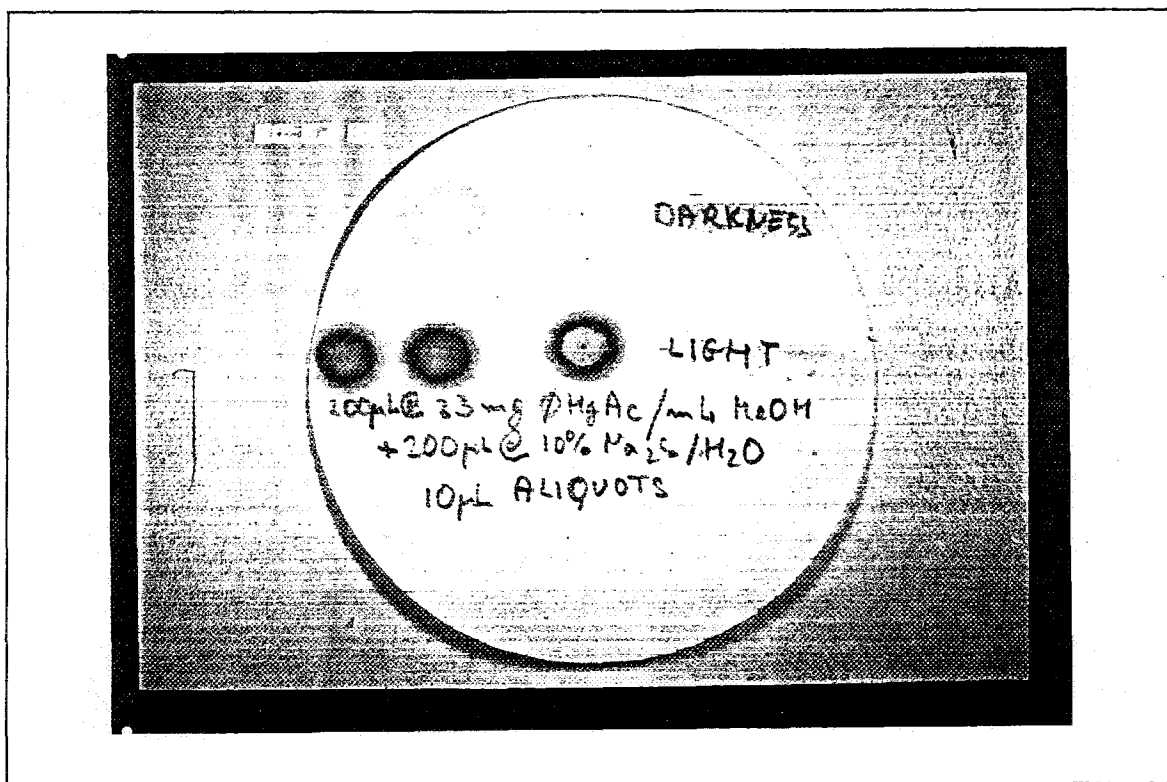
The role of photodecomposition was investigated using two solutions of PMA jointing compound in methanol. One was irradiated while the other was kept in darkness. Figure 19 shows the results obtained when aliquots from each were applied to ashless neutral filter paper. The vivid staining produced by the solutions exposed to UV radiation compared to that kept in darkness clearly shows that light is an important factor in stain formation.

Figure 19. The effect of light on the reaction of Phenyl mercury acetate and sodium sulphide.
