**FRAMEWORK FOR INVESTIGATING
BUILDING ENVELOPE DEFECTS**

By Paul Fazio,
Krishnan Gowri, and
Raymond Blanchette

March, 1992

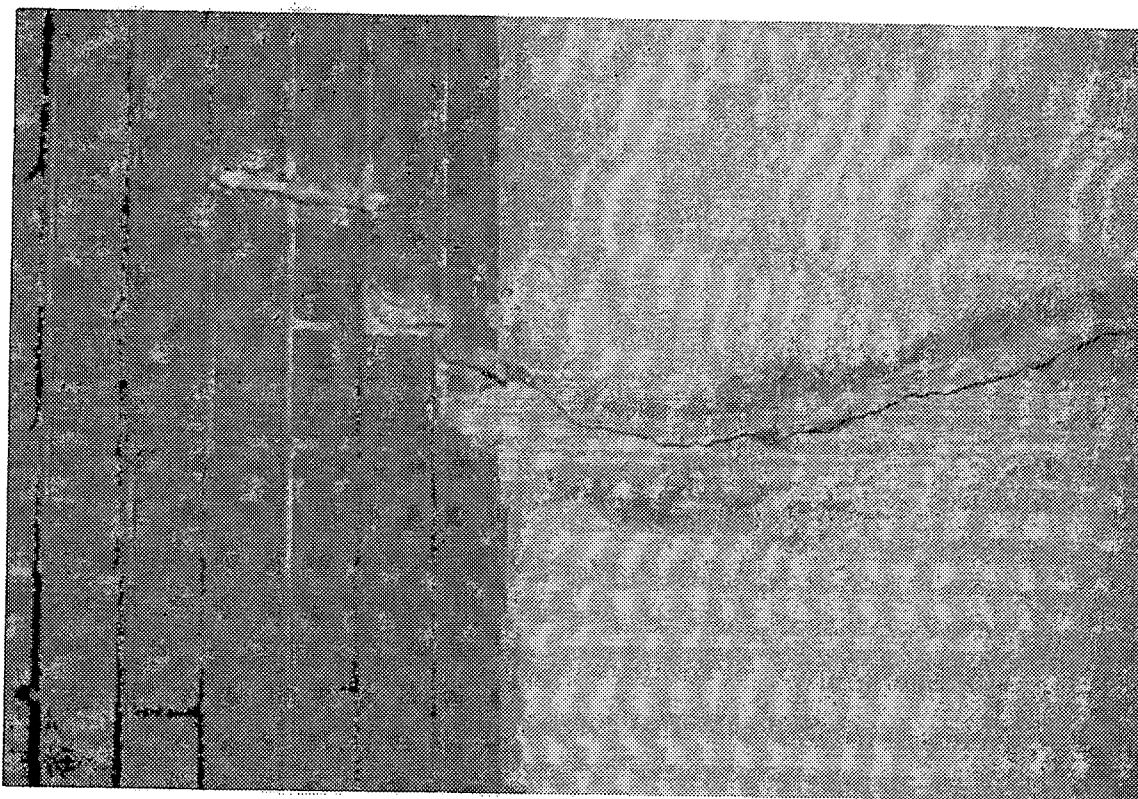
Crack width	3mm or more
Time of occurrence	After a dry spell
Location of crack	Foundation wall (Photo 1)
Cause	<ul style="list-style-type: none"> • Shrinkage of soil • Growing trees close to building
Test methods	<ul style="list-style-type: none"> • Visual inspection • Wax plugs
Remedial measures	Consult a foundation engineer

1. Foundation wall cracking 3mm or more

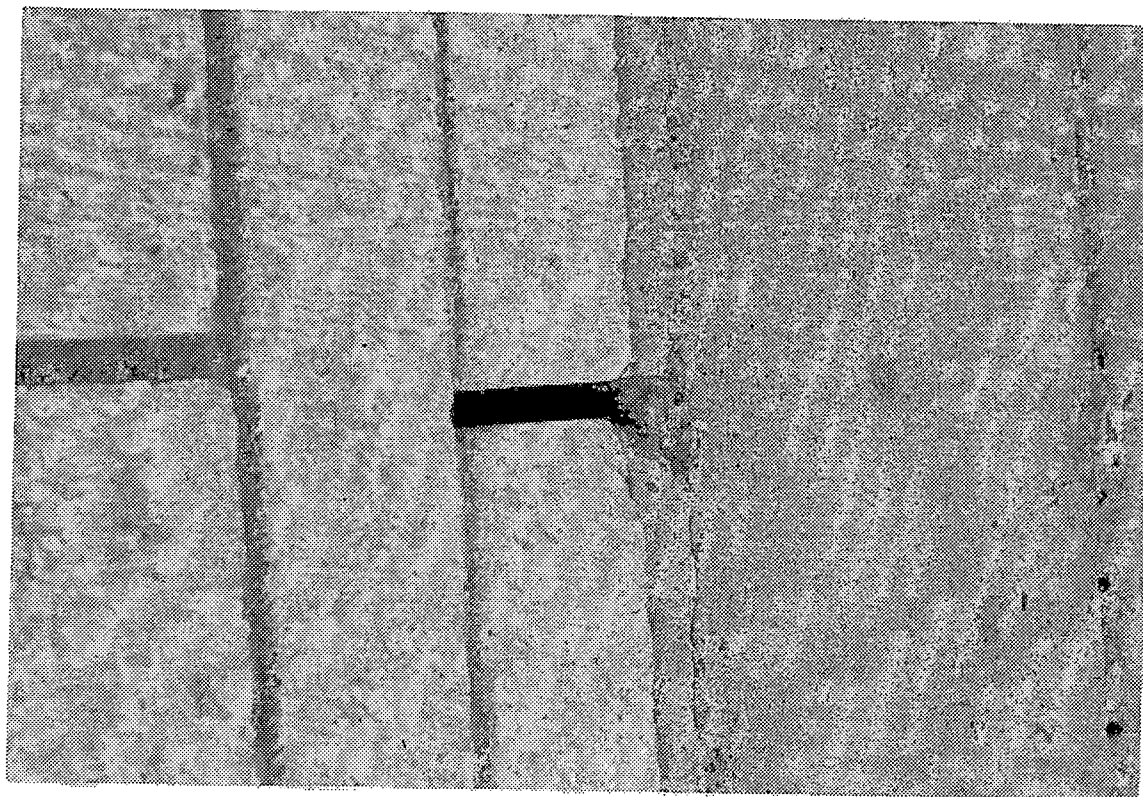
Time of occurrence	<i>Wind-driven rain</i>
Location	<i>Top of foundation wall (Photo 2)</i>
Cause	<ul style="list-style-type: none"> • Lack of inadequate flashing at bottom of exterior wall • Cavity filled with mortar
Test methods	<ul style="list-style-type: none"> • Visual inspection • Removal of bricks or siding element at exterior wall
Remedial measures	<ul style="list-style-type: none"> • Redo flashings: flashings must be installed 150 mm behind the sheathing paper and extend at least 5 mm outside the outer face of the foundation wall • Provide for adequate surface drainage

2. Lack of flashing at bottom of exterior wall

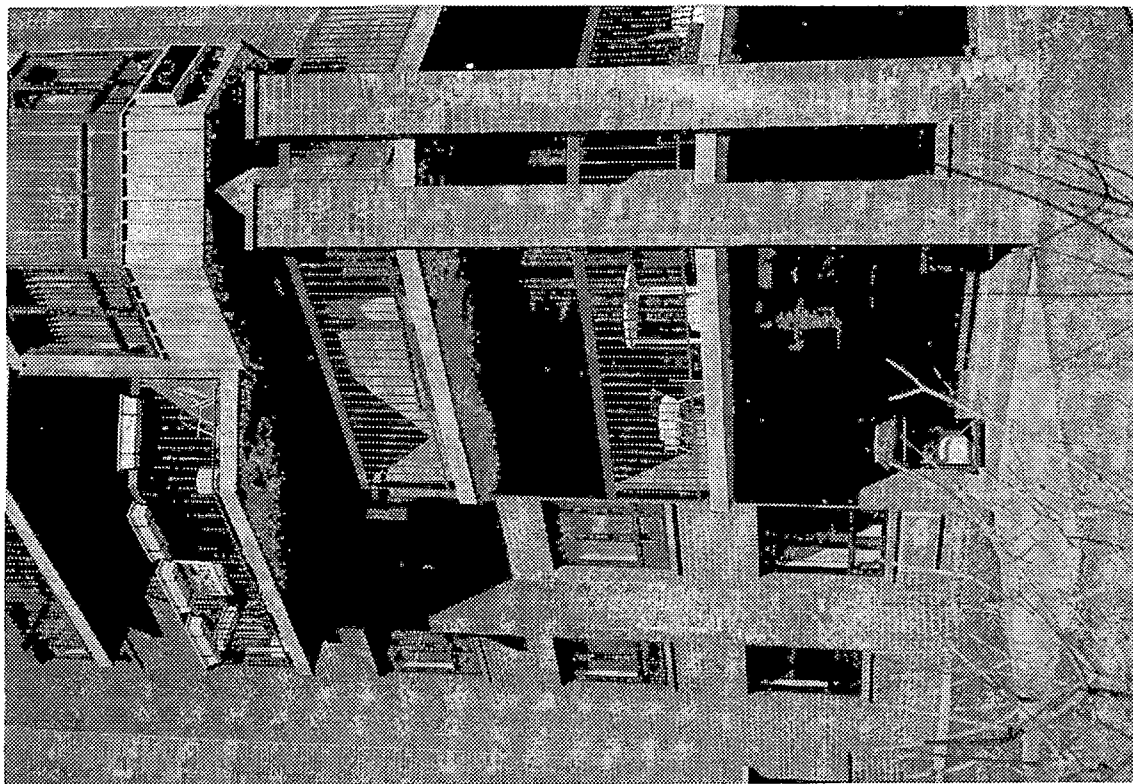
Time of occurrence	Winter
Location	Exterior walls (Photo 3)
Cause	<ul style="list-style-type: none">• Vapour migration due to defective air barrier• Water infiltration
Test methods	<ul style="list-style-type: none">• Visual inspection
Remedial measures	<ul style="list-style-type: none">• Provide a continuous air-barrier• Eliminate water run-off from roofs onto brick walls

3. Efflorescence in exterior walls

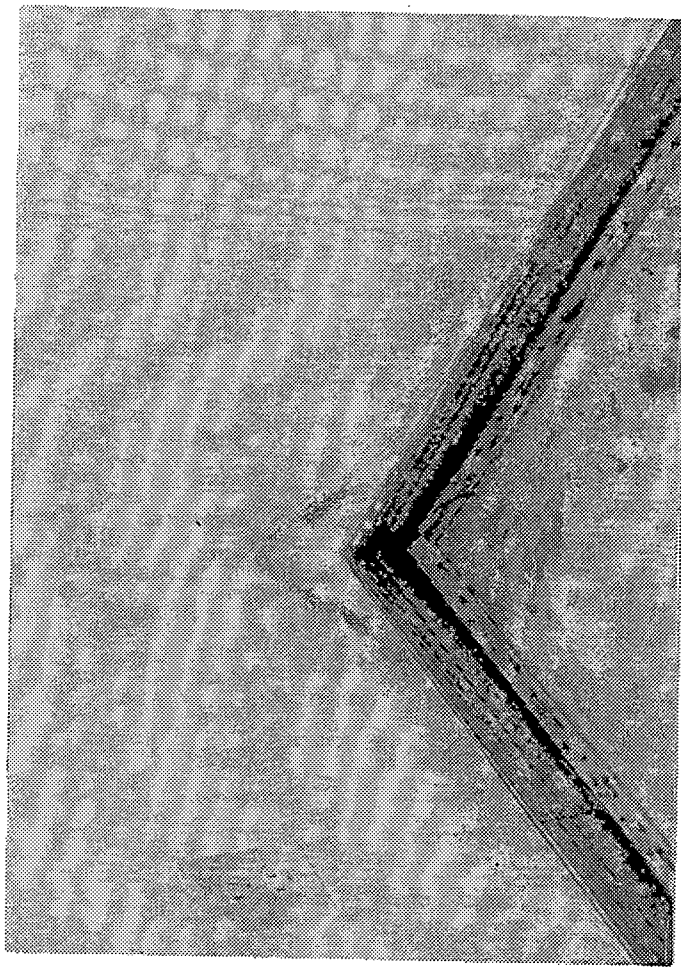
Time of occurrence	Winter
Location	Interior wall surfaces (Photo 4)
Cause	<ul style="list-style-type: none">• High relative humidity at local areas• Low surface temperature
Test methods	<ul style="list-style-type: none">• Visual inspection
Remedial measures	<ul style="list-style-type: none">• Improve insulation in wall• Increase ventilation to lower relative humidity

4. Mildew in interior wall surface

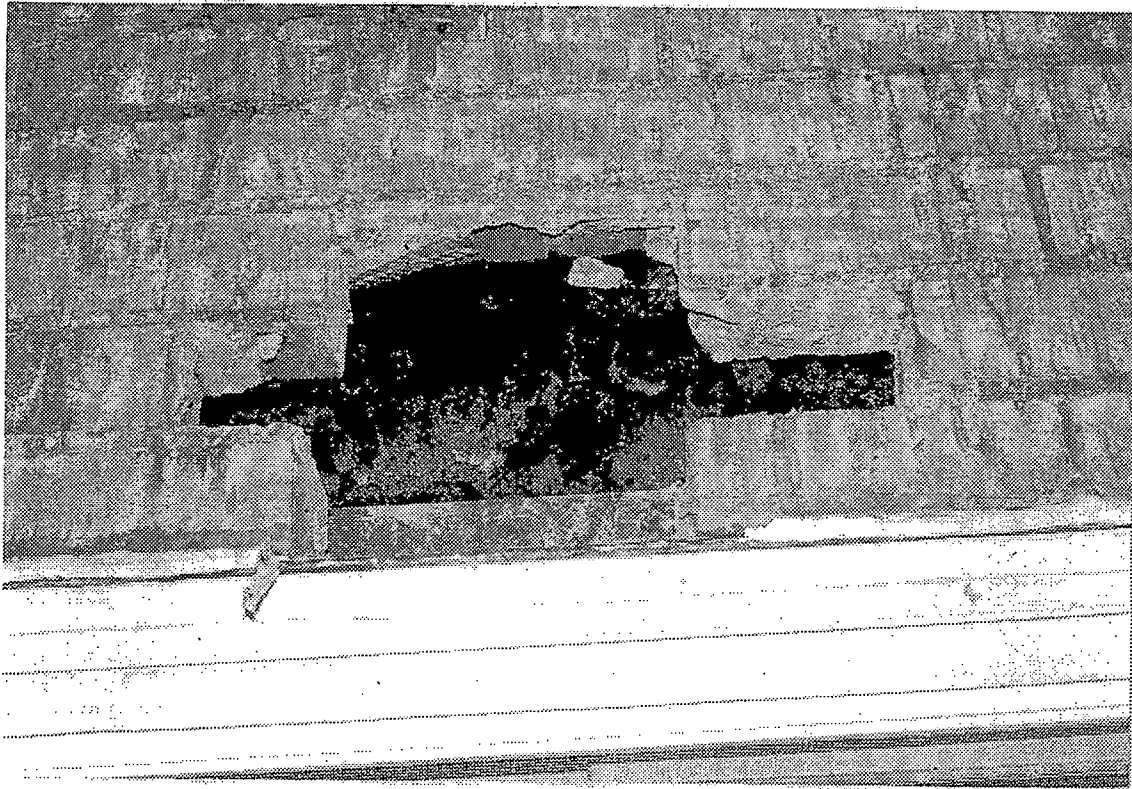
Time of occurrence	<i>Rain or wind-driven rain</i>
Location	<i>At head of openings</i>
Cause	<i>Absent, damaged or poorly installed flashing</i>
Test methods	<ul style="list-style-type: none"> • <i>Visual inspection</i> • <i>Removal of bricks above lintels (Photo 5)</i>
Remedial measures	<ul style="list-style-type: none"> • <i>Install adequate flashings and weep holes in brick veneer</i> • <i>For other sidings, install adequate flashing</i>

5. Removal of bricks above lintels to inspect flashing

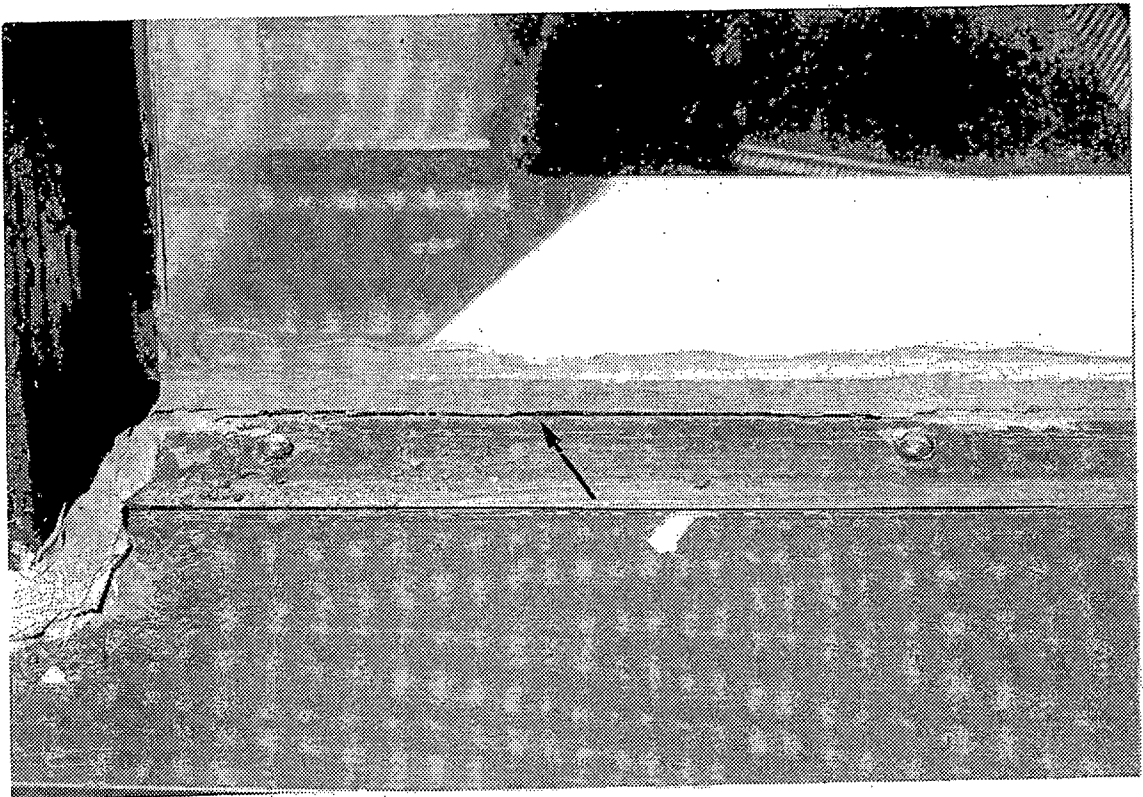
Time of occurrence	<i>Rain</i>
Location	<i>At bottom of openings</i>
Cause	<ul style="list-style-type: none"> • <i>Absent, damaged or poorly installed flashing</i> • <i>Absence or lack of slope on sills & balconies</i> • <i>Cracked caulking (Photo 6)</i>
Test methods	<ul style="list-style-type: none"> • <i>Visual inspection</i> • <i>Removal of bricks above lintels (Photo 5)</i>
Remedial measures	<ul style="list-style-type: none"> • <i>Install adequate flashing at bottom of opening</i> • <i>Provide 10% slope for sill & 2% slope for balcony</i> • <i>Redo the caulking</i>

6. Cracked caulking at bottom of openings

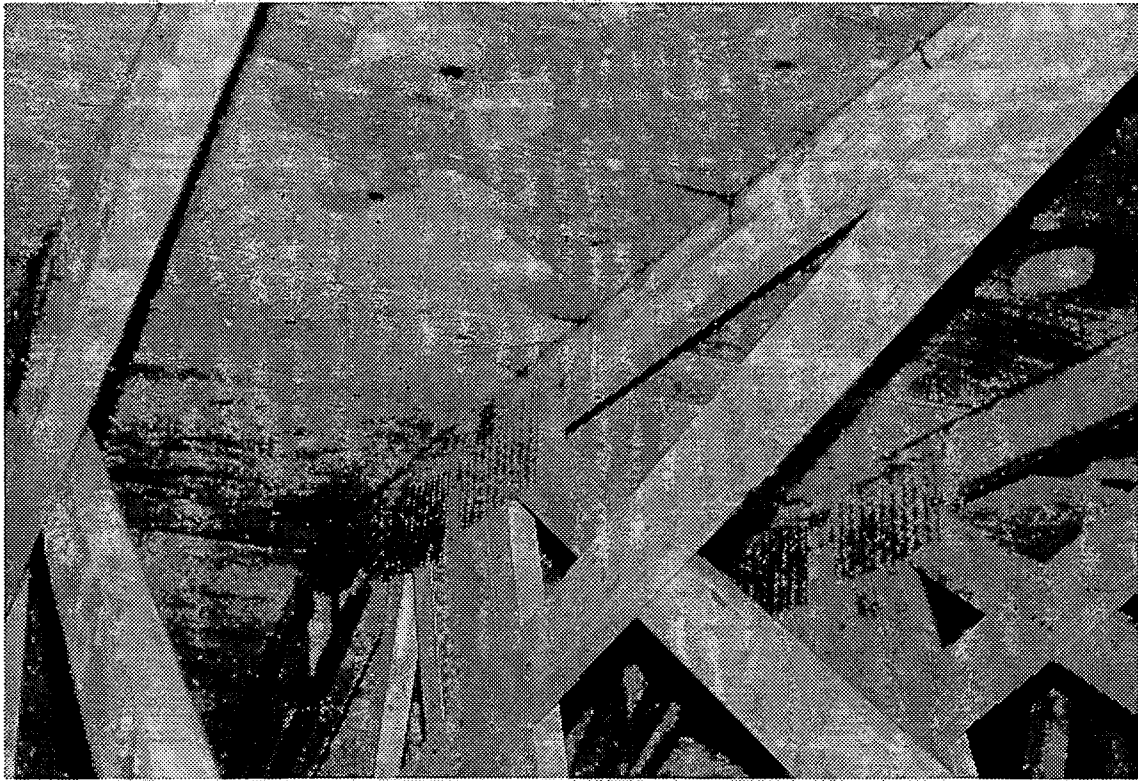
Time of occurrence	Winter
Location	<i>In attic space or within the roof assembly</i> <ul style="list-style-type: none"> • under roof covering (Photo 7) • around access trap (Photo 8)
Cause	<ul style="list-style-type: none"> • Air leakage from heated space • Lack or poor distribution of ventilation
Test methods	<ul style="list-style-type: none"> • Visual inspection (during cold periods) • R.H. and temperature measurement
Remedial measures	<ul style="list-style-type: none"> • Prevent air leakage from heated space • Provide adequate ventilation of attic or roof

7. Condensation under coverings

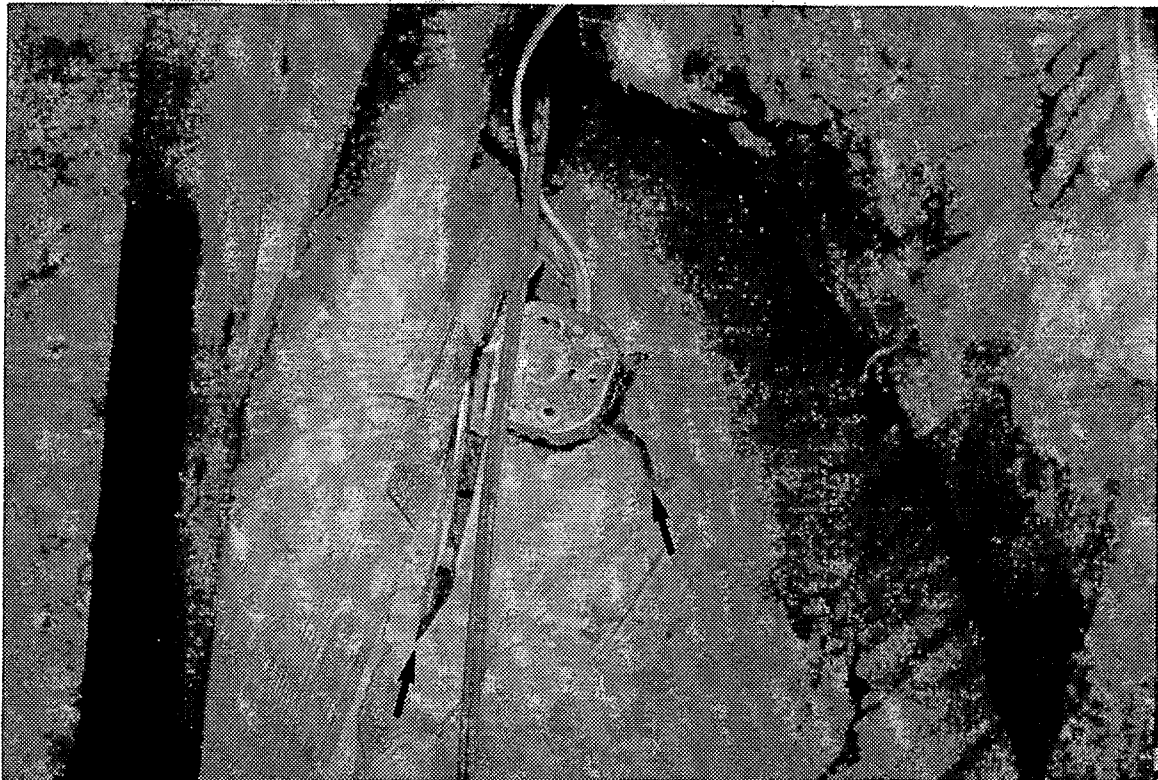
8. Damaged vapour barrier around traps & lights
