Canadian Aviation Service Difficulty Reports

The following content was published between July 13, 2018 and September 30, 2018.

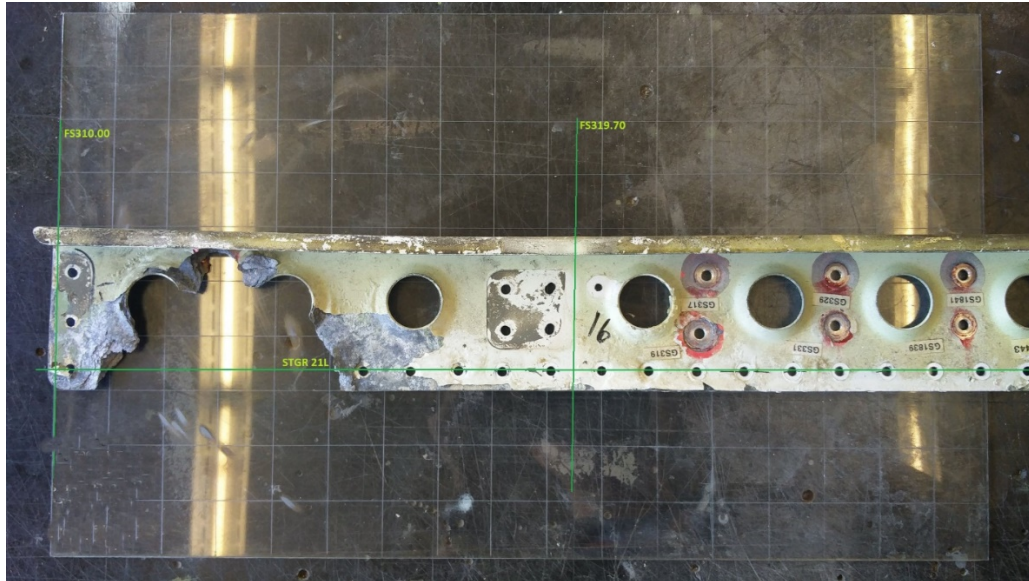
While investigating an unrelated defect, corrosion was found in the area under the floor near the passenger door. Maintenance staff removed and replaced the intercostal from frame fuselage station (FS) 310 to 333.00 and from stringer (STR) 25L to 26L as per Structural Repair Manual (SRM) 51-00-00 and Bombardier Aerospace drawing number SH670-31810. Additional corrosion was discovered on the foot of the frame at FS 319.70 between STR 20L to 21L. This frame was also removed and replaced with a new frame as per SRM 51-00-00 and Bombardier Aerospace drawing number SH670-31810. Please see the attached pictures to view the damaged pieces and severity of the corrosion.

While the submitter does not specify a cause, it is likely that the corrosion was the result of water and moisture that passed through the floor and accumulated in the bilge area. This location is susceptible to water ingress because it is a high traffic area and is often subjected to the outside elements such as rain and snow. When the stairs are raised, any water or melting snow will also drip onto the floor and may then pass through the floor seals. On many models of this aircraft a galley is also located nearby, providing opportunity for spilled liquids.

Corroded intercostal

After discovering this corrosion, the operator chose to update its company's corrosion protection and control program, to better address this issue.

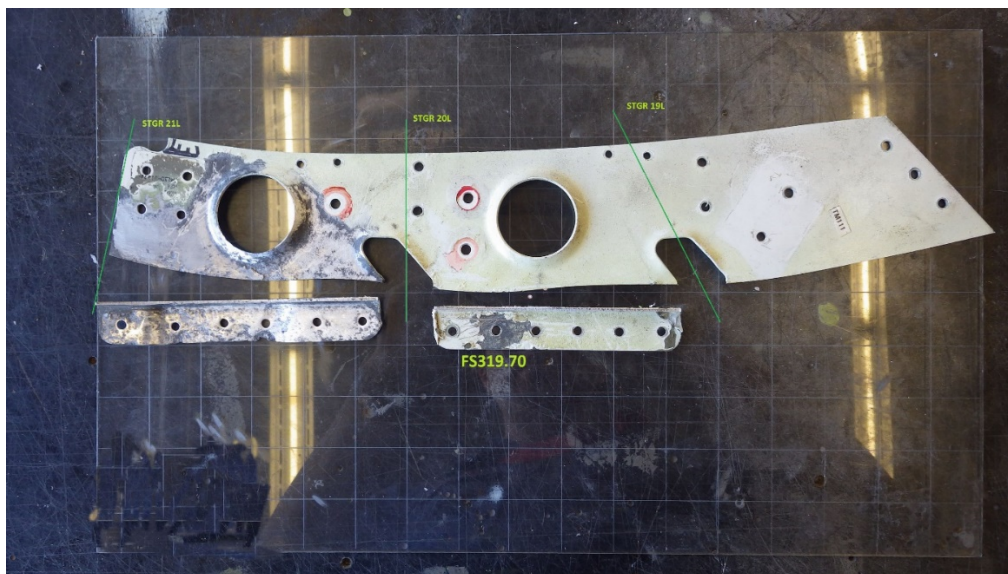
FS 319 frame corrosion

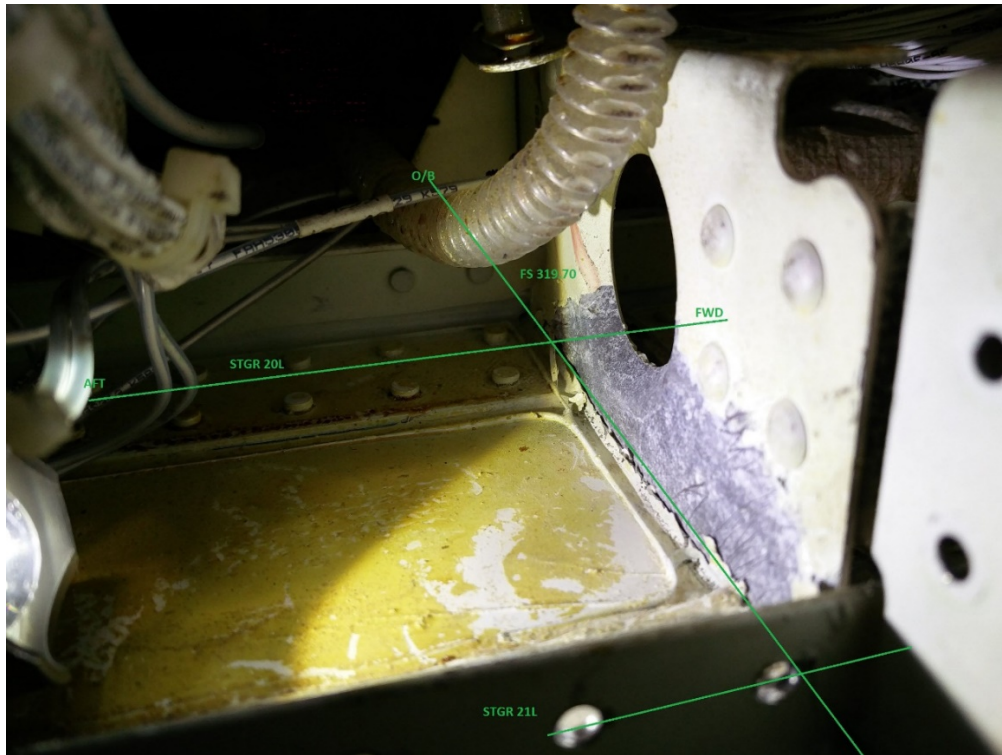
View of corrosion in situ

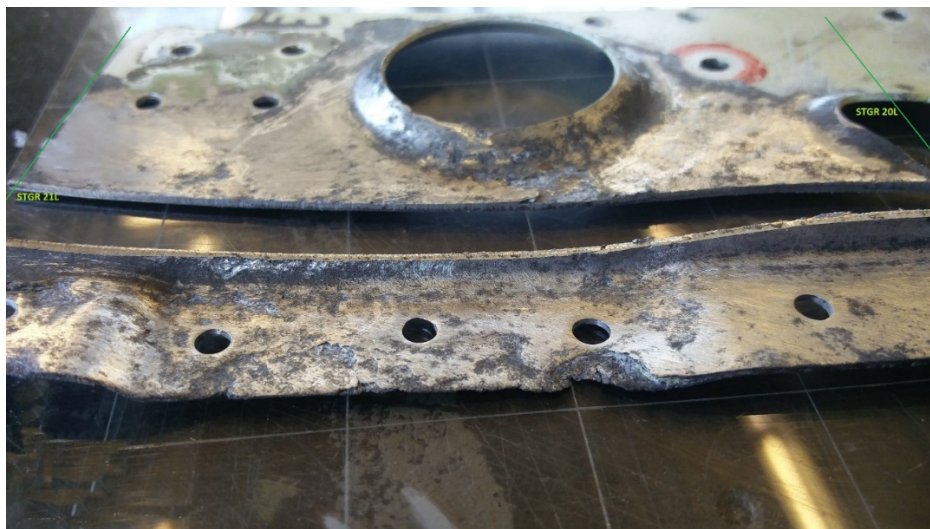
Heavily corroded structure

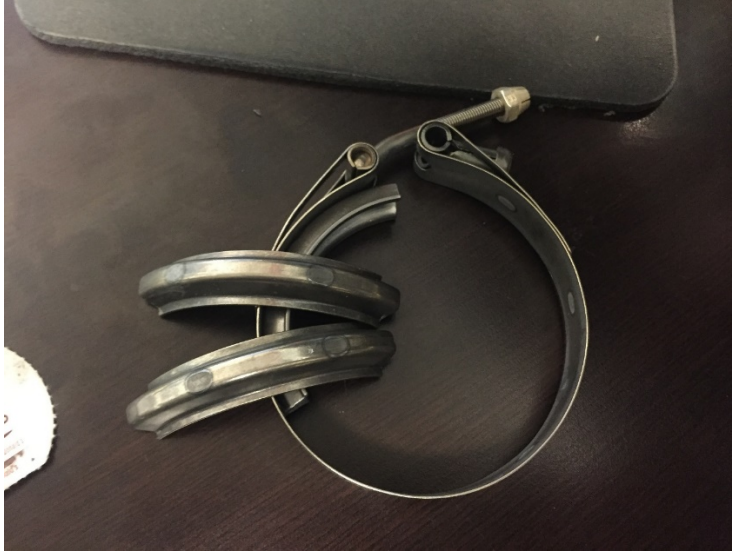
V-band couplings and clamps can be found on many general aviation and commercial aircraft. These units are frequently used to attach exhaust and turbocharger assemblies. This important, yet often overlooked item, plays a critical role in the function and safe operation of the aircraft. Failure of these items has led to serious in flight emergencies including engine power loss, engine failure and in flight fire. The difficulty with these items is that due to the nature of the installations, they are often extremely hard to inspect. Some of the issues that can arise from normal operation (due to the harsh operating environment) can include cracking, loosening of fasteners and weld breaks. It has been reported to Transport Canada that some of these units from PMA (Parts Manufacturing Approval) manufacturers have failed even when new (as seen in the photo below –spot welds not holding together).

V-Band Coupling and Clamp

Recently the Federal Aviation Administration (FAA), in conjunction with an industry working group, released a 'best practices guide' regarding V-band couplings / clamps. This article contains a great deal of valuable information regarding the installation, inspection and maintenance of these units. Transport Canada recommends that operators and maintainers of aircraft equipped with these couplings review this article. The following is the link to the FAA best practice guide:

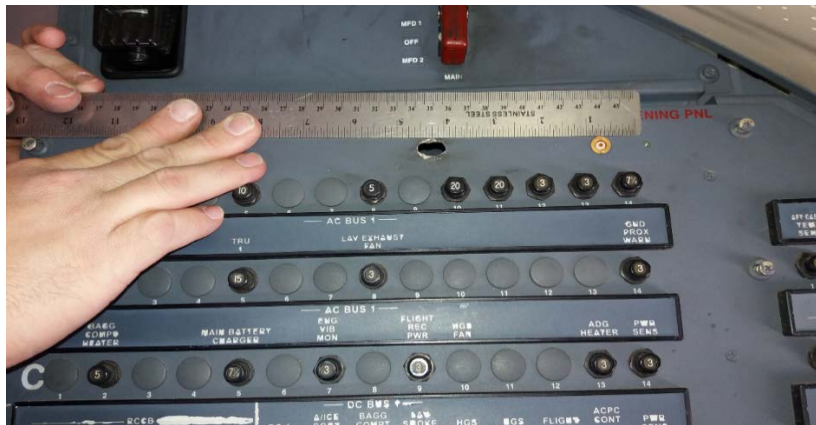
The left hand cockpit main circuit breaker panel was burned through when a foreign metal object contacted the windshield wiper circuit breaker and grounded to the panel door skin. The ensuing electrical arcing burned through the panel creating a hole.

The burnt part of the panel is actually a door which hinges down in order to provide access to the circuit breakers for maintenance and inspections. It is likely that during some previous maintenance event that the foreign object was dropped or left inside the panel. The object then moved and shorted out the wiper circuit breaker causing the damage to the panel door.

Panel showing external hole width

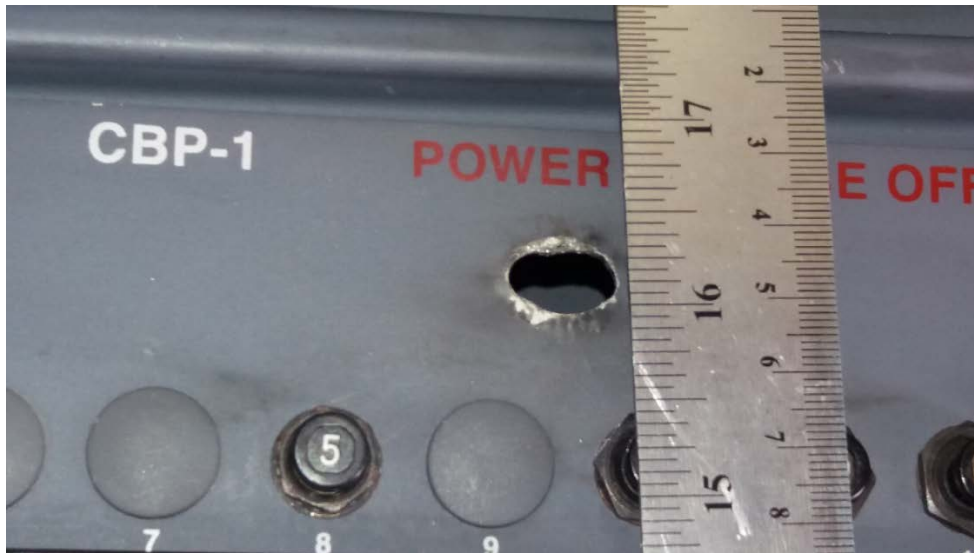
Panel showing external hole height

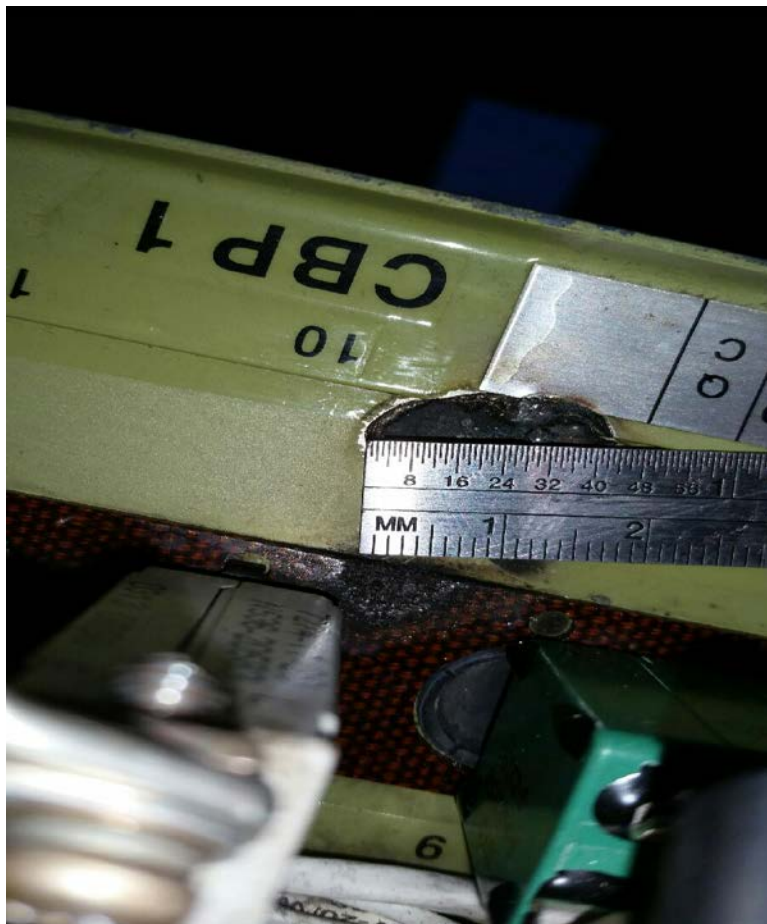
Panel inside showing burnt rail hole size inside panel

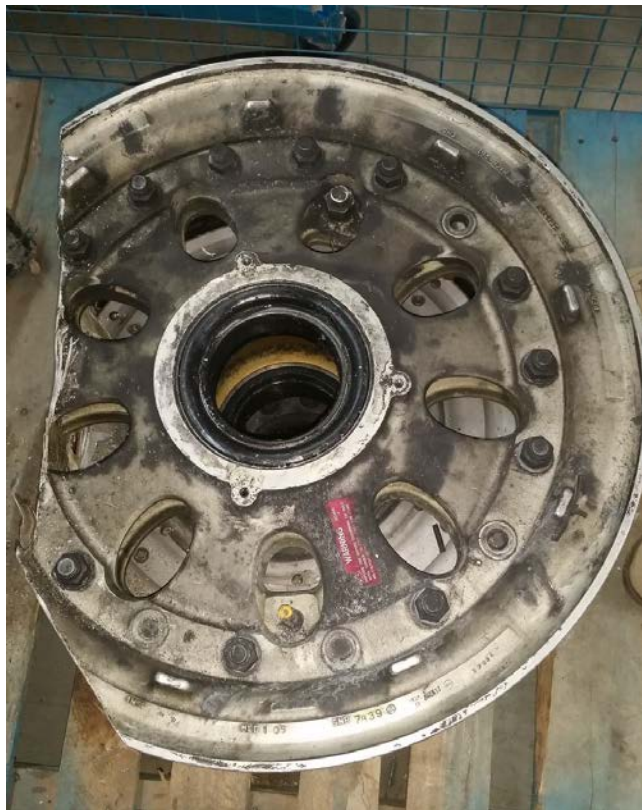
The number 1 and 2 wheel assembly halves were found still held together by the tie bolts. The number 1 wheel assembly had four sheared tie bolts and all the bolts appeared to be intact on the number 2 wheel assembly. The wheel fuse plugs on both wheel assemblies were inspected and found to be intact. The aircraft servicing history was reviewed and no abnormal servicing issues were noted since the installation of the wheel and tire assemblies.

1. All bolts were evaluated and met specifications for hardness, coating and material (H-11 steel) with no indications of a batch or quality issues.
2. The cause of the six fractured bolts was found to be fatigue. Four bolts were found with cracks initiating from the 8th to 9th thread root and two bolts were found with cracks initiating from the under-head radius transition area.
3. No abnormal cause of the fatigue cracking was detected (corrosion, mechanical damage).
4. Overload fractures detected on three of the six bolts were assumed to have occurred during the take-off roll.
5. No indication of bolt stretch was observed.

Wheel showing wheel damage and missing tie bolts

The original equipment manufacturer (OEM) was contacted and reported that they were unaware of any problems with tie bolts in industry. The operator initiated a fleet campaign replacement of all bolts, and limited the bolts to less than the OEM recommended service life, in an effort to prevent these issues. The reduced service life program has worked and reduced the failure frequency. One SDR has been reported since July 2016 where a loose bolt was found during maintenance.

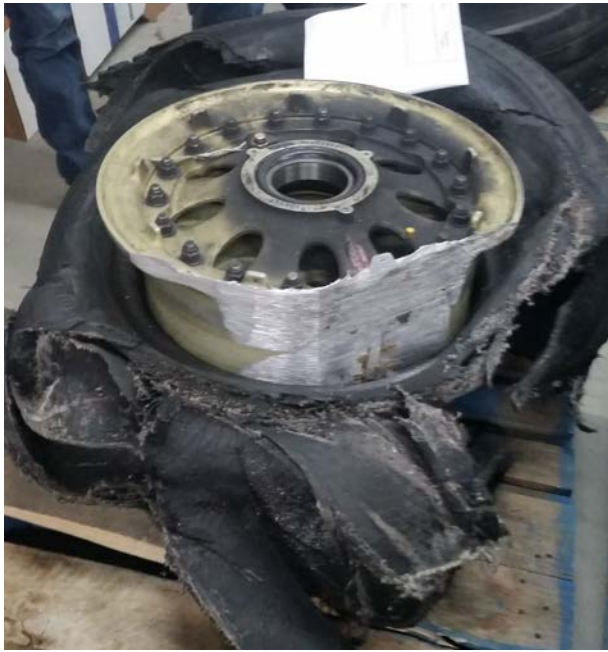
When maintenance arrived at the aircraft, they confirmed that the number 1 and 2 tires had blown and that damage was also found to the wheel halves. The cause of the tire blowout was unknown, but all affected components were changed out and sent to the appropriate vendor for assessment.

Wheel and tire damage

All wheel assemblies and the number 1 and 2 brakes were replaced to return the aircraft to service. The service difficulty report (SDR) will be updated with all findings following vendor analysis.

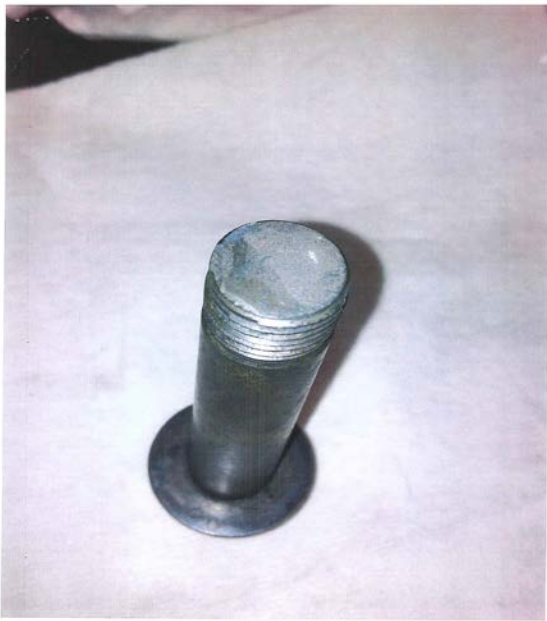
Photo of a sheared tie bolt showing fracture at threads

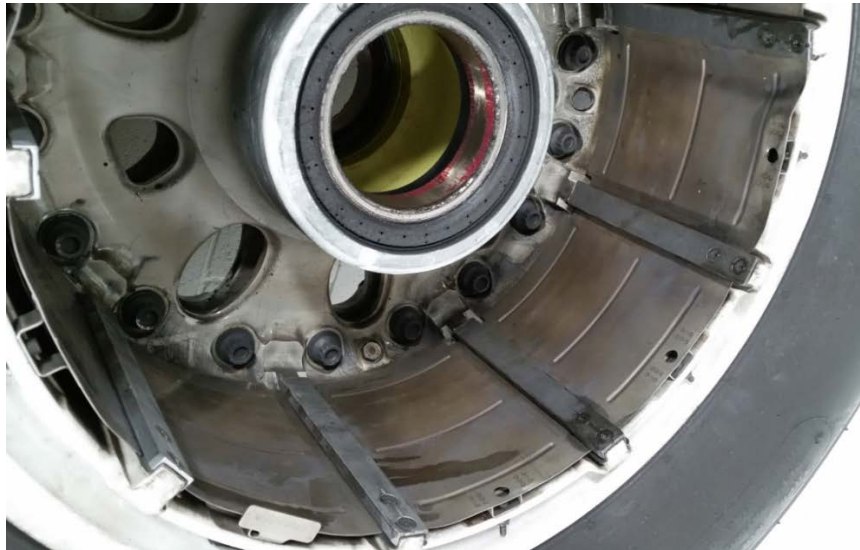
During a gear inspection, the maintenance staff noticed the appearance of loose metal inside the aperture of the rim. After removal of the wheel and brake assembly, the brake disk retainer was found loose and metal was also seen coming from the brake disks assembly. The metal brake disk retainer had started to wear a groove in the interior of the wheel rim and a piece of metal was removed from the brake disk assembly.

Figures 1a and 1b - Brake disk retainer showing the wheel assembly wear (location and close up)

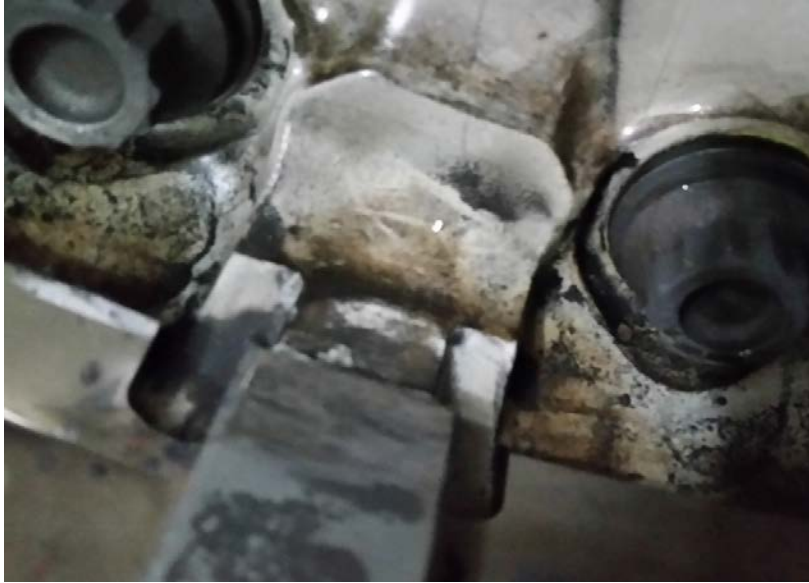
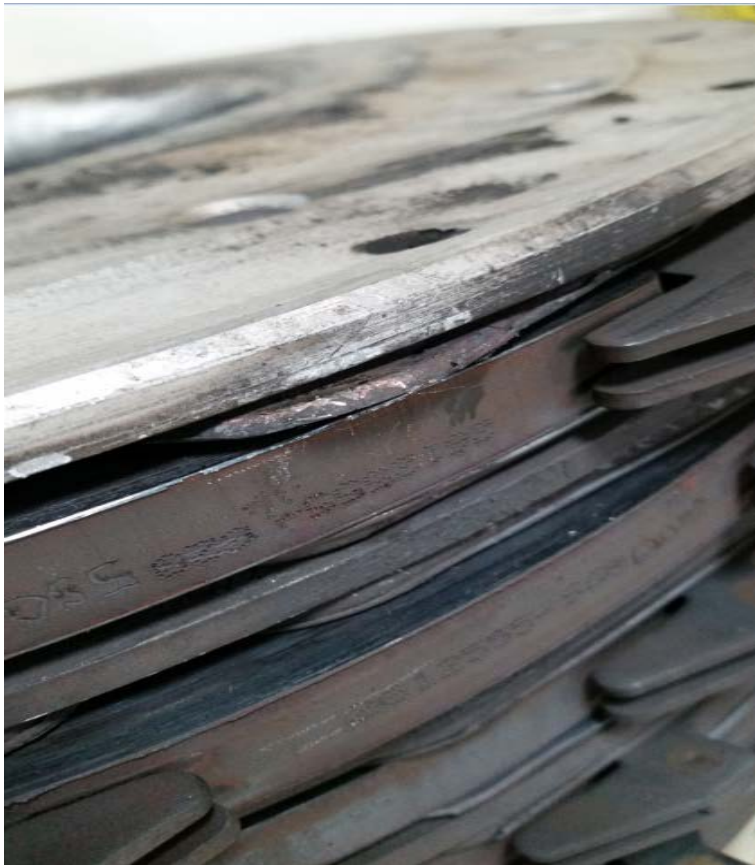
Figures 2a and 2b - Loose metal found inside brake assembly (where found and what it looked like

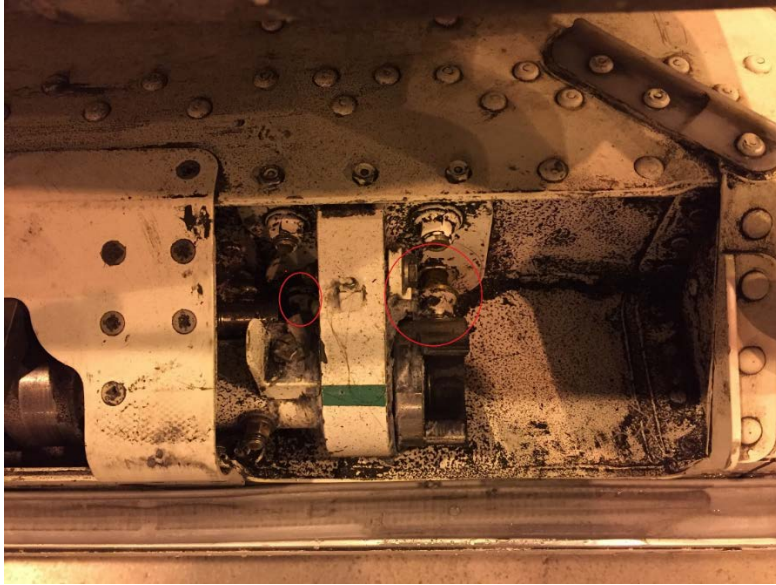
Maintenance heard an object falling inside the main cabin door when it was opened; which turned out to be a sheared bolt. Further investigation revealed that two (2) of the cabin door upper aft latch fitting (part number 601R31805-5) bolt heads had sheared off. These bolts are not normally visible as they are underneath the folding bottom step when the door is in the open position. The door fitting area was accessed and the broken bolts (part number NAS6605-14 and NAS6606-15) were replaced.

The analysis of the damaged parts determined that the bolt heads failed due to corrosion. A safety assessment completed by Bombardier found that the bolts are part of a multi- load path and the remaining bolts and fittings are adequate to secure the door. The latest two (2) failures were found to occur between 18 000 Flight Cycles (FC) and 19 000 FC, but there have been three (3) similar Service Difficulty Report (SDR) events recorded in the Transport Canada Civil Aviation SDR database since 2014. The current inspection program was reviewed and the Maintenance Requirements Manual (MRM) prescribes a detailed visual inspection (DVI) of the backup structure at a threshold of 16 600 FC with a repeat interval of 6000 FC based on the initial investigation.

Upper fitting sheared bolts shown

The current inspection task does not specify removal of the bolts, and operators may wish to consider removal of the bolts to allow a more detailed inspection for corrosion as the bolt heads, when installed, are hidden from view. These defects have all been reported on RJ705 aircraft and this model shares the same door with the RJ900 aircraft.

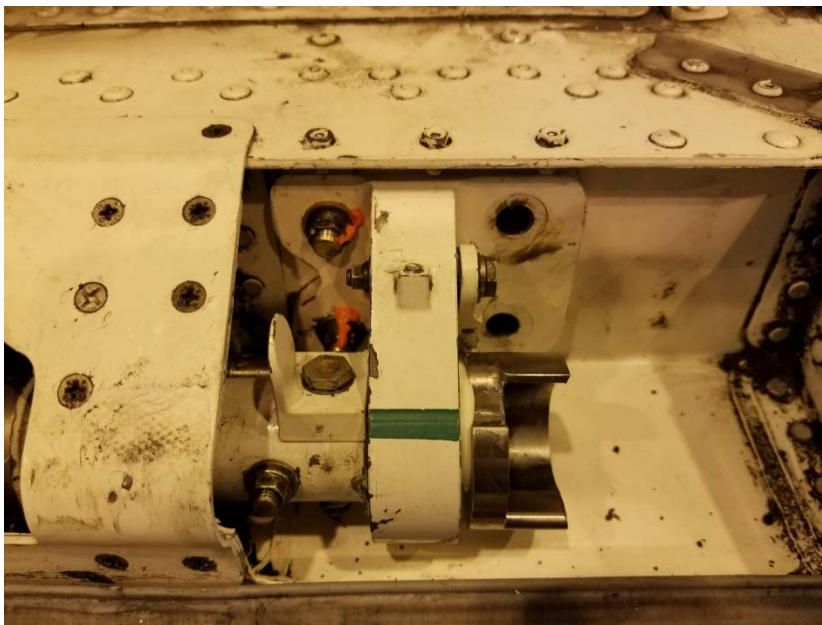
Close up of fitting

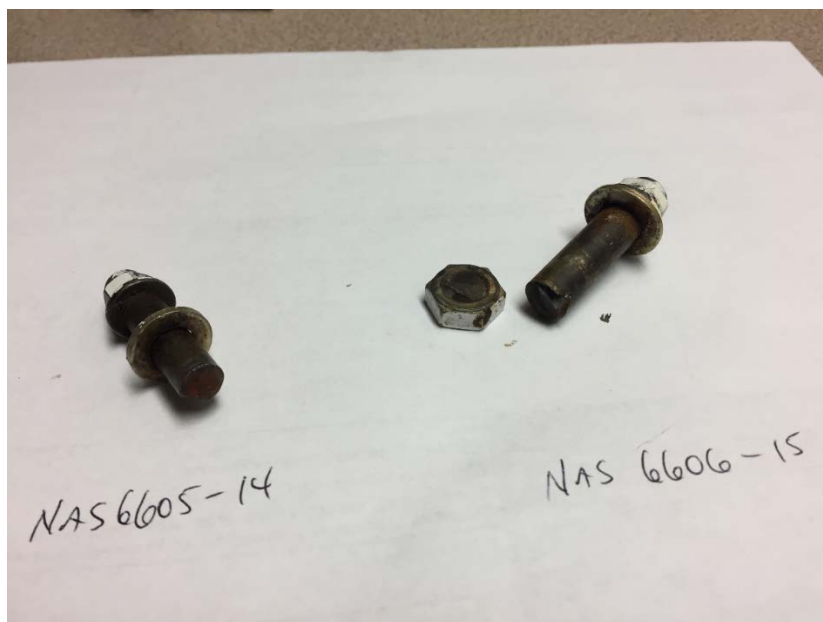
Sheared bolts after removal

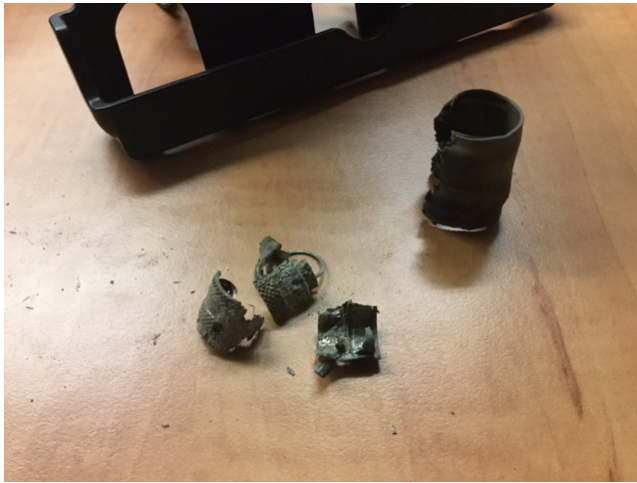
A pilot reported just before landing, a yellow advisory message "air/ground fail" and "RH weight on wheel fault". Upon inspection of the right hand (RH) weight on wheels switch, the cannon plug was found to be severely corroded and disintegrated into multiple pieces when trying to remove it. This

cannon plug was covered by heat shrink, well-sealed at both ends and showed no sign of any faults from an external visual inspection.

Corroded pieces of cannon plug back shell.

This is a good reminder about landing gear electrical components and the effects that our Canadian climate can impose on them. Extra care should be taken when inspecting this area of the aircraft. If necessary, remove heat shrink and coverings to get a closer look.

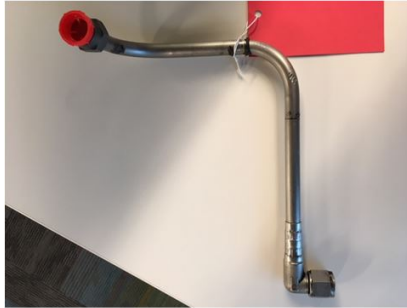
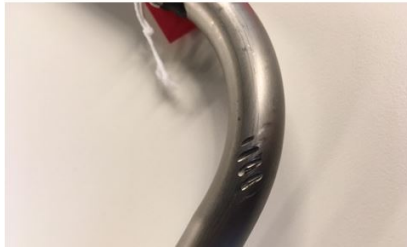
The standby power unit to the reservoir hydraulic line was found with chafing damage. The line was replaced and the aircraft was subsequently released for service.

Chafed line with damage almost through the wall thickness of the line.

When inspecting hydraulic lines, make sure that areas that are tight, or areas where lines may come in contact with other lines or structure, are protected from chafing.

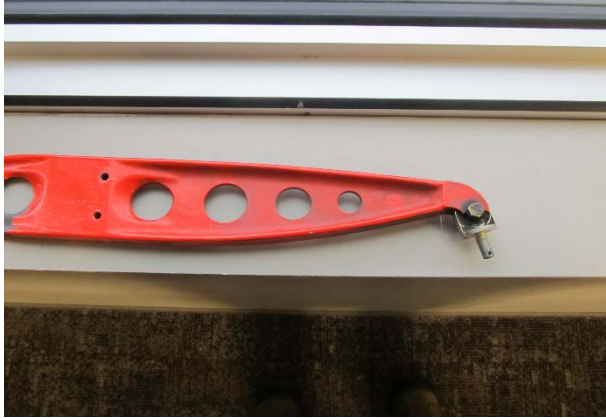
During two separate incidents, an operator of the DC3C with the Basler turbo prop conversion has found cracked outboard elevator attachment hinge fittings. The first incident occurred during a pilot pre-flight walk around. The pilot was checking for free play at the left-hand elevator and noted a clunking sound while shaking the elevator. Further investigation found that the left-hand outboard elevator attachment hinge horn was broken at the bolt attachment.

Hinge with missing piece

In both cases, the elevator attachment hinge was replaced with a serviceable part and the aircraft returned to service.

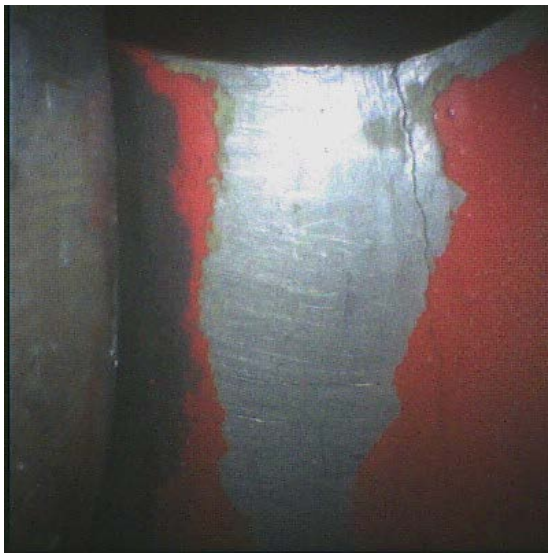
The second incident occurred during a 150-hour inspection. A close visual inspection of the elevator attachment hinge fitting, located on the right-hand outboard stabilizer location, showed signs of cracked paint. The AME further examined the area closely with a borescope and detected a crack. The crack was not visually detectable without the aid of magnification, such as a borescope, due to the limited access while the elevator is installed.

Close up, borescope view of hinge end with crack
