Air Transportation Safety Investigation Report A1900026

COLLISION WITH TERRAIN

Robinson Helicopter Company R66 (helicopter), C-GAUA
Timmins (Victor M. Power) Airport, Ontario, 18 nm WNW
04 March 2019

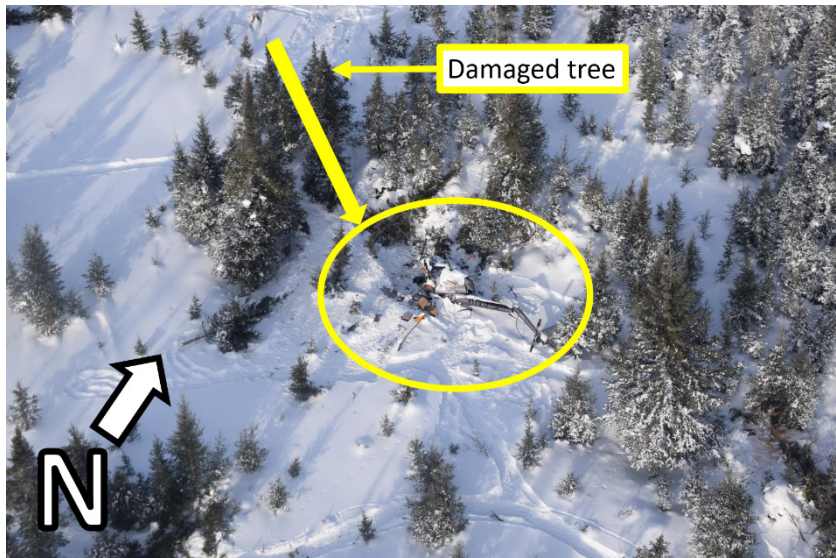
There was tree damage at the top of a coniferous tree located approximately 10 m (33 feet) west-northwest of the impact site (Figure 2). The tree damage and the damage to the helicopter indicated that the aircraft was in a steep nose-down, left-bank attitude when it struck the ground, on an approximate heading of 120° magnetic.

The helicopter then pitched over and came to rest on its back. The tail boom had snapped at approximately the midpoint, and there was minor damage to the tail rotor. The main rotor blades were mostly buried in the snow, but showed significant damage when uncovered. All portions of the main rotor blades were still attached to the mast, which was partially separated from the helicopter. The gearbox and the engine (Rolls Royce RR-300) had broken free of their mounts. There was a strong odour of jet fuel at the site.

Figure 2. Accident site, with the aircraft wreckage circled and an arrow showing the direction of impact (Source: TSB)
