# Air Transportation Safety Investigation Report A19W0052

## ENGINE POWER LOSS AND FORCED LANDING

Buffalo Airways Ltd.  
Douglas DC3C-S1C3G, C-GJKM  
Hay River/Merlyn Carter Airport, Northwest Territories  
03 May 2019

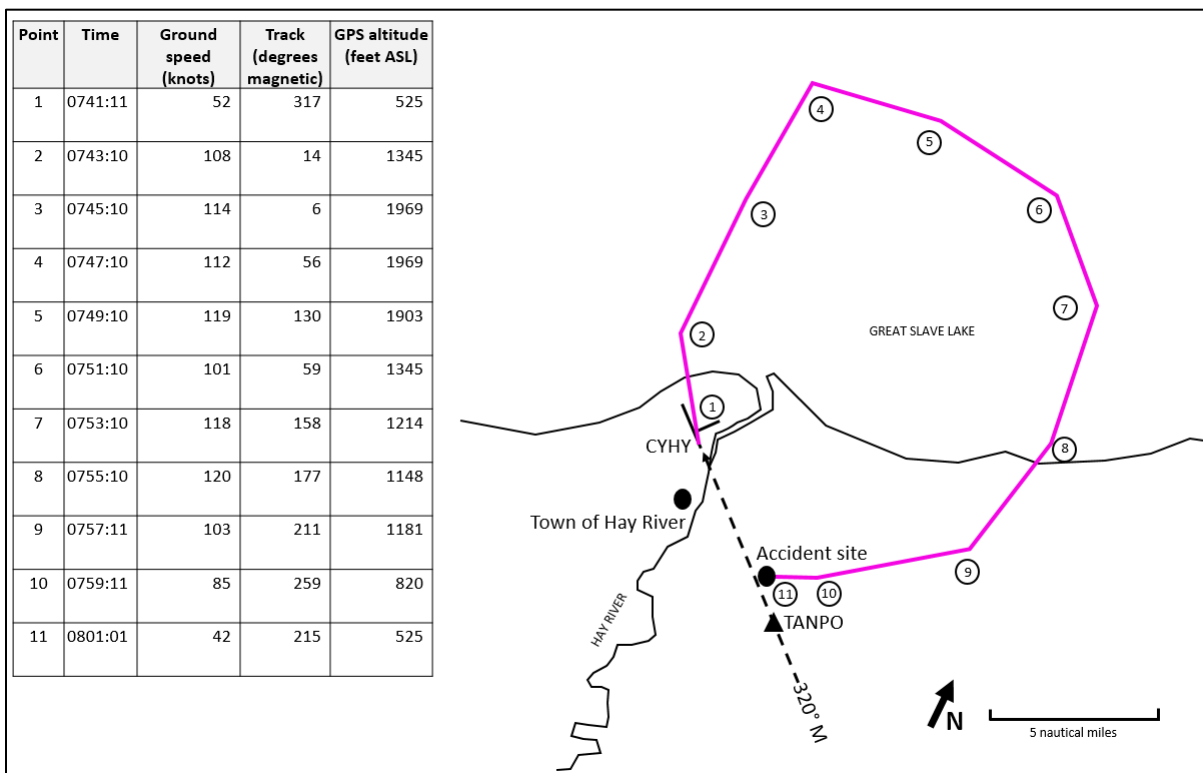
**Figure 1. Satellite tracking information retrieved from the occurrence flight. The magenta line is the aircraft's track. (Source: TSB, based on data received from Latitude Technologies Corporation)**

As the aircraft reached an altitude of 1969 feet ASL (Figure 1, point 3), the captain set the left engine to a reduced power setting and increased the power on the right engine to maximum except takeoff

At 0747 (Figure 1, point 4), while the aircraft was in a right turn proceeding towards TANPO, smoke and oil were observed, and abnormal sounds were heard coming from the left engine. Using the engine failure checklist, the flight crew then shut down the left engine and feathered the propeller. At 0748, because the situation had escalated, a MAYDAY emergency<sup>7</sup> was declared. Moments later, the flight crew completed the descent checklist and initiated the approach checklist. However, due to the escalating emergency, the flight crew was not able to complete the approach checklist, which included the landing briefing.

At 0753 (Figure 1, point 7), the aircraft levelled off at 1214 feet ASL. The FO observed zero hydraulic pressure on the landing gear DOWN gauge.<sup>8</sup> Thinking this zero pressure was an issue, he mentioned it to the captain, who then directed the FO to “prep the gear.” The FO extended the landing gear, which the captain did not expect because the aircraft had not started its final approach and the airport had not been visually acquired.

At 0755 (Figure 1, point 8), as the aircraft continued towards TANPO, the altitude was between 1200 and 1300 feet ASL, and the airspeed was maintained at approximately 100 knots indicated airspeed (KIAS). When the aircraft was abeam TANPO, the captain began a right turn to intercept the localizer for the final approach. The aircraft’s airspeed decreased from 100 KIAS to 80 KIAS, while its altitude decreased to 1100 feet ASL. With the reduced airspeed, the aircraft’s flight control response became sluggish and the captain directed the landing gear to be raised (Figure 1, point 9).

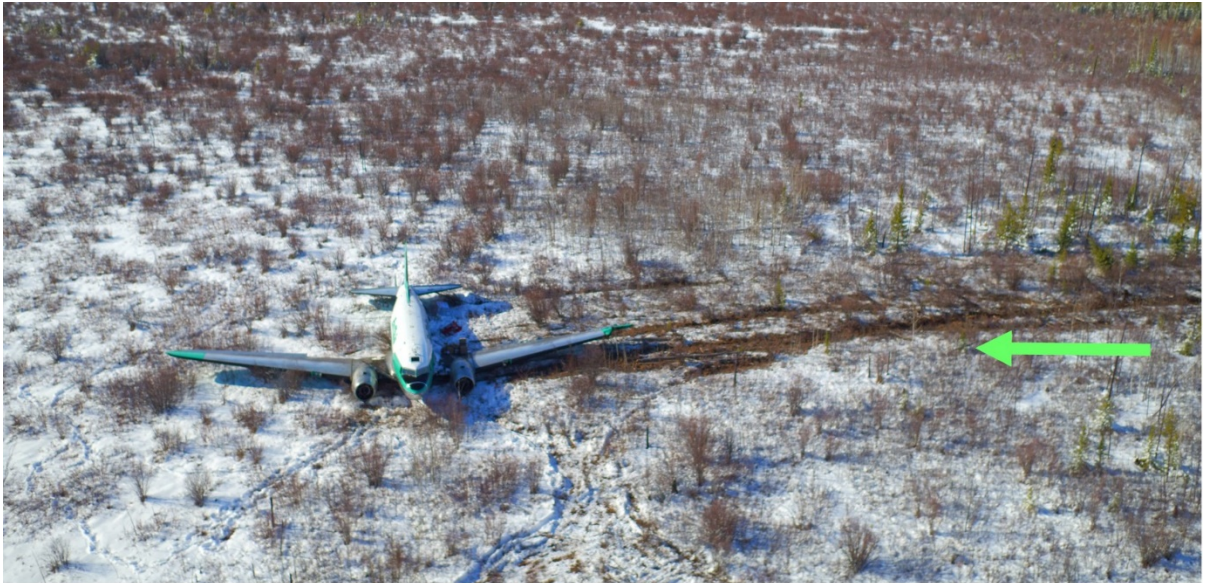
locating the aircraft. The flight crew was uninjured. The aircraft received substantial damage (Figure 2). There was no post-impact fire. First responders arrived at the accident site at 1114.

**Figure 2. Aerial photo of the accident site looking northwest. The green arrow indicates the aircraft's path on touchdown. (Source: K'atl'Odeeché First Nation, with TSB annotation)**
