Air Transportation Safety Investigation Report A19W0094

HARD LANDING

WestJet Encore Ltd.
Bombardier DHC-8-402, C-FKWE
Edmonton International Airport, Alberta
19 July 2019

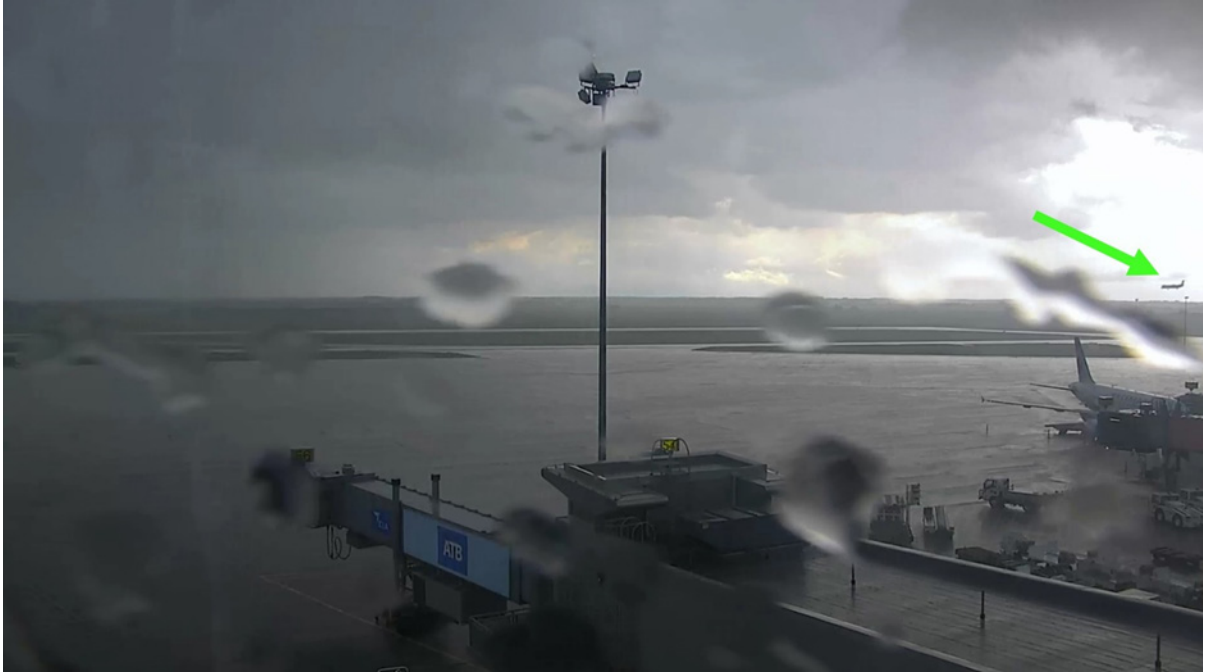
A large thunderstorm cell situated to the northeast of the airport was advancing to the southwest and was over the departure end of Runway 12 as the occurrence aircraft landed (Figure 1).

Figure 1. Closed-circuit television image of Runway 12 taken from Gate 54, looking south, just before the occurrence aircraft (identified by green arrow) landed (Source: Edmonton Airport Authority, with TSB annotation)

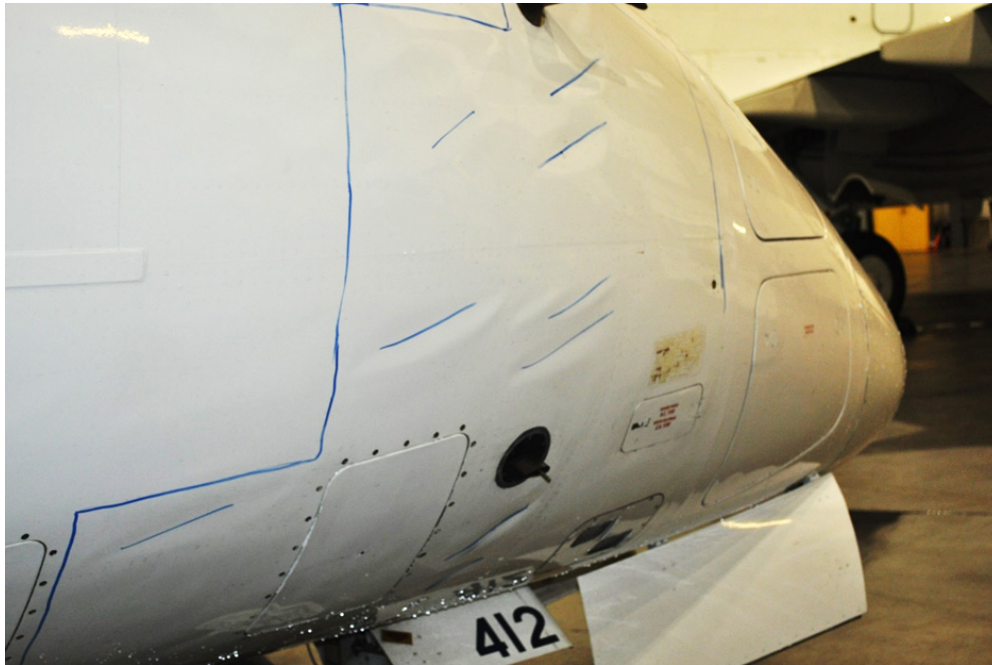
After the passengers deplaned at the gate, WestJet Encore Ltd. maintenance personnel performed a more detailed inspection of the occurrence aircraft, which revealed wrinkled fuselage skins (Figure 2)

as well as damage to the left nose-gear door, the forward pressure bulkhead, and the nose-gear assembly.

Figure 2. Wrinkled skin on the right side of the nose (blue dry-erase marker added for clarity) (Source: TSB)

The data also indicated that the large nose-down elevator deflection at touchdown resulted in the nose being lowered at approximately 10 degrees per second, compared with 4 degrees per second, which was the highest rate of nose-lowering recorded during prior landings.

In this occurrence, the aircraft's speed was not reduced from its approach speed ($V_{REF} + 20$ KIAS) to the touchdown speed (V_{REF}). The nose of the aircraft was lowered at a higher rate than normal, resulting in damage to the aircraft. These highlight the importance of flight crews adhering to operational procedures and techniques.
