Air Transportation Safety Investigation Report A19Q0096

COLLISION WITH TERRAIN

Rans S-6ES Coyote II (advanced ultralight), C-IIIJ
Rougemont, Quebec
01 July 2019

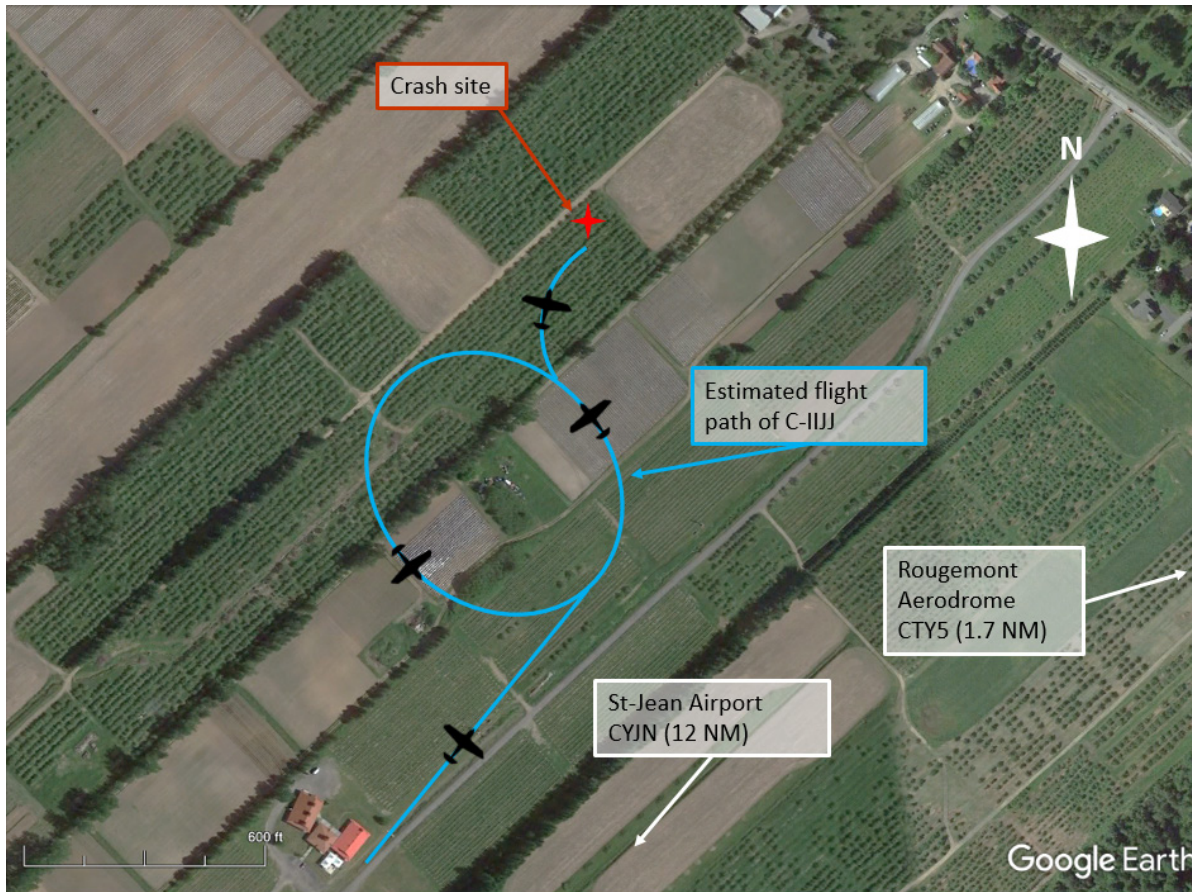
approximately 1135, the aircraft changed direction and turned northeast. It lost altitude and crashed into the orchard trees (Figure 1). The 2 occupants were fatally injured. No signal was detected from the emergency locator transmitter (ELT).

Figure 1. Estimated flight path of the occurrence aircraft (Source: Google Earth, with TSB annotations)

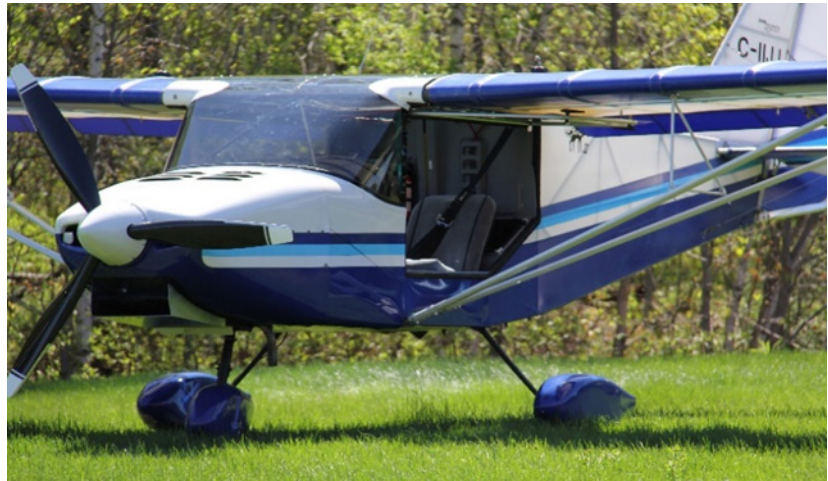
The Rans S-6ES Coyote II is a 2-seat, high-wing advanced ultralight aircraft made from metallic tubes covered in fabric (Figure 2). The aircraft was built in the United States in 2008. It was imported into Canada in early 2009 and inspected by a Rans representative, because it had never flown. The manufacturer then issued a certificate of compliance on 04 May 2009. When the aircraft was purchased on 09 January 2019, its technical logbook indicated that the aircraft had accumulated 336 flight hours since its construction.

Figure 2. Occurrence aircraft (Source: former owner of the aircraft)
