# Rail Transportation Safety Investigation Report R19Q0092

## PASSENGER INJURY

Passenger train VIA 600

Jonquière, Quebec

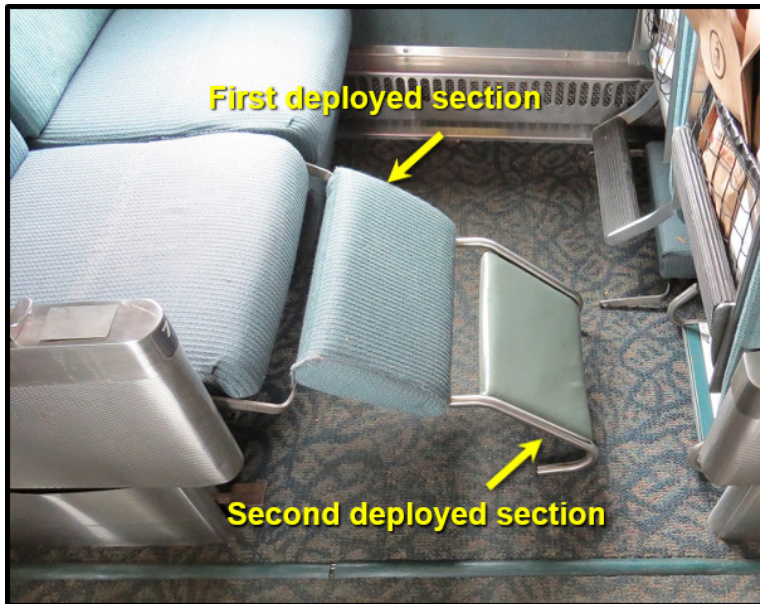
The stowable legrest assembly is composed of 2 sections attached to each other that support the full length of the passenger's legs (Figure 4). The legrest assembly is deployed in 2 separate steps. First, the legrest assembly is pulled out of its stowed position under the seat and moved forward. Second, the bottom section of the assembly is unfolded forward and brought to rest on the floor. The legrest assembly weighs about 5 kg.

Figure 4. Seat 7B with its stowable legrest deployed (Source: TSB)

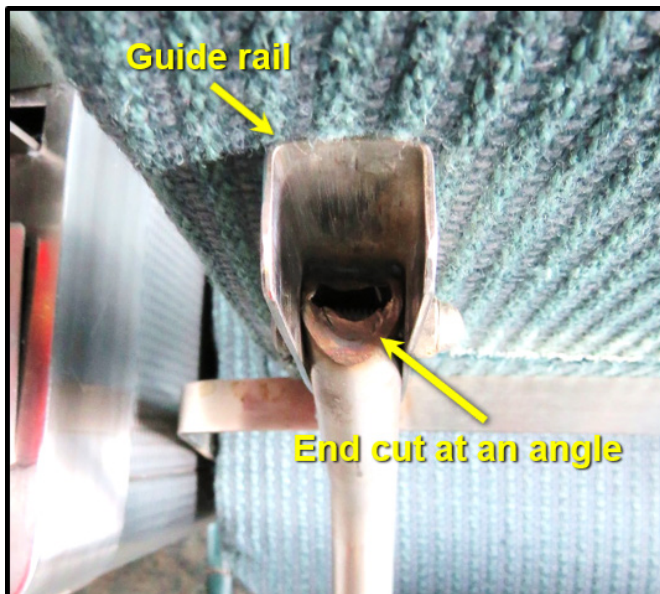
The first section of the legrest is attached to each side of the seat by 2 pivoting metal arms. The second, smaller section unfolds with 2 pivoting arms made of metal tubing that slide into guide rails attached to the bottom of the first section. The ends of the metal tubes are cut at an angle to allow them to pivot freely from front to back and vice versa within the metal guide rails (Figure 5).

Figure 5. Metal tube on the second section of the legrest assembly (Source: TSB)

The passenger was trying to deploy her seat's stowable legrest assembly to familiarize herself with its operation so that she could help another passenger travelling with her. While the passenger was raising the sections of the assembly, the tip of her right ring finger got stuck between the end of the metal tube and the guide rail. When the second section of the legrest assembly fell forward, the

passenger felt a sharp pain in her right hand. The tip of her finger, starting at the base of the fingernail, had been severed by the tapered end of the metal tube. She immediately informed the person responsible for the group she was travelling with that she had been injured and needed emergency medical care.

The Transportation Safety Board of Canada (TSB) performed a reconstruction of the accident using the same seat. This reconstruction showed that little protection is provided for a passenger's hands and fingers when operating of the legrest assembly. Furthermore, no signs were posted near the seats instructing passengers on how to deploy the stowable legrest assembly or warning them of the risks involved in its operation.

In 2018, VIA launched the Heritage Program in order to renovate and modernize a large portion of its fleet, including 25 of the 43 VIA HEP 1-type Economy Class passenger cars. The renovation of the first cars is expected to be completed in early 2020. As part of this program, VIA had already started to modify the stowable legrests in these cars by removing the sharp edges of the metal tubes and installing a plastic tip.

VIA will continue to examine the stowable legrest assembly and will assess if other modifications are necessary.
