Marine Transportation Safety Investigation Report M18A0076

CAPSIZING WITH LOSS OF LIFE

Unnamed fishing vessel
Medway Harbour, Nova Scotia
05 May 2018

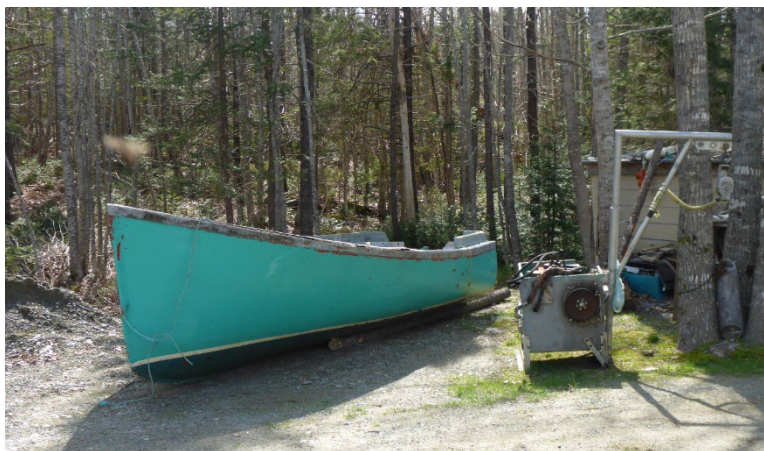
The occurrence vessel, which was unnamed, was a 5.79 m fishing vessel of open construction and made of fibreglass (Figure 1). The vessel was powered by a 25 hp, 4 stroke outboard motor, and was equipped with a trap hauler driven by a gasoline engine and had an on-board battery-powered electronic fish finder.

Figure 1. The occurrence vessel, with trap hauler beside it (Source: TSB)
