Marine Transportation Safety Investigation Report M19C0387

BOTTOM CONTACT

Bulk carrier *Kaministiquia*
Kahnawake, Quebec
27 November 2019

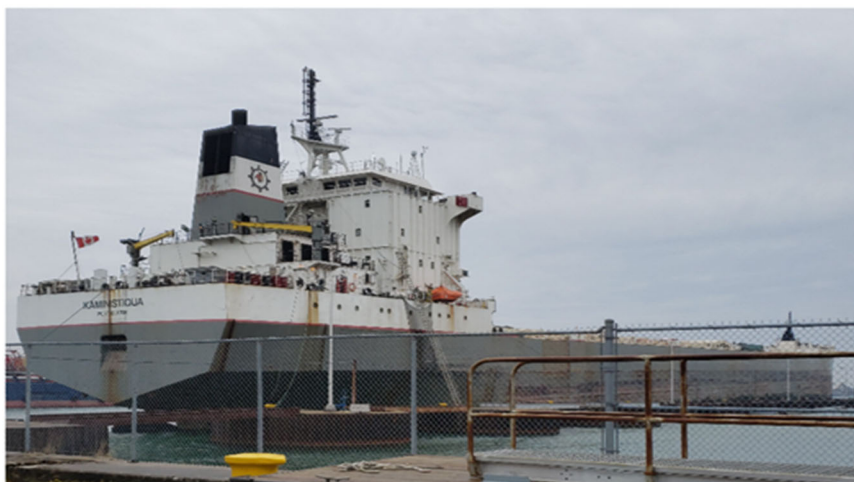
Figure 1. The bulk carrier *Kaministiquia* on the day of the occurrence, secured alongside the north wall of lock No. 4 in Beauharnois, Quebec (Source: TSB)

The following day, 28 November 2019, the vessel's classification society reported that the *Kaministiquia* had sustained damage to its No. 6 starboard side hopper and double-bottom ballast tank. Temporary repairs were carried out before the vessel resumed its normal operations.

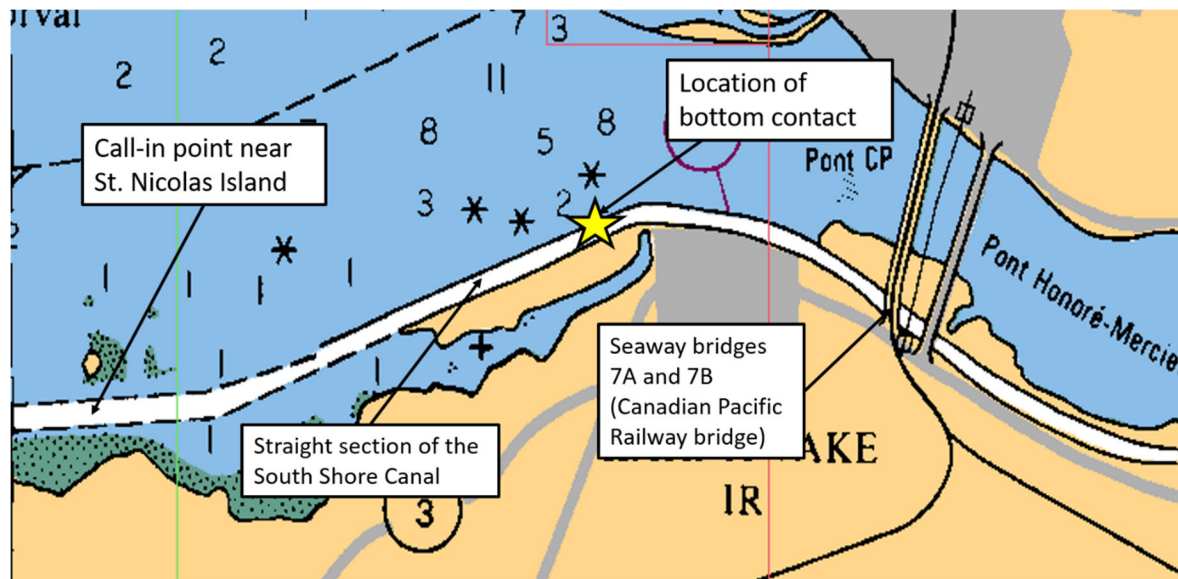
Figure 3. Image depicting the occurrence location (Source: Canadian Hydrographic Services, Chart No. 1409, with TSB annotations)

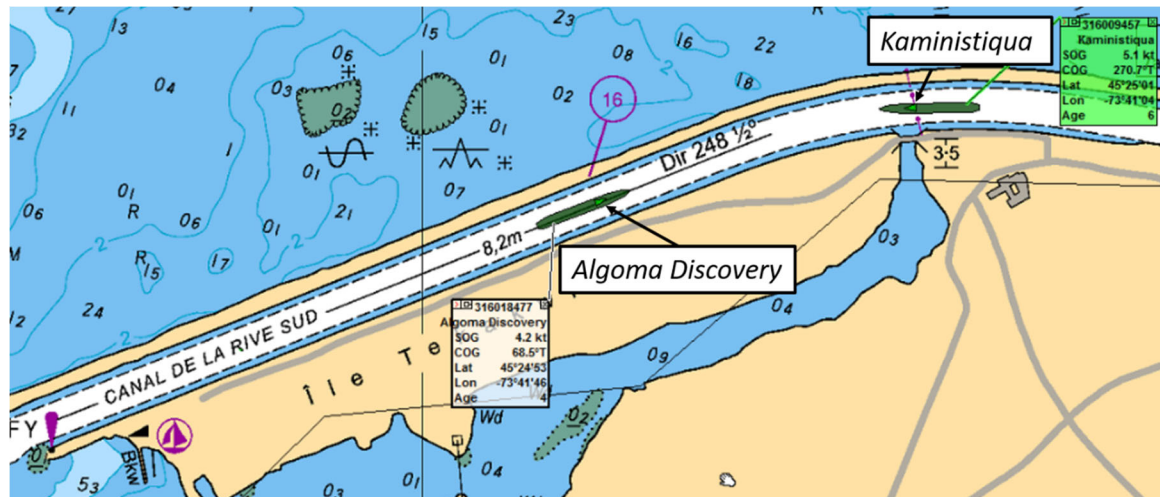
At 0646:23, as the *Kaministiquia* was altering its course away from the centre of the canal, the *Algoma Discovery* was approaching the curve at a speed of 4.9 knots. The *Algoma Discovery* was positioned close to the centre line of the canal, and the vessels were approximately 0.4 NM apart (Figure 4). The master of the *Algoma Discovery* made a VHF call to the *Kaministiquia*, requesting that it give the *Algoma Discovery* more room. The *Kaministiquia* did not acknowledge the *Algoma Discovery*'s call.

Figure 4. Electronic chart capture depicting the vessels' positions before their meeting. Vessels are not to scale. (Source: St. Lawrence Seaway Management Corporation, with TSB annotations)

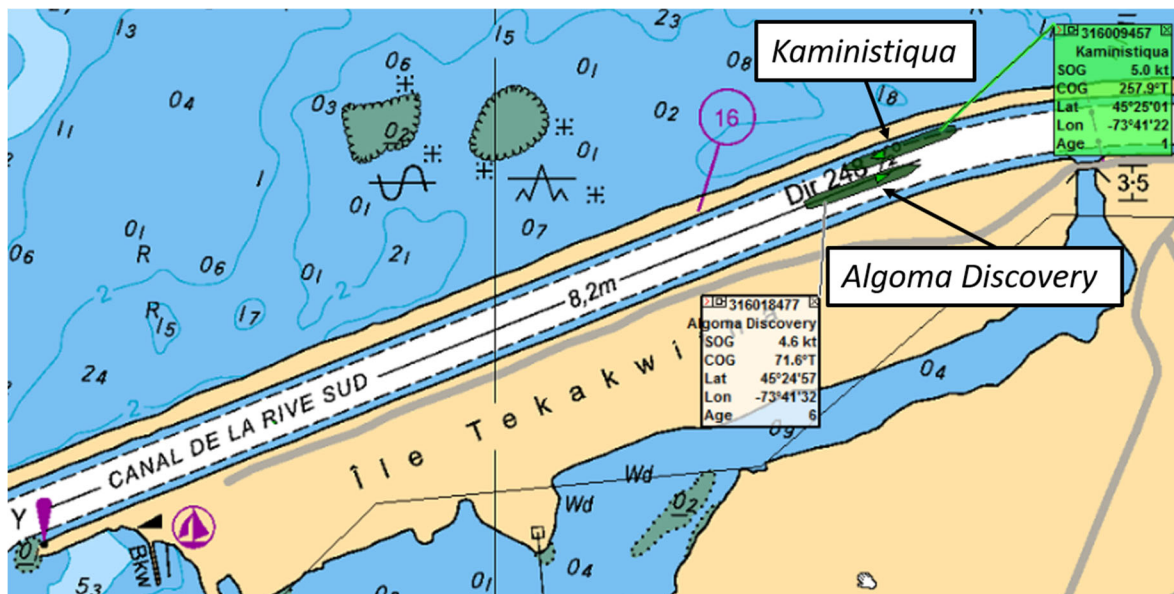
At 0648:50, the 2 vessels were abeam each other (Figure 5). The *Kaministiquia* was slowly changing course to port, toward the centre of the canal. The *Algoma Discovery* was still positioned close to the canal's centre line, just before the curve, and maintaining its course. While manoeuvring, the *Kaministiquia*'s starboard quarter came within approximately 7 m of the north bank of the canal⁴ and the vessel made bottom contact. Seconds later, the vessels passed each other and continued their intended voyages.

Figure 5. Electronic chart capture depicting the positioning of the vessels during their meeting. Vessels are not to scale. (Source: St. Lawrence Seaway Management Corporation, with TSB annotations.)
