"Environmental assessment
of maintenance
practices along
Yukon highway
rights-of-way"

ENVIRONMENTAL CONCERNS
ASSOCIATED WITH
HIGHWAY MAINTENANCE

An Audio-visual Presentation Prepared by
Environmental Protection Service
Whitehorse, Yukon

March, 1984

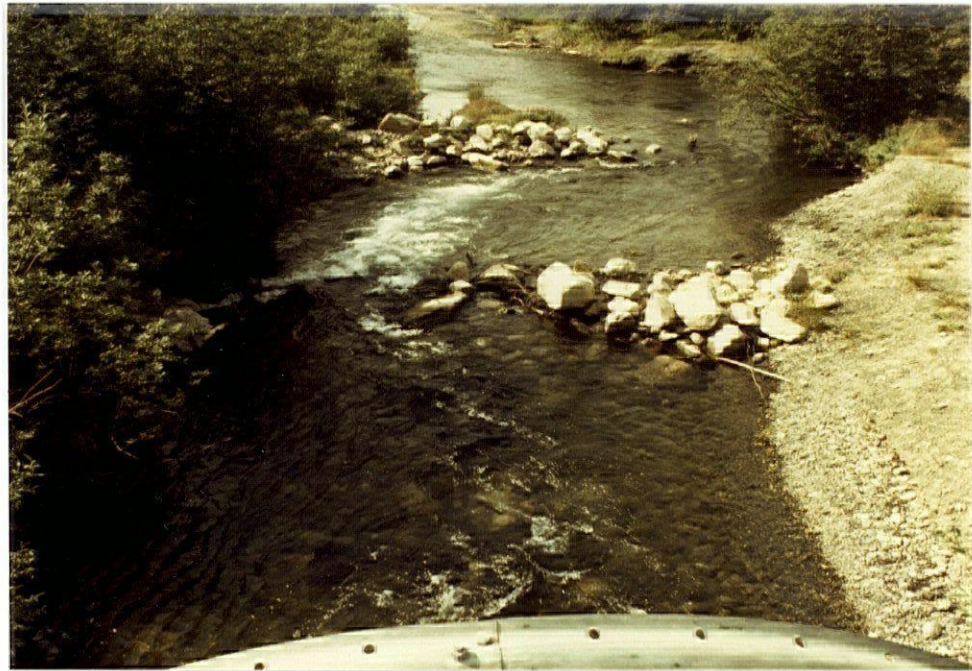
23. Maintenance crews can minimize the barriers to fish passage by constructing stable arrangements of rock to decrease flow velocity and raise the backwater pool elevation (km 190.6, Hwy. 3).

PLATE 69 - Stable rock arrangements in the downstream channel are useful techniques to decrease water velocity and improve fish passage (km 190.6, Hwy. 3).

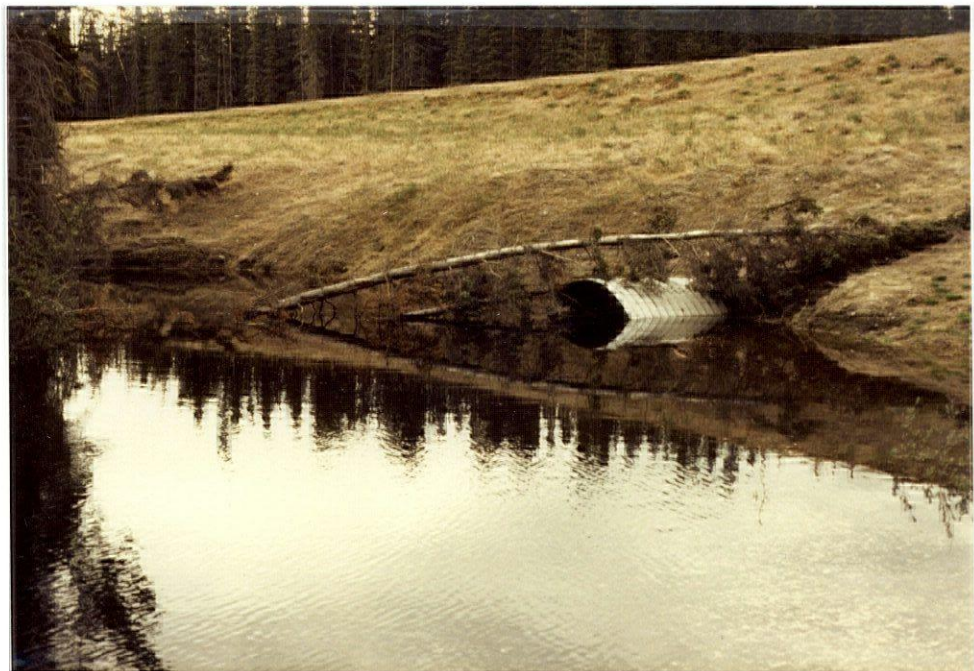
PLATE 70 - Debris plugging this culvert blocked fish passage and flooded off-right-of-way vegetation (km 1411, Hwy. 1).

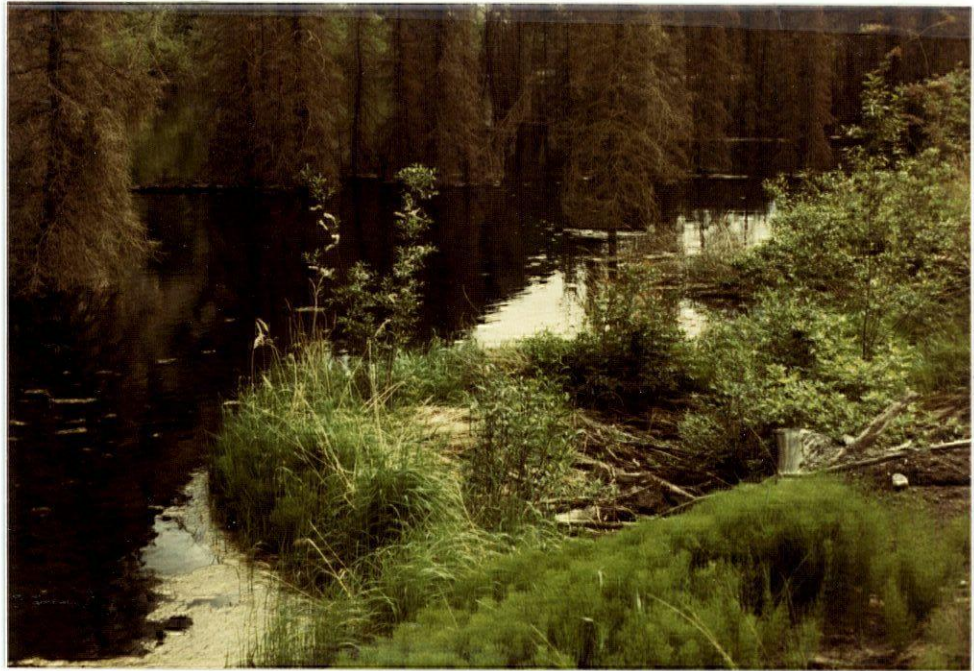
PLATE 71 - A beaver dam near the culvert inlet is flooding off-right-of-way vegetation (km 473, Hwy. 4).

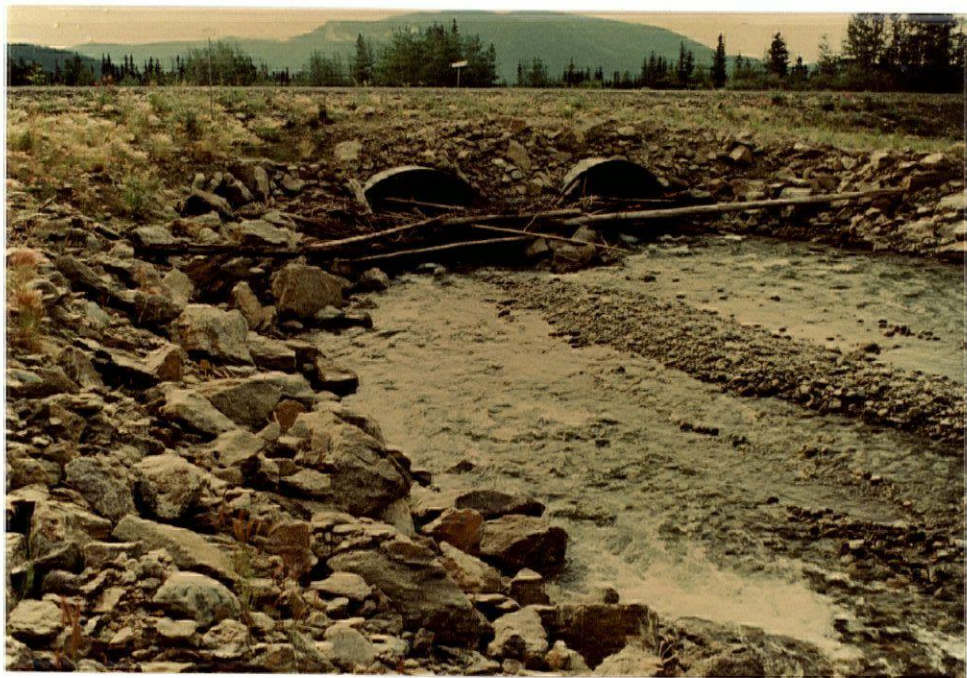
21. Debris must be routinely cleaned from culverts to ensure the unimpeded flow of water and the unrestricted passage for fish (km 29.6, Hwy. 5).
22. Culverts can become a barrier to fish passage by velocity and outfall barriers. This can prevent fish from reaching their spawning grounds and restrict access to extensive reaches of rearing habitat (km 1895.3, Hwy. 1).

PLATE 72 - Debris will affect the capacity of the culvert to pass water, which is particularly important during periods of high flow. Improperly maintained culverts are a threat to the stability of the road embankment (Km 29.6, Hwy. 5).

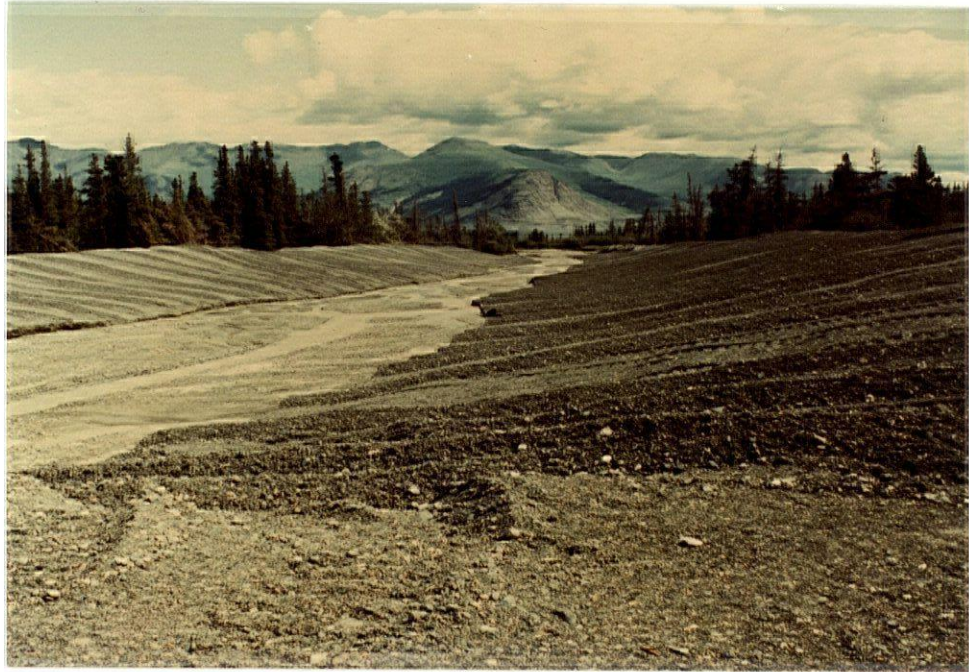
PLATE 73 - Streams with a high bedload movement are dredged for extensive lengths above and below the highway right-of-way to maintain the integrity of the road crossing (km 1724.8, Hwy. 1).

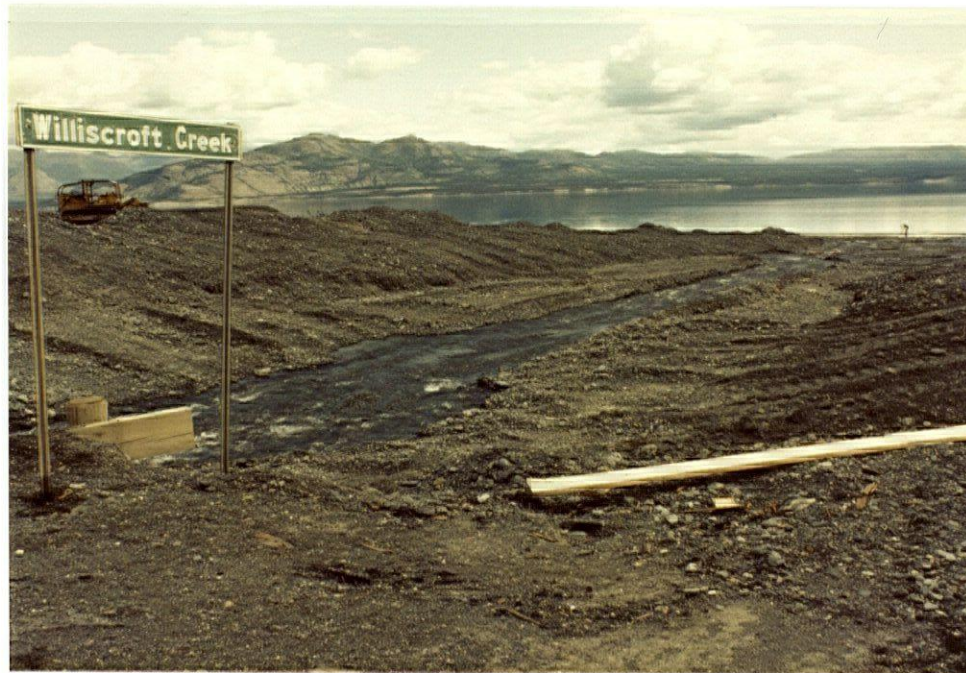
PLATE 74 - The downstream portions of these streams may receive periodic use by fish which reside in the lake. River training programs should be properly planned to avoid possible conflicts with fish utilization (km 1715.8, Hwy. 1).

River training causes environmental impact through the displacement of stream dwelling invertebrates and in some situations, river training could conflict with fish spawning habitat (Plate 74). Minimizing the environmental impact can be accomplished through selection of timing, frequency, and location of river training programs. Consultation with other government agencies, and in particular, the Department of Fisheries and Oceans, is recommended prior to commencement of a river training program.

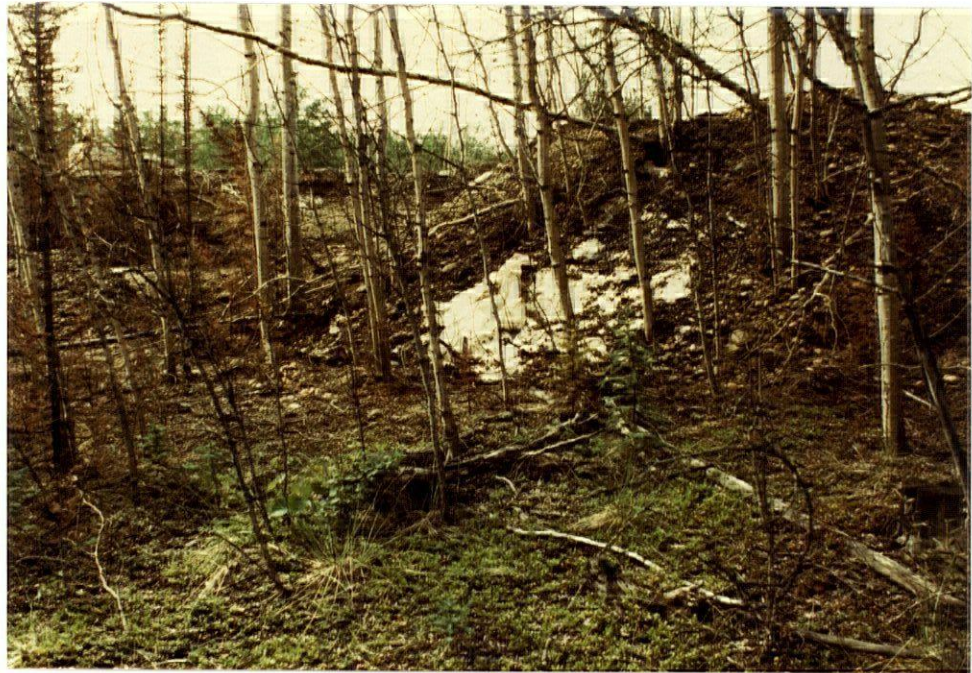
The stockpiles of calcium chloride were always located on well drained sites and protected from water runoff. At only one site did the stockpile site appear to present a concern. This occurred when calcium chloride was pushed into standing timber which resulted in localized killing of the surrounding vegetation (Plates 75 & 76).

PLATE 75 - Calcium chloride has been inadvertently mixed with overburden material and caused localized killing of the vegetation (km 38.9, Hwy. 11).

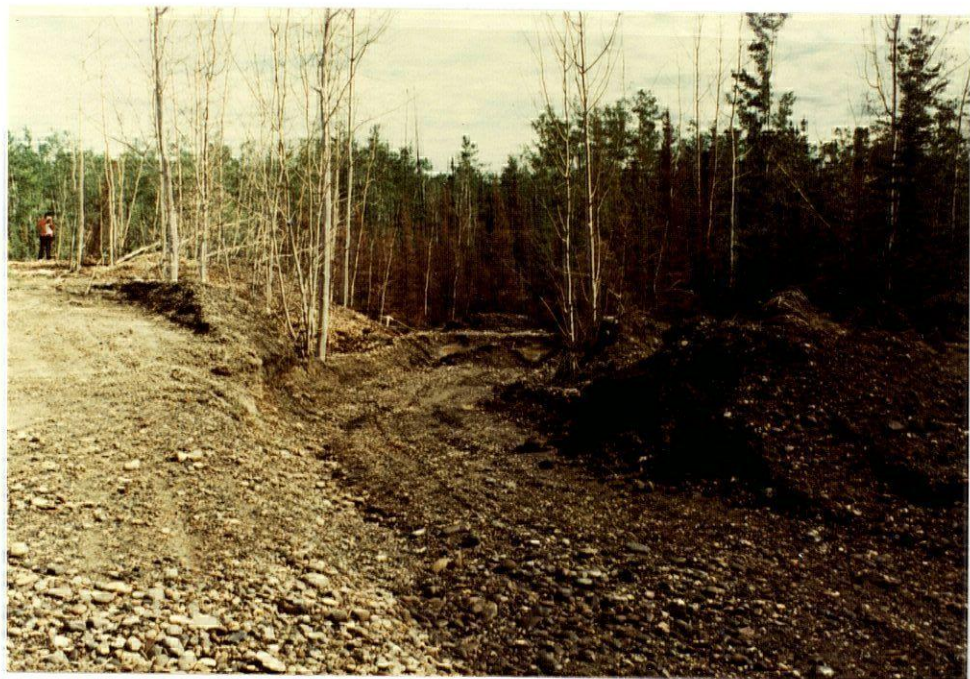
PLATE 76 - Surface runoff from a calcium chloride stockpile site is affecting the nearby vegetation (km 38.9, Hwy. 11).

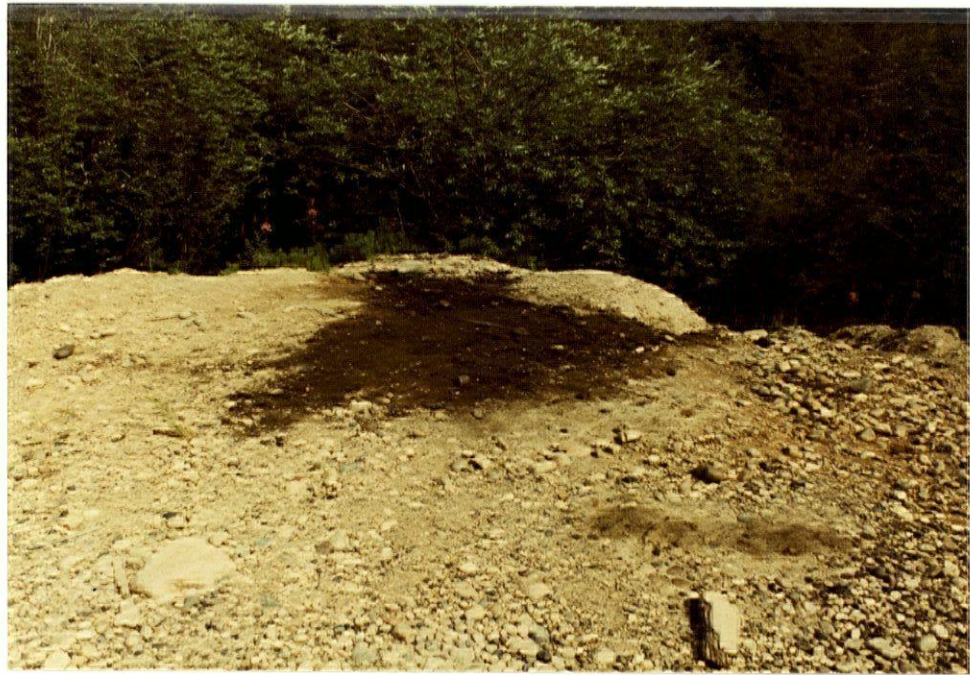
25. Water withdrawal sites should be sloped away from the watercourse so that accidental water and fuel spills do not directly re-enter the stream (km 637.8, Hwy. 2).

Associated with the calcium chloride program are the numerous water withdrawal sites. These sites can be damaging to local watercourses if the area is not properly prepared. The pump, where possible, should be located on a well drained site and sloped away from the water source, preferably into a vegetated buffer. In this manner, accidental oil and water spills can be filtered before re-entering the watercourse (Plate 77). If a sump is required, the spoil should be placed above the highwater mark (Plate 78).

PLATE 77 - Water withdrawal sites should be prepared so that accidental water and oil spills are contained or drain into a vegetated buffer. Oil contaminated soil should be removed to a site where it will not affect water quality (km 637.8, Hwy. 2).

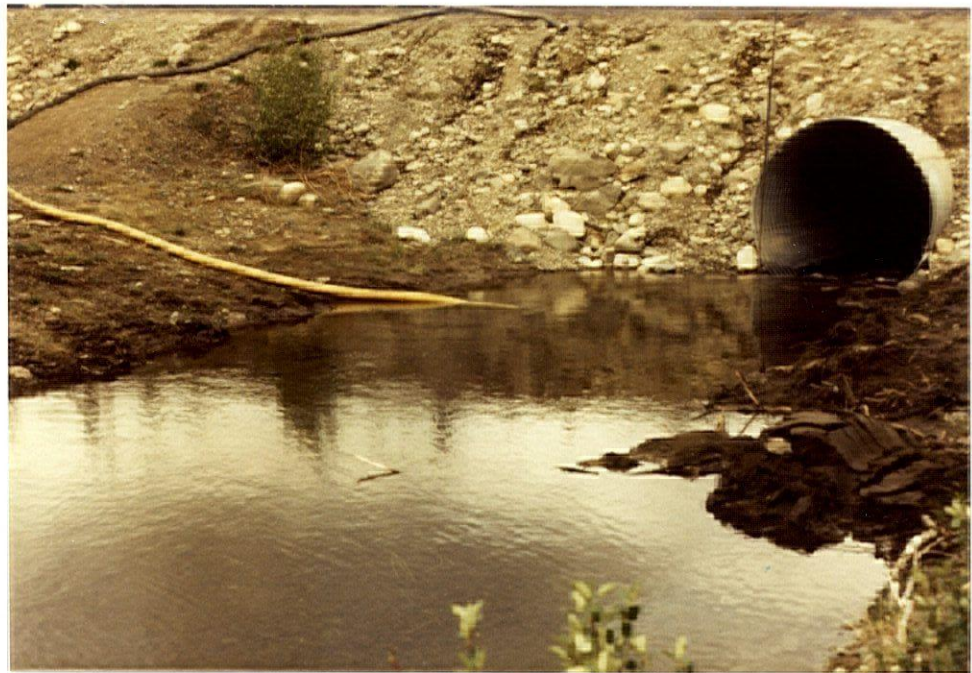
PLATE 78 - The spoil from this sump was deposited into the stream on the right hand side of photograph. If sumps are necessary, the spoil material should be deposited in a stable location above the high water mark (km 128.3, Hwy. 2).

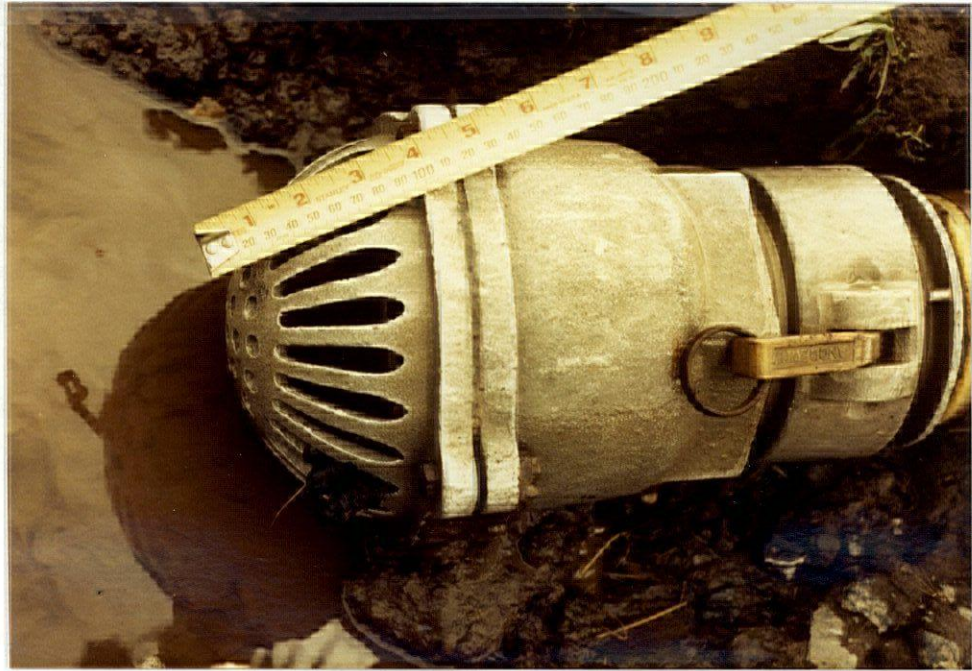
26. Intakes on water pumps should be modified to comply with DFO intake screening guidelines which prevent the entry of fish into the pumping system (km 128.3, Hwy. 2).

All water pump intakes were screened, whether or not located in a fish bearing stream. However, none of the screens met the current design specifications recommended by the Department of Fisheries and Oceans (Plate 79). Intake screens can be easily modified to comply with the mesh opening size of 0.1 inch (25mm). These and other regulatory matters should be clarified with Department of Fisheries and Oceans prior to establishing a water withdrawal site.

PLATE 79 - A typical water intake screen which exceeds the recommended mesh opening size of 0.1 inch (25 mm). Intakes, such as this, may entrap small fish (km 128.3, Hwy. 2).

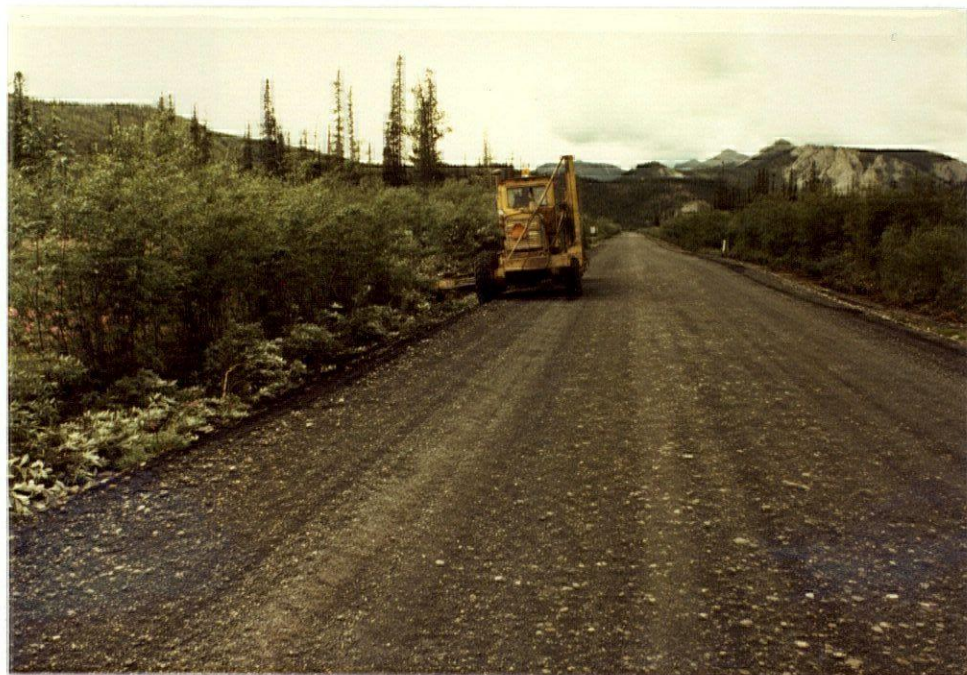
PLATE 80 - Vegetation control is a common maintenance program along Yukon highways (km 202, Hwy. 5).

The control of vegetation is a necessary part of highway maintenance (Plate 80). Various methods are in use ranging from hand clearing to mechanized methods using the hydro-axe or road graders.

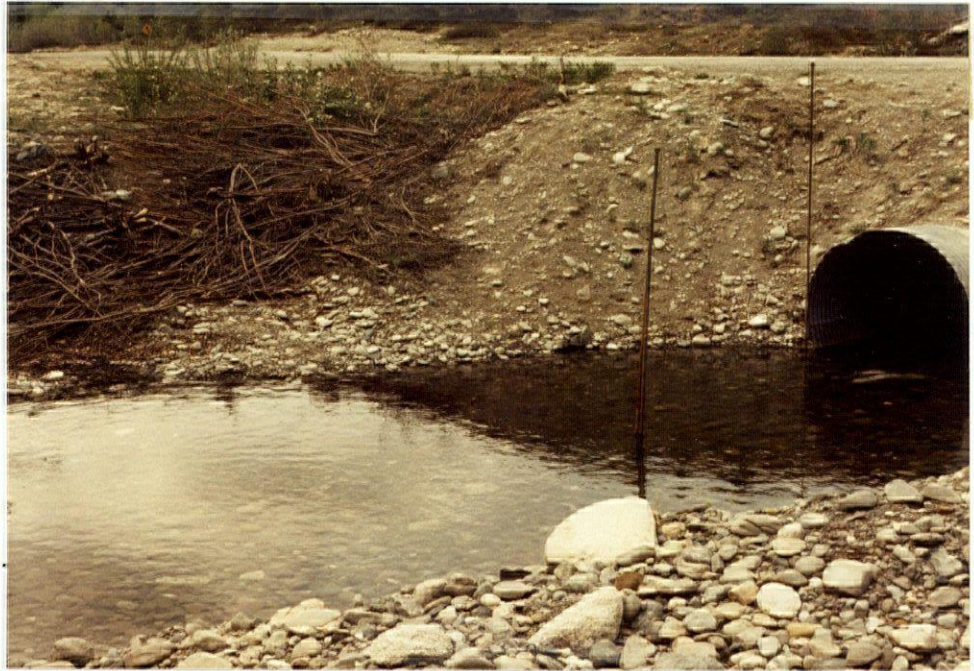
28. If vegetation control is absolutely necessary at stream crossings, it should be accomplished by methods which do not affect the stability of the stream bank, such as hand clearing. Slash should be removed above the high water mark to permit it from interfering with flow patterns (km 37, Hwy. 8).

Hand clearing causes the least environmental disturbance and should always be used, if necessary, on streambanks (Plate 81). The hydro-axe has certain environmental advantages in that it can operate from the roadway and avoid terrain damage. Road graders, on the other hand, cause considerable environmental damage by destroying all vegetation, instead of selectively removing the problem shrubs as the hydro-axe does. The blading method exposes the erodable soil surface and redirects surface runoff patterns, contributing to accelerated surface erosion and sedimentation to watercourses. In addition, blading the right-of-way directly conflicts with aesthetic values (Plate 82), and in certain areas with the benefits of revegetation programs.

PLATE 81 - If vegetation control is necessary at stream crossings, the least environmental impact is caused by hand clearing methods (km 37, Hwy. 8).

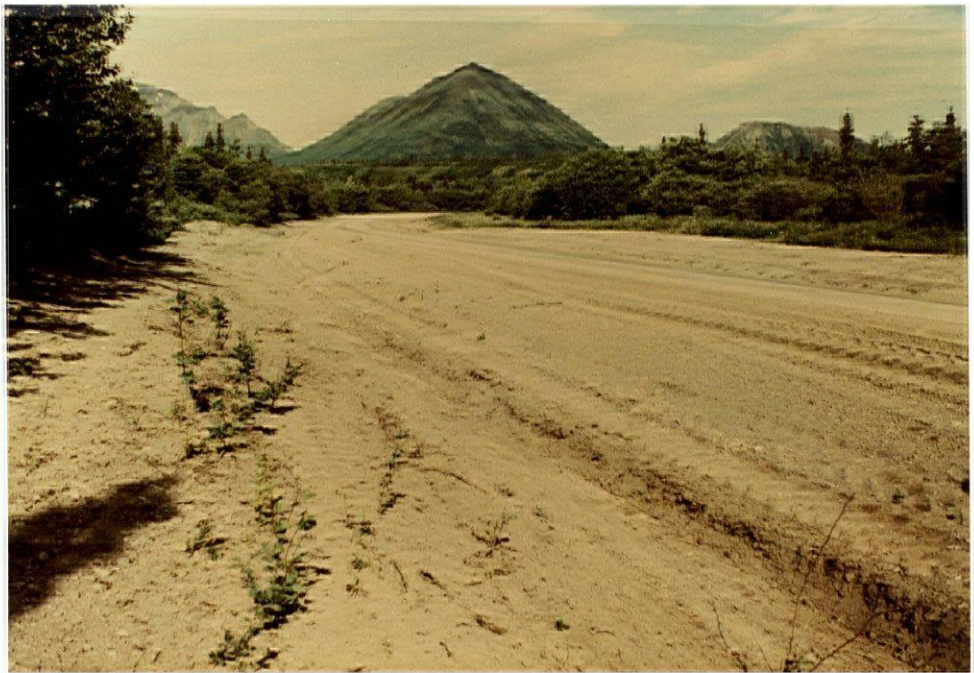
29. Vegetation control on the right-of-way has utilized conventional road graders. This exposes large areas of the right-of-way to surface erosion which will increase the amount of sediment transported into watercourses (km 193, Hwy. 3).

PLATE 82 - Blading the entire right-of-way exposed large areas to surface erosion and conflicts with aesthetic values (km 193, Hwy. 3).

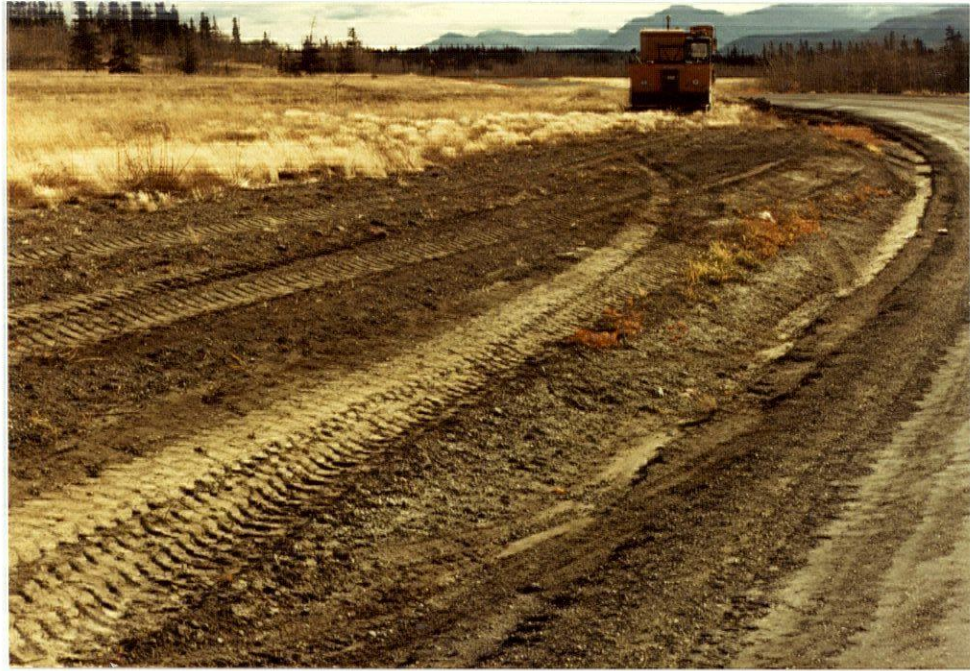
Although blading on well drained granular soil types generally caused minimal environmental impact, the objectives of the maintenance program are questioned when stable, self perpetuating grass communities are destroyed (Plate 83) and when the bladed width appears to be excessive (Plate 84). It was also observed that repeated blading may actually encourage the growth of non-desirable shrub species (Plate 85).

PLATE 83 - Blading in areas which are predominantly grass communities conflicts with good right-of-way management (km 1549.3, Hwy. 1).

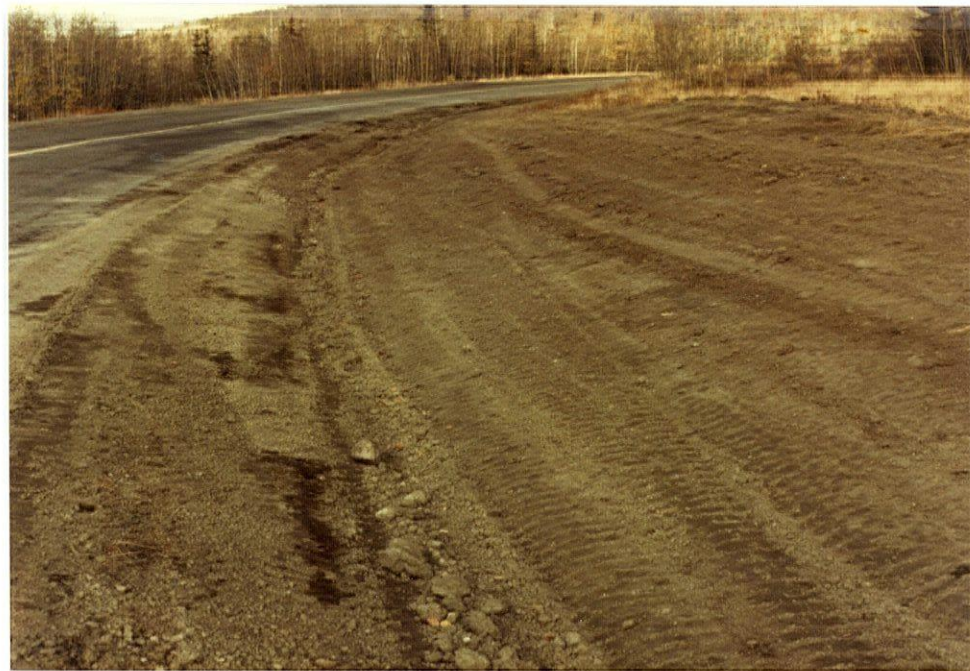
30. Maintaining proper right-of-way drainage is an important maintenance consideration, however the amount of area disturbed should be restricted to the ditch. This slide shows that a road grader exposed a large area beyond the ditch which was previously vegetated in a self-perpetuating grass community. This practice will accelerate surface erosion which will increase the amount of sediment being transported into the ditch, requiring further maintenance, as well as causing sedimentation to the downstream watercourse. Exposing the mineral soil also encourages the growth of undesirable shrubs, which create another maintenance problem (km 1547, Hwy. 1).

PLATE 84 - Blading, if necessary to restore drainage systems, should not expose large areas (km 1547, Hwy. 1).

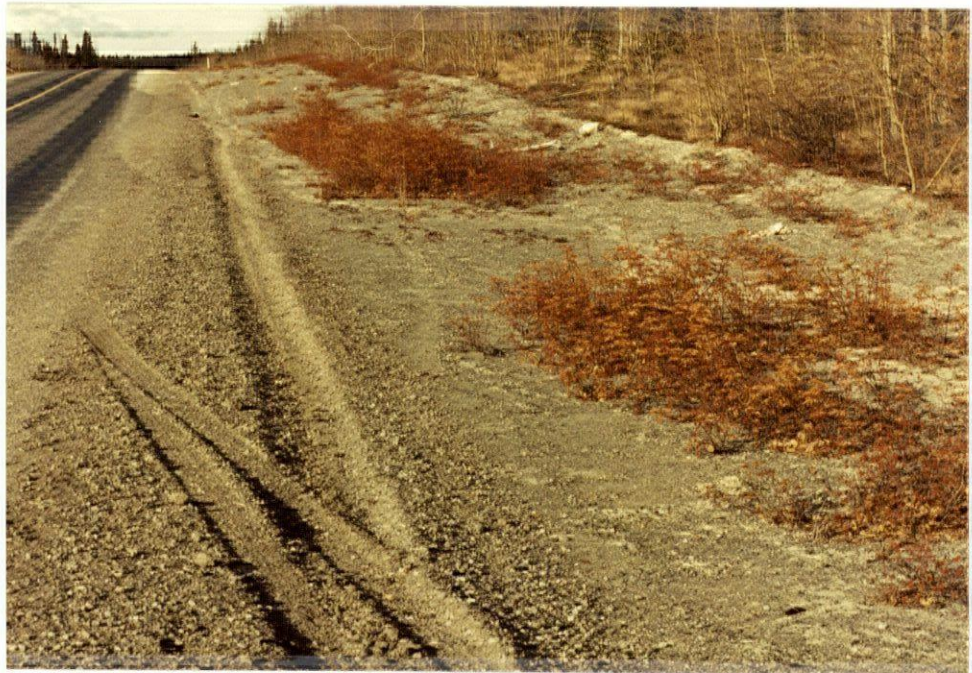
PLATE 85 - In certain areas, repeated blading may actually encourage the growth of undesirable species of shrubs (km 1573.8, Hwy. 1).
