# AVIATION SAFETY LETTER

ISSUE 1/2020

### **TSB final report A17P0170—Visual flight rules flight into deteriorating weather and collision with terrain**

## **TSB final report A19C0026—Wing lift strut assembly failure and collision with terrain**

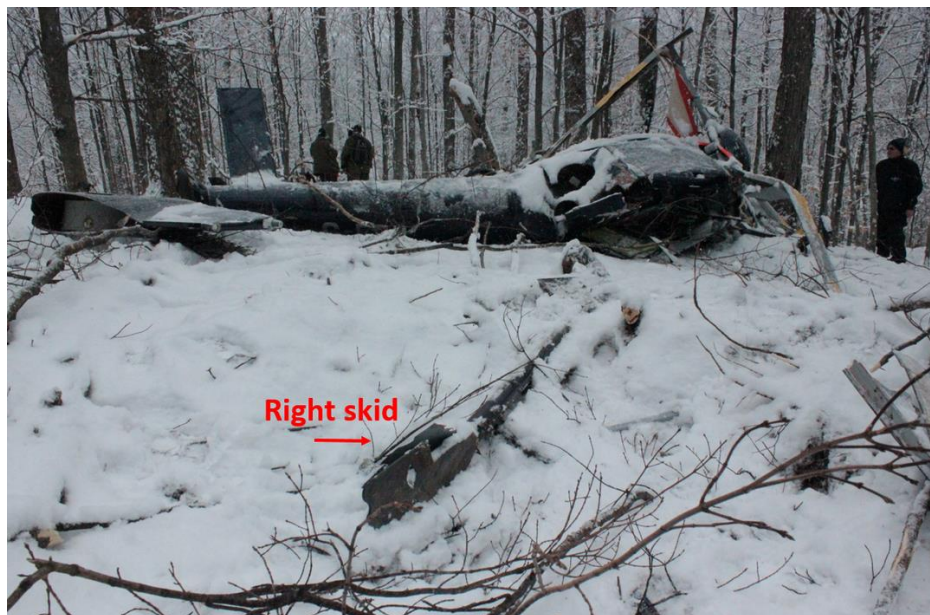
*Collision with terrain, TSB report A18Q0186*

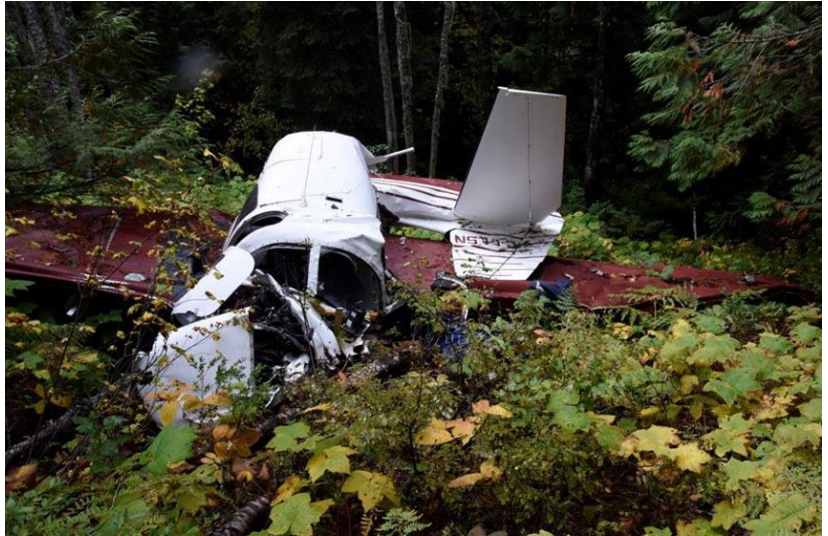
*Figure 6. Accident site, view looking downhill  
(Source: Royal Canadian Mounted Police)*

The aircraft was found at approximately 3 500 feet ASL, 500 ft north of the Trans-Canada Highway in a heavily forested area (Figure 6). Examination of the wreckage indicated that the aircraft struck the terrain in a steep,

nose-down attitude. The flaps were found in the fully retracted (up) position. The landing gear was found in the partially extended position; however, the investigation was unable to determine if the landing gear had been selected down or if it had been extended a result of the impact forces.

All flight control surfaces were accounted for. Damage to the propeller was consistent with power being produced at the time of impact.

The aircraft's flight instruments were severely damaged. The GPS was recovered and sent to the TSB Engineering Laboratory in Ottawa, Ont., for further examination.

The aircraft's 121.5 MHz ELT was also recovered at the accident site. The ELT's antenna was found detached from the connector, and the batteries had been ejected from the battery enclosure during the impact sequence. When initial power was applied to the ELT, it started to transmit a strong signal, which confirmed that the inertia switch was in the activated state. Due to the absence of the antenna, signal detection would have been limited to a few metres (m). Furthermore, without a battery, the ELT transmission would have ceased immediately.

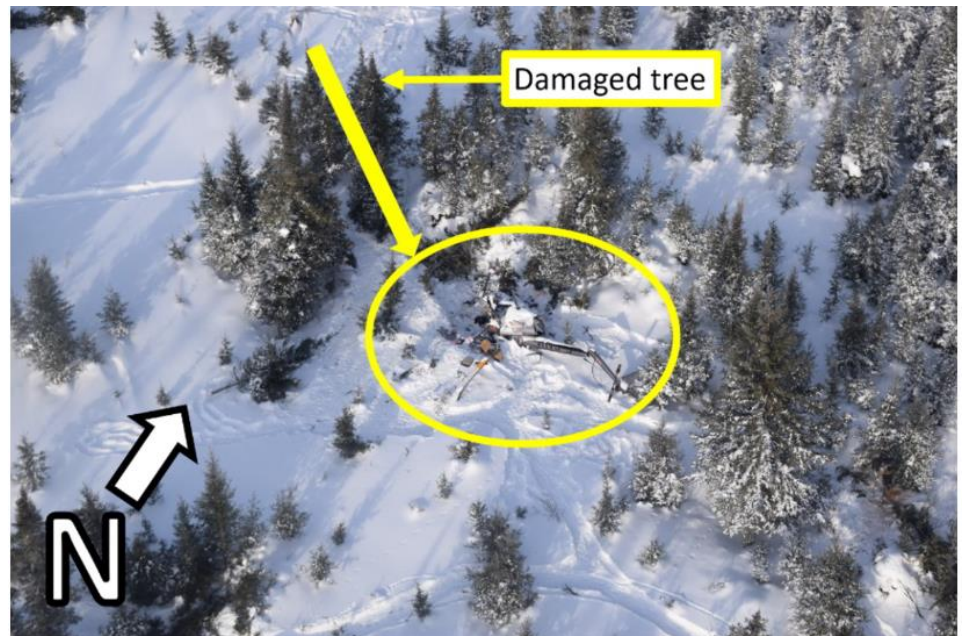
*Figure 2. Accident site, with the aircraft wreckage circled and an arrow showing the direction of impact (Source: TSB)*

The collision with terrain occurred in an area that had been previously logged. The area had some sporadic regrowth, and the trees in the immediate vicinity of the accident site were approximately 6 metres (m) (20 ft) tall. The accident site was covered in at least 1.5 m (5 ft) of snow; a significant amount of snow had fallen during the week between the accident and the discovery of the wreckage. There was tree damage at the top of a coniferous tree located approximately 10 m (33 ft) west-northwest of the impact site (Figure 2). The tree damage and the damage to the helicopter indicated that the aircraft was in a steep nose-down, left-bank attitude when it struck the ground, on an approximate heading of 120° magnetic. The helicopter then pitched over and came to rest on its back.

The occupants were ejected from the helicopter during the impact. There is no evidence that either occupant had been wearing a seatbelt at the time of the occurrence; however, given the damage to the helicopter, the accident was not survivable.

During the impact sequence, the plastic mounting bracket for the 406 MHz ELT broke; however, the antenna and the remote switch wiring were still intact. The ELT was found in the OFF position; therefore, it did not activate during the crash or transmit a signal to the search-and-rescue satellite system. The pilot had removed the ELT in January 2019 for recertification and had picked it up from the avionics shop after the recertification was complete. The investigation could not determine who had re-installed the ELT. Because of the orientation of the ELT mounting bracket, the position of the switch cannot be seen once the ELT is installed in the helicopter.

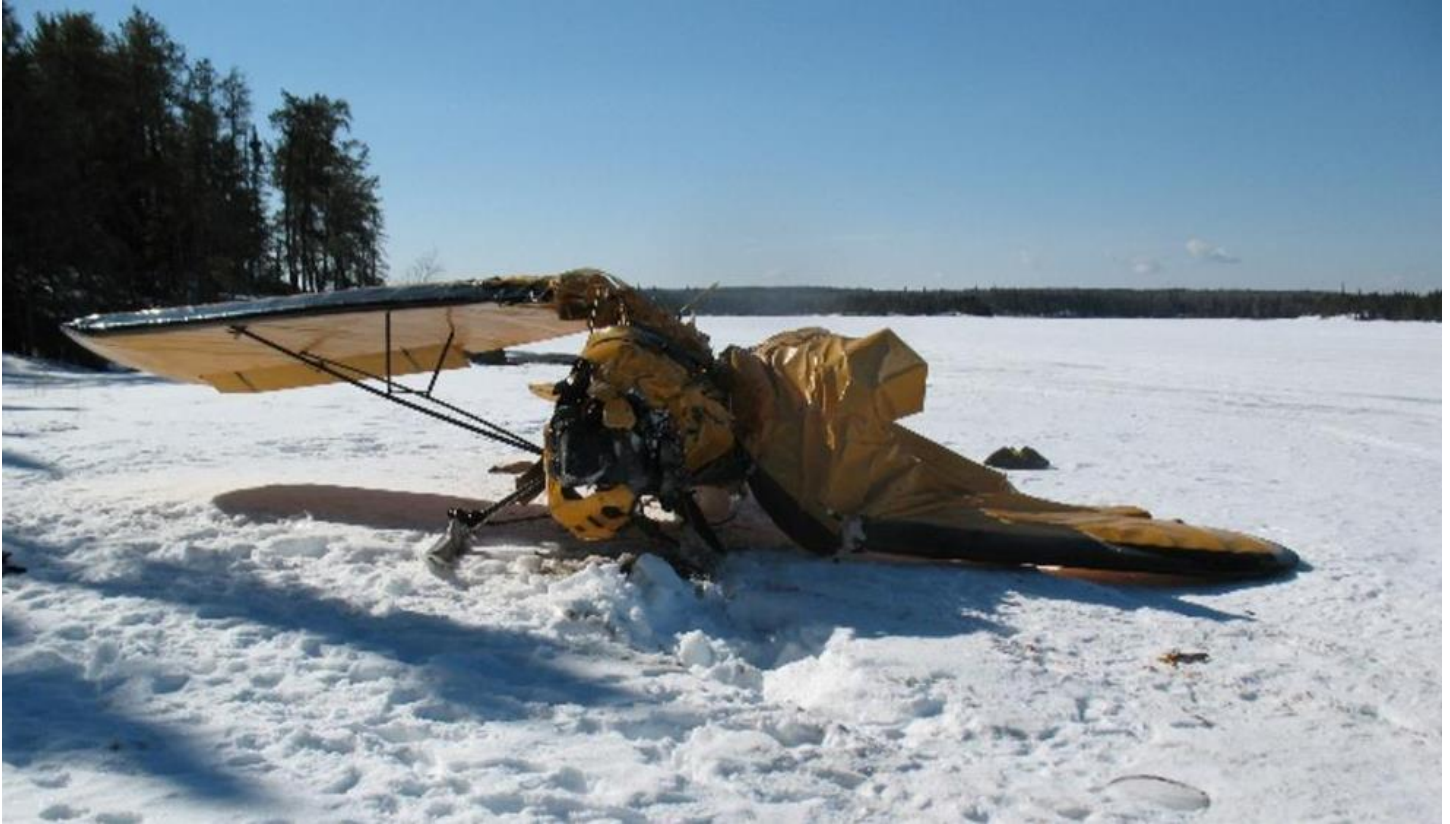
*Figure 1. Wreckage site (Source: TSB)*

The aircraft struck the frozen surface of the lake in an inverted position and at a shallow angle, with a high rate of vertical descent and at high forward speed. The aircraft came to rest in an upright position approximately 125 ft from the initial point of impact, facing north (Figure 1).

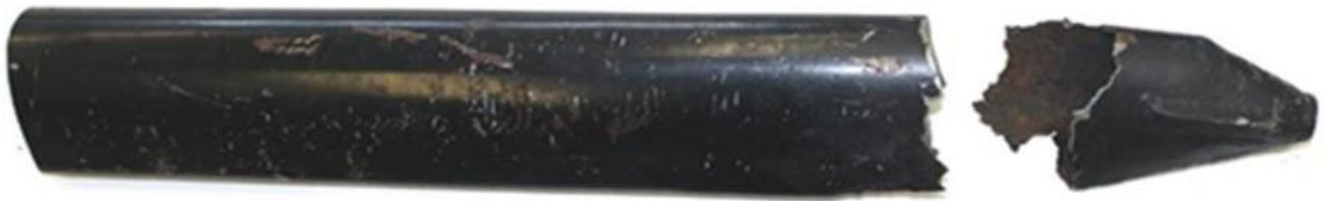
*Figure 2. Damage on the upper half of the left main spar wing lift strut assembly (Source: TSB)*

An inspection of the airframe at the site revealed that the left main spar wing lift strut assembly separated near the lower fork end attachment (Figure 2). A visual examination of the wing lift strut assembly revealed excessive corrosion in the area of the separation. The failed wing lift strut assembly was sent to the TSB Engineering Laboratory in Ottawa, Ont., for further analysis.

The TSB Engineering Laboratory's analysis of the failed wing lift strut assembly revealed that the failure was initiated by excessive corrosion and thinning of the load-bearing wall inside the wing lift strut, followed by fatigue, and eventual overload failure.

The alternative inspection method described by the AD is the ultrasonic method. Whereas the typical thickness of an exemplar wing lift strut assembly wall is between 0.034 and 0.041 in., the ultrasonic inspection procedure specifies that wall thickness measurements of 0.024 in. or less require replacement of the wing lift strut assembly prior to further flight. Although an ultrasonic inspection was not completed on the failed wing lift strut assembly, an examination using a scanning electron microscope was accomplished to take accurate measurements of wall thickness. This examination determined the following:

- the heavily corroded area on the lower half of the failed wing lift strut assembly had a remaining wall thickness between 0.002 and 0.019 in., well below the required minimum. Punch tests applied to this area revealed one perceptible dent.
- the corroded area of the upper half of the failed wing lift strut assembly had a remaining wall thickness between 0.021 and 0.031 in.; therefore, some areas were below the required minimum. Punch tests applied to these areas did not produce any perceptible dents.
