### Canadian Aviation Service Difficulty Reports

The following content was published between January 1, 2020 and April 1, 2020

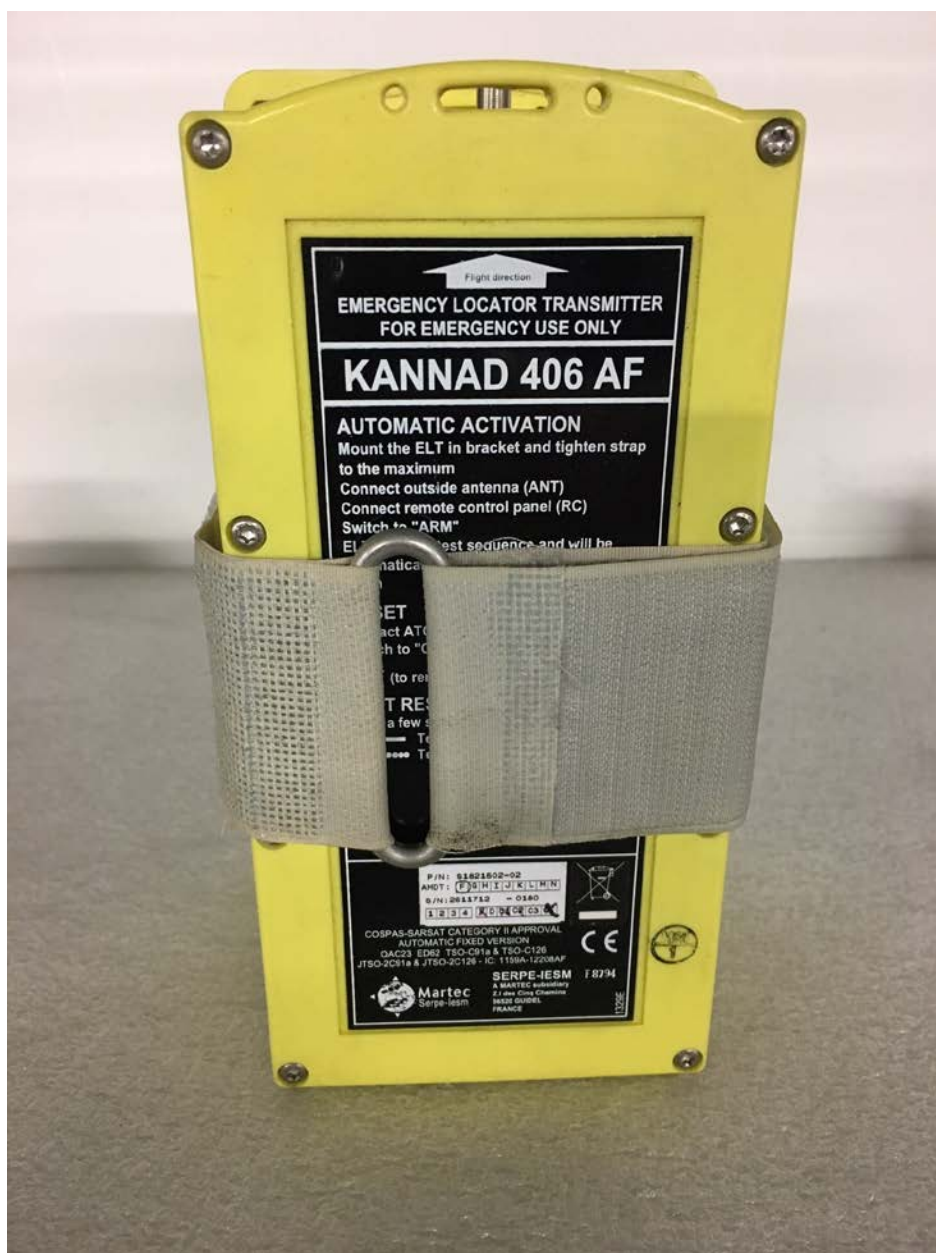
It was noticed during an annual inspection that the Velcro strap (included with the S1840502-01 mount) was found with the metal buckle directly overtop the top face of the ELT. As per the Kannad Aviation installation/operation manual, the metal buckle must be positioned on the left or right of the ELT only. The position is listed as a caution that incorrect installation of the Velcro strap could lead to an unsafe condition. Upon removal of the strap, it was found that the factory-installed Velcro strap had its small Velcro tab (which attaches to the backside of the mount to orient the Velcro strap) incorrectly attached to the strap approximately 5.5" from the buckle (normal is approx. 3.5"). This allows for the Velcro strap to be installed incorrectly without the installer knowing it is incorrect (unless they are aware of the proper procedure and figure within Kannad's manual). The Velcro strap itself does not have a part number, it is only listed as "included with the bracket mount." It is unknown if this Velcro tab is meant to be glued, sewn, or otherwise attached to the Velcro strap. It is also unknown if it is required for the Velcro strap to be considered in a serviceable condition.

Image 1 – Example of an incorrect installation of the hook and loop fastener with metal buckle on the face of the Kannad 406 AF ELT.

This Service Difficulty Report (SDR) is an excellent example of observing an incorrect installation that could have led to a possible malfunction of the ELT in an emergency situation. The Federal Aviation Administration (FAA) published Special Airworthiness Information Bulletin (SAIB) HQ-12-32 to inform ELT manufacturers, installers and aircraft maintenance personnel of a concern of hook and loop-style fasteners' ability to restrain ELTs during accident impact. Subsequently, Kannad Aviation published service bulletin (SB) S1800000-25-00 to outline the instructions for properly securing the ELT during installation and reinstallation. In addition to the SB, Kannad Aviation has also published service letter (SL) SL S18XX502-25-12 to provide instruction for completing the Canadian Aviation Regulations (CARs) Part V & VI ELT periodic testing and inspection requirements. The SL also directs the reader to multiple bolded caution messages related to the incorrect installation of the hook and loop fasteners. Seemingly simple work should not be overlooked; it is important at all times to read each manufacturer's installation instructions and instructions for continued airworthiness to correctly complete the job.

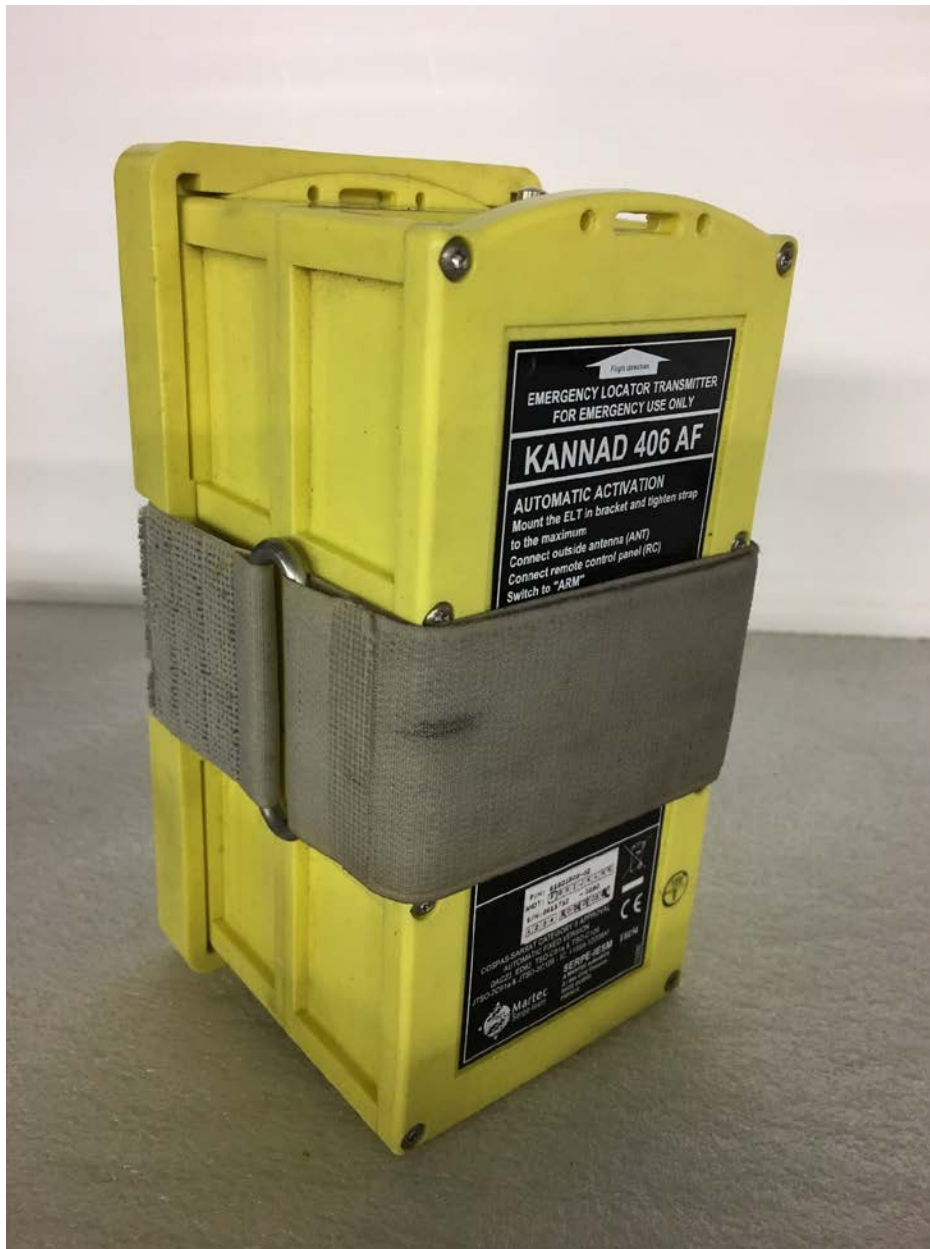
Image 2 – Example of the correct installation of the hook and loop fastener where the metal buckle on the side of the Kannad 406 AF ELT.

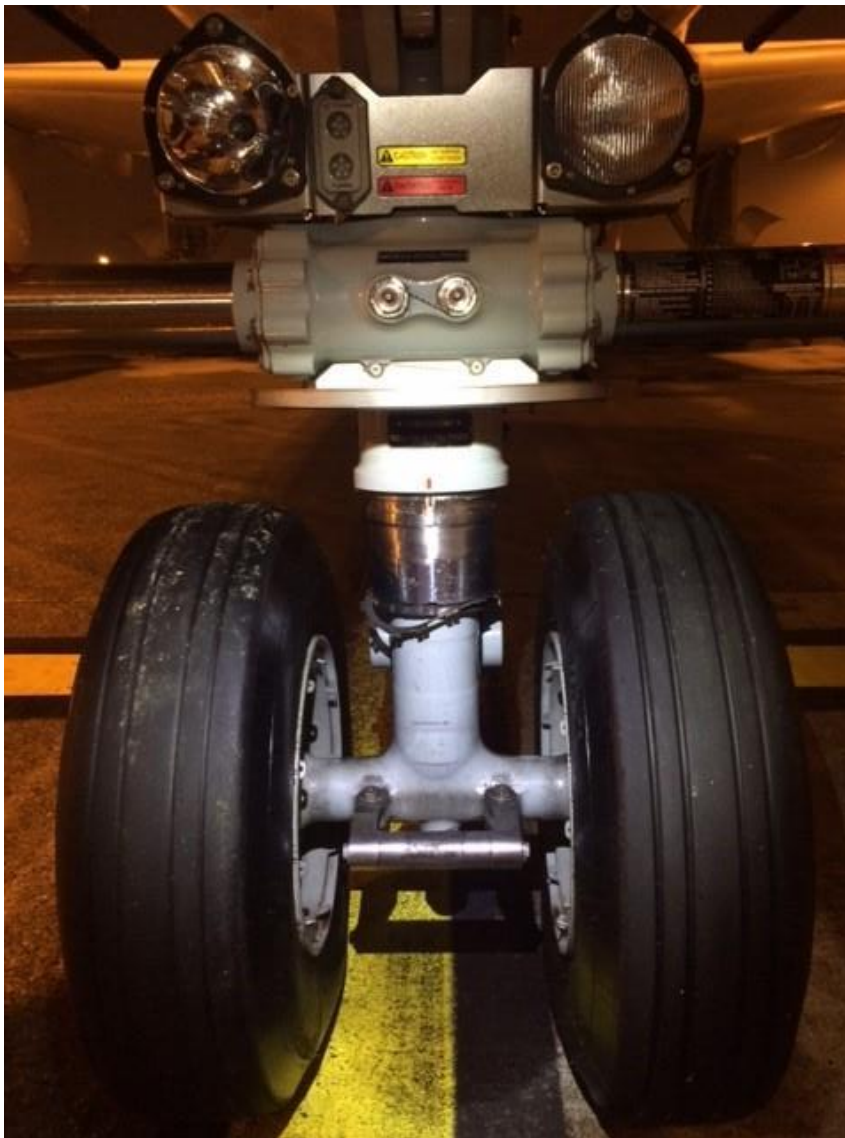
The Nose Landing Gear (NLG) oleo strut collapsed in-service. After touchdown, a very strong shimmy and vibration from the nose gear was observed. The same shimmy and vibration was observed at the (2) previous landings. During the arrival inspection, the NLG was found deflated and fully collapsed. Further inspection found the groove nut touching the sliding tube and the gland nut locking washer displaced and bent.

Figure 1: Fully collapsed oleo with locking ring damaged

In February 2018, Bombardier issued Service Letter (CS-SL-32-20-0001) to inform operators to perform a pre-flight inspection for proper oleo extension. In November 2018, to address the loss of fluid and nitrogen, Liebherr issued Vendor Service Bulletin (VSB) 4124A-32-04 to upgrade the lower cam, dynamic seals and the scraper seal of the NLG shock strut assembly. These changes are intended to reduce the possibility of a NLG shock strut sudden leakage in-service. At the time the VSB was issued it applied

The last event occurred in January 2019 and according to the Service Difficulty Report (SDR) information, the oleo was reported as P/N 4124A10000-4 which is the P/N of a pre-VSB oleo. This VSB incorporation is strongly recommended so operators should confirm that they have P/N 4124A10000-5 oleos.

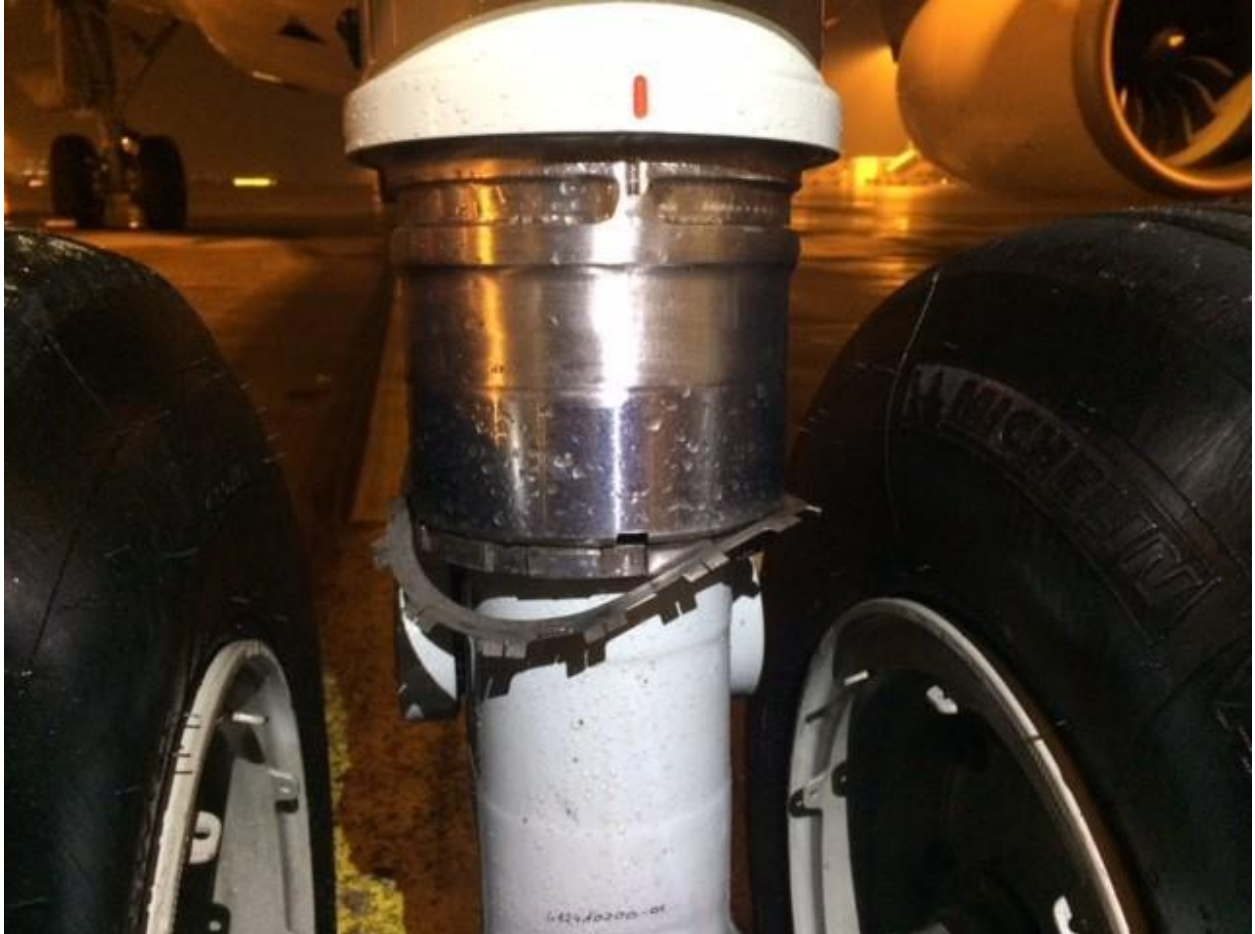
Figure 2: Close-up of gland nut lock ring pulled out and collapsed oleo

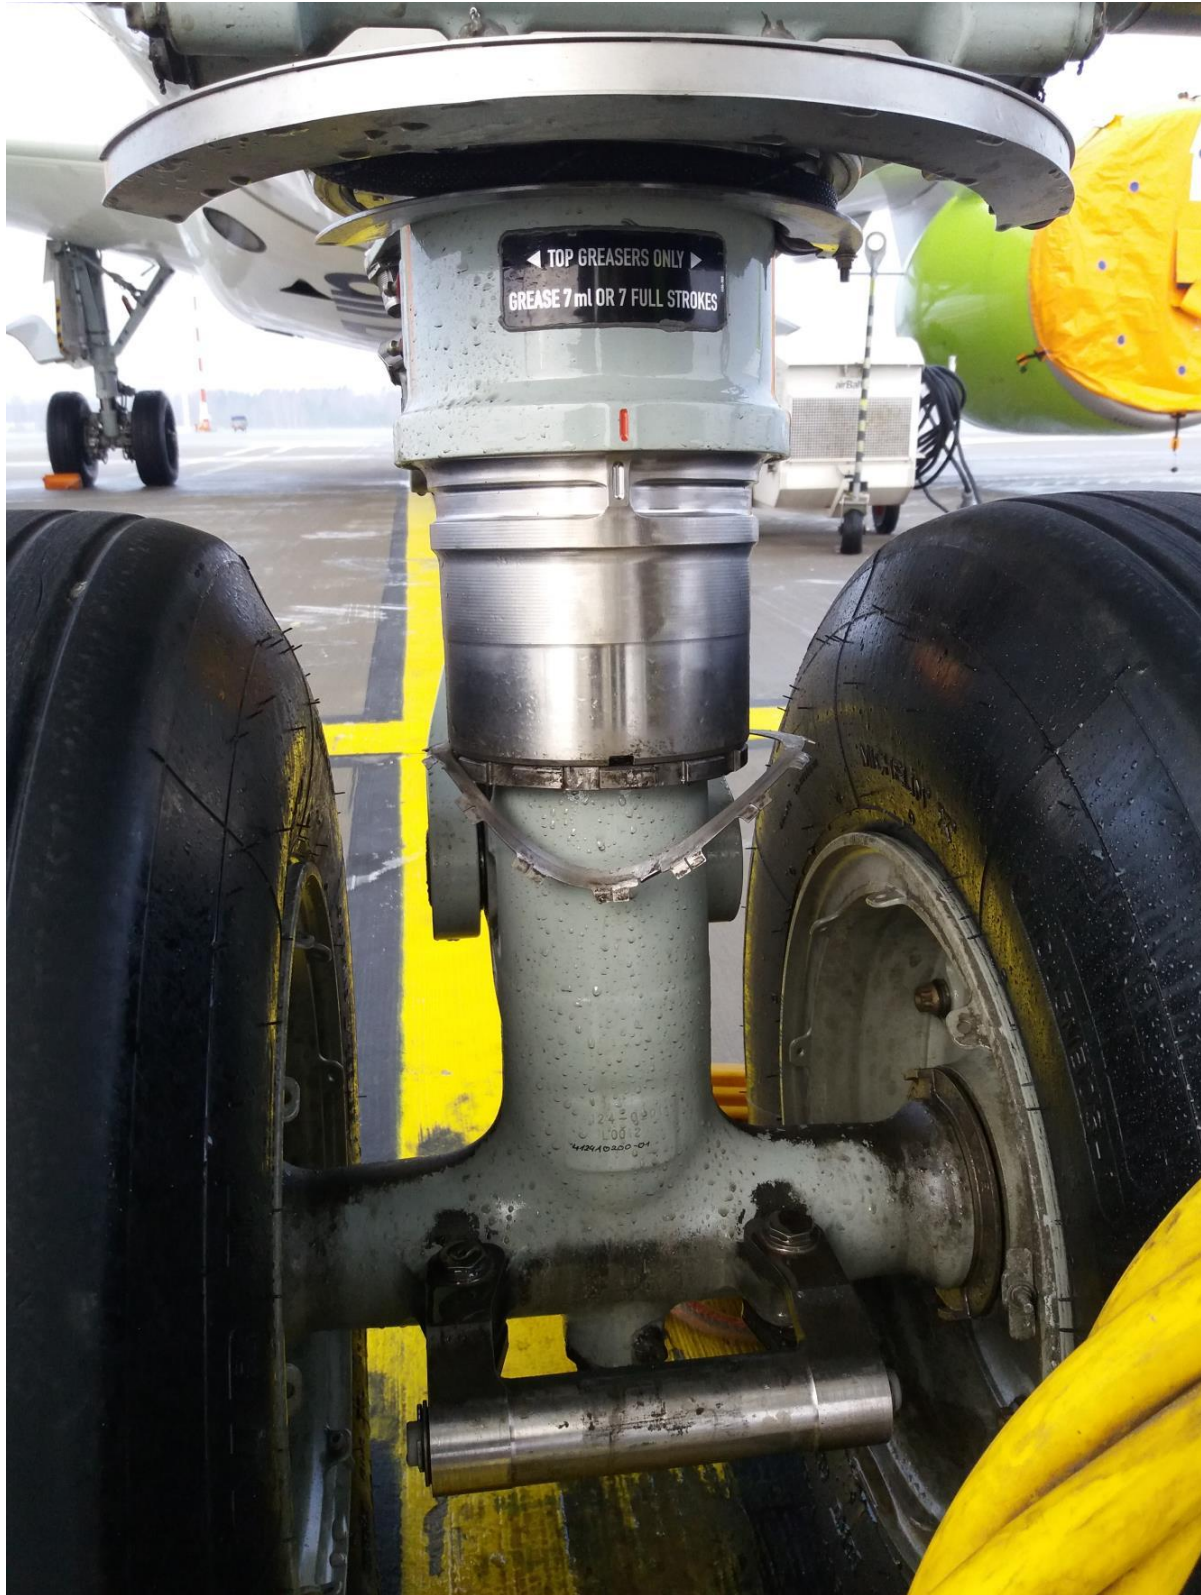
Figure 3: Another aircraft with similar fully collapsed oleo and bent and damaged gland nut lock ring. Note silver colour of outer cylinder

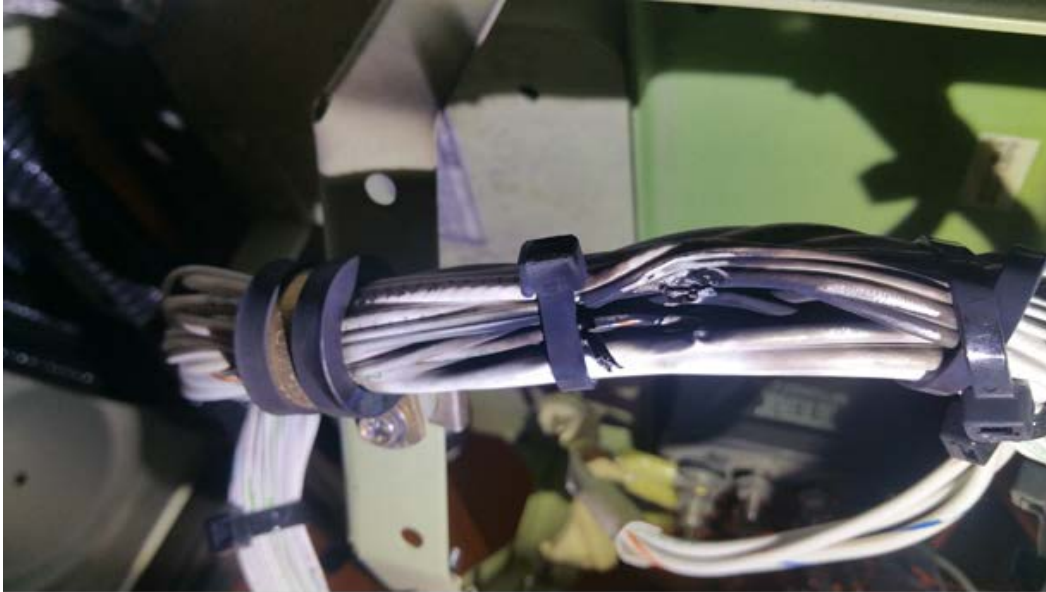
While troubleshooting a snag about seats 1F and 1D, the power outlet was found to be unserviceable. The technician found the power outlet was missing one of the three AC phases. After consulting the wiring schematic, the wiring was traced and the fault was discovered in panel 2000VU. Wire w9019-909-16 was cut and wire 4641-ac9251-yy16 was found chafed. The second wire was found to be the 115vAC power for the onboard GOGO WIFI. Upon further inspection, it was found that the routing of the harness was wrong and it was rubbing against a bolt holding a clamp inside panel 2000VU.

The results of chafed wiring. Arcing evident.

Installers and maintainers are reminded to confirm there is no contact between items or components. While this instance simply resulted in an inconvenience for a few passengers, chafing of wiring can result in a much more serious event.

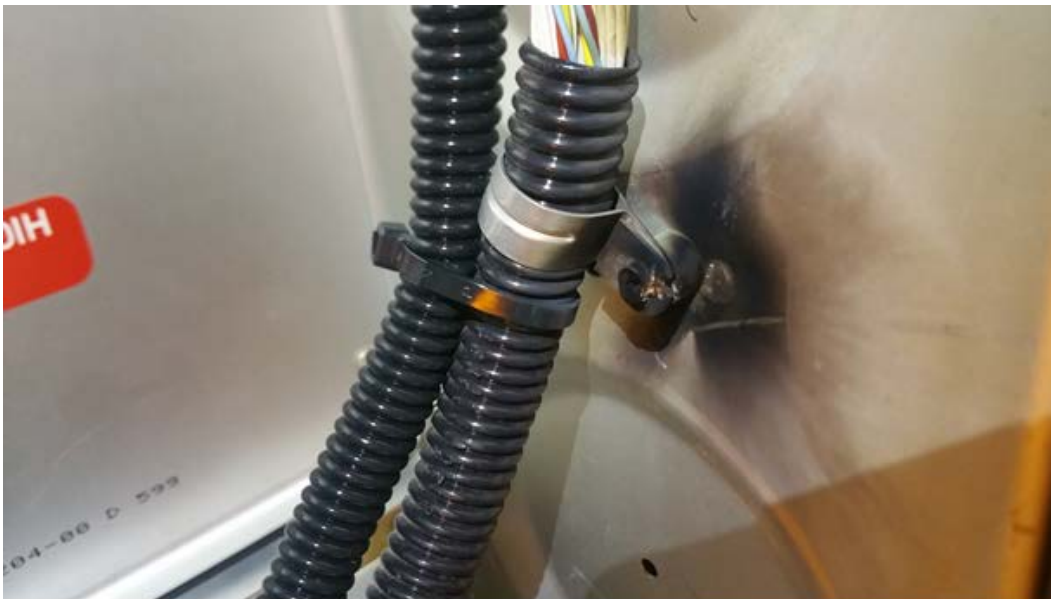
Arcing evident on bolt for DG clamp.

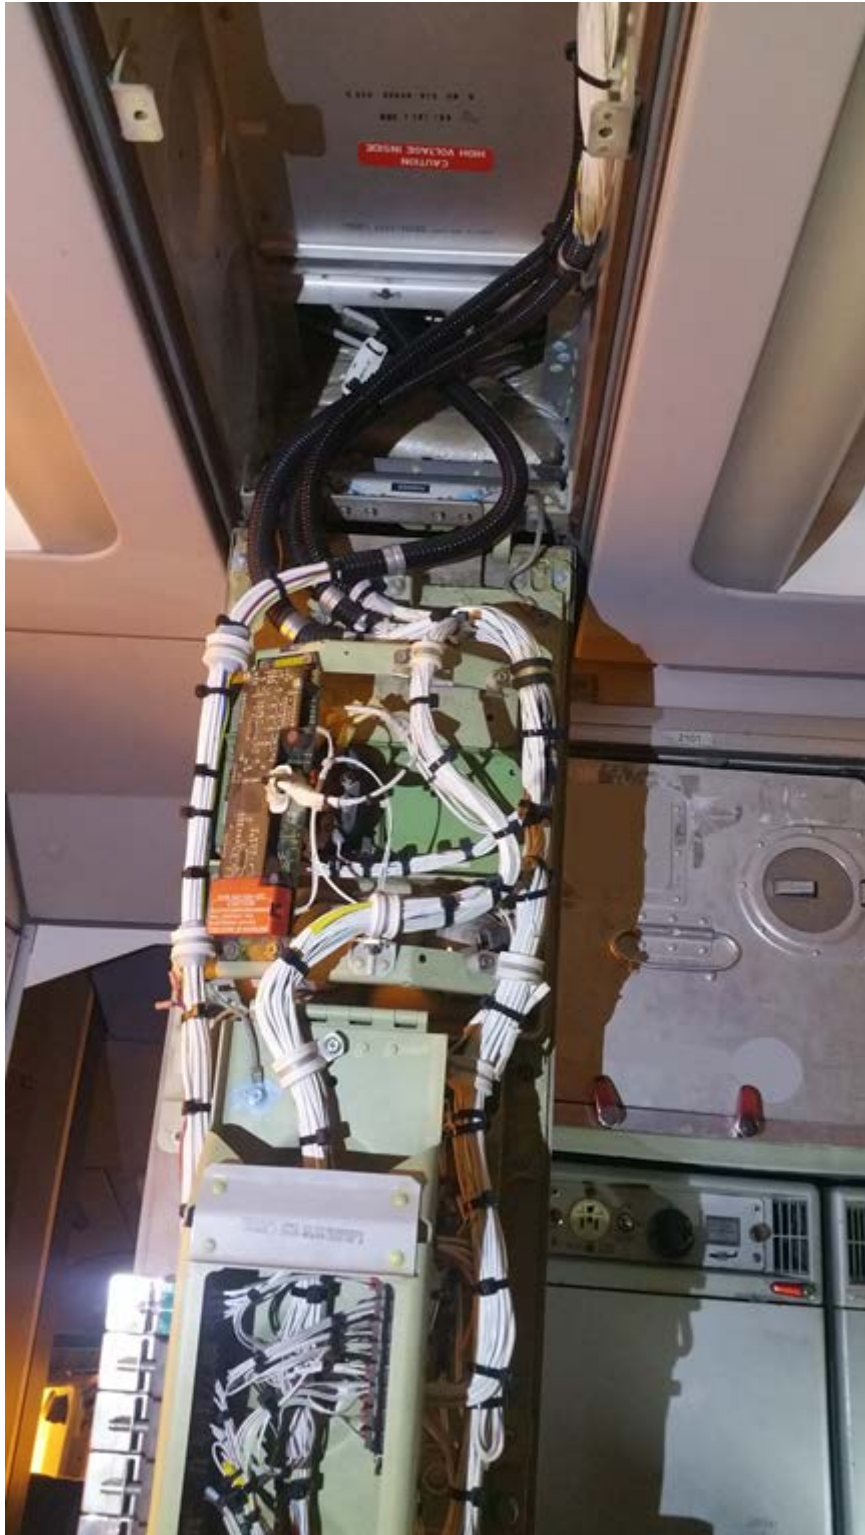
Small panel with tight clearance compounded with many wires.

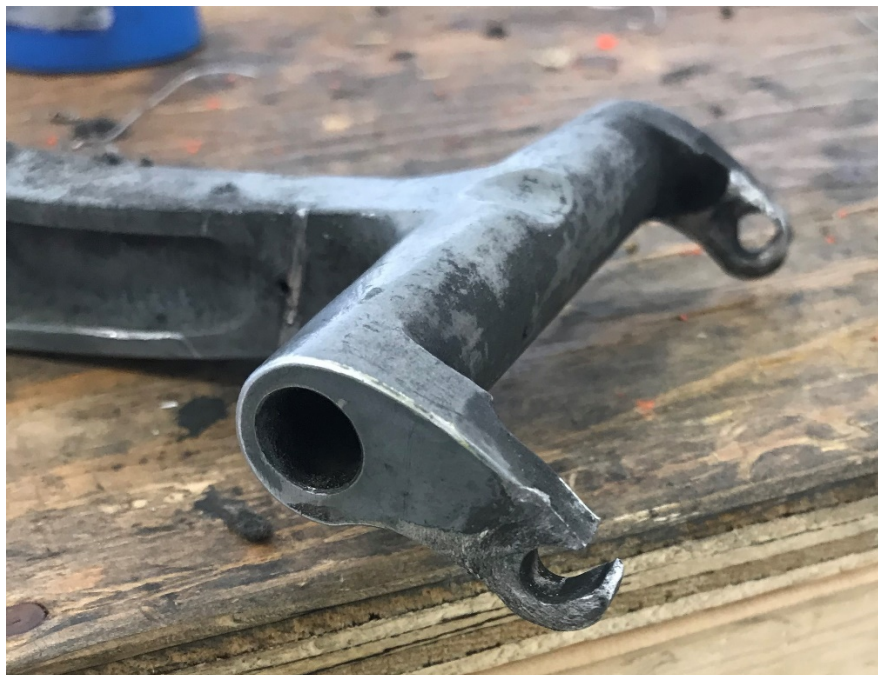
Pilot reported that the aircraft was hard to steer. Maintenance found the pilot's right-hand rudder pedal arm had broken off where the pedal is attached to the arm.

This rudder pedal design is common across multiple Beechcraft models. Part Numbers (P/N) 50-524326 (all dash numbers) and P/N 002-524020 (all dash numbers). Beechcraft does include detailed inspection criteria and possible bushing insert repair instructions. Multiple Service Difficulty Reports (SDRs) continue to be submitted regarding excessive wear or failure of the rudder pedal.

Failure of the rudder pedal arm at the brake pedal pivot holes.

Transport Canada Civil Aviation (TCCA) recommends particular attention be given during scheduled inspection. Wear may be difficult to estimate or cracks may go unnoticed while the pedals are still attached.

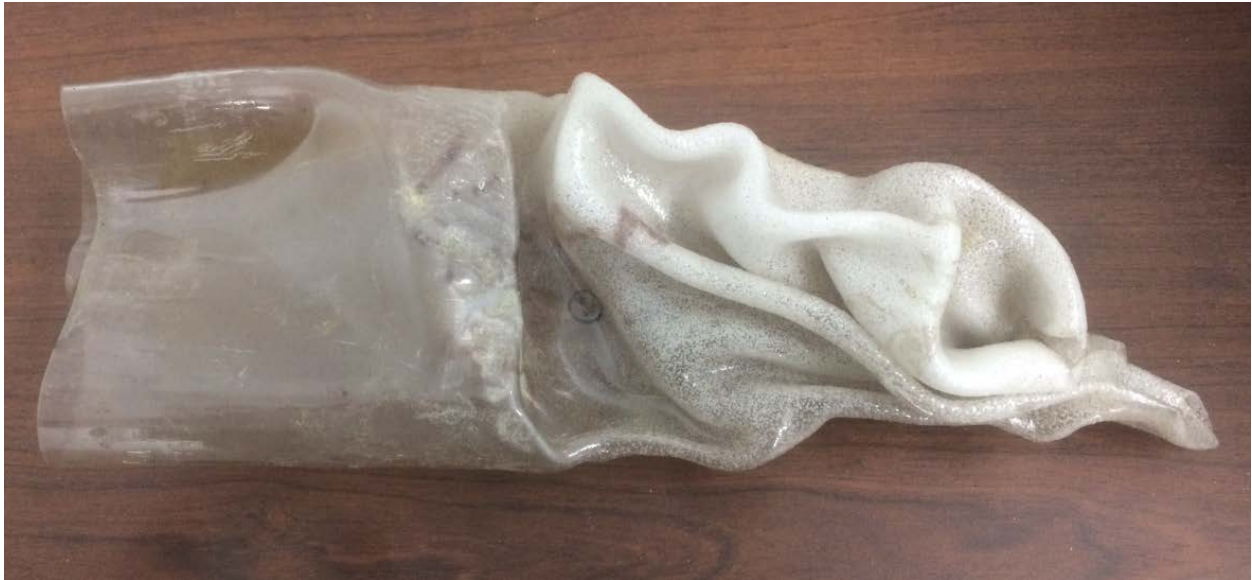
During the initial climb, the pilot felt it was unusually hot even though the heating system was set correctly. Shortly after, smoke began flowing from the exhaust tubes. The pilot declared an emergency and returned to the airport of departure where it landed safely. The maintenance team investigated and found a melted heating duct. The aircraft is still on the ground so that the cause of the overheating can be investigated. The King Air B100 has no system to indicate overheating of its heating system. An inspector from the Transportation Safety Board (TSB) came to report on the situation. Two heating ducts (part number (P/N) 97-555011-15) were replaced, the right-hand bypass valve was found to be non-functional, which caused the overheating. The bypass valve actuator (P/N NYLC9871) was replaced, the system was ground-checked and operates normally. The aeroplane was returned to service, and it flew. The system is functioning normally.

Beech King Air 90 and 100 series aircraft do not utilize a duct overheat annunciator. Repeated overheating of the system, environmental exposure to heat (proximity to bleed lines), or other unreported anomalies relating to the bleed air and heating system, can all exacerbate the problem. A faulty bypass valve in this case could introduce air hot enough to cause damage to air ducts.

Melted cabin heater duct

Maintenance personnel are reminded to pay particular attention to the hot air ducts and under-floor bleed air lines. The ducts are covered with insulation, and it could be difficult to detect any thermal deterioration or deformation. Beech recommends to physically inspect ducts by touching ducts, checking for thermal deterioration, deformation of the ducts, and proper connection at the joints.

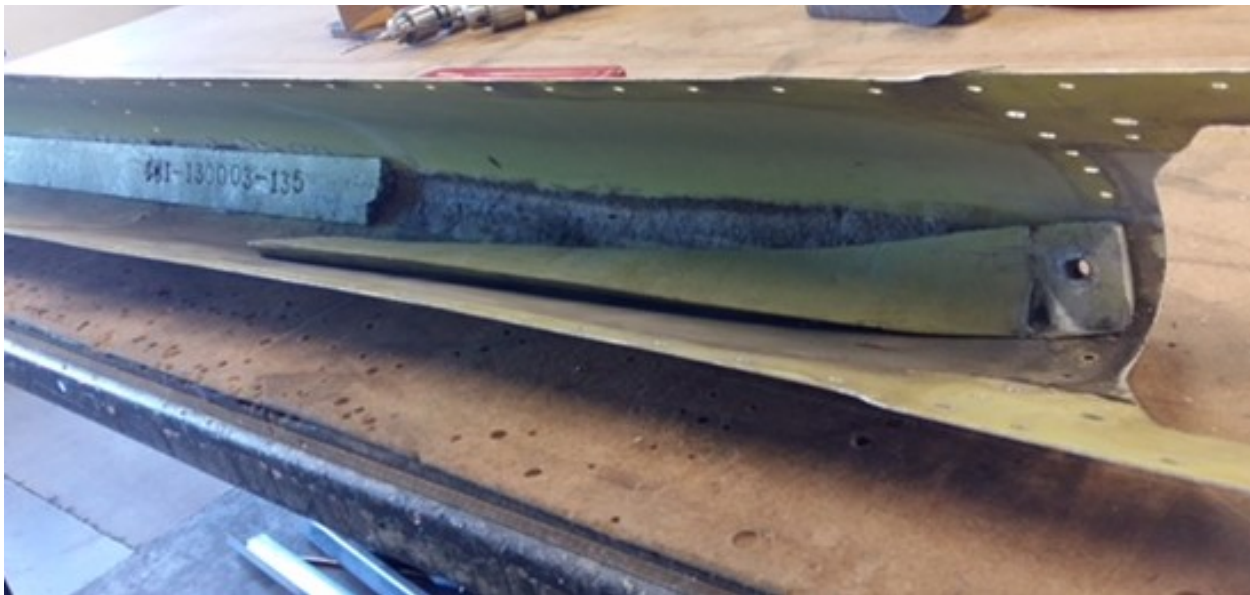
During unscheduled maintenance, abnormal noise was heard coming from the right-hand aileron. Removed aileron and found aileron balance weight broken into 2 pieces. Outboard 13 inches of balance weight was found to be held on with 1 CherryMAX rivet which it was rotating on.

It is important to note, flutter is a phenomenon that can occur when an aerodynamic surface begins vibrating. This can lead to failure of the control surface.

Example of a B300 Cracked Aileron Weight

Pilots and maintainers are reminded of the importance of a thorough pre-flight inspection.

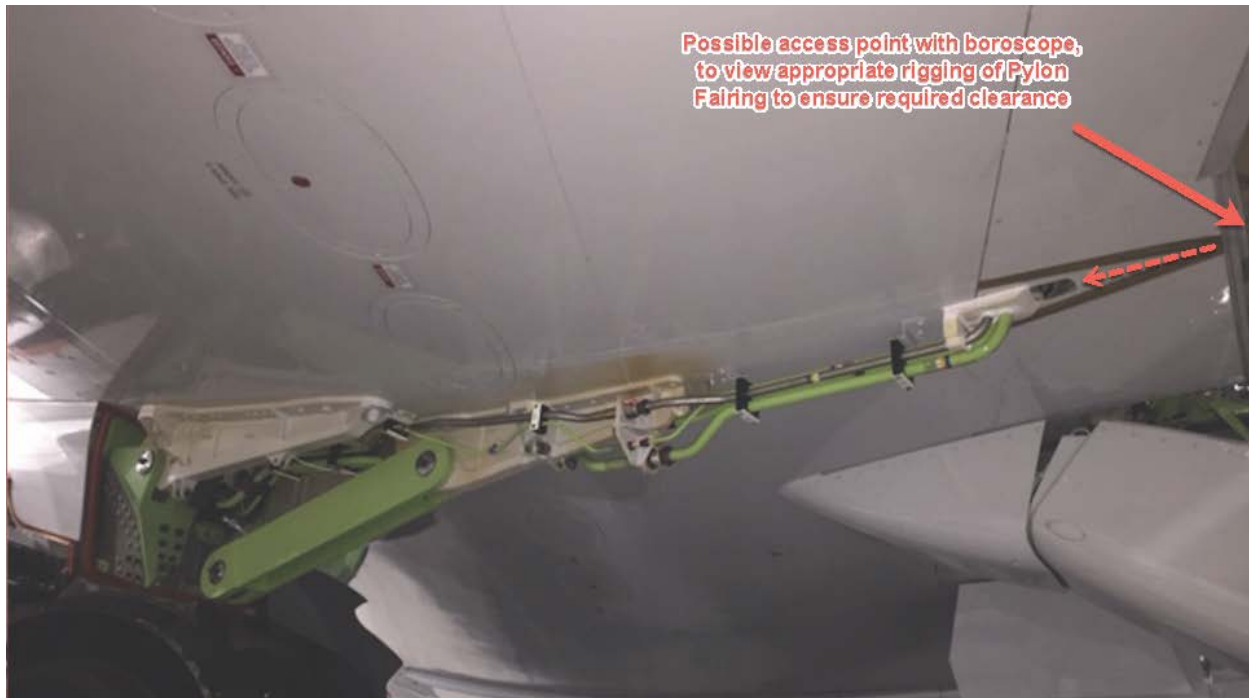
Maintenance found system "A" hydraulic quantity at 60%. Upon inspection, fluid was found leaking from the #1 engine aft fairing drain tube at a rate of approx. 4 drops/sec.

Pic 1: Location on wing of leaking line

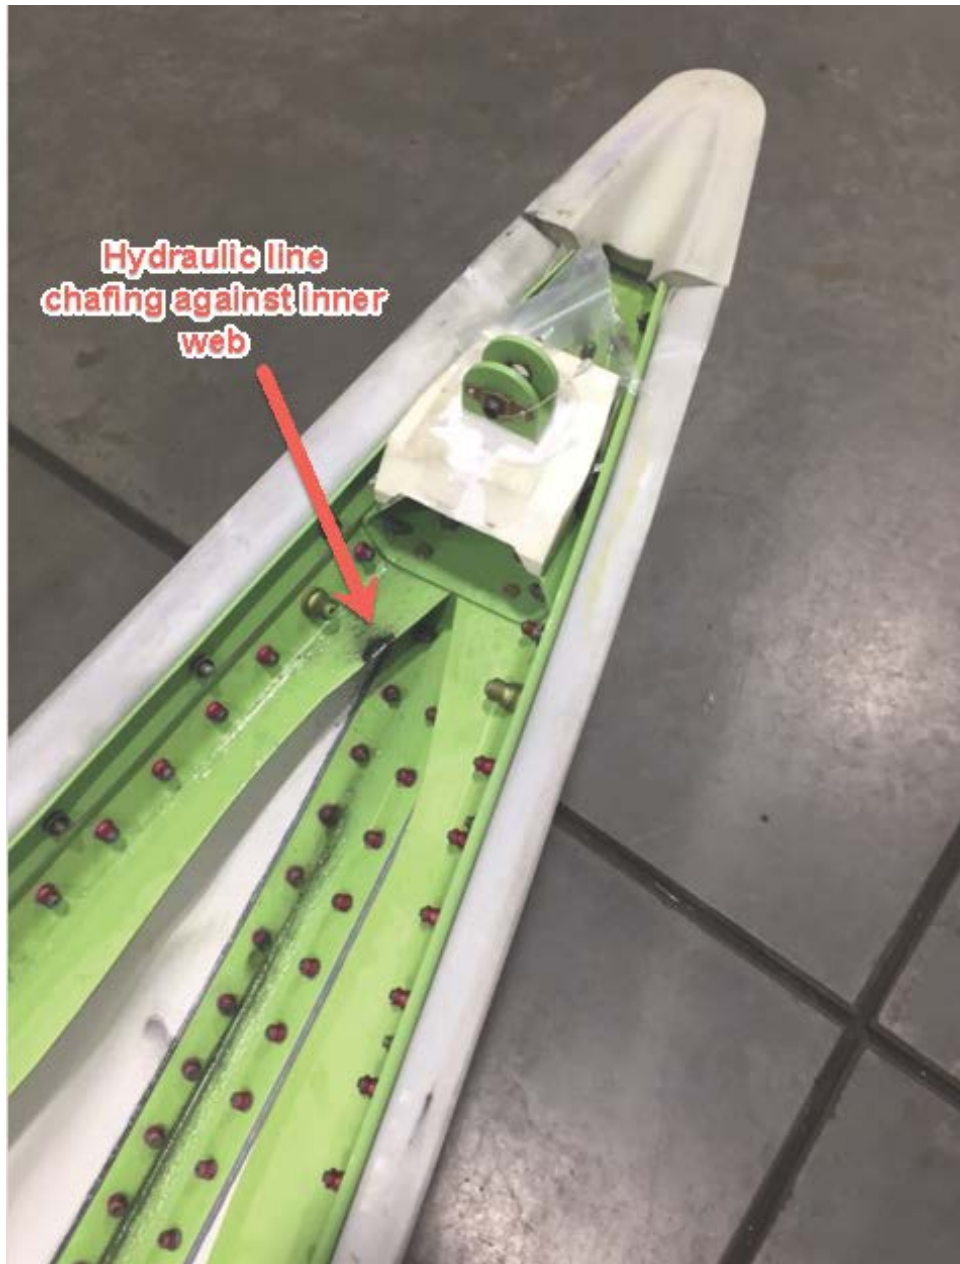
Hydraulic supply line was found chafed from contact with the aft strut fairing. Hydraulic line was replaced and leak checked serviceable.

Pic 2: Chafe mark on inner web of fairing

Even new aircraft may have surprise leaks. When installing components or performing visual inspections, maintainers are reminded to be diligent for potential chafing between lines, conduits, hoses, electrical harnesses, structure, etc. Maintainers are also reminded to wear all the proper personnel protective equipment while working around Skydrol and all other harmful chemicals used on aircraft.

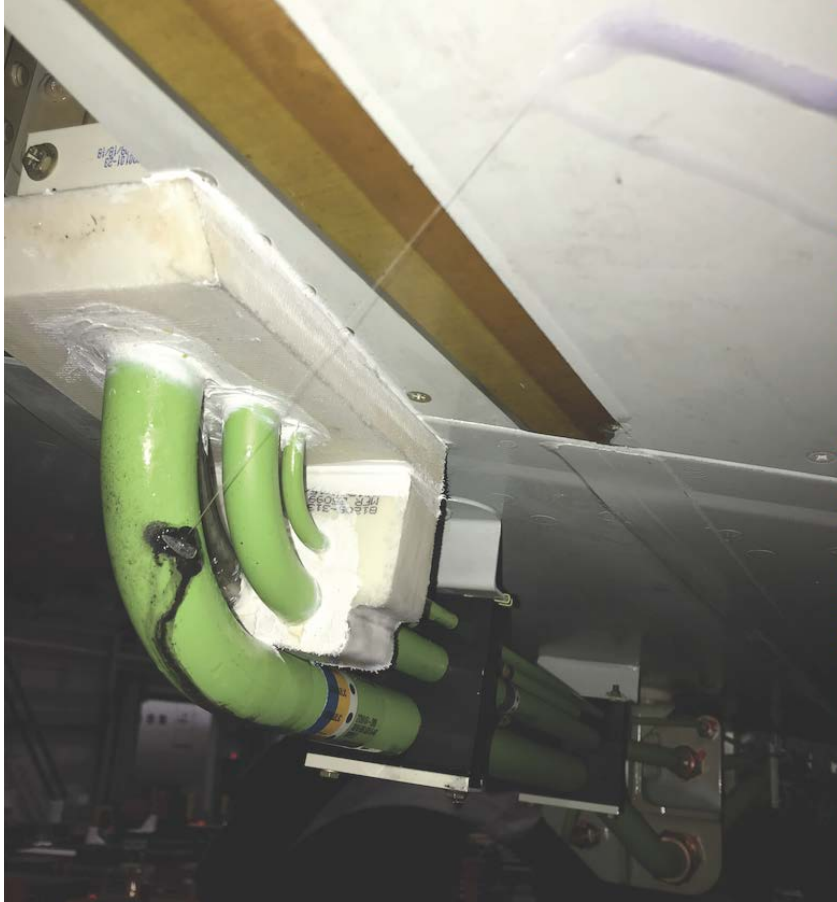
Pic 3: Chafe mark on line with hydraulic fluid spraying from hole

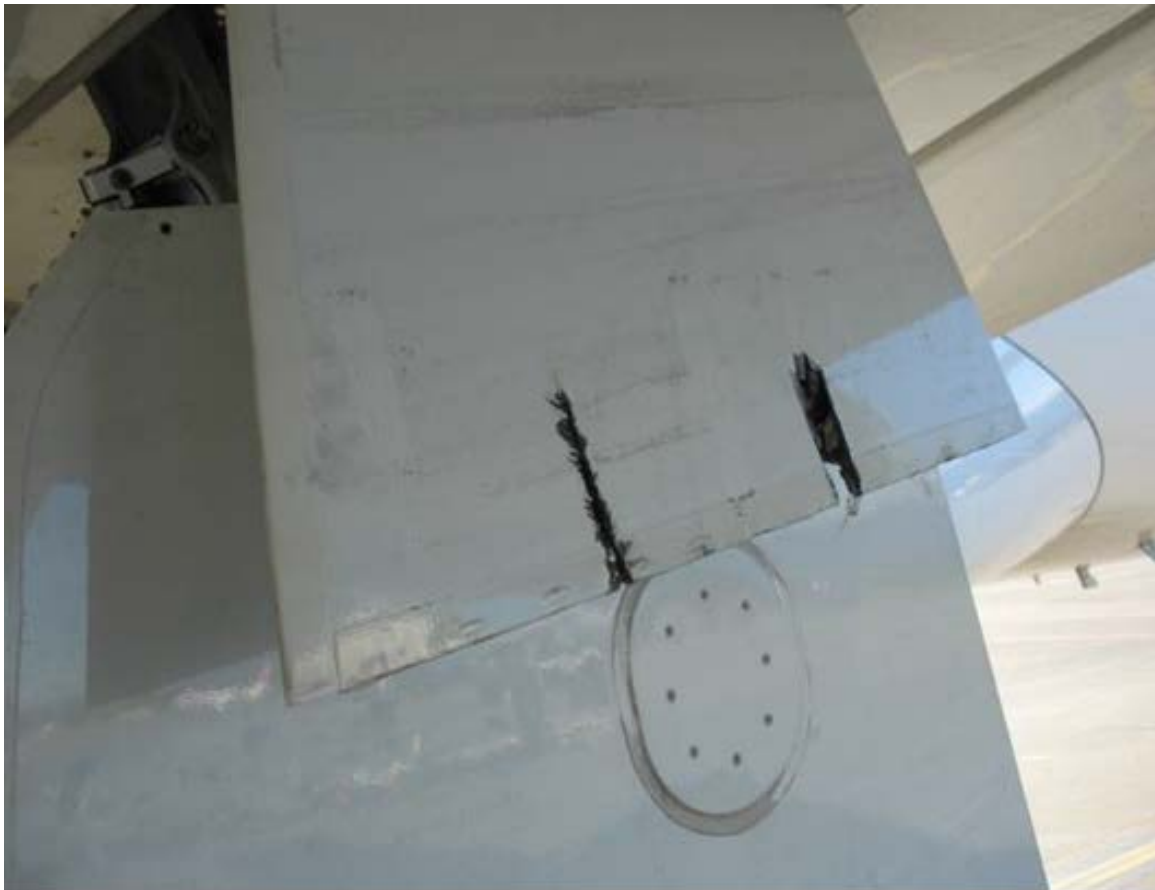
The left main landing gear (MLG) auxiliary door was damaged, the actuating rod was broken and the wing lower surface was found damaged. The flight crew also reported damage on MLG door to be inspected by Maintenance (missing material) and Maintenance confirmed damage found. A damage assessment was performed and a report was sent to Bombardier requesting further action and repair advice.

Following the occurrence of this and similar events, Bombardier opened an in-depth investigation and discovered that installation, adjustment and rigging issues had not been performed correctly. The fleet was inspected and four CS300 aircraft were discovered with loose fittings and one CS100 was found with a door interference issue. Additionally, one CS100 was found with a broken gear door rod, landing gear door damage and lower wing damage and is the case referenced in this article.

Figure 1: Damage to main auxiliary gear door

Bombardier carried out a fleet campaign and subsequently issued Reference Instruction Letter CS-RIL-32-0005 in October 2017. Since then, there have not been any further reports of damage similar to this event.

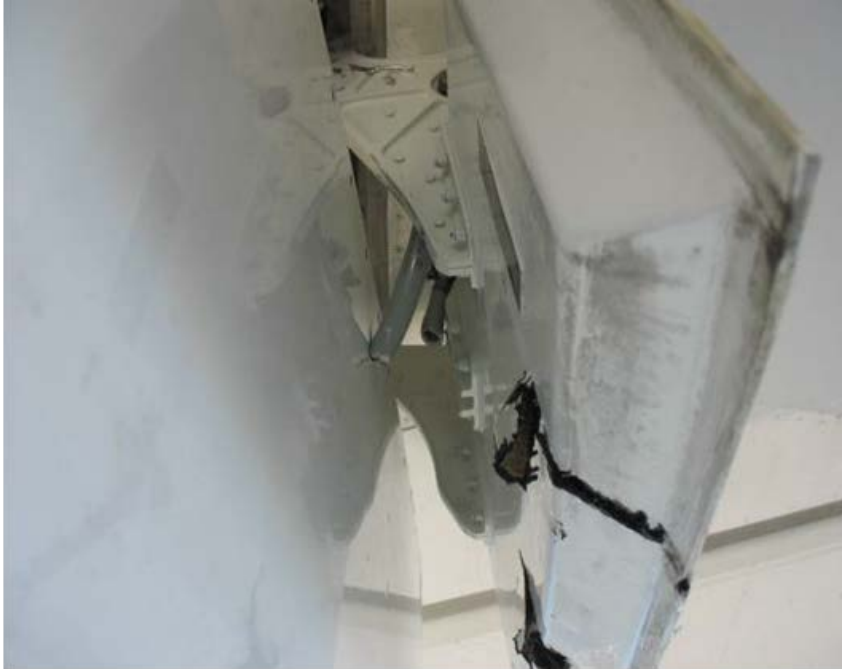
Figure 2: Gear door damage as seen from inside

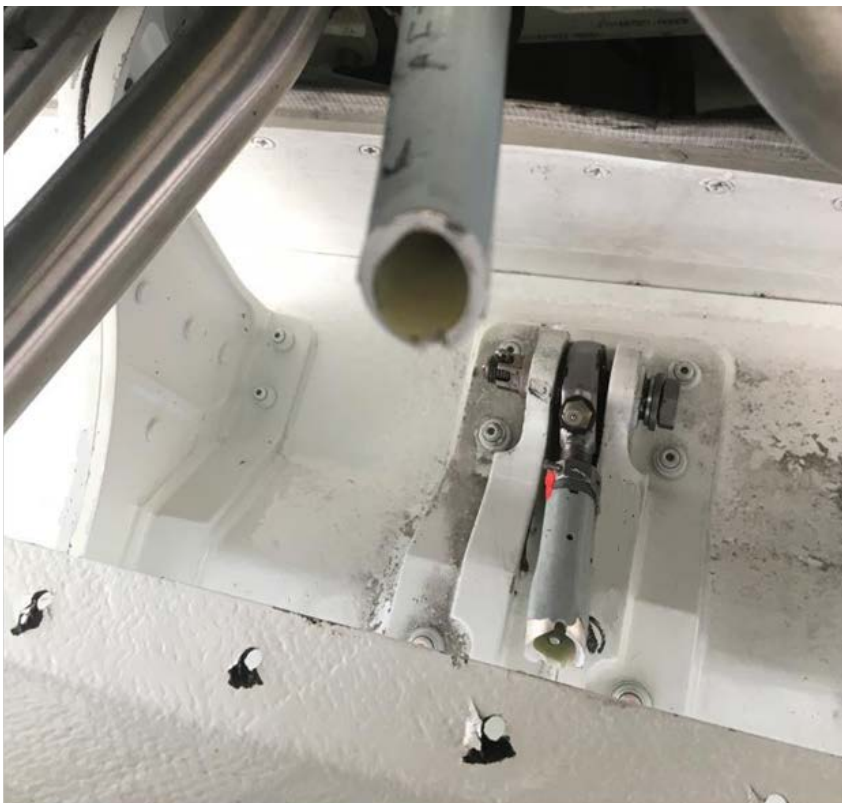
Figure 3: Broken gear door rod

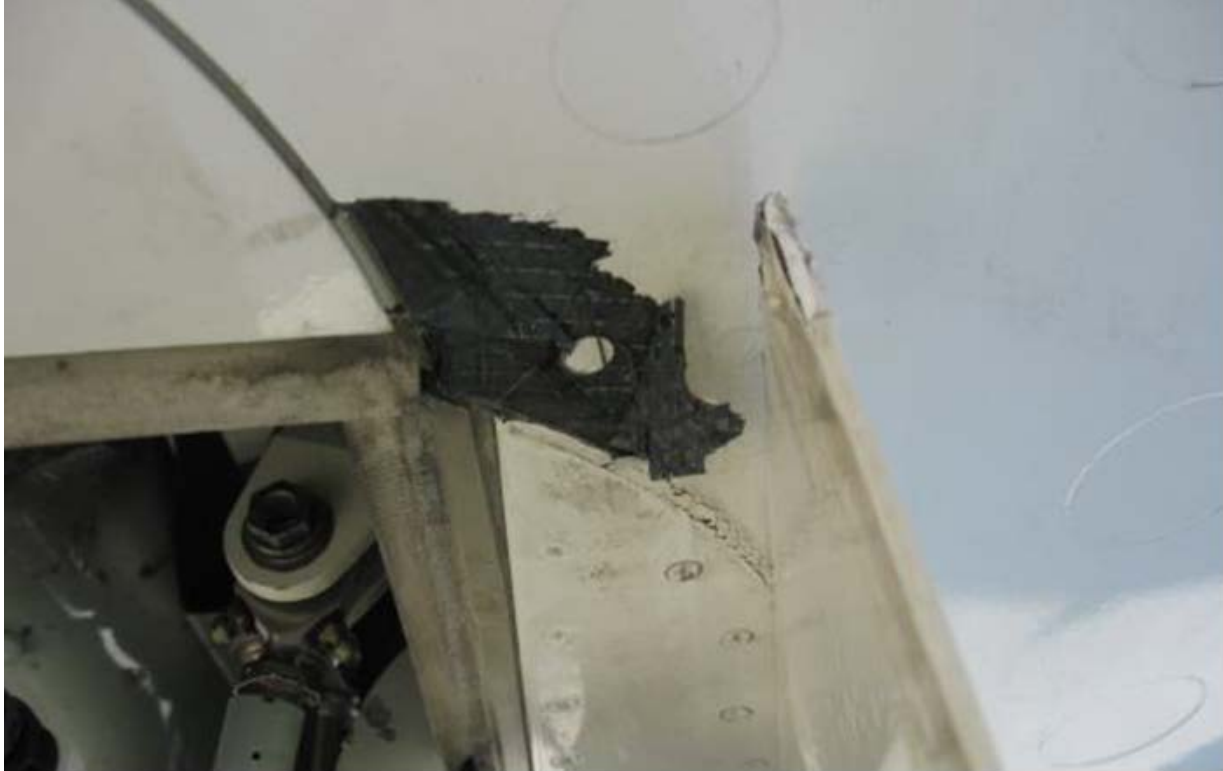
Figure 4: Damage to composite wing

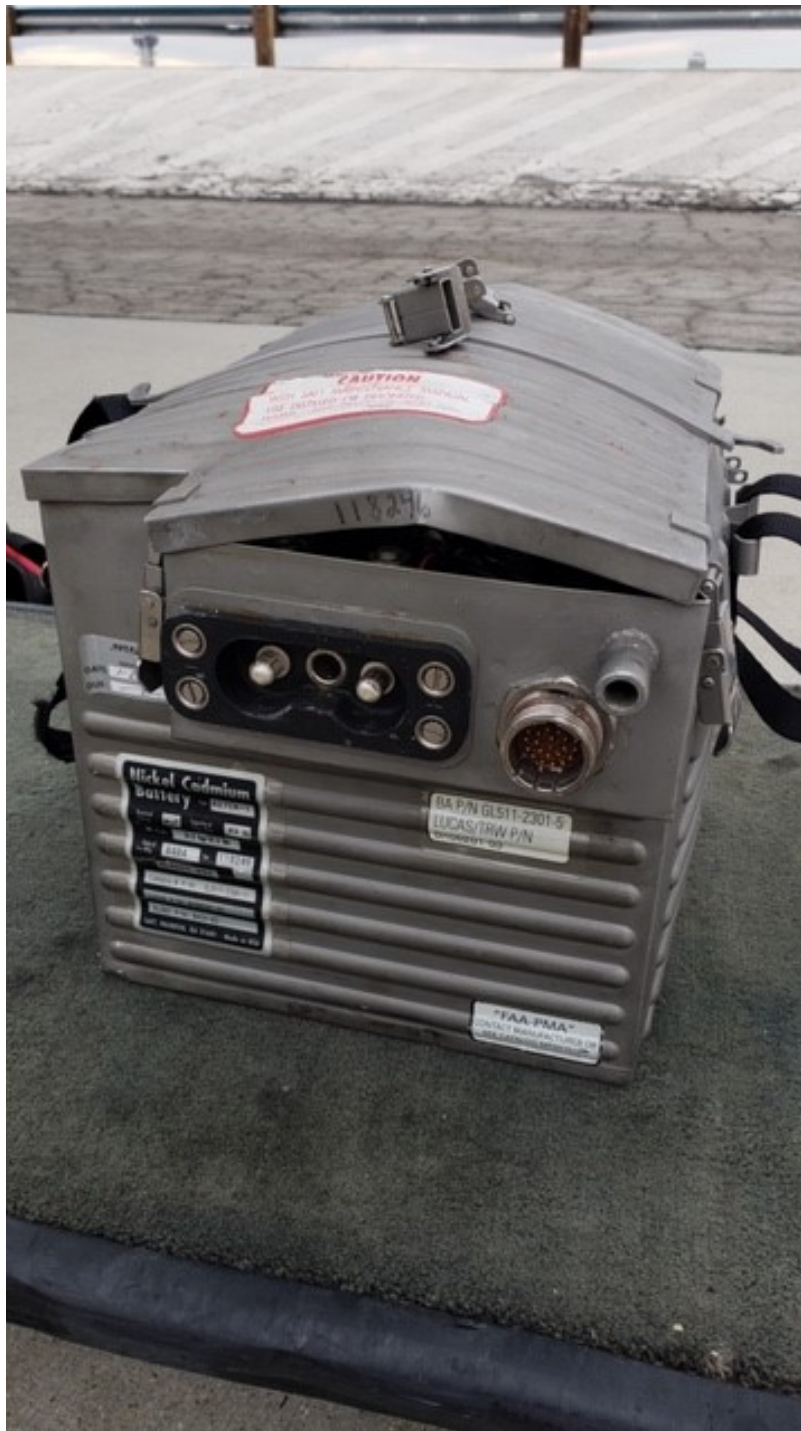
The Auxiliary Power Unit battery was dropping to 9 volts on start and the operator decided to replace it with his spare. When they got access to the battery, they found the battery case deformed and one of the latches seemed to have detached from the case. It was confirmed that the battery heater circuit breaker was out at the time of the event.

An aircraft should never be attempted to start an engine with a dead Ni-Cad battery. Here is an example of the kind of damage thermal runaway causes. They are fortunate that it did not damage the aircraft. Proper voltage and temperature monitoring can prevent battery damage from overheating caused by thermal runaway.

Damaged battery

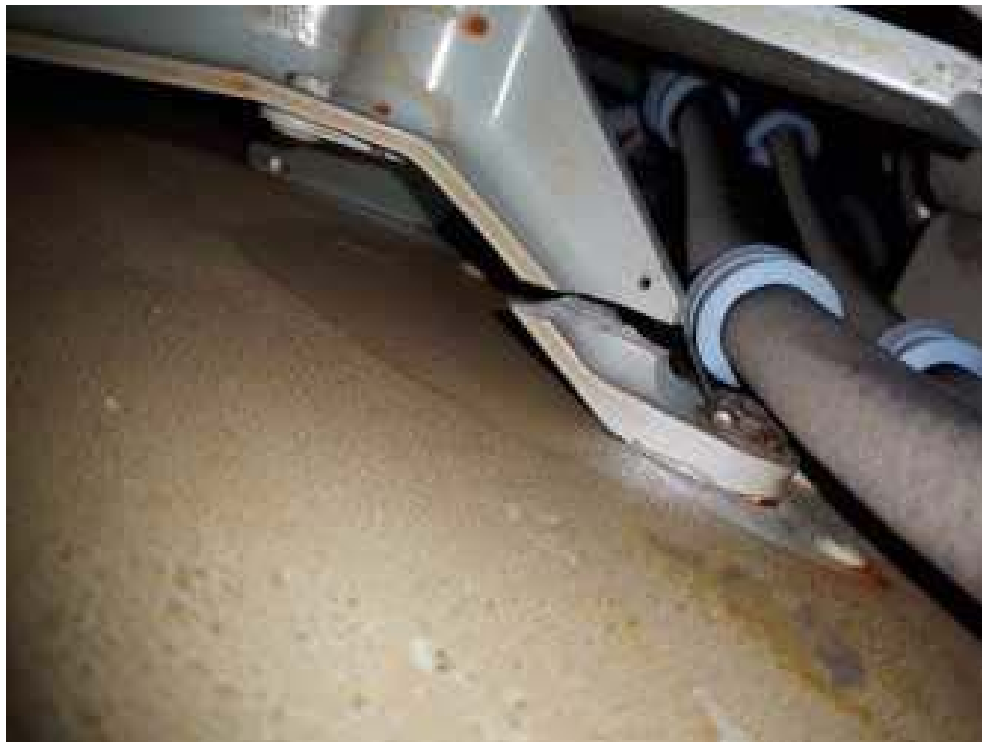
During the closeout inspection before installing the main landing gear wheel bins, the inspector found that the R/H aileron mixer support bracket was cracked and one of the three legs of the bracket was severed. Pictures attached show its location and the severed leg of the support bracket which supports the aileron control system pulleys.

The area where the damage was located is not easy to inspect, and the severed support leg was behind some lines that are clamped to the attaching bolt for the support leg. The subject aircraft was a low time executive CRJ100 aircraft built in 2002 that was in for maintenance. Thorough and detailed inspection techniques were able to locate this defect before it became an issue.

Fig 1: Severed aileron quadrant support leg.

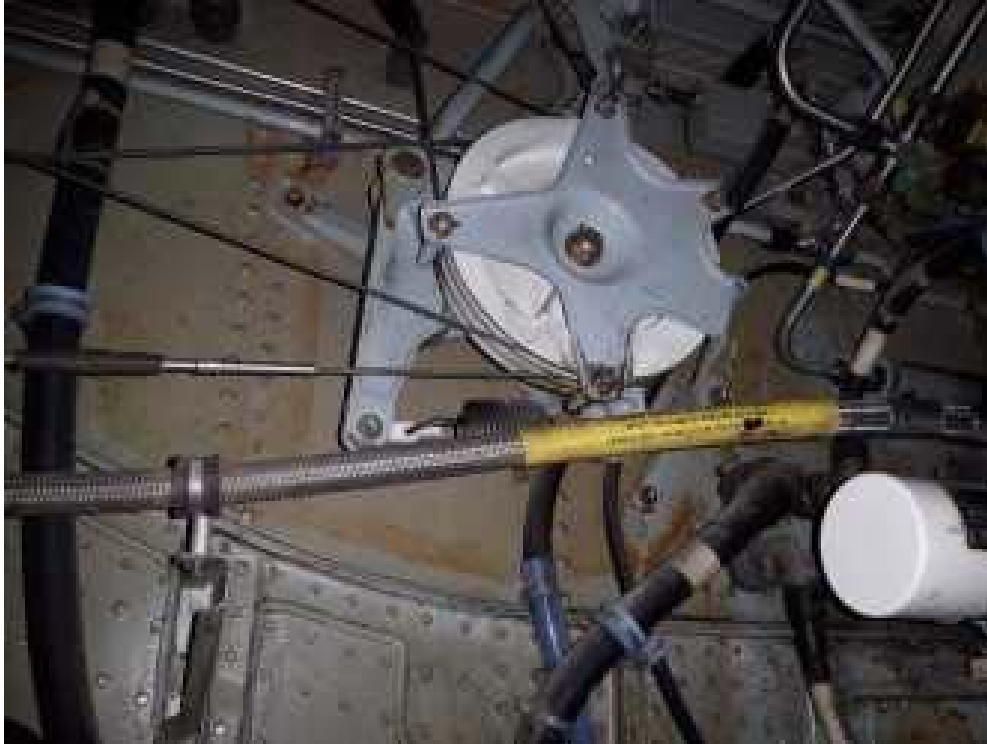
Fig 2: Location of aileron mixer and support bracket.
