### Canadian Aviation Service Difficulty Reports

The following content was published between January 1, 2020 and April 1, 2020

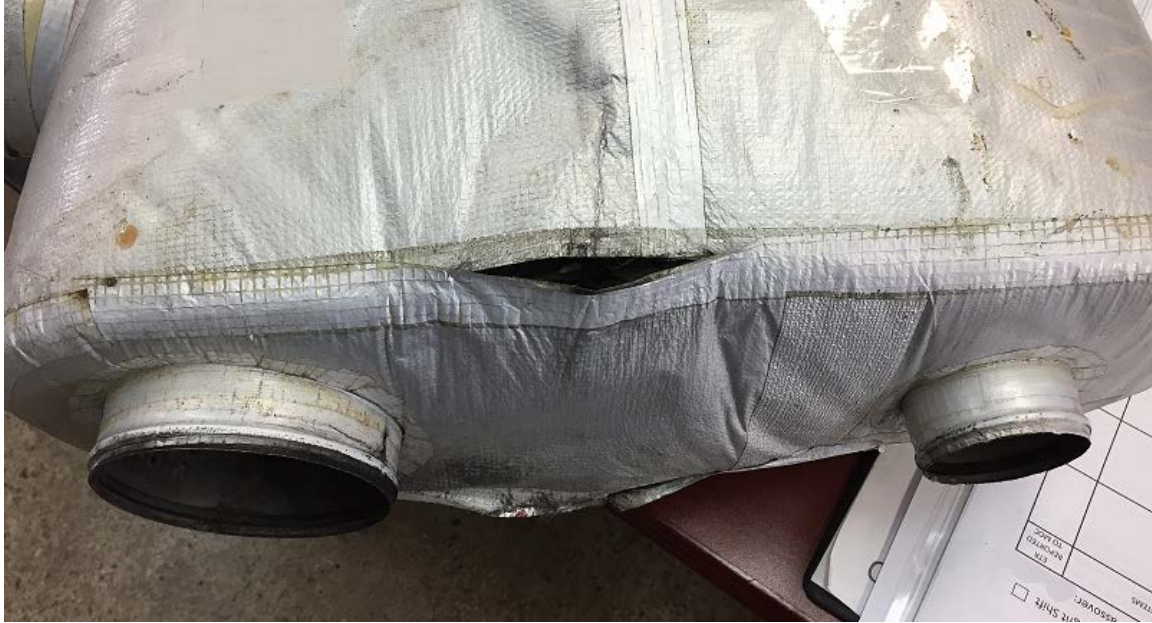
Very low airflow was noted entering the cabin and flight deck with both air conditioning packs selected on. Subsequent investigation found the main feed manifold ruptured. The main feed manifold was replaced and the air conditioning system checked serviceable.

The duct was found with a small split at one end and a large split at the other end. The damaged duct was replaced and the aircraft was returned to service.

Figure 1 – Small split in duct

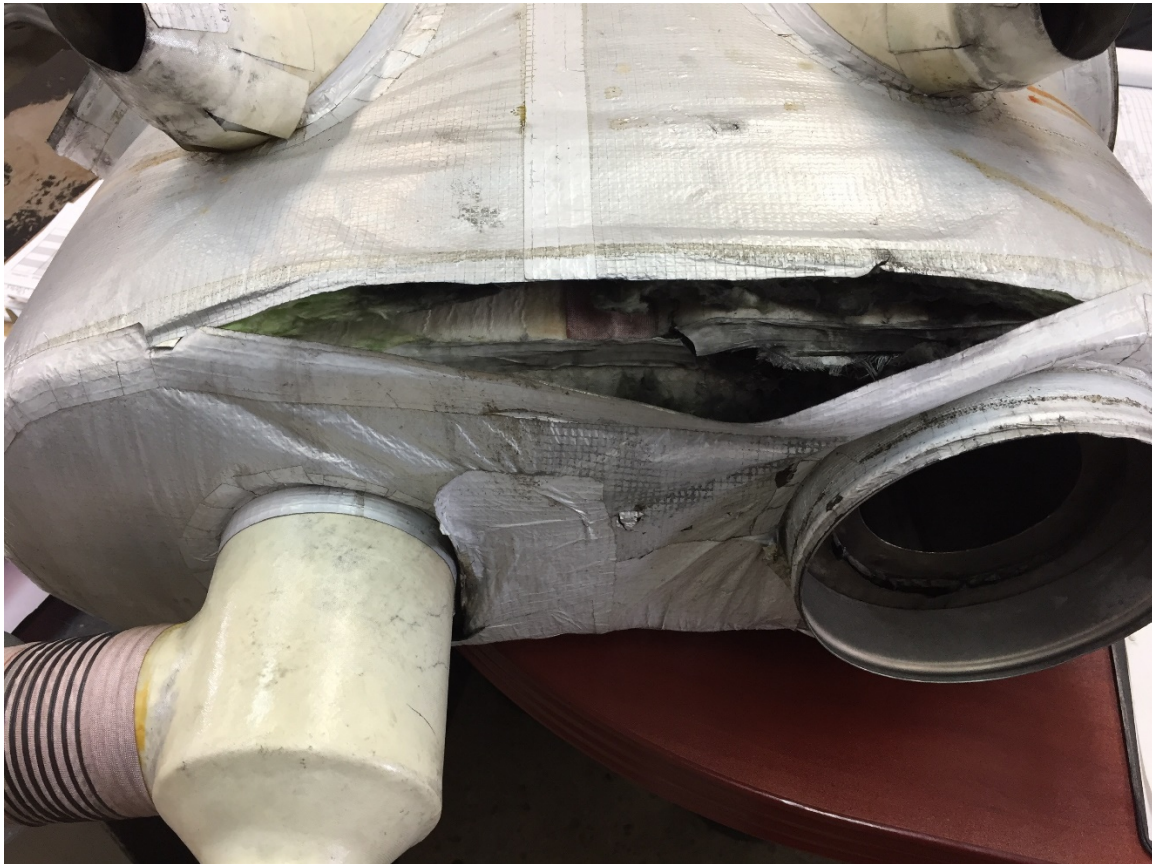
Figure 2 – Large split in duct

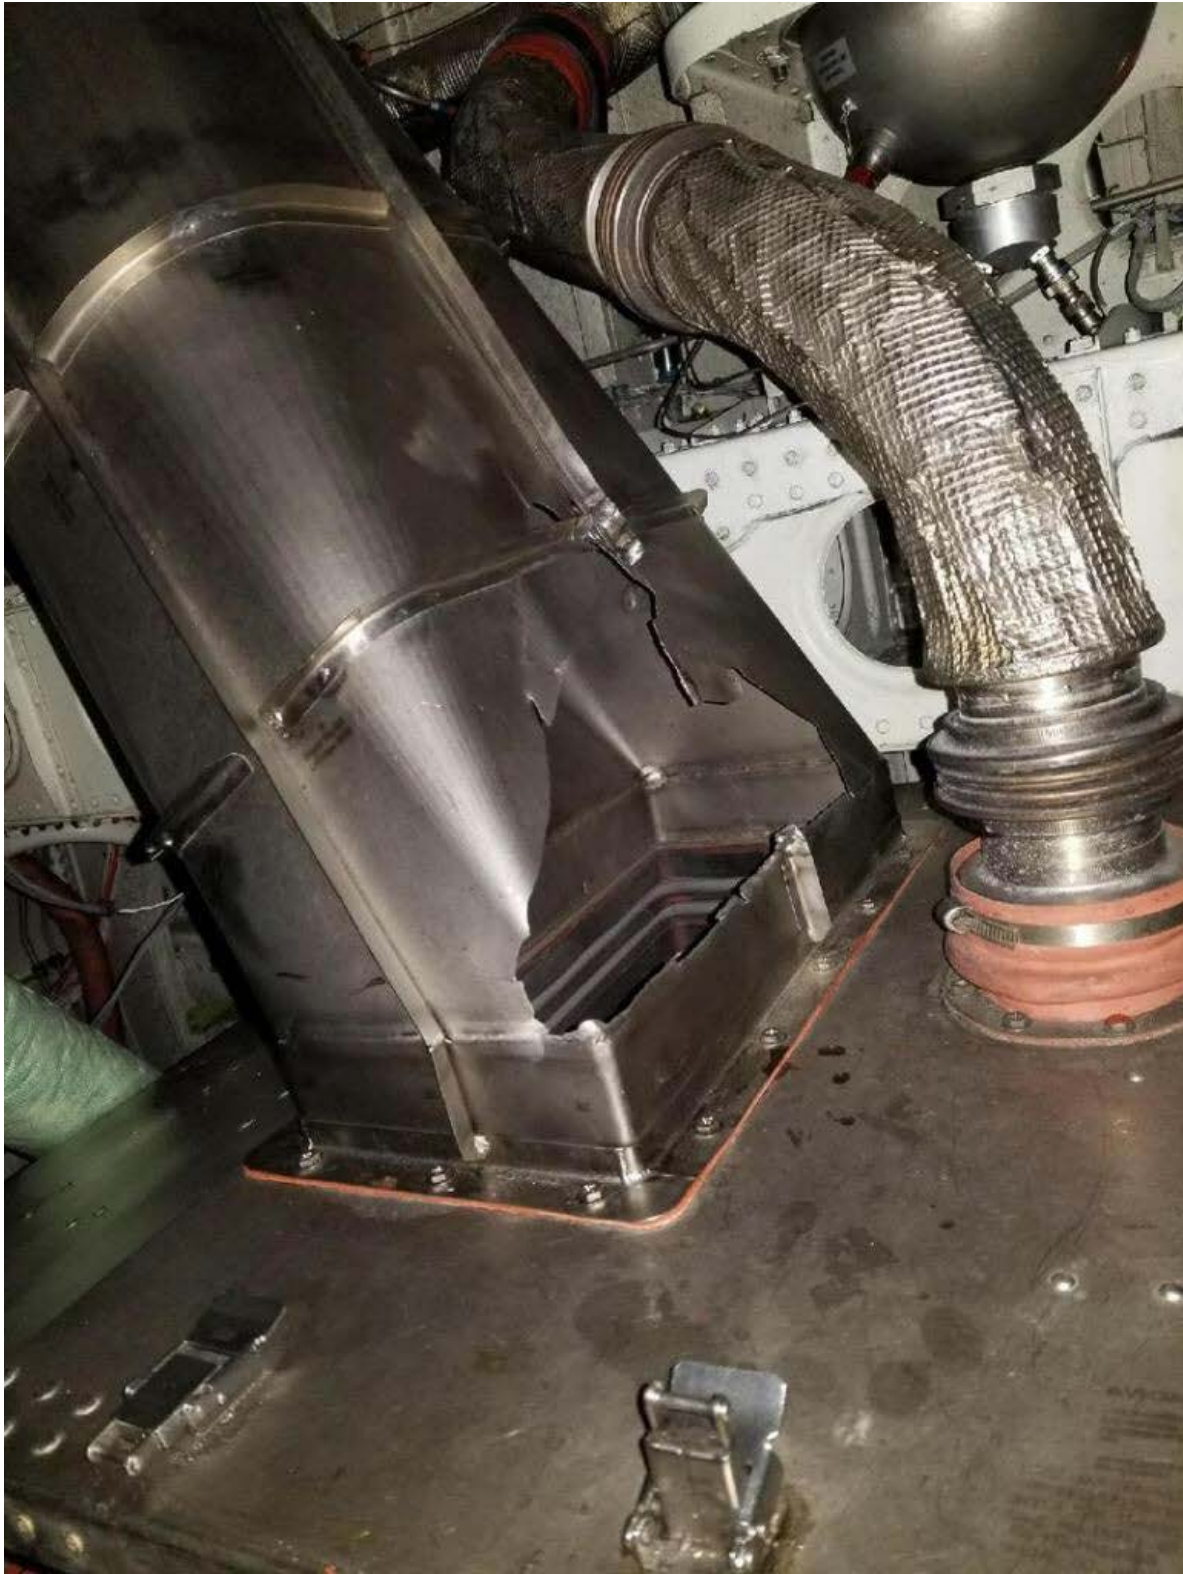
While investigating a snag of the Auxiliary Power Unit (APU) "no start" condition and accessing the APU compartment, the APU lower inlet duct was found to be cracked with pieces of the duct wall missing.

Figure 1: Picture of broken APU air inlet duct

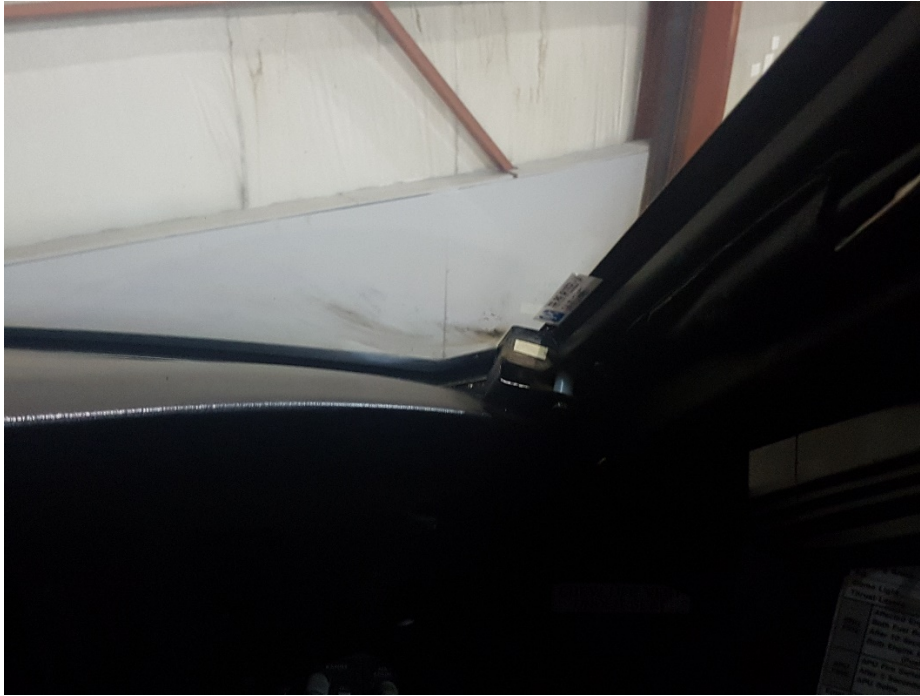
The aircraft was enroute and experienced a windshield heat failure. The crew noticed some arcing and then a small fire/flame near the terminal block at the lower right-hand side of the windshield. The crew turned off the windshield heat and the arcing and fire stopped. The event occurred close to the destination airport and there were no further issues after turning the windshield heat off, so no emergency was declared and the aircraft continued the flight and landed without incident. No other damage to the aircraft other than the windshield and one of the crew's checklist that was damaged by the arcing flame.

Figure 1: Lower right corner showing burning on the windshield.

Aircraft Maintenance Manual (AMM) 56-11-01 notes, “...inspect the outboard moisture seal for cracks or erosion... and repair if necessary...” This is a reminder to all owners, operators and maintainers of the various inspections and repairs that are available to prevent such occurrences as seen in this article.

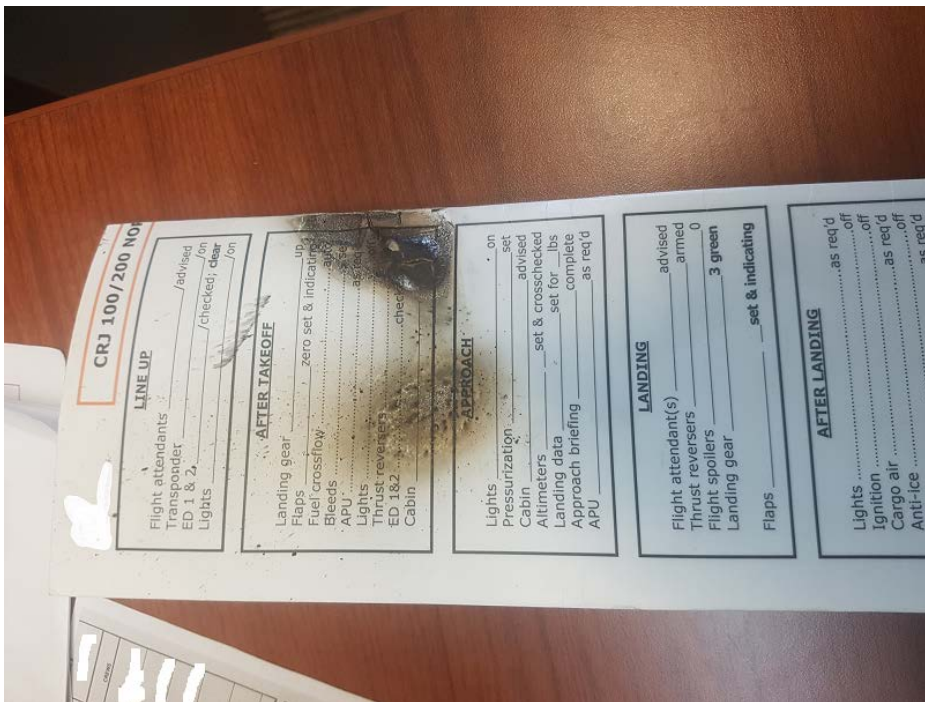
Figure 2: Pilot checklist shown burns caused by arcing.

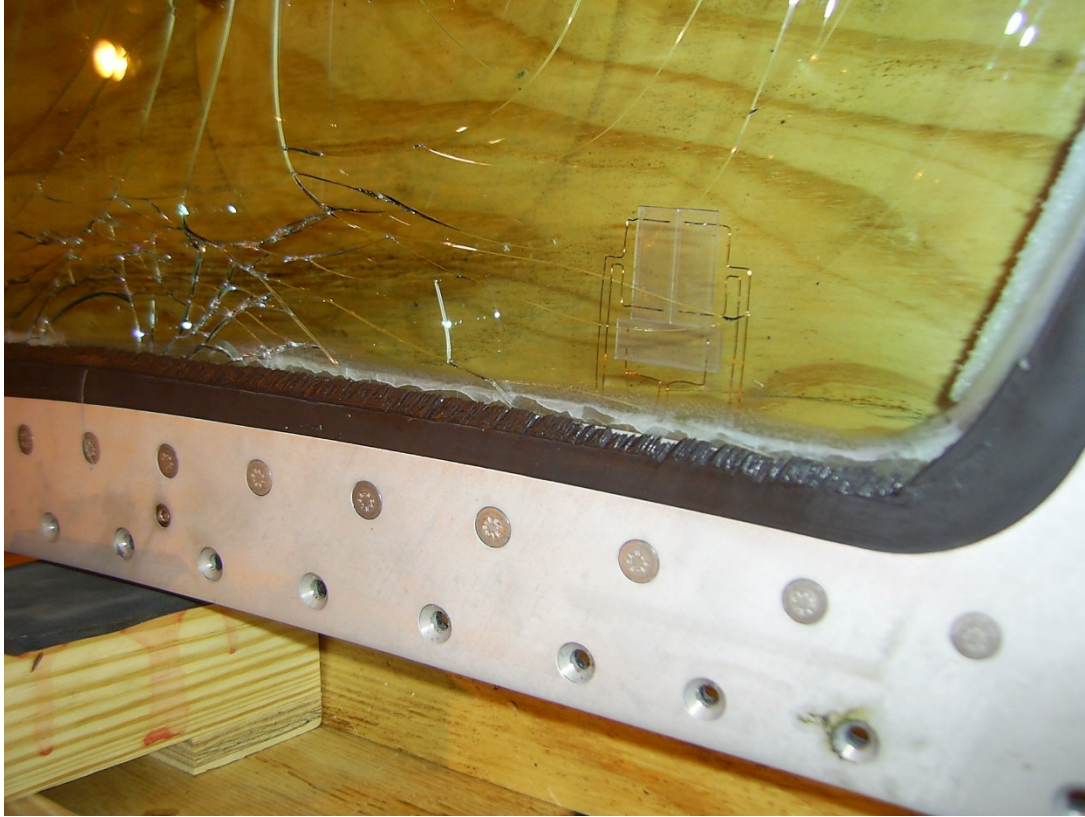
Figure 3: Picture from 2013 Feedback article showing eroded window seal and foggy area caused by water ingress.

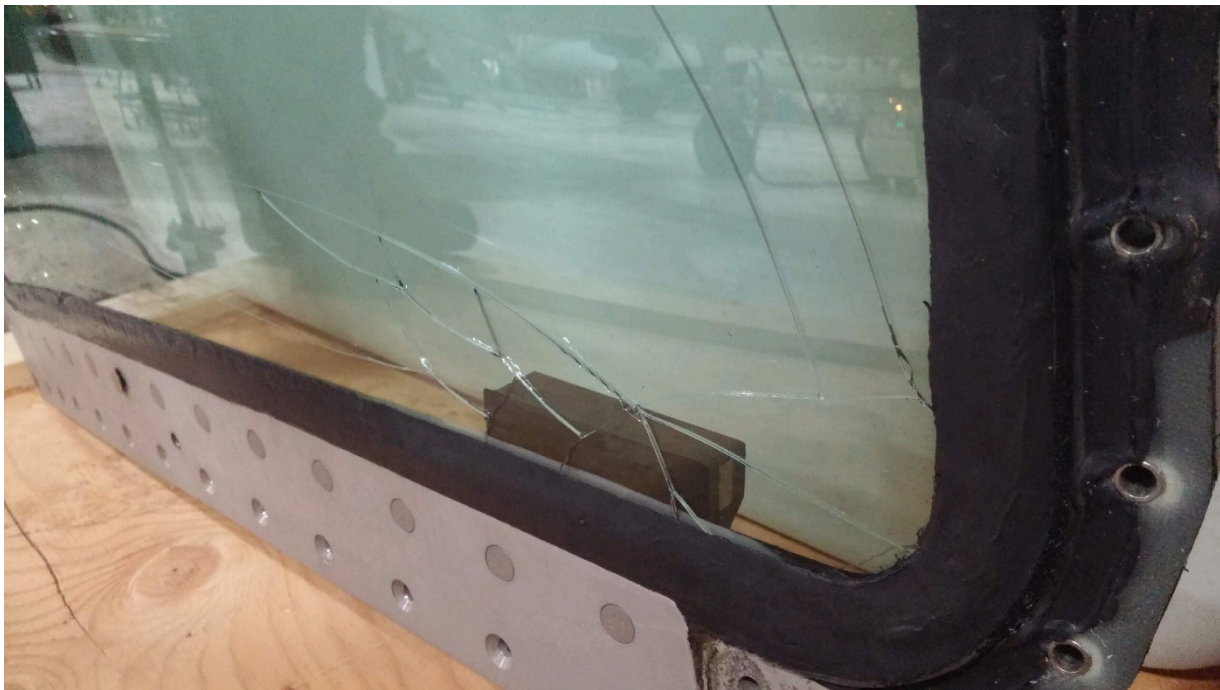
Figure 4: Another SDR event showing windshield water ingress foggy area.

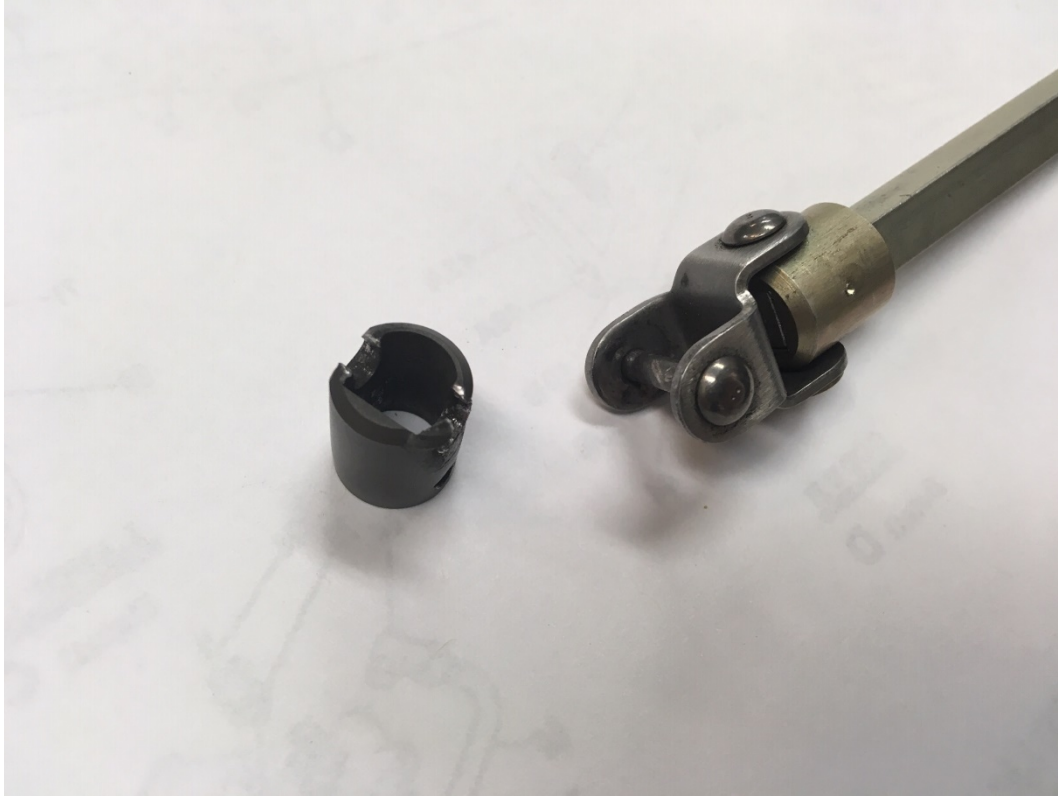
Excessive wear resulting in drive shaft disconnect

Cessna Model 172 Series Service Manual recommends – Each 100 Hours:

Fuel Selector Valve – Check controls for detent in each position, security of attachment, and for proper placarding.

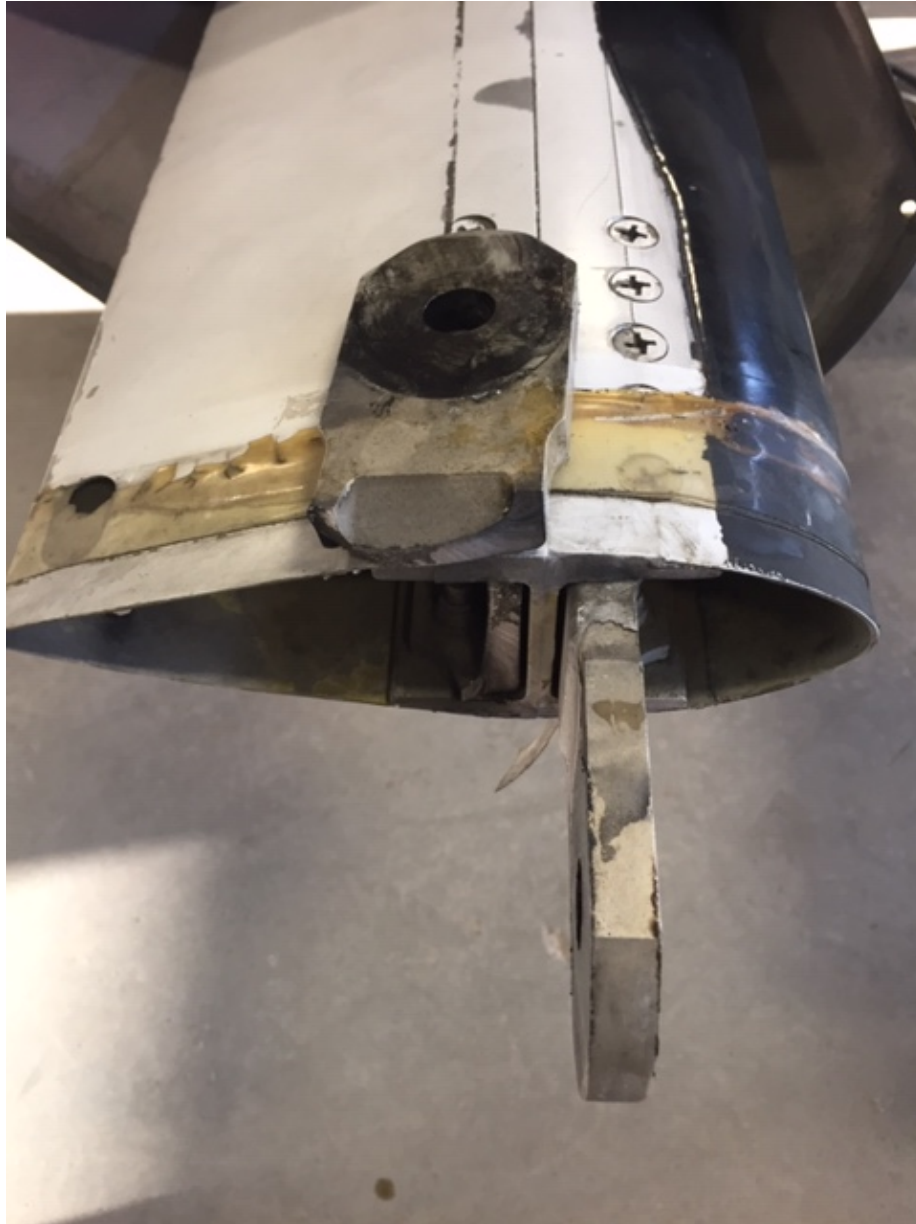
Photo 1 Lower Wing Strut Fitting Top View

Operators are reminded that mandatory replacement times and inspection intervals may be dictated by the type of operation. In this case, “Typical” and “Severe” are defined in chapter 4-00-00 Airworthiness Limitations section Model 208/208B Maintenance Manual.

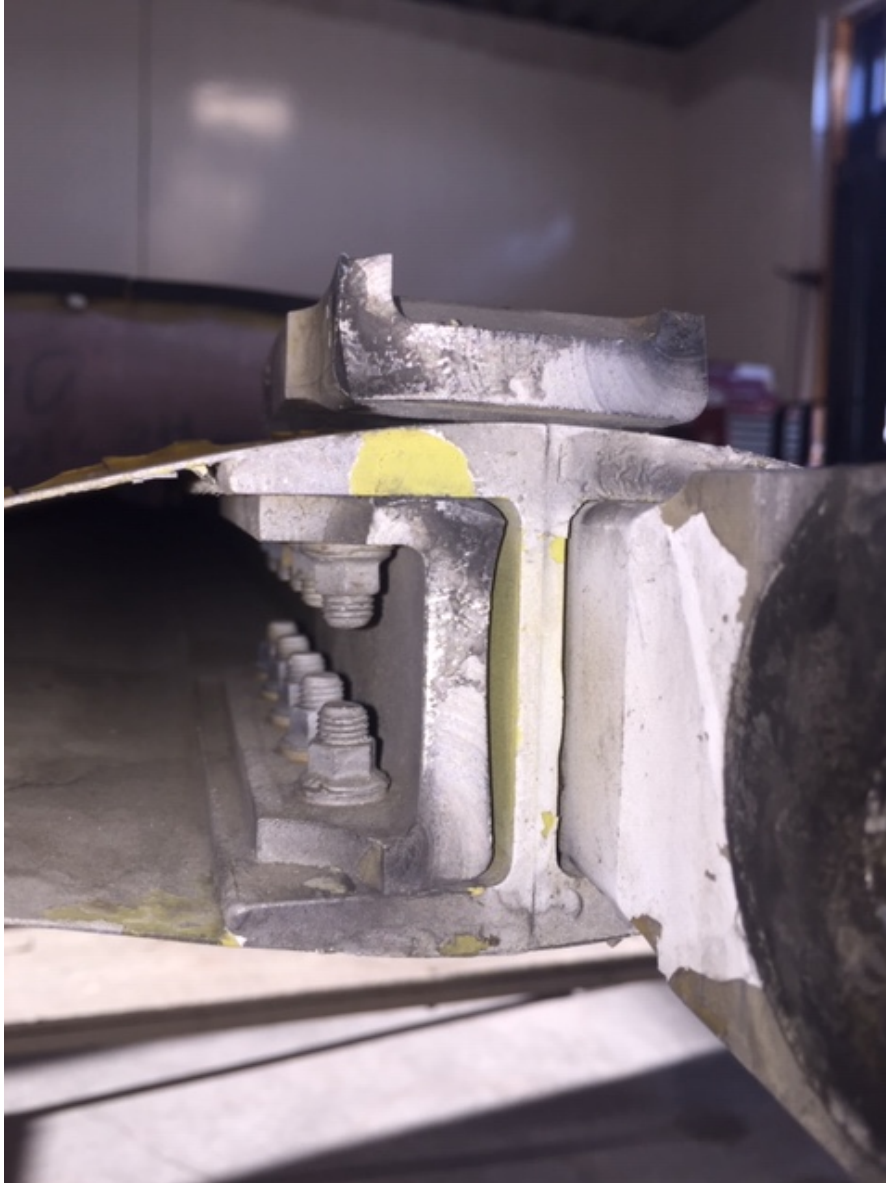
Photo 2 Lower Wing Strut Fitting Side View

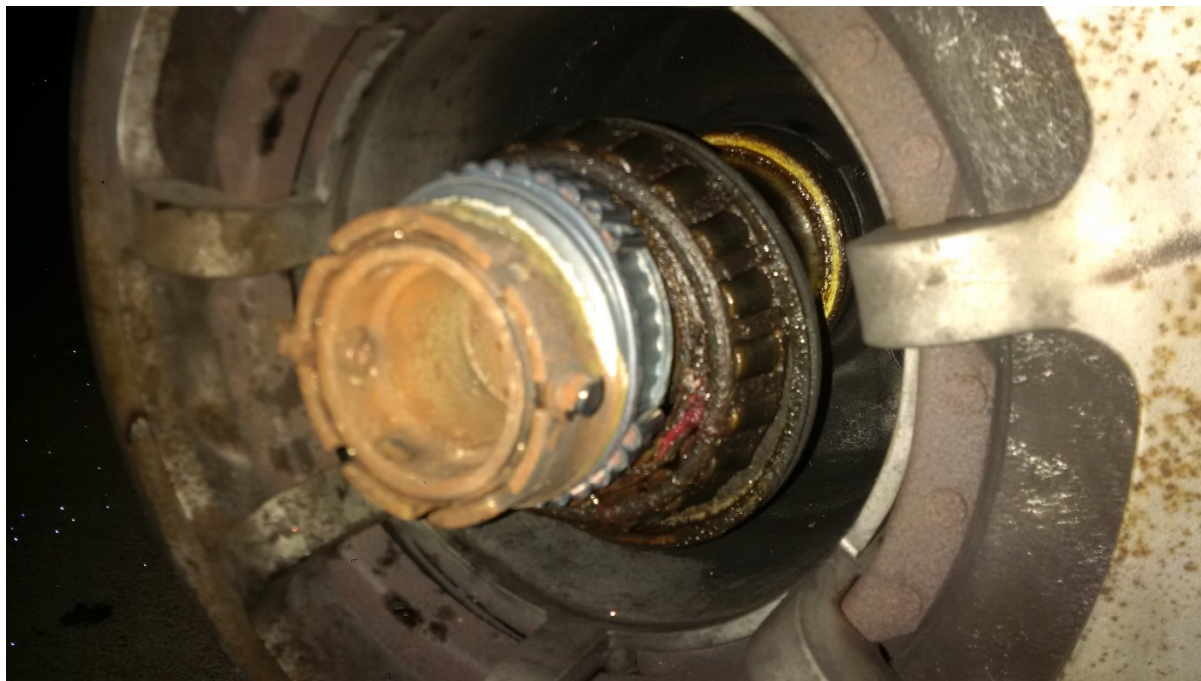
Fig 1: Axle showing bearings still there and wheel missing.

Transport Canada wants to remind all operators that installation of aircraft wheels must be performed strictly in accordance with the Aircraft Maintenance Manual's (AMM) instructions.

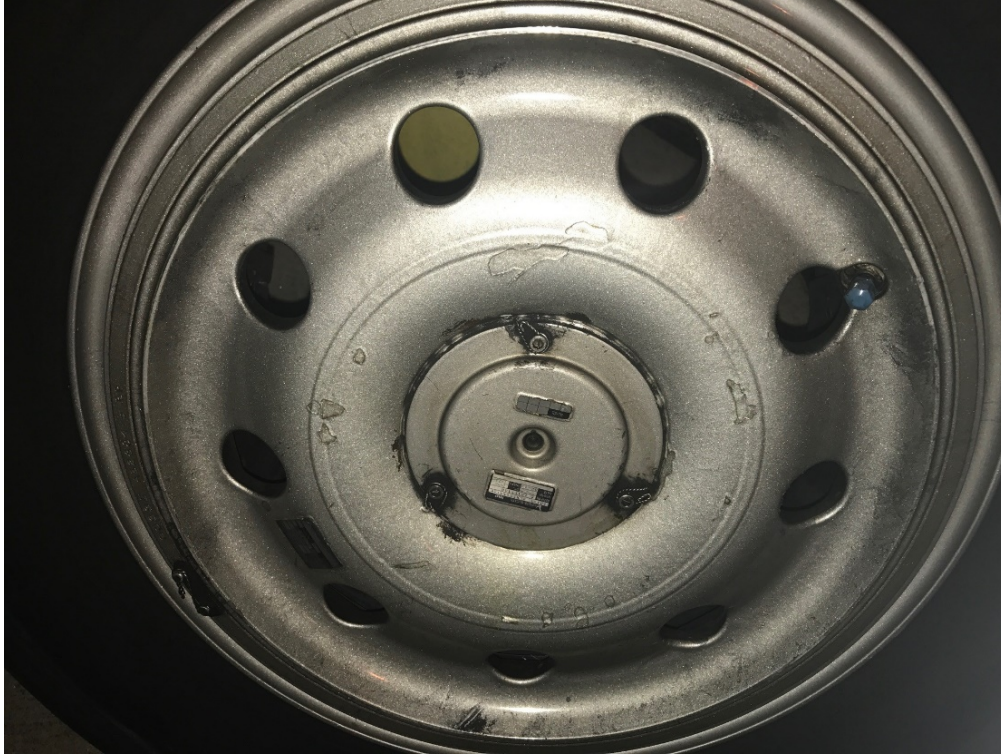
Fig 2: Wheel after being found.

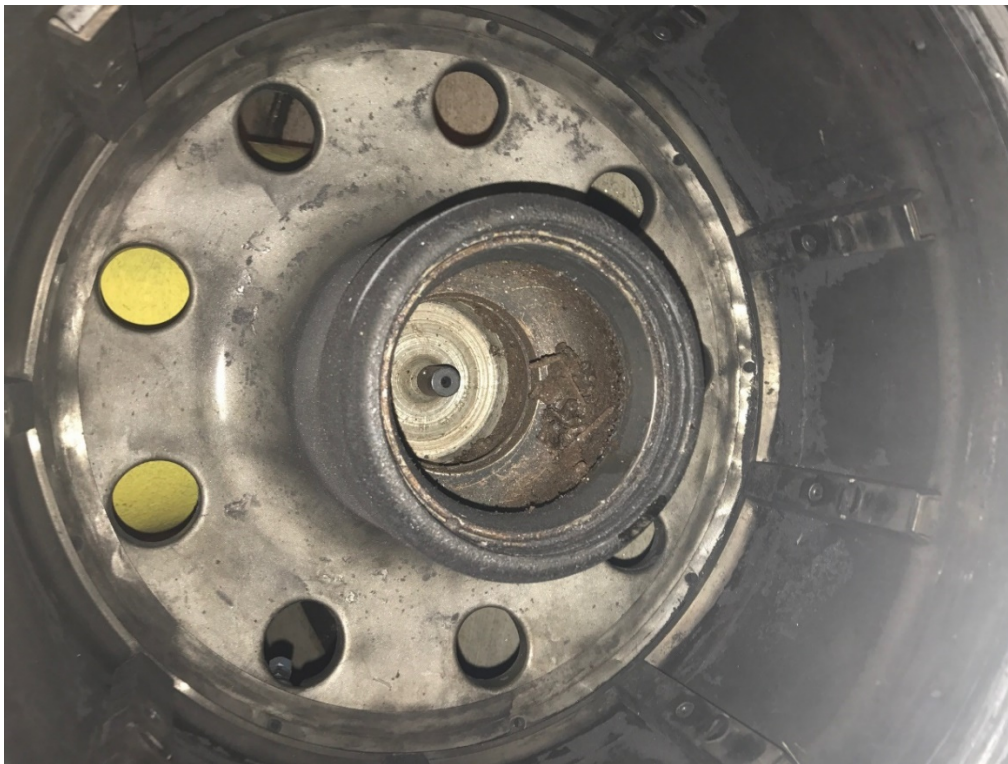
Fig 3: Inside of wheel showing residual materials from broken bearing. Note the different sizes of bearing races with larger diameter inner bearing.

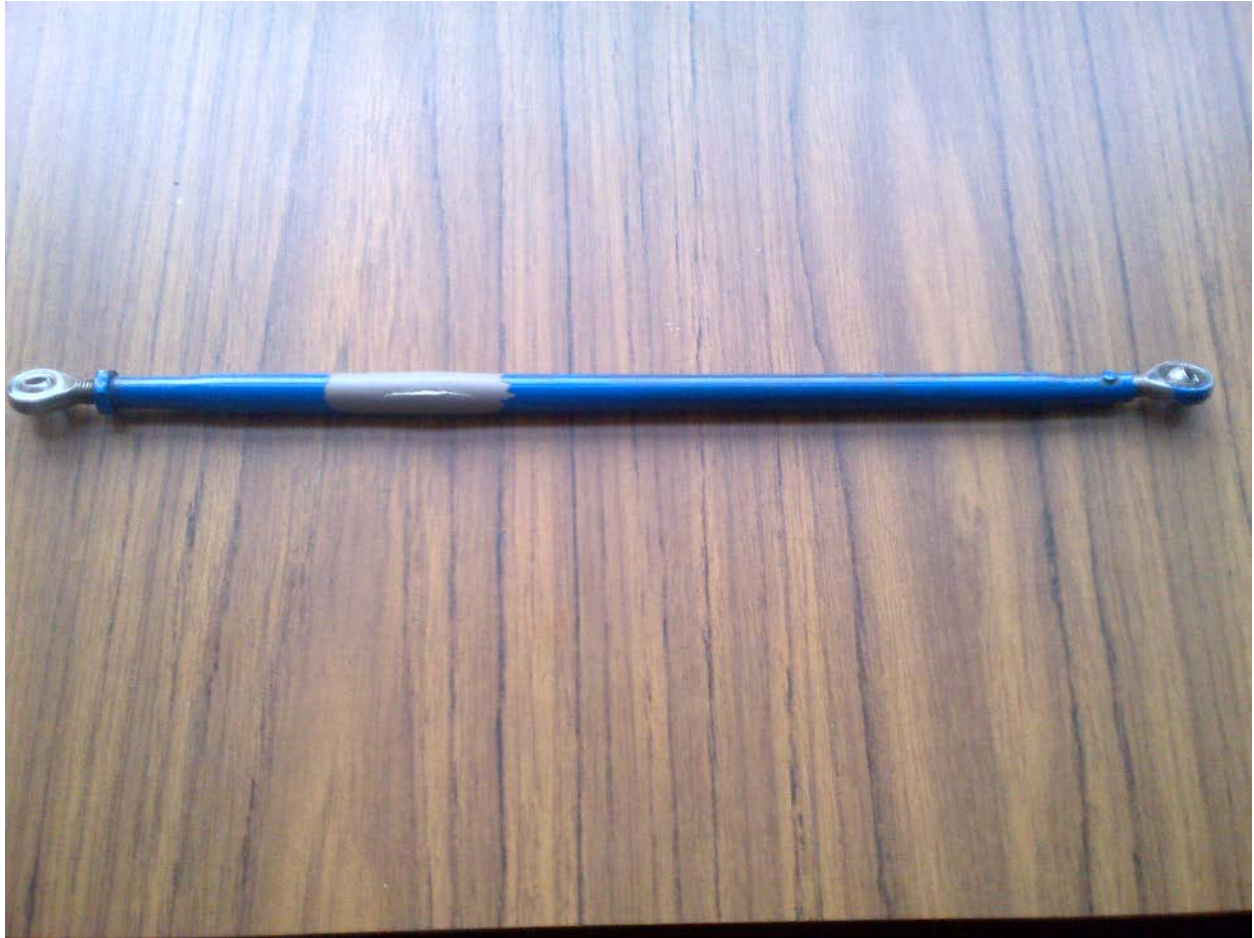
C6CW1048-1 Control Rod Assembly.

Transport Canada Civil Aviation (TCCA) recommends that DHC-6 operators and maintainers consider inspecting their fleets to see if they still have the older P/N C6CW1048-1 hollow tube control rods installed and if so, incorporating SB 6/472 due to the inherent safety benefits achieved by replacing the hollow tube rod assemblies with P/N C6CW1087-1 solid rod assemblies.

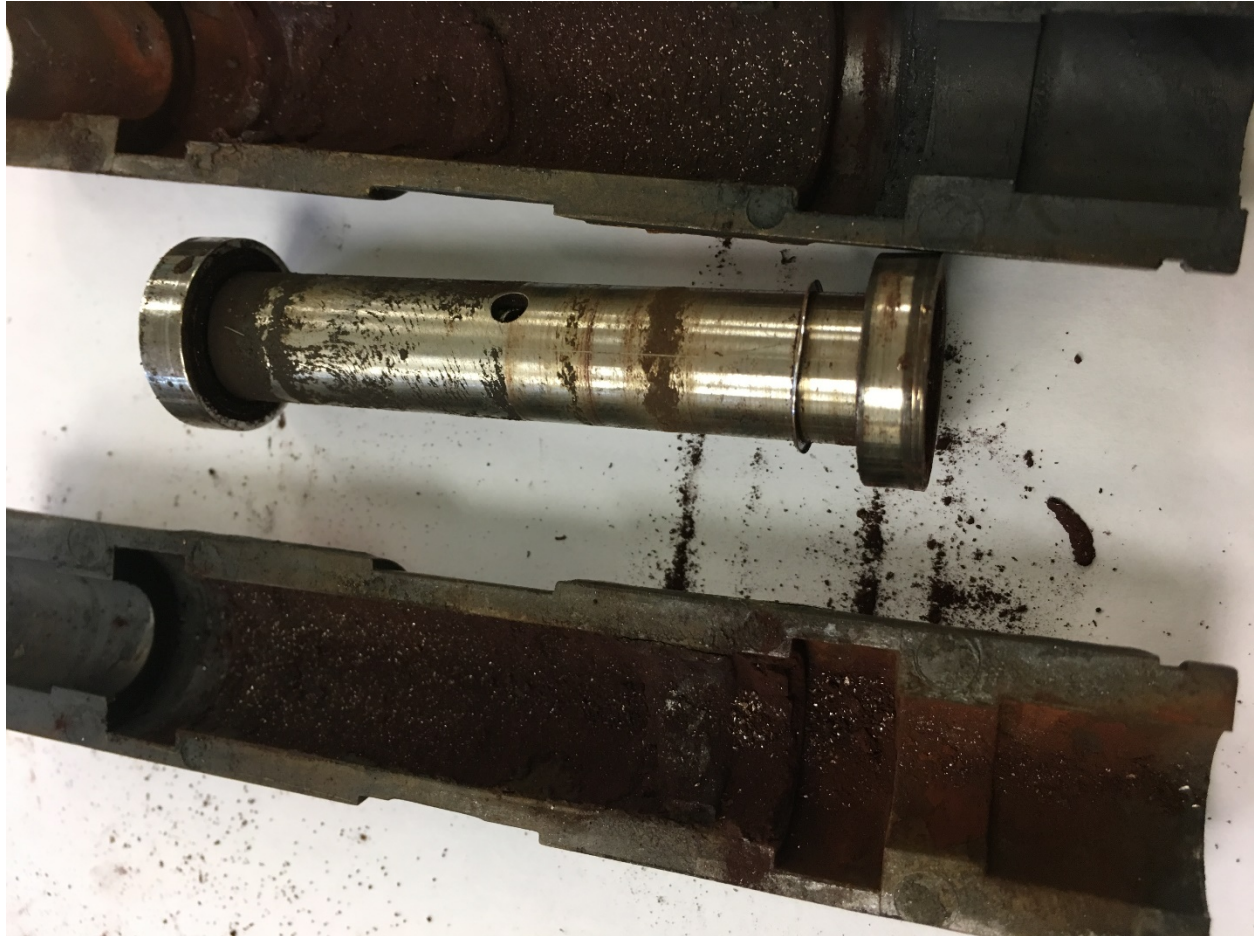
This drive coupling failed due to lack of lubrication. Aircraft operating environment has an impact on components that are sealed if the seals fail and let moisture in. These areas are very hard to inspect for preventive maintenance. Operators should track the reliability of these components and replace them at a predetermined interval that suits their operating environment.

Coupling without any lubrication.

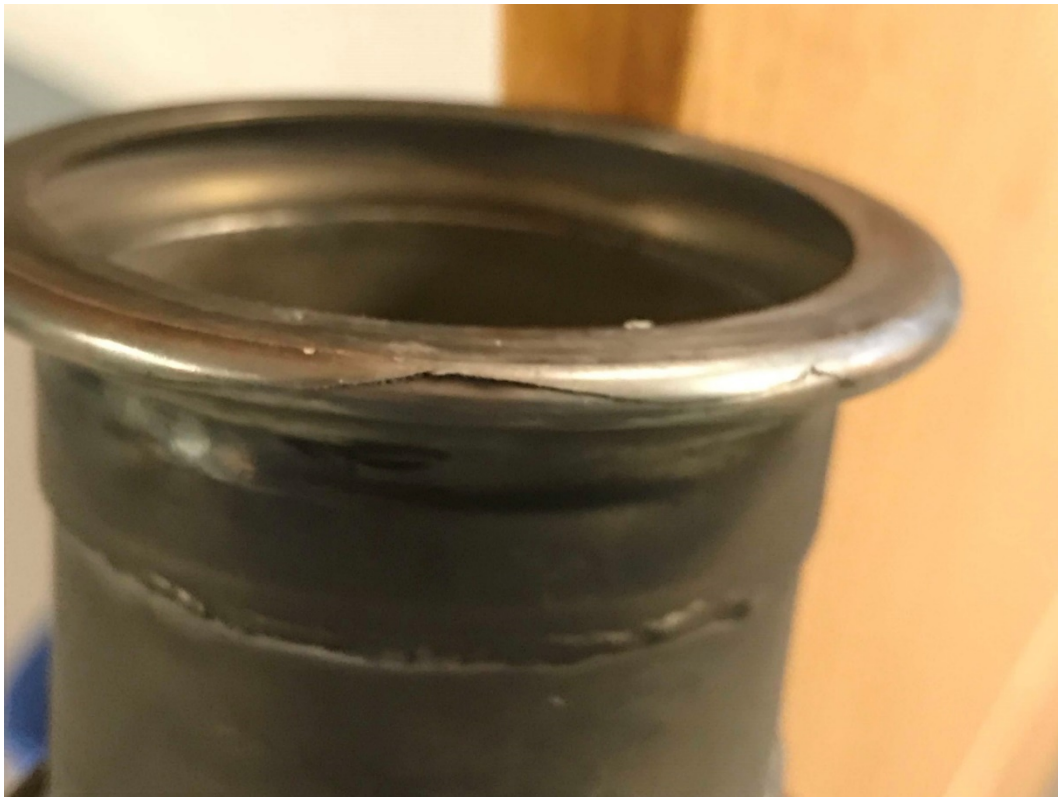
Cracks on ducts can be hard to find when they are hidden under clamps. Sometimes some disassembly will be required to find the damage. Also some parts are known to fail on regular intervals which makes troubleshooting easier if the person doing the work is familiar with the aircraft model.

Cracked flange on the pipe

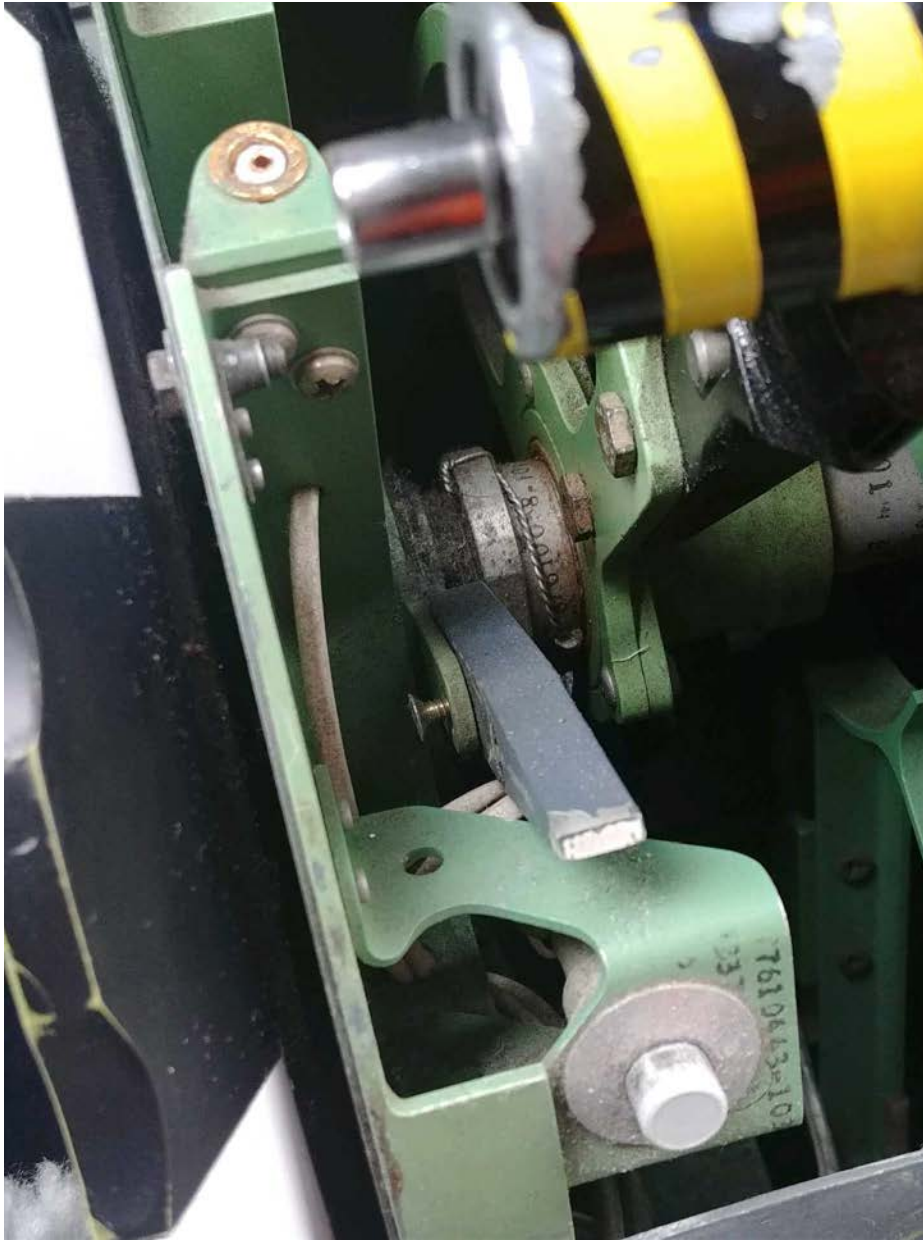
These screws are located in an area that is not accessed often and is easy to miss. Maintainers should make sure that free movement of the control levers or trim wheel is not restricted by loose parts. Also, when working in this area make sure that the screws and bolts have the correct torque when replacing parts.

Image shows the screw backed out from the lever.

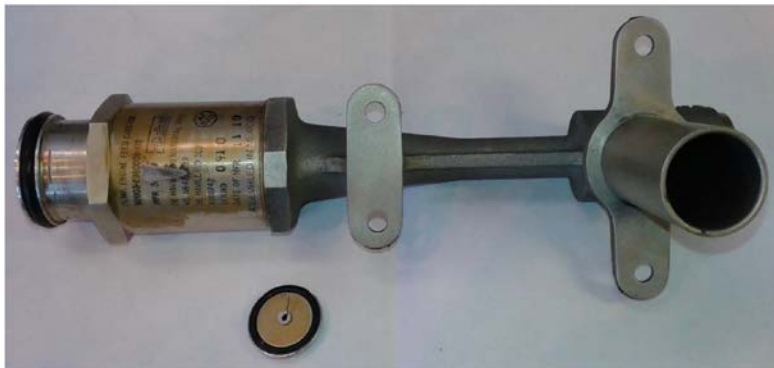
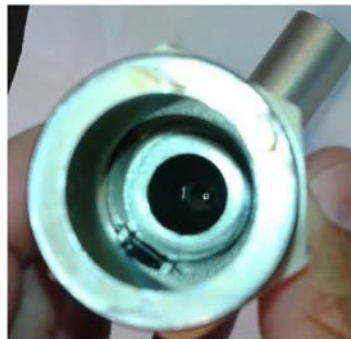
Broken ejector pump check valves are hard to troubleshoot since disassembly is required to find the failed parts. However, this type of failure can be expected to be found on older aircraft because moving parts do wear out and require replacement when they fail.

Photo: Ejector pump and damaged check valve

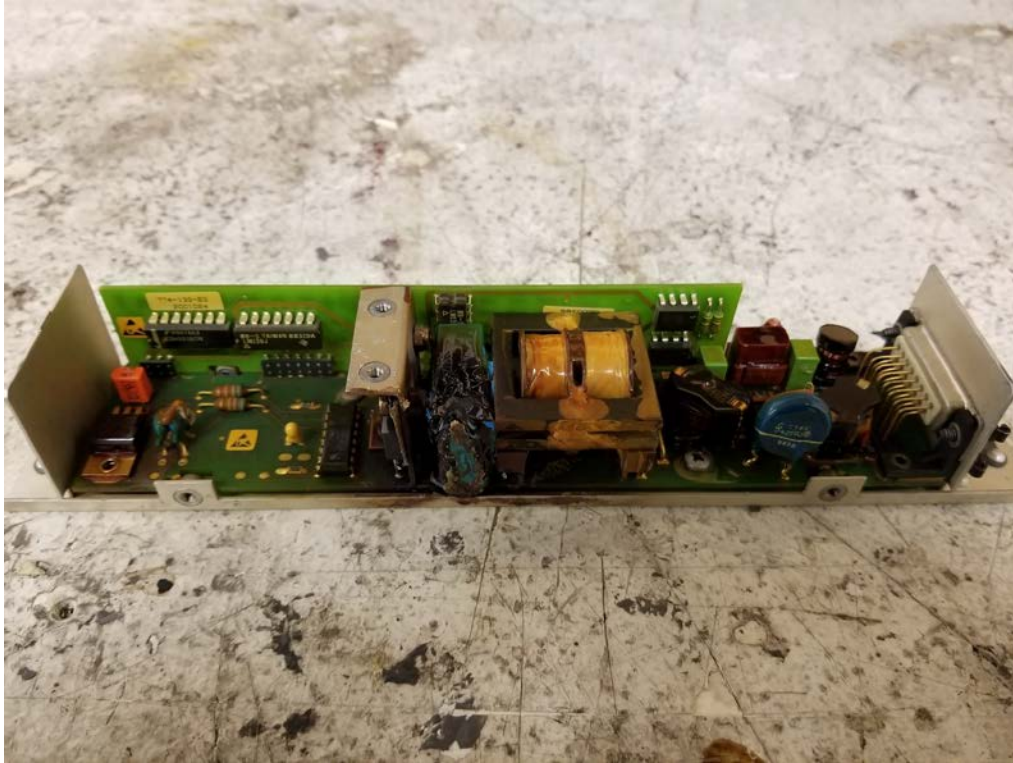
The quick reaction and persistent approach the flight attendant took in this case prevented what could have been a very different outcome. It can sometimes be difficult to pinpoint the source of electrical fires/smoke like in this case. Often, electrical components are buried behind sidewalls or under floor. During routine maintenance, a thorough inspection of these components could prevent inflight emergencies.

Pic 1: Internal view of Emergency Light Ballast. Notice the charred internal components.

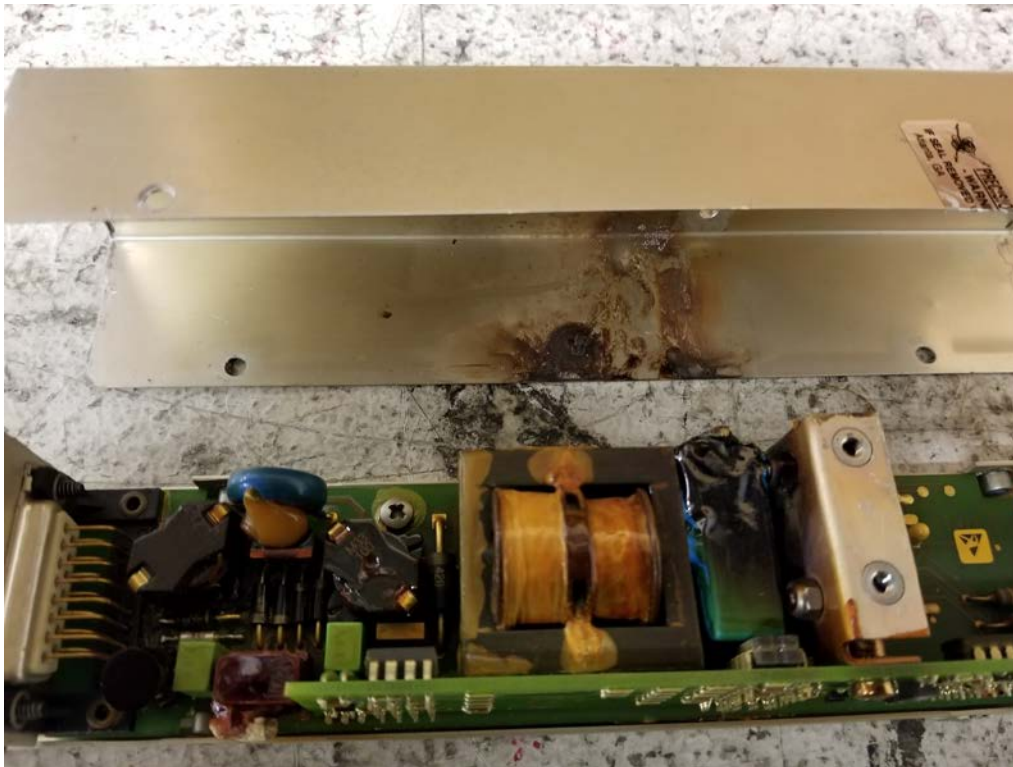
Pic 2: Scorching and heat residue on the inside surface of the Ballast cover.

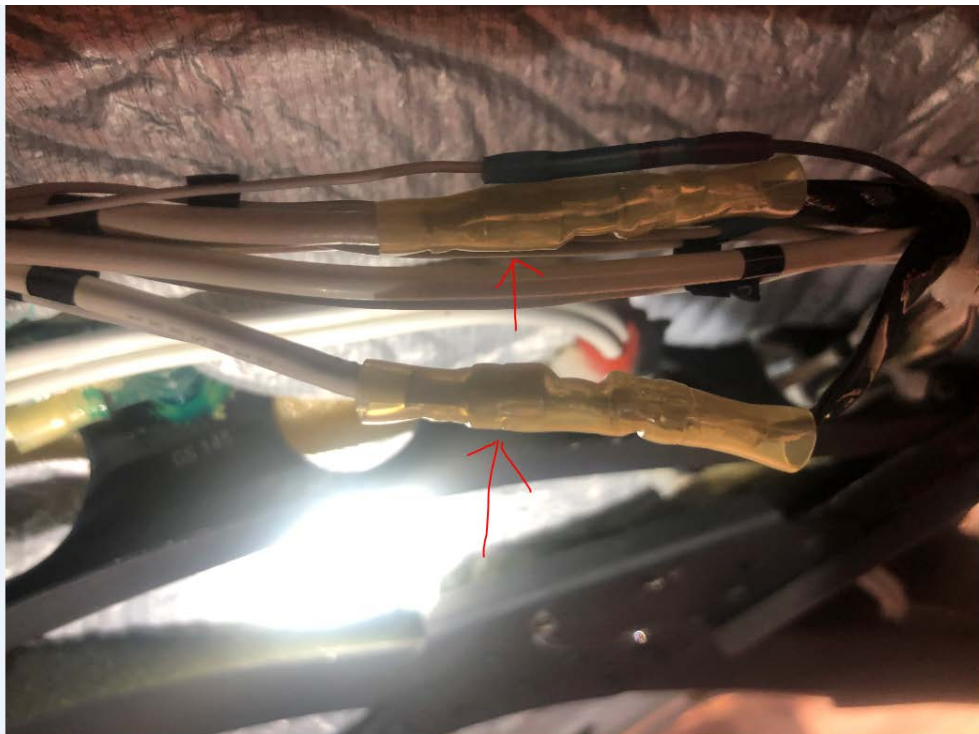
This special inspection proved its worth. Sometimes routine maintenance can seem mundane and uninteresting. This particular maintenance staff was able to find the exact issue the inspection was calling out. Following procedure and being attentive during inspections can save a crew from an inflight failure.

Pic 1 - Improperly spliced wiring

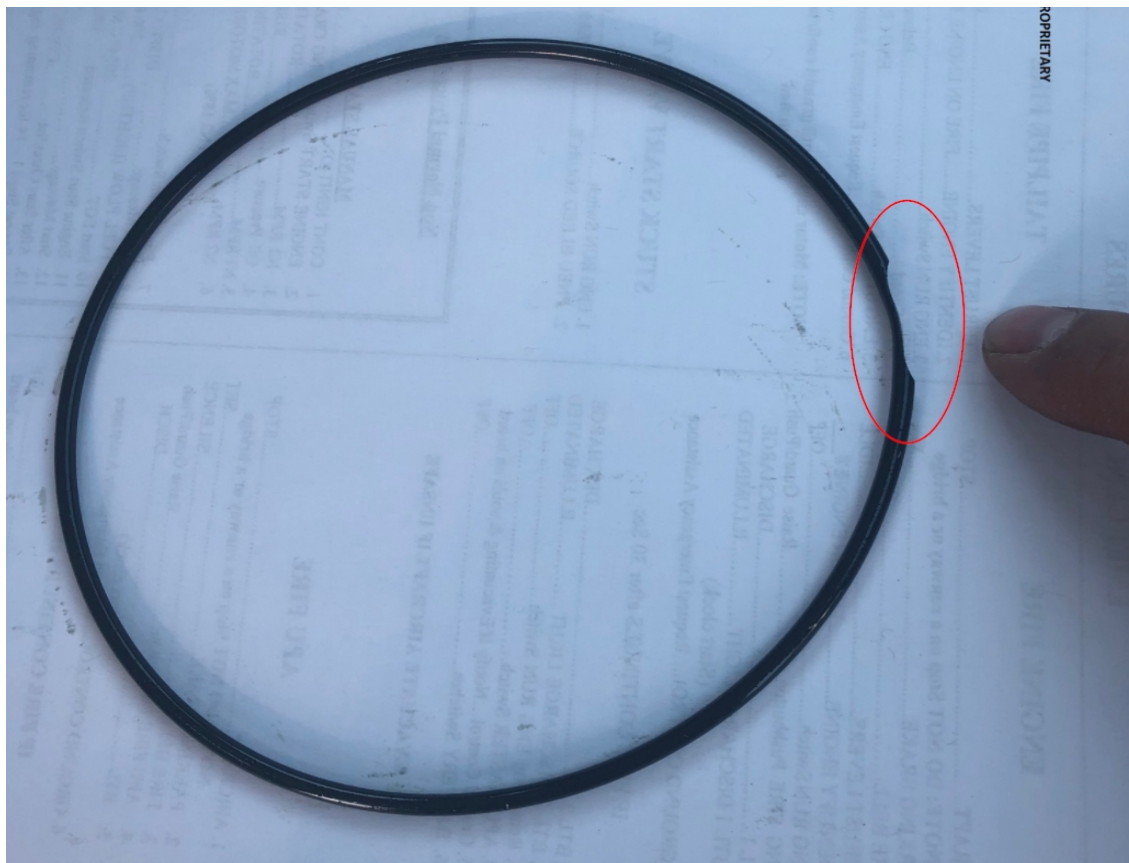
This event appears to be a “human factors” related issue and serves as a valuable reminder for maintainers to be diligent even when carrying out some of the most basic maintenance tasks. This Service Difficulty Report (SDR) highlights the importance of post maintenance procedures such as engine run ups and leak checks, verifying for correct part numbers, and adherence to instructions for O-ring lubrication prior to installation. Transport Canada supports and recommends the replacement of used O-rings after each use. Documenting and investigating events such as these through a Safety Management System (SMS) program could assist in determining a possible means of prevention in aviation organizations.

Example of Pinched O-ring

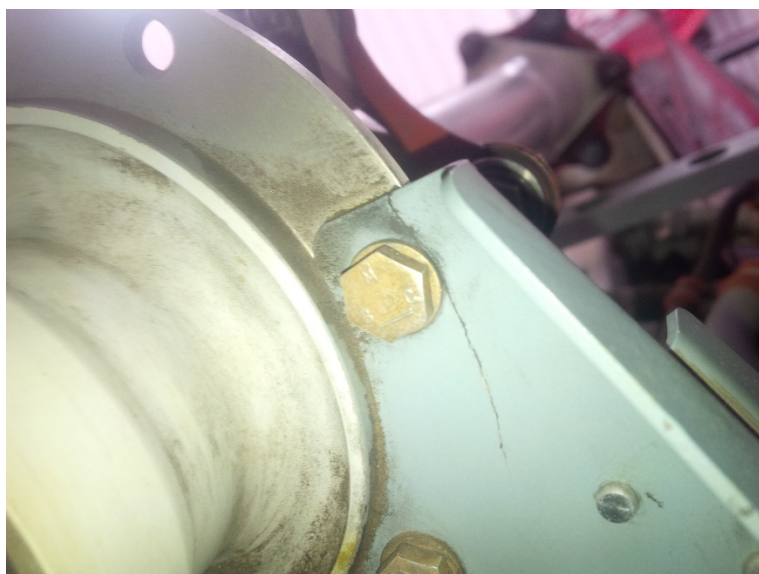
This Service Difficulty Report serves as a reminder to inspect all areas of the aircraft including the items in the post-flight inspection. The cracks may have been caused by the lack of grease in the bearing but detection prior to failure was definitely a break in the chain of events. Routine servicing can play a vital role in safety and serviceability of your aircraft.

Example of the crack found in the flange.

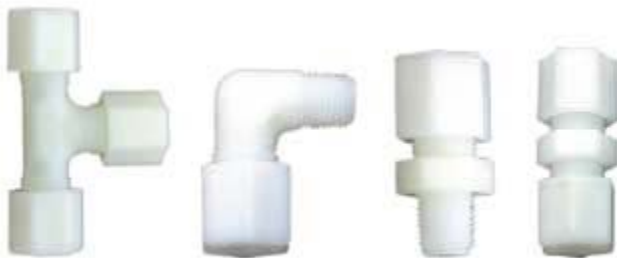
Transport Canada has received several service difficulty reports for the Bell 429 model helicopter with loose hardware on the pitot-static system. The loose hardware was investigated and found to be the result of incorrect tightening of the plastic fittings. Subsequently, Bell has amended the torque procedures for all plastic fittings in the instructions for continued airworthiness. Be aware that the torque values identified as standard practices can be different than the manufactures' instructions for a specified task. The Caution and Note sections for each procedure should be read carefully and adhered to as they may differ from one job to the next.

Example of the plastic fittings that can be found in a pitot-static system.
